## Preliminary Analysis of Slope Stability in Kuok and Surrounding Areas

Dewandra Bagus Eka Putra<sup>1,\*</sup>, Tiggi Choanji<sup>1,\*</sup>

<sup>1</sup> Universitas Islam Riau, Jl. Kaharuddin Nasution, Pekanbaru 28284, Riau, Indonesia

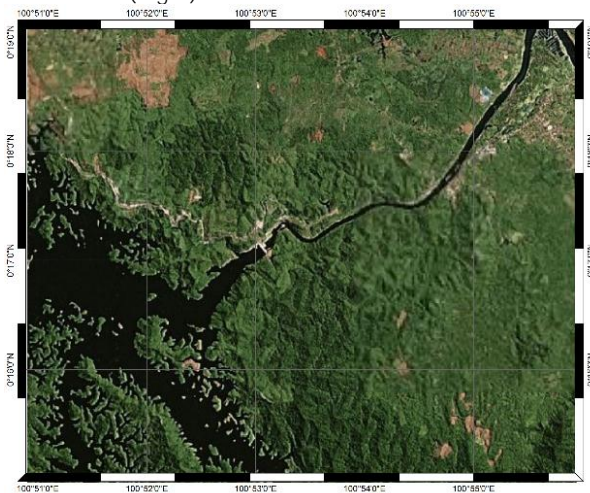
Fig 2. Topography map of research area

Kuok and the surrounding area are composed by several formations and geological structures which formed the topography at recent time (Figure 2). Based on the Geological Map of Pekanbaru [12] suggested that formation on the research area consist of Bohorok Formation (Pub) consist of Wacke, conglomeratic wacke and turbidite deposit; then also at the same age deposited Member of Tanjung Pauh (Pukt) of the Tapanuli Group that consist of muscovit chlorit cabonate schist with strong lineation. Then an intrusion of Granite Pulaugadang triad (MPigg), consist of strong foliation of granite gneiss. On the northeast side, Pematang Formation was deposited containing red and mottled mudstone, breccio-conglomerates and conglomeratic sandstones. After that Sihapas Formations (Tms) deposited on miocene which contains the conglomerate sandstone, and siltstone. The youngest formation on research area is Petani Formation (Tup) consisting of mudstone, carbonaceous, lignite, slightly siltstone and sandstone. (Fig 3).

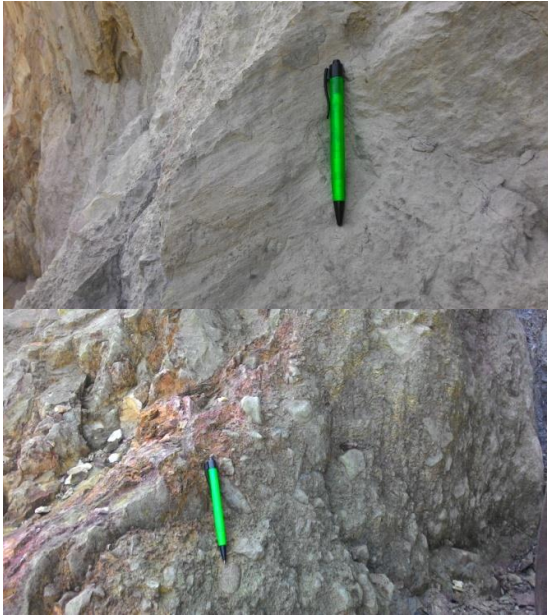
Fig 5. Fault breccias and slickenside feature indicating the slope was affected by a fault system.

A slope stability analysis had been assessed to the cut slope. The slope was considered as heavily jointed slope due to a fault system that developed in the site (Fig 5).

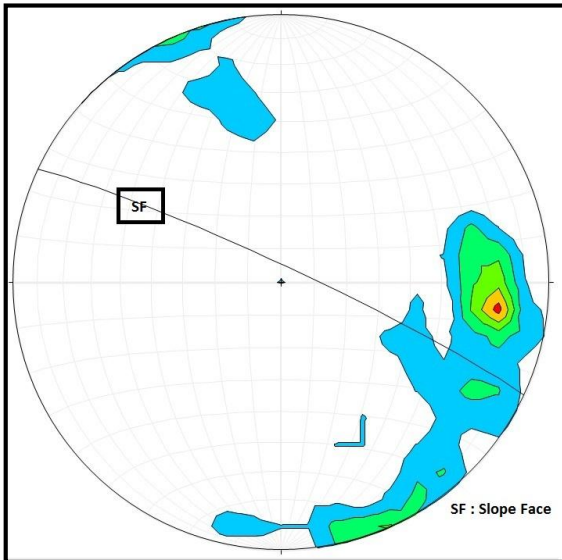
Fig 6. 1% area contour analysis to determine the major sets of joint.

The analysis had been conducted using Stereonet software to identify the mode of active failure and the potential failure zone of the slope. The slope face direction is N295E and 85o dip. Overall, 193 joint sets had been plot into the Stereonet and 2 sets of joint considered as major sets based on the 1% area contour analysis (Fig 6). The mode of failure had been analyzed based on the relationship between slope face and major joint sets plane. The mode of failure is toppling failure or rock fall and the potential zone of failure is in the center part of slope (Fig 7).

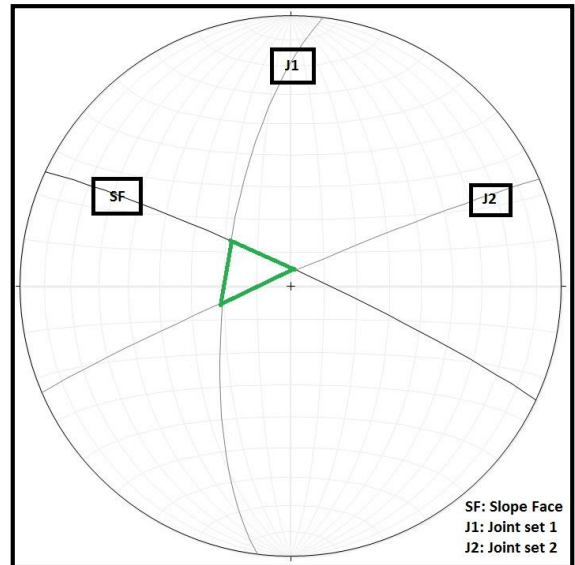
Fig 7. The mode of failure is toppling failure or rock fall (indicating by green triangle) and the potential zone of failure is in the center part of the slope.
