## **Alumina-on-Alumina Total Hip Arthroplasty. A Five-Year Minimum Follow-up Study**

Jeong Joon Yoo, Young-Min Kim, Kang Sup Yoon, Kyung-Hoi Koo, Won Seok Song and Hee Joong Kim  
*J Bone Joint Surg Am.* 2005;87:530-535. doi:10.2106/JBJS.D.01753

# ALUMINA-ON-ALUMINA TOTAL HIP ARTHROPLASTY

## A FIVE-YEAR MINIMUM FOLLOW-UP STUDY

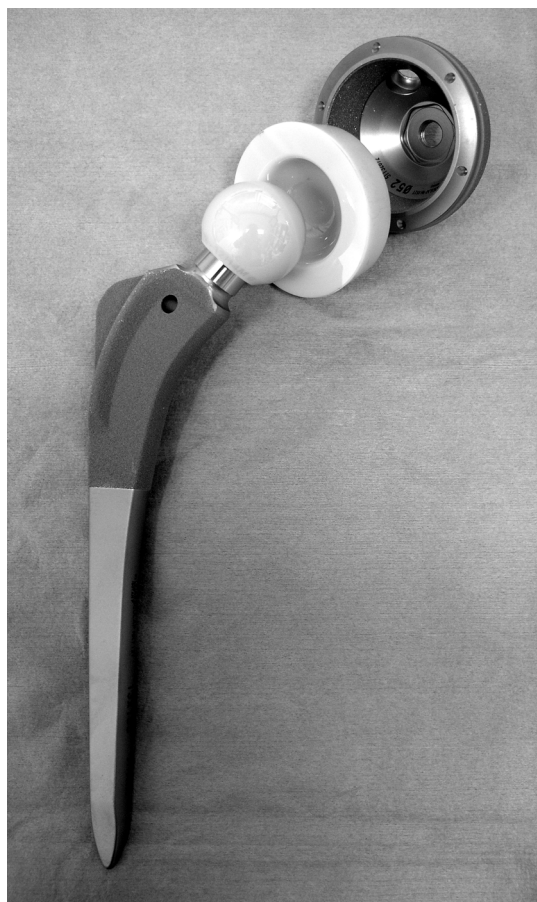
Fig. 1

Photograph showing the alumina-on-alumina PLASMACUP SC-BiCONTACT hip system. The PLASMACUP acetabular component is a titanium-alloy cup that is coated with Plasmapore with use of a plasma-spray technique. The BiCONTACT femoral component is a straight, tapered, rectangular, collarless titanium alloy stem, the proximal one-third of which is also coated with Plasmapore with use of a plasma-spray technique.

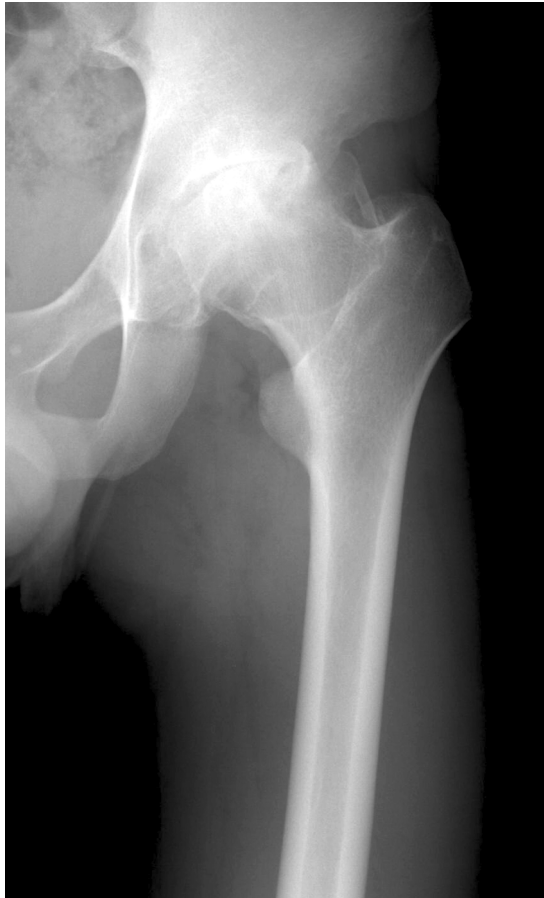
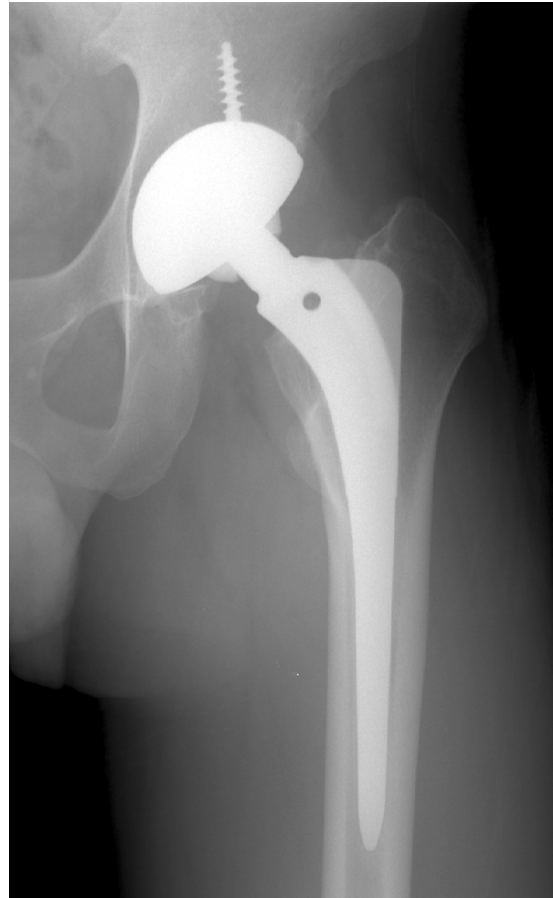
Fig. 2-A

**Figs. 2-A and 2-B** Radiographs of the left hip of a twenty-five-year-old man who underwent a total hip arthroplasty with use of the alumina-on-alumina PLASMACUP SC-BiCONTACT hip system. **Fig. 2-A** Preoperative radiograph showing the sequelae of hip-joint infection. **Fig. 2-B** Radiograph, made five years postoperatively, showing no evidence of osteolysis or loosening.

Periprosthetic osteolysis was not detected around any cup or stem, and there was no radiographic evidence of ceramic wear in the thirty-seven hips that could be so evaluated (Figs. 2-A and 2-B).

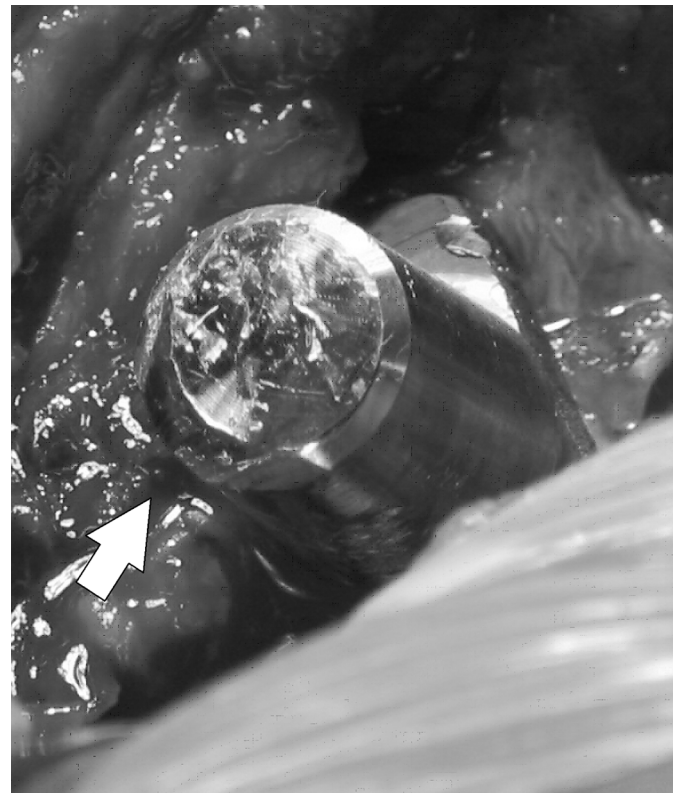
Fig. 3-B

Photograph showing damage to the inferior portion of the summit of the Morse taper of a well-fixed stem (white arrow).

One patient sustained a fracture of the alumina femoral head and a peripheral chip fracture on the posterosuperior portion of the alumina acetabular insert following a major motor-vehicle accident that occurred four years and two months postoperatively. Intraoperative examination showed that the inferior portion of the summit of the Morse taper of the well-fixed stem was damaged (Figs. 3-A and 3-B). So-called stripe wear (a long, narrow area of damage on ceramic bearing surfaces caused by edge loading of the bearing<sup>20</sup>) was not observed on the fractured ceramic head. After extensive débridement and synovectomy to remove as much of the ceramic debris as possible, a new cobalt-chromium femoral head and a polyethylene insert were implanted. The stem and the cup were left in place.
