Ceramic Fracture Following Cervical Disc Arthroplasty

A Case Report

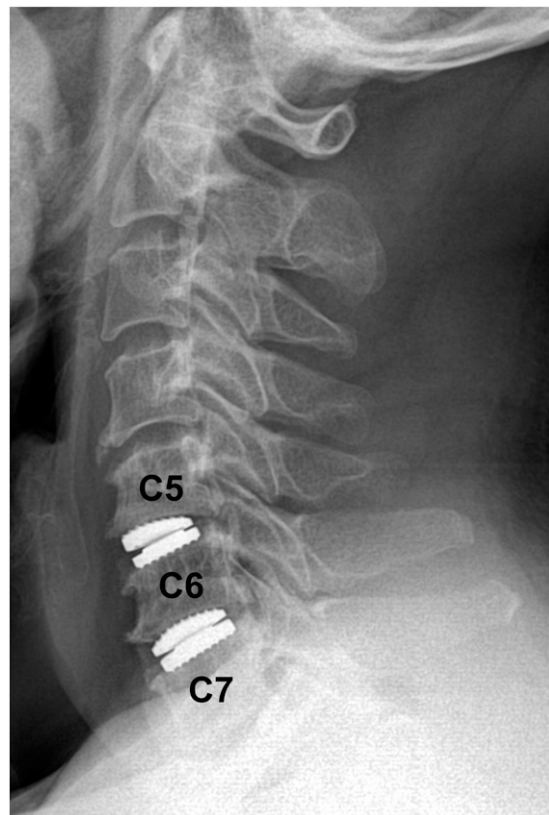
Fig. 1
Lateral cervical spine radiograph showing artificial discs at the C5-C6 and C6-C7 levels with no definite evidence of ceramic fracture, although, in retrospect, the distance between the metal plates at the C6-C7 level appears slightly decreased compared with that at the C5-C6 level.

An important consideration in ceramic fracture following cervical disc arthroplasty is whether the implant fracture can be diagnosed without surgical exploration. Since our patient did not have a history of abnormal impact loading, did not feel a crunching, cracking, or squeaking sensation or sound, and had no acute onset of symptoms, there were no clinical reasons to suspect fracture of the prosthesis. Most alarmingly, the imaging studies yielded no clues to suggest that the ceramic component had fractured. Even in retrospect, with full knowledge of the events, the ceramic fracture was not seen on the imaging studies. Evaluation of the prosthesis on the CT scan (Fig. 2) and MRI was limited by the metal artifact. Even though the distance between the metal plates at C6-C7 on the lateral radiograph may appear slightly decreased, the decrease is minimal and was considered an indeterminate finding (Fig. 1), possibly because the fragments were contained in the concavity of the lower liner, preventing total collapse.

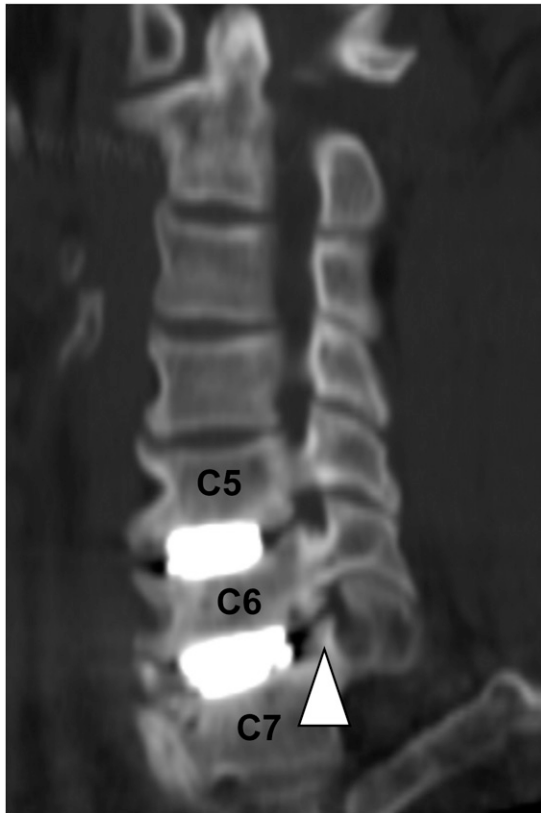
Fig. 2
CT image with sagittal foraminal oblique reconstruction showing a right uncoforaminal spur (arrowhead) at C6-C7.

tomography (CT) scan (Fig. 2) demonstrated a large right paracentral spur at C5-C6 and foraminal stenosis at C6-C7 on the right, raising the question as to whether he should have undergone cervical disc arthroplasty initially. Since he had had no improvement in symptoms with nonoperative treatment, the patient requested revision surgery. Given the persistent spondylotic changes and inadequate decompression at both levels as well as evidence of C6 and C7 radiculopathy, removal of the cervical arthroplasty devices and anterior cervical fusion from C5 to C7 was recommended.

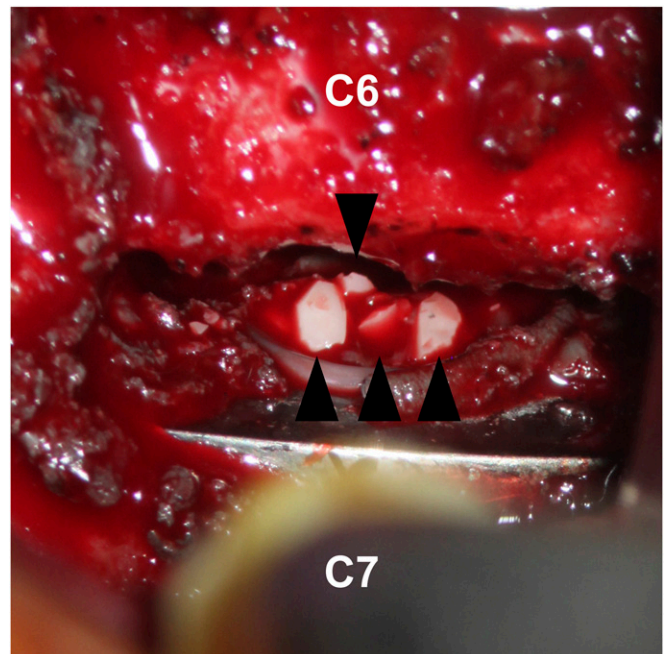
Fig. 3
Intraoperative photograph of the C6-C7 level, made after removal of the cranial part of the artificial disc from the lower end plate of C6, demonstrating four fractured fragments (arrows) of the ceramic ball lying on the remaining caudal part of the implant. The other fragments have already been removed.

Intraoperatively, the metal plates of the implants were well fixed to the vertebral end plates; they were separated from the end plates without difficulty by gently inserting a 5-mm-wide osteotome between the metal plate and the end plate with use of a mallet. There was no notable bone loss during implant removal. After removal of the cranial metal plate from the C6-C7 level, we noted that the ceramic ball in the cranial part of the implant had been comminuted into approximately ten pieces (Fig. 3), while the portion of the ceramic insert within the cranial metal plate remained unfractured (Fig. 4). The fractured fragments were surrounded by scar tissue around the metal plates and thus did not cause direct compression on or injury to the neurovascular tissues with their sharp edges. There were numerous scratches in the anterior parts of both the cranial and the caudal metal plate (Fig. 4). A complete foraminotomy on the right side and an anterior cervical fusion were performed (Fig. 5). At C5-C6, the implant was intact.

Our patient denied experiencing trauma or participating in sports activity that might have caused notable axial impact loading. We believe that some degree of repetitive shear force is likely to be applied on the ceramic ball of the artificial disc even without trauma, since there is normal anteroposterior motion coupled with flexion and extension. The fact that the part of the ceramic insert within the cranial metal plate remained intact while the convex-ball portion was fractured supports the hypothesis that shear force was the cause of fracture. Had it been axial impact loading, one might expect that both parts of the cranial ceramic insert would have been fractured. Since this semiconstrained implant permits only spherical motion and does not allow anteroposterior motion, shear forces to the convex

portion of the ceramic implant could have been present, predisposing the ceramic implant to fracture, especially since ceramics are known to be brittle with shear forces¹.

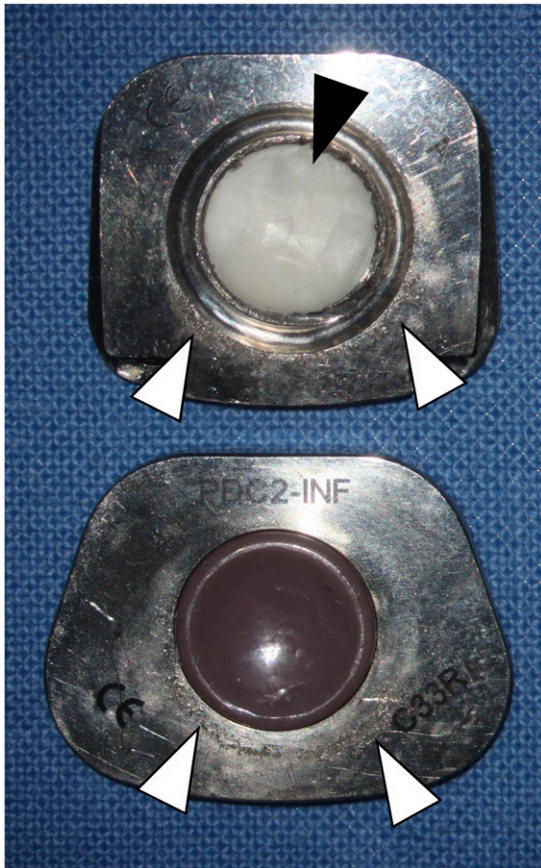
Fig. 4 Photograph of the implant removed from the C6-C7 level. The part of the ceramic insert located within the cranial metal plate (black arrowhead) remains intact, although the ceramic ball had been fractured off and is not seen in this photograph. The anterior parts of both the cranial and the caudal metal plate are scratched (white arrowheads). These scratches were likely made by the sharp edges of the fractured ceramic fragments. **Fig. 5** Lateral cervical spine radiograph obtained six months following the revision operation, demonstrating anterior cervical fusion and plate fixation from C5 to C7.
