HIDROMETEOROLOŠKI ASPEKTI POPLAVA U MAJU 2014. NA SLIVU REKE SAVE I U SRBIJI

HYDROMETEOROLOGICAL ASPECTS OF FLOODS IN MAY 2014 IN THE SAVA RIVER BASIN AND IN SERBIA

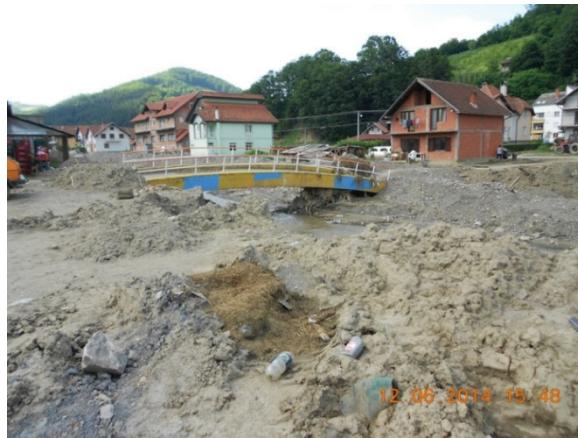
Slika 1: Prizori poplave 2014. godine u Krupnju
Figure 1: Scenes from the 2014 flood in Krupanj

Intenzivne kiše u maju 2014. godine su izazvale pojavu velikih voda na bujičnim tokovima u zapadnoj Srbiji. Najpoznatiji je primer poplave Krupnja, u kome se susiće nekoliko malih, bujičnih vodotoka. Iako su sve ove bujice bile regulisane na potezu kroz naselje, njihovi slivovi nisu bili uređeni. Krupanj je popavljen za vrlo kratko vreme, uređena korita su potpuno uništena i zatrpana ogromnim količinama nanosa, a pokrenuta su i brojna klizišta.

The heavy rainfall in May 2014 triggered high water flows of torrential streams in western Serbia. The most notable example was the flood in Krupanj, where several small torrential streams joined forces. Although the in-town courses of these streams were all trained, their catchment areas were not properly managed. Krupanj was flooded in a very short time; the trained sections of the channels were totally destroyed and covered with enormous amounts of sediment, while many landslides were activated.
