PROVISION OF BARRIER-FREE ENVIRONMENT AT WATERFRONT DEVELOPMENT IN MALAYSIA

ABSTRACT

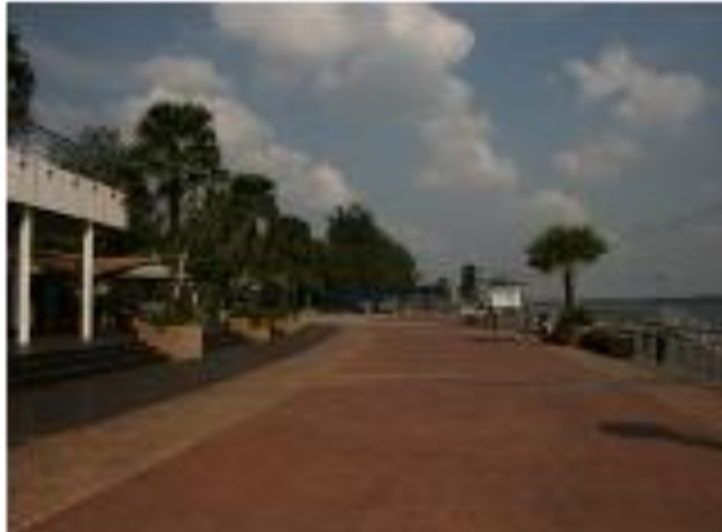
Figure 3: The Promenade

The main path along Danga Bay is the promenade that is wide and accessible for the PwDs, especially the wheelchair users. Meanwhile, at the Bay Leaf Court, the use of wood as paving surface that is not properly maintained creates a lot of hazard to those using crutches and wheelchair as well as the vision impaired due to uneven surface. The ramp at the International Restaurant is also made of wood, where it is quite steep for the wheelchair user to utilize (as stated to the MS 1331:2003, MS 1184:2002, MS 2015: Part 1-4: 2006, slope of 1:12). Guiding blocks are also not available to guide the vision-impaired to move in and around the Danga Bay. The width of the promenade is between 8 to 13 meter and in accordance to MS 1331:2003, MS 1184:2002, MS 2015: Part 1-4: 2006. The hand railings along the water edge fronting the Bay Court Leaf is too low to be of comfort to the vision-impaired. Since only this part of the promenade was equipped with railings along the water edge, the

rest of the water edge is exposed and thus can be dangerous for the vision-impaired. The other problem faced by the vision-impaired is the presence of many obstacles in the grounds, such as the roller coaster columns near the theme park, located along the promenade. The promenade is not exclusively for pedestrians as vehicles such as mini trains, bicycles and staff vehicles also share the promenade with the pedestrians. This is a problem to the hearing-impaired as they may not be able to know if there is a train coming from behind as no special lane is provided for the vehicles.

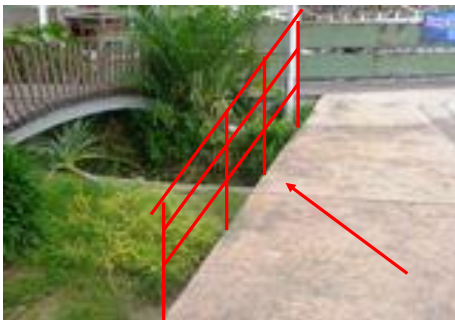
Figure 4: The part of the promenade which is not provided with railings that separate the path and the open drain

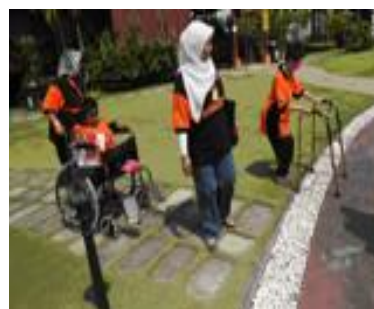
The overall Danga Bay development is fairly accessible to the PwDs with certain areas such as the Rumah Limas and the fair-grounds being not accessible by them. This is due to the paving materials and presence of obstacles that restricts movement by wheelchair users and those with crutches. The absence of tactile guiding blocks in the area meant that the vision-impaired person will have difficulties in orienting himself in the area. The other constraint observed is the mixture of vehicular and pedestrian traffic along the promenade that makes it dangerous for the hearing-impaired who cannot hear vehicles that come from behind. Some parts of the water edge as in Zone 1 near the Lido Beach area, are not fixed with railings making it dangerous for the vision-impaired. The choice of paving materials also makes this part of the development not friendly to wheelchair users and those with crutches.

Figure 5: Inappropriate paving materials that limits access

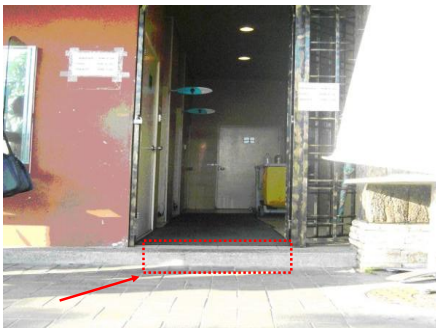
Figure 6: Inappropriate drop for entrance to toilet at the Festive Street Mall

The other toilet near the Festive Street Mall is also not accessible to the wheelchair user because of the huge drop and absence of ramp. The arrow in the picture shown in Figure 6 indicates the drop that is too high (more than 8cm) and therefore making it impossible for the wheelchair user to get into the toilet. The toilet cubicle itself, although being labeled as a toilet for the PwDs, is too small to allow for easy maneuver by the wheelchair user. Hence, despite the presence of grab bars built inside the toilet for the PwDs, the size of the toilets failed to accommodate the wheelchair user. The vision impaired will also find difficulties to access the toilets due to the absence of tactile blocks to guide them to the toilet and the absence of suitable signage with Braille letterings.
