Application of Universal Design in the Built Environment

**Editors:
Asiah Abdul Rahim
Ismawi Hj. Zen**

**INTERNATIONAL ISLAMIC UNIVERSITY
MALAYSIA**

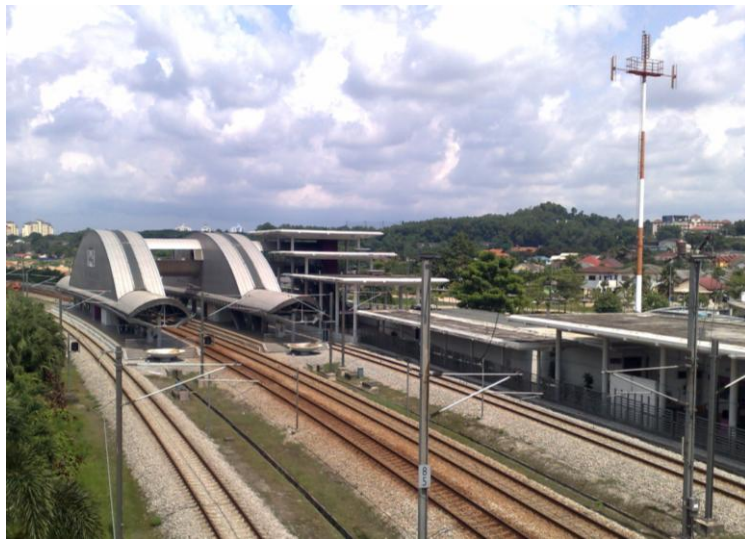
Figure 3.5:
The ERL KLIA Transit Station

Results from the access audits show that for ERL KLIA Transit accessibility from main entrance is good however not from the drop-off point as the drop is too high without curb cuts. There is no obstruction to the trains for all PWDs. However there is a gap from platform to the actual train which can be a danger to PWDs on wheelchair and on sticks. The ticket counter is slightly high for wheelchair users. For the vision impaired tactile guiding blocks are provided all along from main entrance right to the train platform. There is PWDs toilet available however no Braille signage to differentiate between male and female toilets. There is also no Braille on lift buttons.

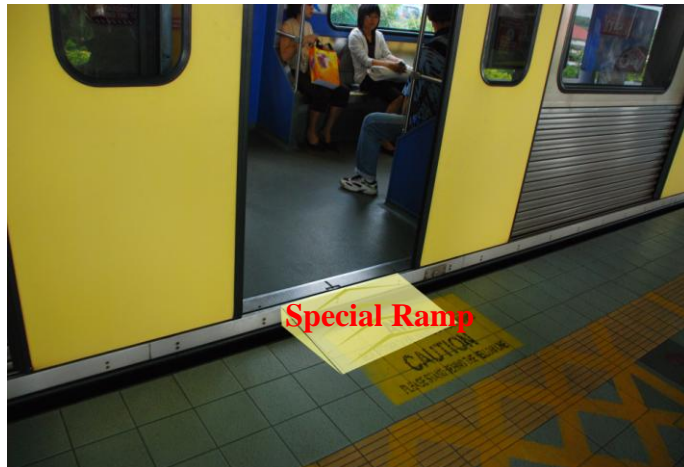
Figure 3.8:
Proposed mobile ramp for PWDs on wheelchair

Two years after this research was completed, and in 2011, Rapid KL Ampang is now upgrading their facilities by providing vertical circulation – that is to add lifts and other facilities for PWDs.

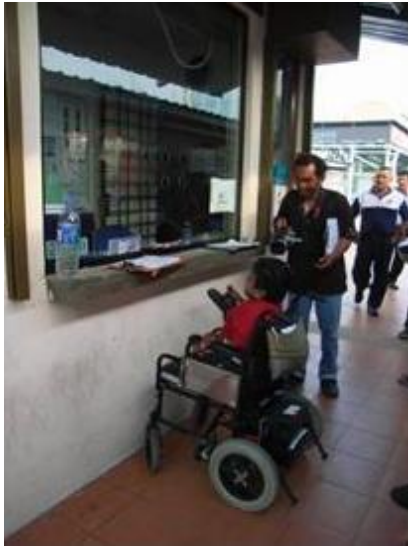
The terminal buildings allows pedestrians to be linked from the bus and taxi station at Raja Tun Uda Ferry Terminal Penang, aboard the ferry to Sultan Abdul Halim Ferry Terminal and connects them to the bus, taxi and KTM train station in Butterworth and vice-versa. The simulation found that PWDs were able to access the circulation route at Terminal Raja Tun Uda from Rapid Bus Station with ease. However no PWDs drop off point and car parking facilities were provided. The ticket counters were too high and without leg room for wheelchair users to comfortably engage in communication.

Figure 3.10:
High Counter Ticket

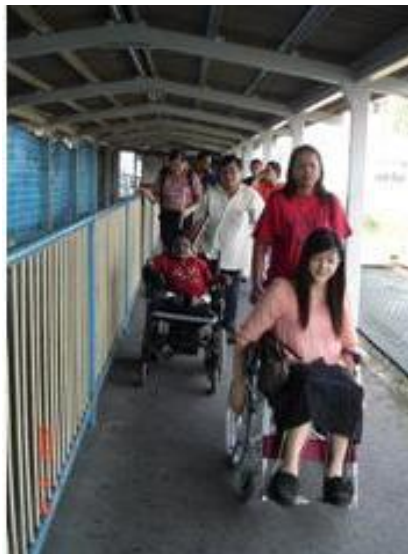
Figure 3.11:
Long Corridor

Long and narrow circulation path (2000mm wide) with uneven surfaces treatment due to wear and tear creates difficulty in PWDs mobility especially during peak hours between 6:30–8:30 am and between 4:30–7:30 pm. Placement of dustbins and uncontrolled parking along the circulation route hinders the movement of the PWDs. The use of tactile for the vision impaired were only found between the pathway from Rapid bus drop off point to the point connecting the main circulation route at Terminal Raja Tun Uda.

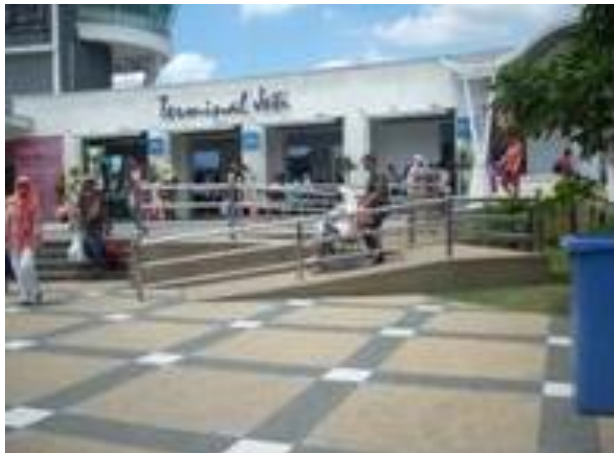
Figure 3.12:
Ramp leading into the Terminal

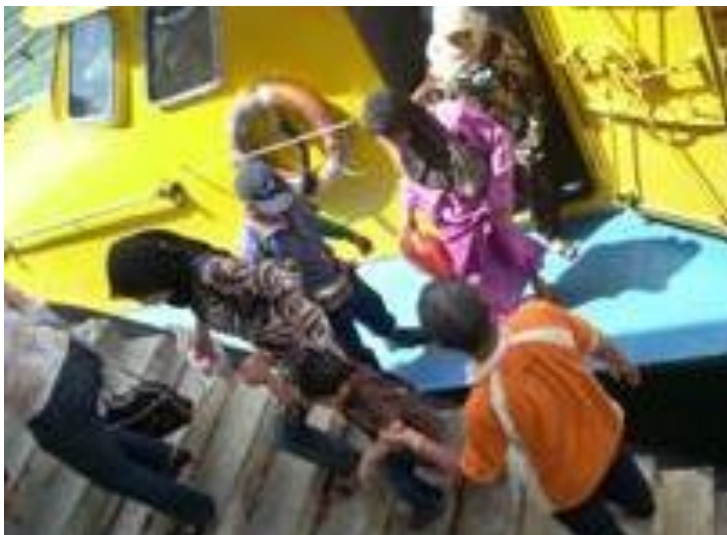
Figure 3.14:
Steep staircase into ferry

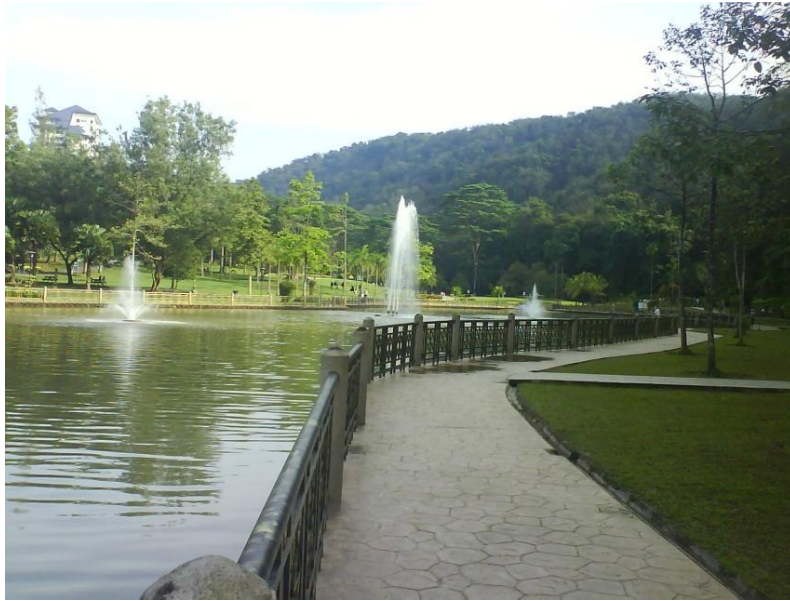
Figure 4.2:
Access around the main lake at Taman Rekreasi Kiara

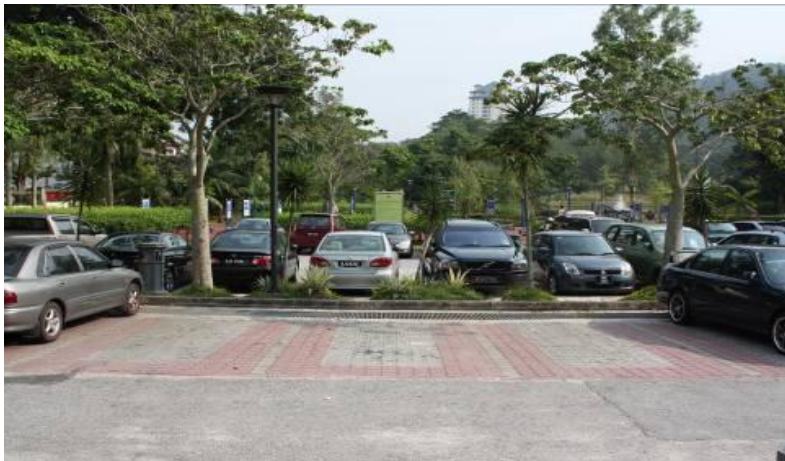
Figure 4.4:
parking space in Zone A

There are ample parking spaces for the users to park their vehicles. However, there is none for the disabled users. The pedestrians are able to reach most parts of the park. However, certain steep paths are not accessible to the wheelchair users. Signage indicating the forbidden areas for the wheelchair users is available.

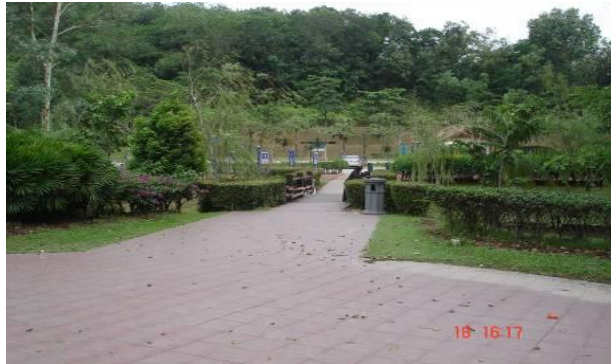
Walkways in Zone A are generally accessible and are disabled friendly; however it needs some enhancements to make it usable by all disabled persons categories, including the elderly and children. Wheelchair users found in this area expressed their satisfaction concerning their accessibility since there are not many changes of levels, particularly surrounding the main lake. The ground materials used are also in a good condition with concrete paving, which is suitable and do not harm the users and the jogging track offers shock-absorbing rubber material which is safe and suitable for joggers. It is proposed that ramp available to be installed with handrails on both sides of the ramp. To assist the blind, guiding blocks or any textural cues are good to be installed at any necessary locations especially that will direct them to important spaces such as resting areas, public toilets or seating facilities etc.

Figure 4.5:
Walkway in Zone A

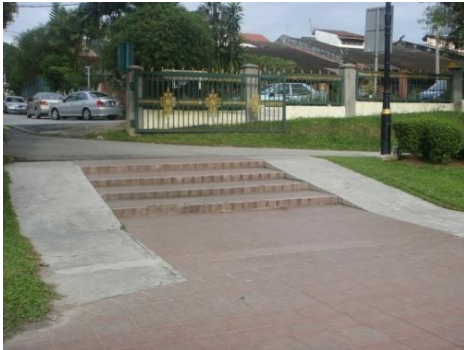
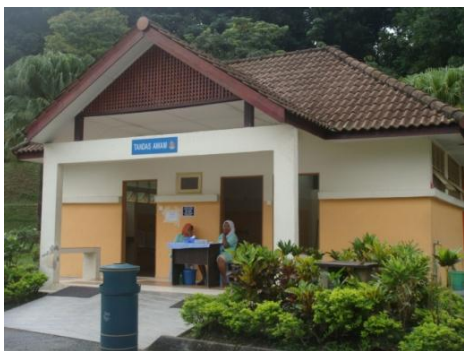
Figure 4.8:
Facilities provided for all

Two accessible toilet facilities are available for the users. Both are accessible to the disabled. However, the toilet in Zone A has been vandalized. Therefore, they need to be repaired. Wooden hanging bridge is available and accessible for all users to explore the nature.

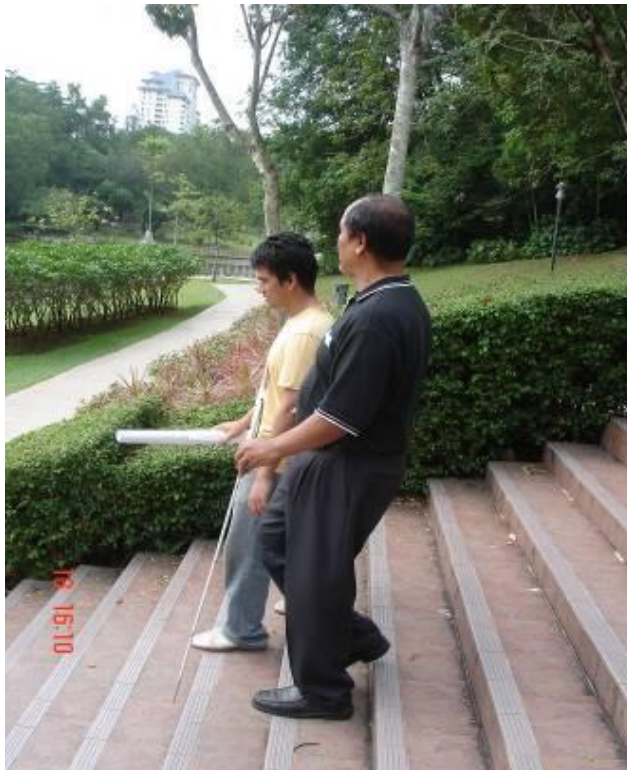
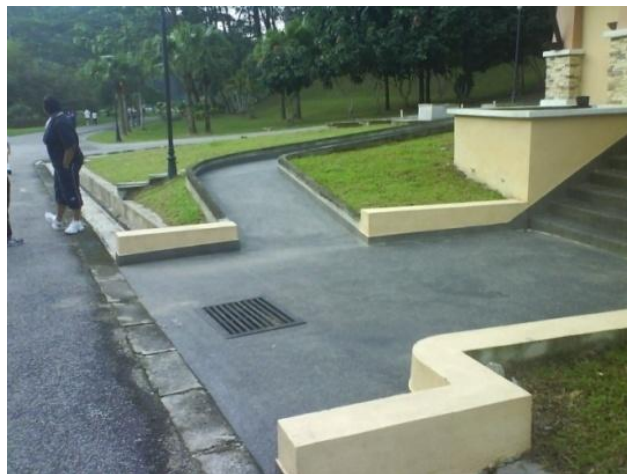
Figure 4.14:
Need improvement for users

On the whole, the park is accessible to all (the disabled, elderly and children). However, certain places such as the stairs need to have railing for the users to hold on to. The wheelchair pathway should also be provided with railing to ensure the safety of the users. This is because the gradient of the pathway is rather steep.

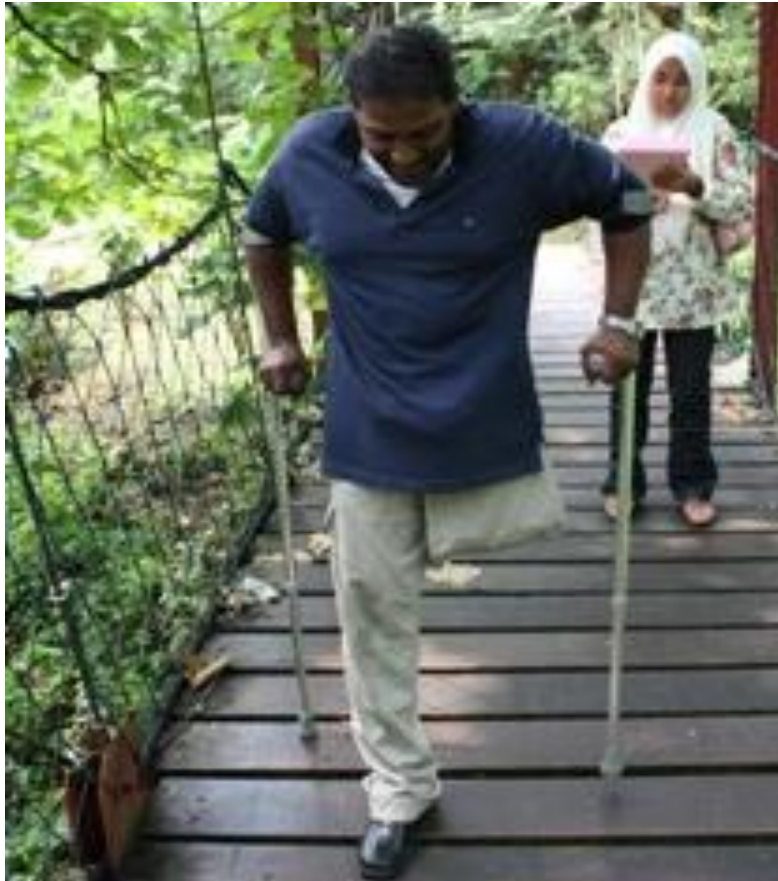
Hanging wooden bridge built across a river with manmade waterfall provides facility for the users without disturbing the terrain of the landscape. Close to the hill with secondary forest makes the sight soothing and calming.

Figure 4.16:
Hanging wooden bridge for users to appreciate nature

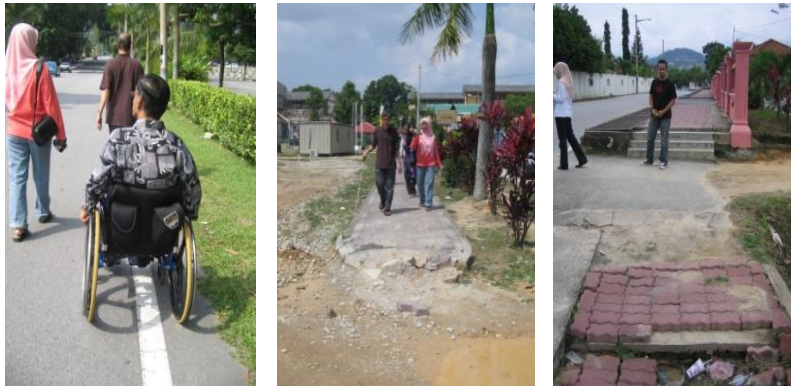
area as it can only be found in certain areas only. Problems encountered were often a combination of faulty or inadequate design and construction practices and inadequate maintenance of the facilities/infrastructure as shown in the following Figure 5.2 as follows.

Figure.5.2:
Not all areas have designated pedestrian pathway (left image);
and pathway not well designed and maintained
(middle and right image).

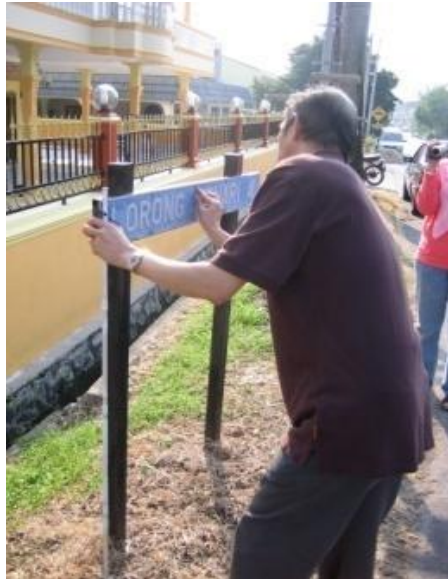
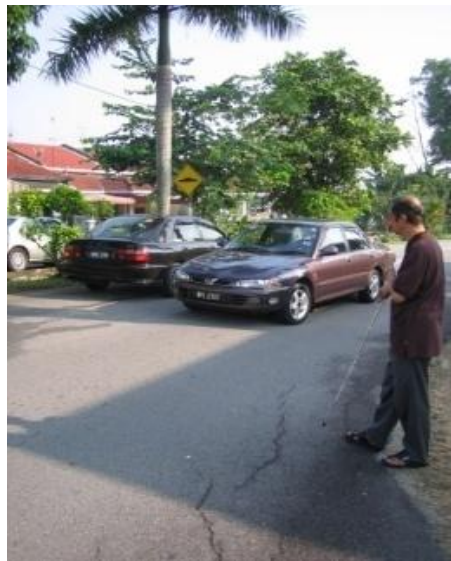
- Lack of legible directional signs, street names and numbering. Visual impaired person has difficulties in identifying the streets or the area as well as designated road crossing.
- Lacking of warning marking/tactile for road crossing. Thus, this leads to difficulties to safely cross the road especially for the vision impaired person. It was also found that not many people were aware of the sign given by the visual impaired person as he waved his stick vertically up and down to get motorist to give him way to cross the road.

Figure 5.3:
Image on the top shows the vision impaired person trying to identify the street's name, while image on the right shows him waving his stick vertically to cross the road.

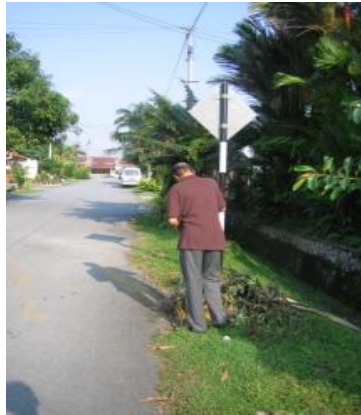
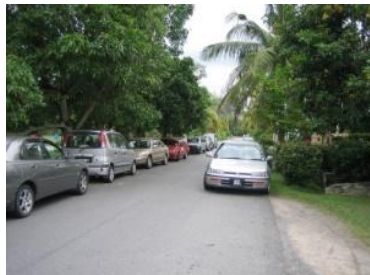
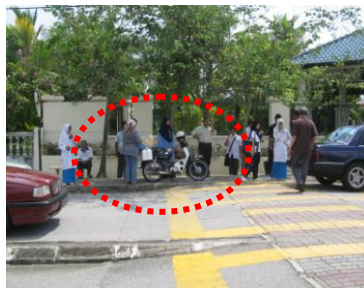
- Obstructed pathway by improper location of street furniture such as road sign, dustbin, telephone booths and such, as well as motorists that parked their vehicles on the roadside/pedestrian walkway.

Figure 5.4:
Improper locations of road sign (top image);

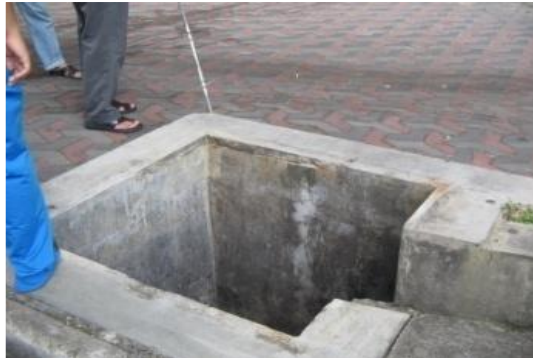
Figure 5.5:
The uncovered manhole can bring danger situation to the users especially people with visual impaired.

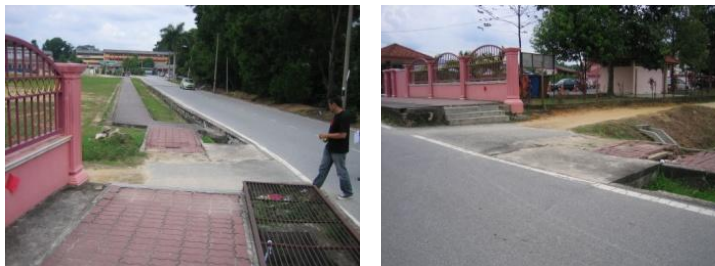
- Inconvenient and insufficient width of path
- Changes in level in the pathway that creates difficulties especially for wheelchair users

Figure 5.6:
Changes of level in the pedestrian walkway.

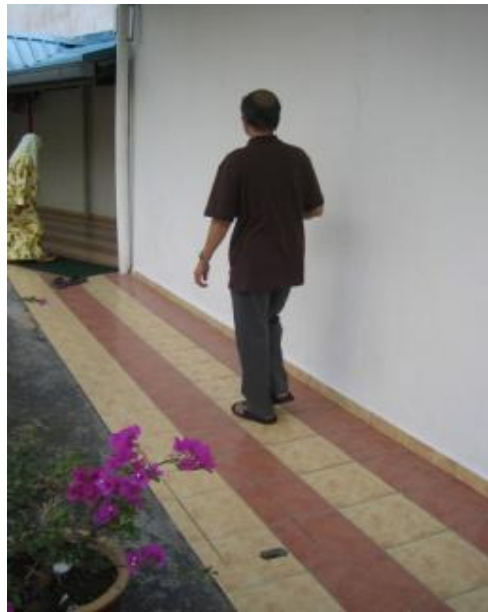
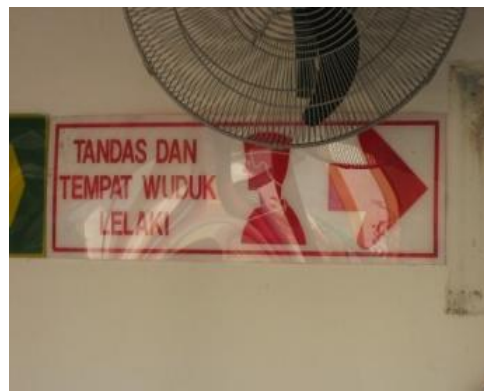
- Problems in way finding due to lack of signage (embossed signage is needed for the vision impaired) and marking.

Figure 5.8:
The vision impaired did not have
a clue to get to the facilities

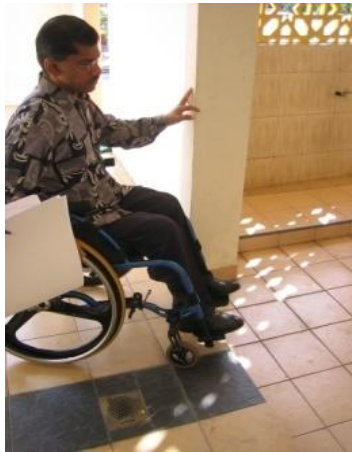
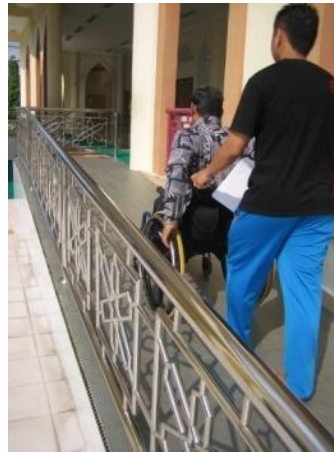
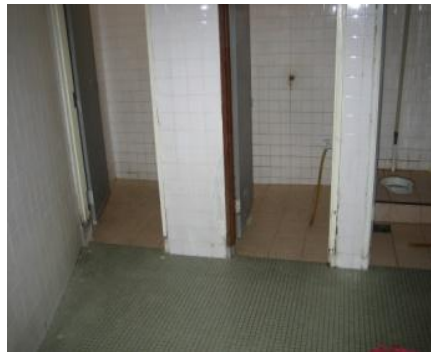
- Narrow toilet design with changes of leveling and only squatting toilet provided – cannot be accessed and used by the wheelchair user
- Raised platform at the ablution area – no access for the wheelchair user.
- Improper design of ramp – very steep and/or long ramp with no landing makes it difficult for the wheelchair user to get into the mosque building.

Figure 5.9:
Problems with the narrow and squatting toilet (bottom image), raised platform at the ablution area (top left image) and steep ramp with no landing (top right image).

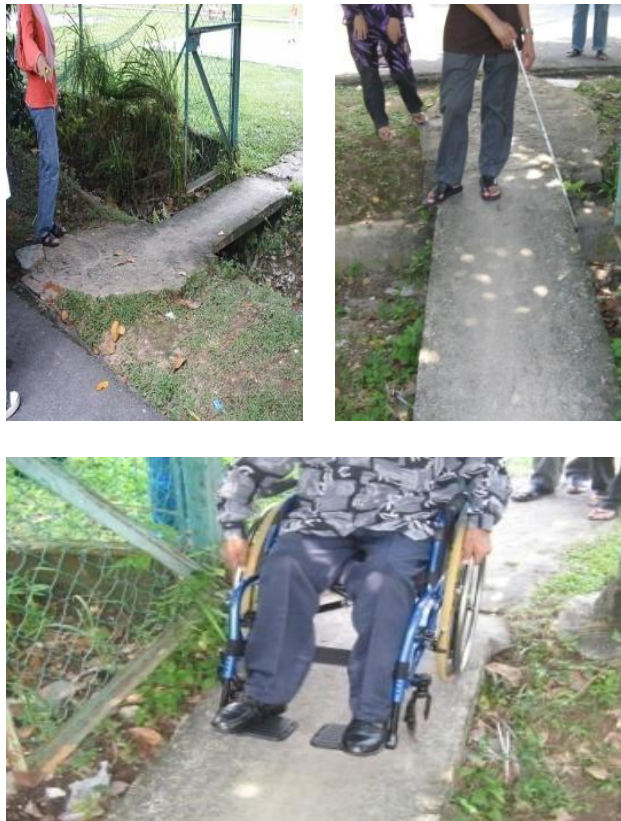
However, the concrete platform provided at Gate A is very narrow and without any handrails which makes it difficult for the PwDs to get through.

Figure 5.11:
Narrow concrete platform at Gate A

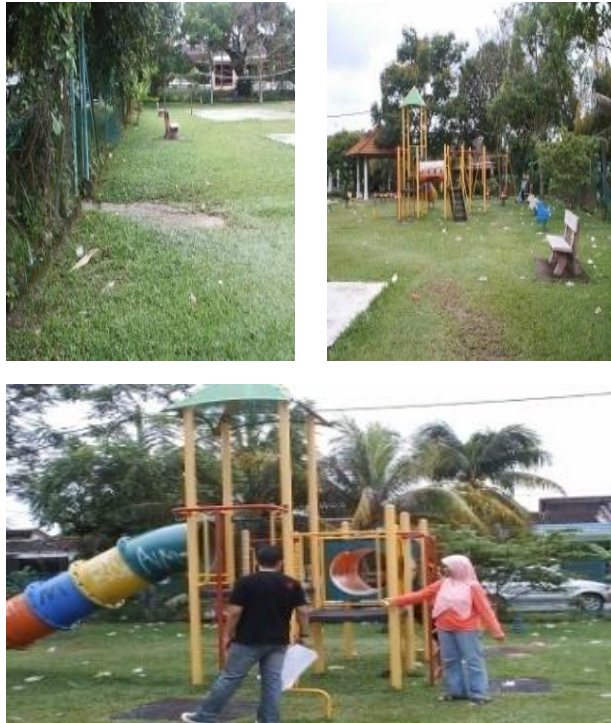
Figure 5.12:
The recreational area

There is no designated pathway within the recreational area and thus, it is quite difficult for wheelchair user to maneuver the wheelchair, and for the vision impaired person to find his way. The play structure provided might be unsuitable to be used by children with disabilities too.

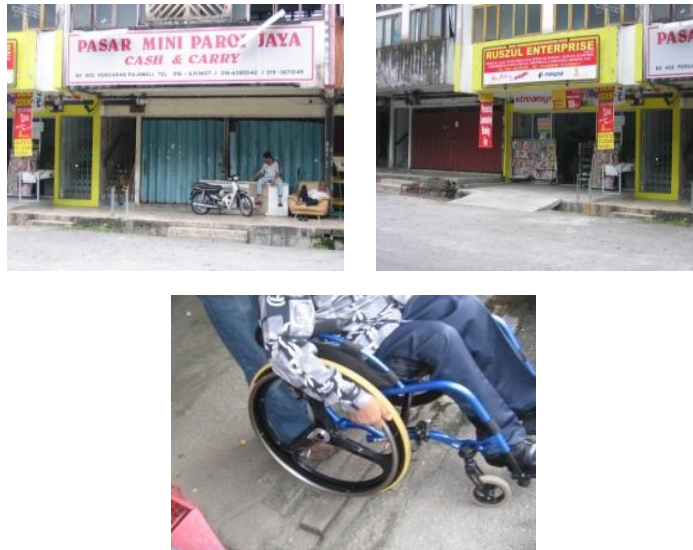
- No specific area/clear marking for the PwDs to cross the road (tactile is needed to assist the vision impaired person)
- No designated parking space for the PwDs.
- Changes of level from the road as well as among shops with no provision of ramp (only a few shops have ramps). The surface sometimes also quite bumpy which makes it difficult to maneuver the wheelchair (not well maintained).

Figure 5.14:
Changes of leveling among shops and bumpy surface to the shop corridor.

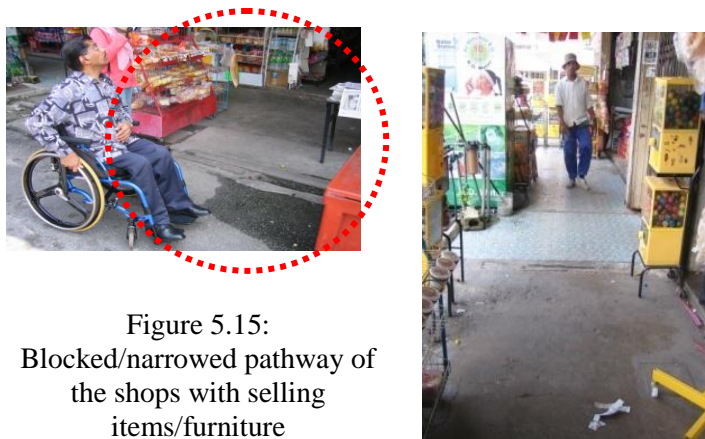
- Blocked/narrowed corridor as well as shop's entrance with selling items/shop furniture.

Figure 5.15:
Blocked/narrowed pathway of the shops with selling items/furniture

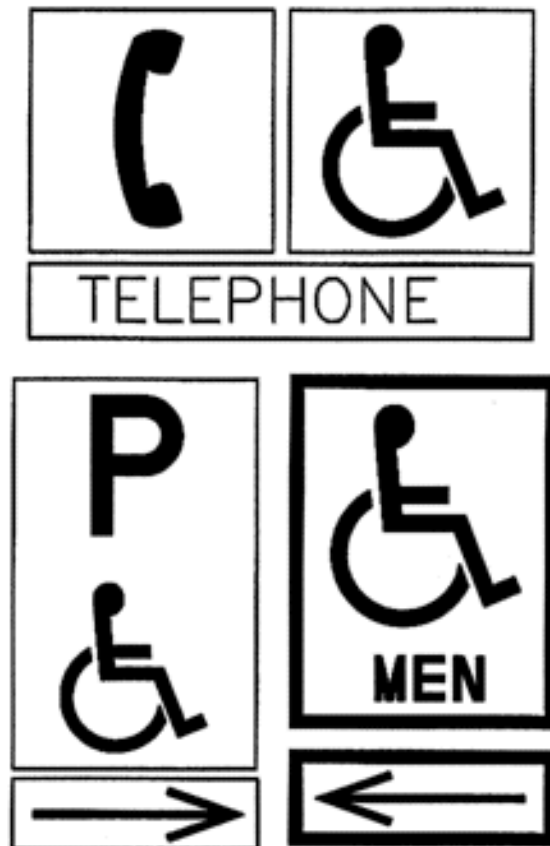
- **Seating:** Seating should be provided at regular intervals to provide resting places.
- **Signs/ Signboards:** Provide the signs that are contrast with the surrounding surface so as to be clearly distinguished. The signage also should be provide continuously along the walk and should be added to indicate clearly the location and function of accessible spaces and facilities.

Figure 5.17:
Example of signage that should be provided to
indicate clearly the location of the facilities

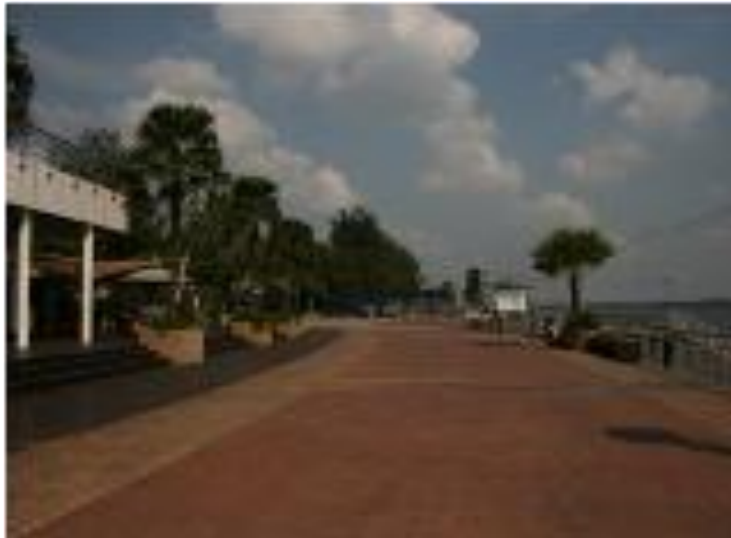
Figure 6.3:
The Promenade

The promenade is not exclusively for pedestrians as vehicles such as mini trains, bicycles and staff vehicles also share the promenade with the pedestrians. This is a problem to the hearing-impaired as they may not be able to know if there is a train coming from behind as no special lane is provided for the vehicles.

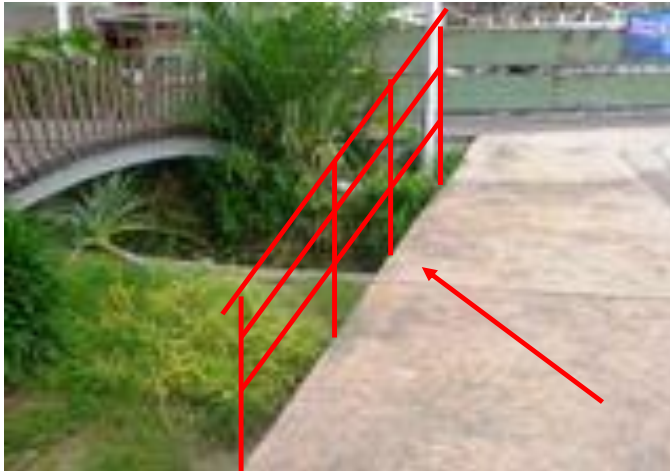
The trees planted along the sidewalks of the Festive Street Mall are without any railings or grating making them an obstacle to the vision-impaired. The landscape features such as huge boulders near the entrance of the Festive Street Mall also serve as a dangerous obstacle to the vision impaired. There is also a vehicular access between the theme park and the Rumah Limas but no pedestrian crossing was provided, making it dangerous for the vision-impaired and wheelchair user to cross.

Figure 6.4:
The part of the promenade which is not provided with railings that separate the path and the open drain

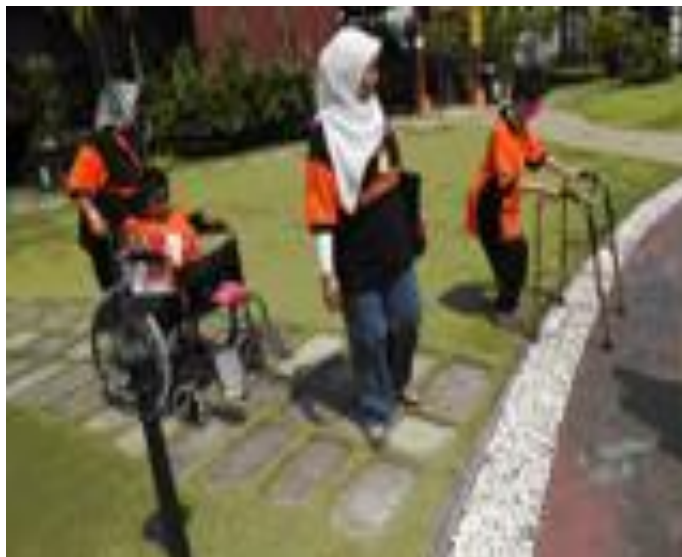
Figure 6.5:
Inappropriate paving materials that limits access

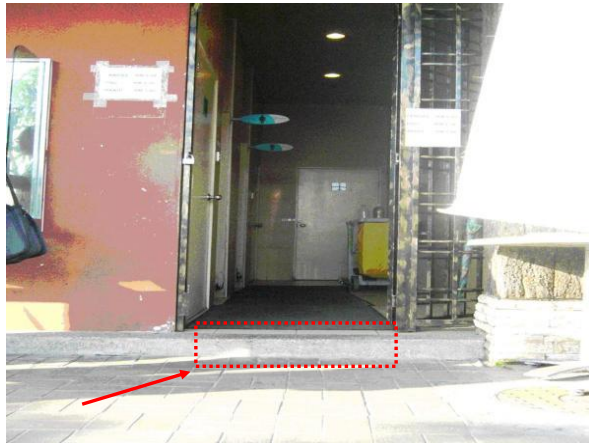
There are 3 public toilets designated for the PwDs (Bayleaf under re-construction, celebration ground and festive mall). However, the signboards indicating public toilets are not made according to the MS 1331:2003, MS 1184:2002, MS 2015: Part 1-4: 2006 and therefore making it hard for the PwDs especially the vision-impaired to find it. Even though it is quite easy for the PwDs to make their way into the toilet, however for the wheelchair user, it is quite a struggle to maneuver from the pavement into the toilet due to the drop that is higher than those stipulated in the standards. The door of the toilet cubicle near the Bay Court Leaf Court is too small to enable the wheelchair user to get through. Even if the person is able to enter the cubicle they will not be able to maneuver themselves in the cubicle due to its tight space.

Figure 6.6:
Inappropriate drop for entrance to toilet
at the Festive Street Mall

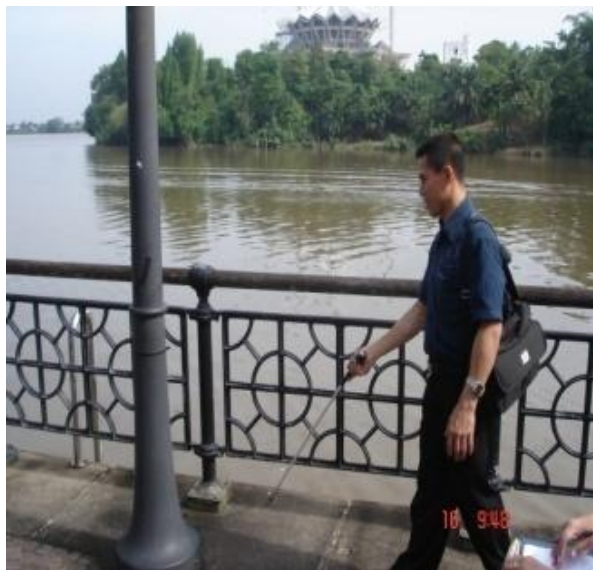
Figure 6.9:
Obstacles along walkways

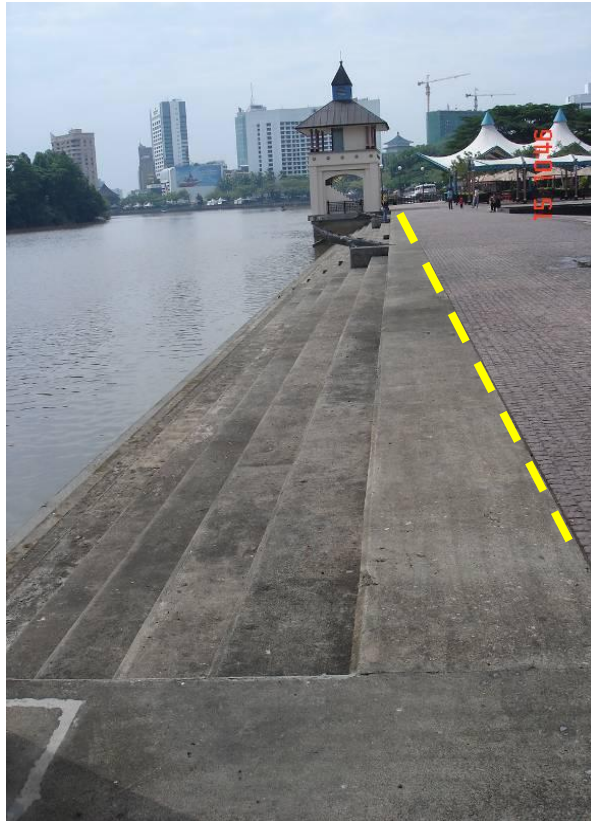
In general, the walkways along the Kuching Waterfront can be accessed fairly well by PwDs. The walkways are wide and spacious, however the rather rough cobble stone surface and wide gratings on drain covers can cause discomfort and difficulties for wheelchair users. The many obstacles along the walkways such as lamp posts, potted plants, food stalls and water fountains without any warning blocks are potential hazard and danger to the vision-impaired. There are safety railings along the riverside which are used by the vision-impaired as a guide, however the railings end in Zone A, leaving a stretch of area where the walkways lead directly to a flight of steps overlooking the river without any warning blocks to caution the vision-impaired of the impending danger (see Figures 6.9 and 6.10).

Figure 6.10:
Stretch of steps overlooking the river

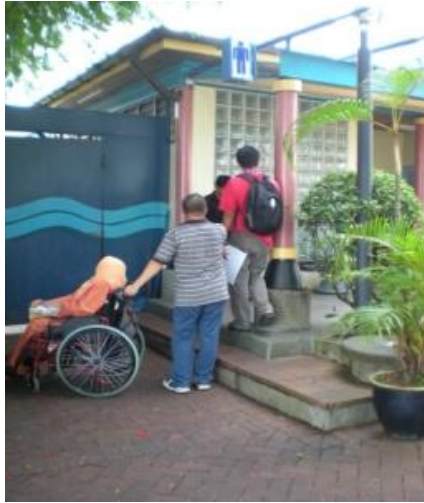
Figure 6.11:
Steps leading to the public toilet

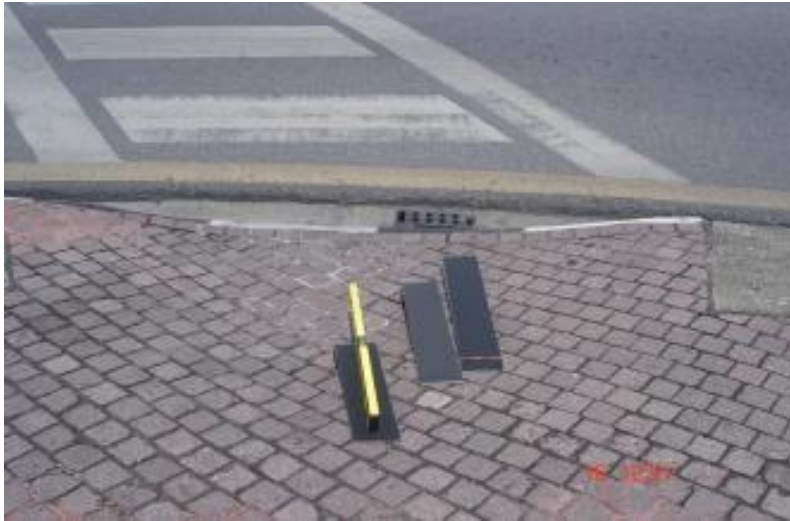
Figure 6.12:
Uneven curb cuts at pedestrian crossing

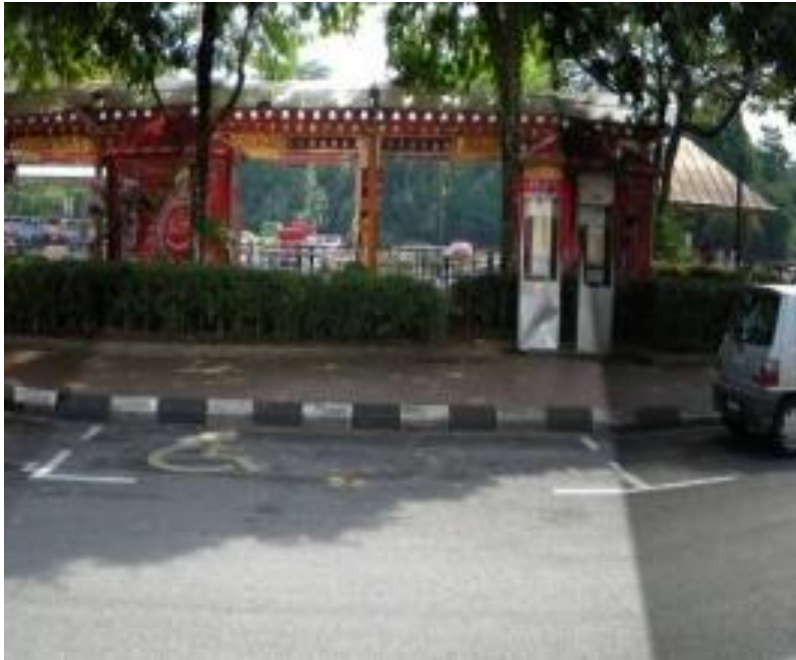
Along the 1 kilometer-long waterfront area, there is no taxi stand provided and there is only one designated handicap parking in Zone B, which is actually provided by the local authority, not by Kuching Waterfront management. However, this designated parking space does not comply with the Malaysian standards and there is no continuity of access from the parking area to the waterfront walkways as there is a pavement from the parking area to the promenade. The size of the parking space is only 2500 mm x 4800 mm instead of 3300mm x 4800mm as required, and the wheelchair sign is marked on the ground instead of the preferred standing signage which causes easy and frequent abuse of this facility by non-disabled users.

Figure 6.13:
Existing handicap parking (Zone B)

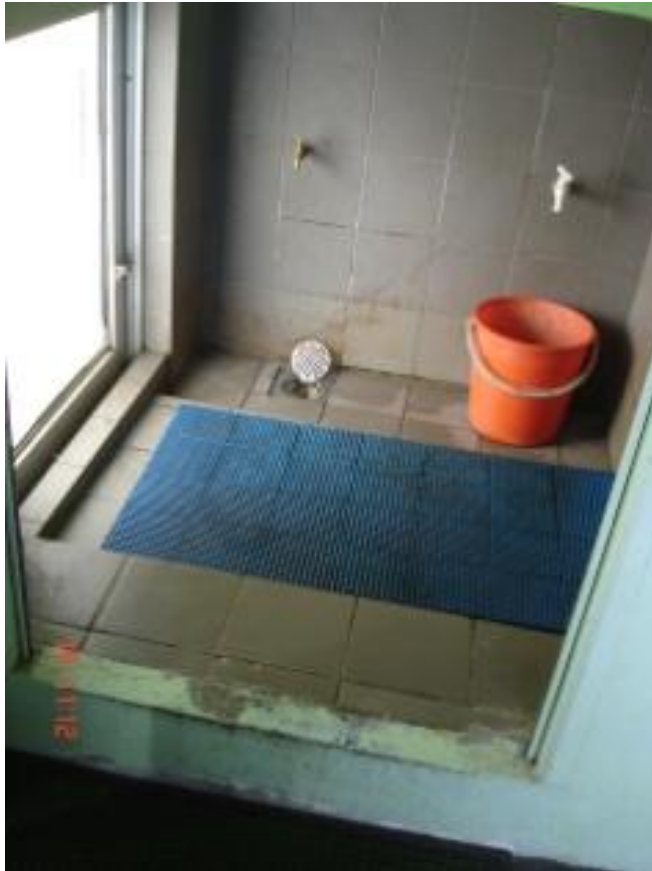
As mentioned earlier, the public toilet is completely inaccessible by wheelchair and its set-up is not meant for PwD users in all aspects, such as spatial dimension, as well as the material and equipment installed. Similar problems exist for prayer rooms, which are provided only in Zone B. The tight ablution area is connected to the prayer rooms and cannot be accessed safely and easily by PwDs. The doors are too narrow and the raised edge that separates the ablution area to the praying area not only prevents wheelchair users from accessing the ablution area but also poses a danger to the vision-impaired.

Figure 6.14:
Ablution area
