INTERNATIONAL JOINT-CONFERENCE
SENVAR-INTA-AVAN 2015
24-26 November 2015
Faculty of Built Environment,
Universiti Teknologi Malaysia,
Johor Malaysia

Visual Inspection on Sources and Factors of Deterioration in Wood Components of Malay Traditional House

Zumahiran Kamarudin¹, Siti Najwa Nazuki²

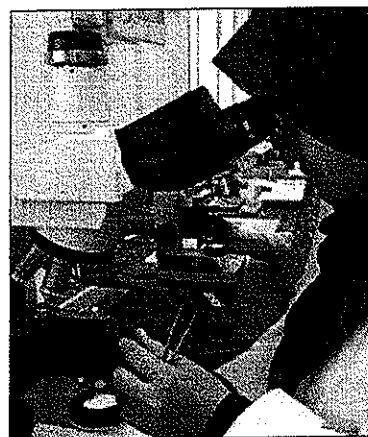
Figure 2: Species identification of the selected wood samples are performed via the macroscopic and microscopic methods

A

B
