Landslide Hazard of Maninjau Area

Purpose – The purpose of this paper is to determine the potential landslide of Maninjau area.

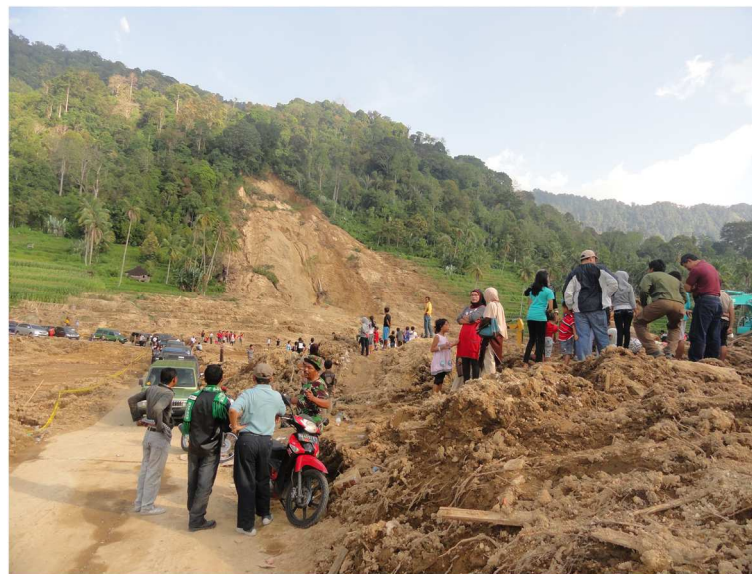
Figure 4. Field survey on landslide location in 2013

In order to understand the behaviour of landslides in Maninjau, a field survey was conducted (Figure 4). The soil samples were also taken from the field to find out the technical properties of the soil for landslide analysis (Hakam et al., 2013). This survey aims to obtain the geometry of the landslide area. The geometry data was needed for verification data of the landslide that had happened before. Based on the field survey, it is also found that the Maninjau landslide has a linear type of failure surface. The slope stability analyses was done by assuming that the linear failure surface in the slope has the same direction with the surface slope (Figure 5).
