THE MAYA SITE OF CALAKMUL: *IN SITU* PRESERVATION OF WALL PAINTINGS AND LIMESTONE USING NANOTECHNOLOGY

Piero Baglioni, Ramón Carrasco Vargas, David Chelazzi, Marinés Colón González, Alice Desprat and Rodorico Giorgi

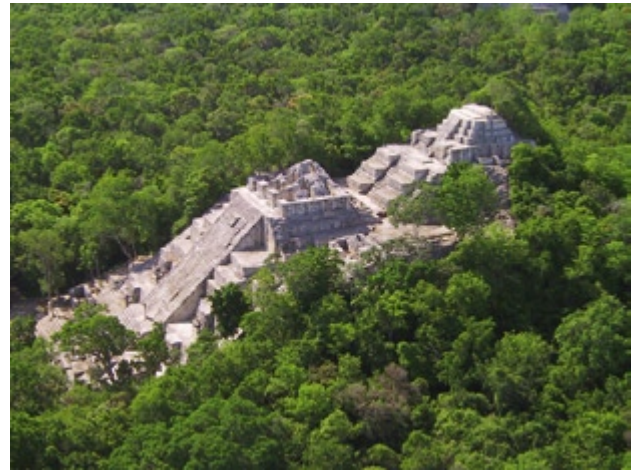
Fig. 2 Aerial view of Structure II.

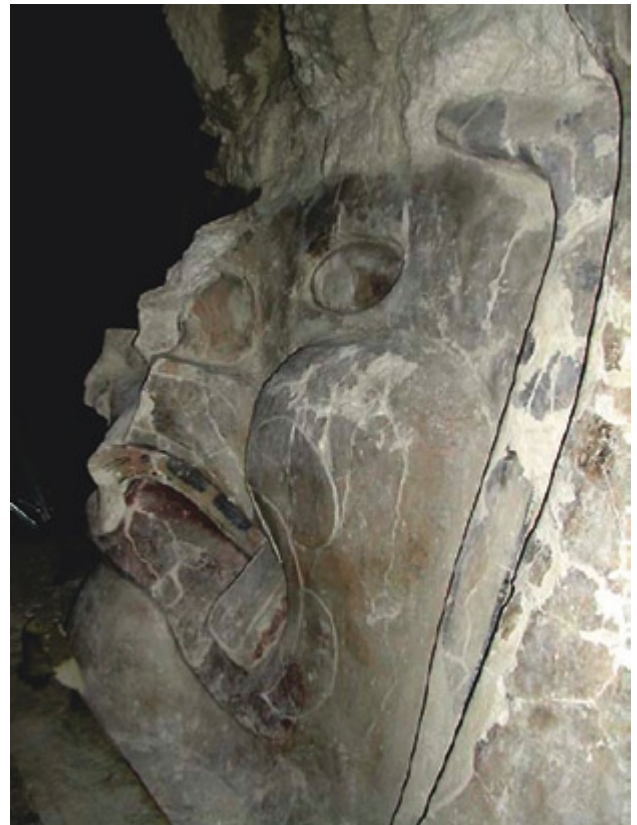
Fig. 3 Polychrome-modelled stucco mask in the sub-structure II c-1, in the inner part of structure II. The image was taken after re-adhesion of several detached fragments using autogenously air-setting mortar.

Mortars with ammonium carbamate have been used for repairing detached stucco fragments and also for filling voids and re-adhering flaking layers. This paper specifically reports their use on the polychrome-modelled stucco mask in sub-structure II c-1 in the inner part of structure II, Fig. 3. In this case, the mortar was used for the re-adhesion of large pieces, Fig. 4. The degree of carbonation of the mortar used for the intervention was investigated by X-ray diffractometry (XRD) on reference material. Experiments showed that carbonation of autogenously air-setting mortar initiates a high-binding calcite capacity, while CO₂ from the air does not ensure a fast and efficient carbonation of the mortar, Fig. 5. A detailed description of the laboratory tests is reported in Appendix 1. The procedure for the application of autogenic mortars does not require any specific technical skill, and the costs for the preparation of mortar are modest, or lower than those of the materials commonly used for restoration (Appendix 1).

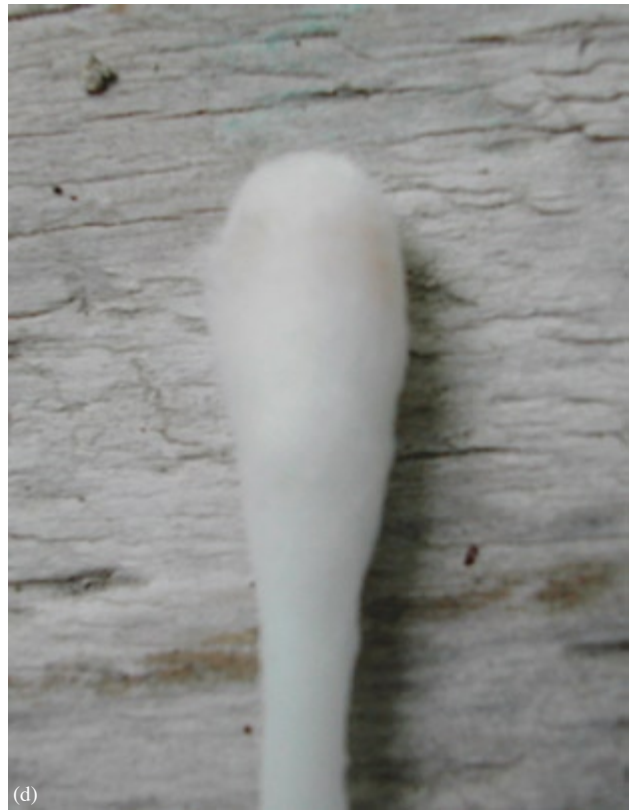
Decorative glyphs, painted over stucco plaster at the base of the columns, in Structure XX (the *Gran Acrópolis*) of Calakmul had a friable and powdered paint layer, which needed consolidation. The consolidation was performed using nanoparticle dispersions applied by gentle brushing, Fig. 6a. Following the application of nanoparticles, a wood-fibre poultice soaked with water was applied for eight hours in order to keep the upper paint layers wet, Fig. 6b. A few days later, a second application of nanoparticles was made. At the end of the whole treatment, a simple test with a wet cotton-wool swab demonstrated that the colour was now completely fixed, Figs 6c–d.

Fig. 6 (a) Application, by brushing, of nanoparticle dispersion on decorative glyphs; (b) wood-fibre poultice soaked with water applied for eight hours in order to keep the first paint layers wet; (c) powdered pigments removed with a wet cotton-wool swab before fixing of paint layer; (d) test repeated on the consolidated area (indicated by the box in Fig. 6e); (e) the paint layers a few days after the completion of the treatment.

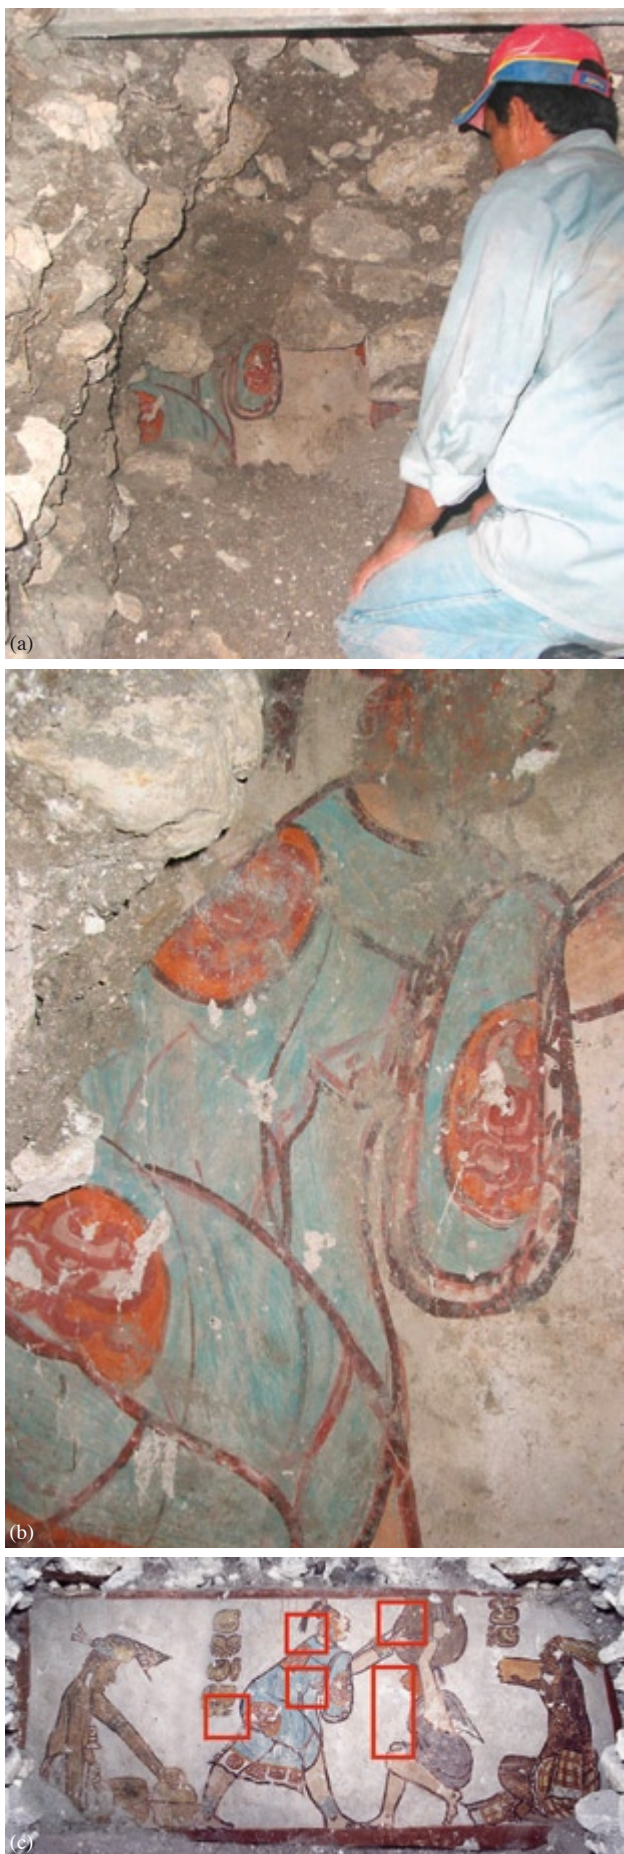
Nanoparticle dispersions were also used in Early Classic period wall paintings of the *Acrópolis Chik Naab*. Fig. 7 shows some steps in the excavation and an overview of the whole painting, which had several areas with powdering paint surfaces, where dispersions were used to fix the colours and to consolidate the painted layer.

Fig. 7 (a)–(b) Discovery and excavation of wall paintings of Structure I in the *Acrópolis Chik Naab*; (c) overview of the paint after consolidation treatment with nanoparticles.

The level of degradation of the paintings did not allow the extensive use of water, since the paint layers were in most cases very friable and weak. The use of alcohols as carriers for nanoparticles avoided possibly dangerous consequences of the restoration through the solubilization of salts in the painted layer. Furthermore, nanomaterials are characterized by a high surface area that influences the chemical reactivity of nanoparticles, producing a consistent consolidation of treated surfaces just a few days after application. These positive effects can be particularly important on archaeological sites where *in situ* conservation requires effective conservation and preservation treatments.
