NEW TECHNOLOGIES FOR SURVEYING BUILDING RUINS

G. Tucci*¹, V. Bonora¹, N. Crocetto², A. Nobile¹

¹University of Florence, Dept. of Restoration and Conservation of Architectural Heritage, 50121 Florence, Italy
grazia.tucci@unifi.it valentina.bonora@archimetro.it alessianobile@gmail.com

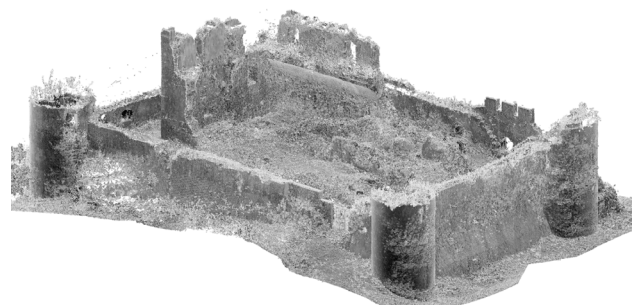
Figure 5. View of the points model surveyed using three-dimensional scanning

Three-dimensional scans were used to realise the detailed survey. The acquisition from different positions made it possible to reciprocally integrate the shadow zones and to obtain an almost complete points model of the castle. 14 scans were taken outside the castle and 19 inside.

Scanning was carried out using a Leica HDS6000 laser scanner; the scanning resolution adopted was centimetric in correspondence to the surfaces considered.
