## XVII<sup>th</sup> World Congress of the International Commission of Agricultural and Biosystems Engineering (CIGR)

### FLUSH SYSTEMS FOR DAIRY MANURE REMOVAL: THE ALLEY ROUGHNESS VALUE

#### CSBE100442 – Presented at Section II: Farm Buildings, Equipment, Structures and Livestock Environment Conference

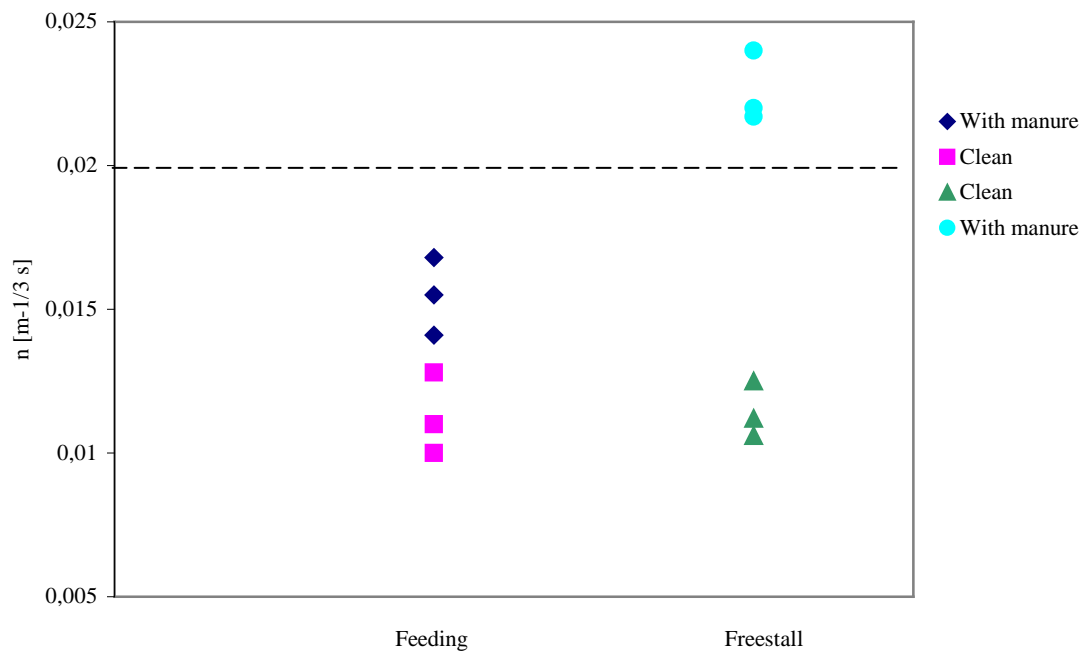
Figure 3. Manning coefficient ( $n$ ) for the different alleys under normal and clean conditions for the freestall barn 1 (dash line represents the  $n$  value equal to 0.02 as suggested in literature).

**RESULTS AND DISCUSSION** The values of the Manning coefficient  $n$  are obtained from the Chezy formula substituting the measured velocity and the surveyed flow depth for each trial. Data elaboration has been made both separately for each freestall barn and then grouped for alley type. The barn 1 and 2 have in fact the same alley grooves. In figure 3,  $n$  values for the barn 1 are shown, with the reference value of 0.02 as suggested in literature, separated between feeding and freestall alley types. The repeated trials on the clean alley of both types show comparable values included in the interval 0.010-0.013, thus a value of 0.01 (cut at the third digit) may be considered as the typical roughness number for an alley made of concrete with longitudinal grooves, 0.02 m wide and deep and 0.1 m spaced. As regards the feeding alley, the range is 0.014-0.017, showing an increase of 27% compared with the  $n$  value for the clean alley. The freestall alley presents values in the interval 0.022-0.024, showing an increase of 46% compared with  $n$  value for the clean alley. The higher value calculated for the freestall alley, compared with the value obtained for the feeding alley, may be justified by the presence on the alley of both manure and litter material. From the graph, it is clear how all the values are under the 0.02 line with the exception of values for the freestall alley.

With reference to the barn 2, the roughness values for the clean alleys are 0.012 and 0.011, confirming the previous values calculated for the alleys of barn 1, presenting similar groove type. For the freestall alley, the obtained  $n$  value is 0.018 representing an increase of 39% with respect to the clean situation. This percentage is lower than that one obtained for the same type of alley of barn 1, but it may be justified by considering that the presence of litter (type and quantity) influences the roughness. In barn 2, the feeding alley presents some differences in comparison with barn 1 as it is wider (4.2 vs 3.3 m) and gives access to a single row of freestalls. The obtained value for the roughness is equal to 0.027, showing an increase of 52% with reference to the clean value. It is obvious that this value cannot be compared with any other among those belonging to the other freestall barns. It can be observed that this roughness value is the maximum obtained and it may be justified by the fact that the amount of manure present will be greater. As regards the barn 3, the 0.017  $n$  value for the feeding alley is comparable with the previous ones.
