Seismic vulnerability of the ‘Palazzo degli Uffici Statali’ a public building realized in Italy at the beginning of last century

This paper deals with the seismic vulnerability assessment of the ‘Palazzo degli Uffici Statali’, realized in Forlì, central Italy, at the beginning of last century, during the Fascist period. The investigated building is the corner body of a wider RC complex consisting of several structural unities. The structure consists of a basement and six storeys in elevation and presents marked irregularities both in plan and in height. Two types of analysis have been performed: a preliminary vulnerability analysis, following conventional procedures of the current Italian technical code, and a non-linear dynamic analysis, based on a set of accelerograms consistent with seismic hazard characteristics of the building site. Obtained results pointed out significant torsional modes as well as marked problems in brittle mechanisms due to shortage in transverse reinforcement.

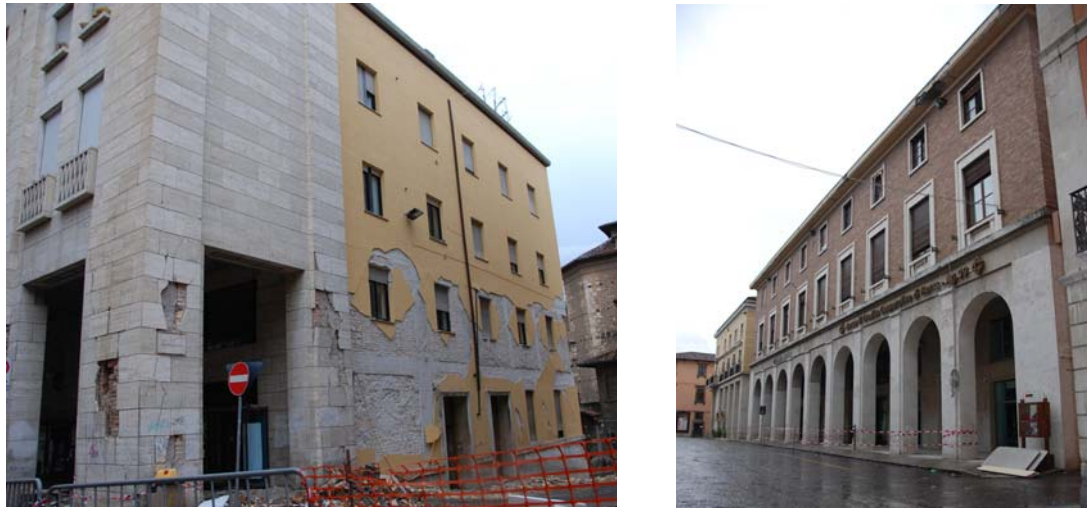
Figure 1. Public buildings of the 30s in L'Aquila (central Italy) affected by the earthquake of April 6, 2009.

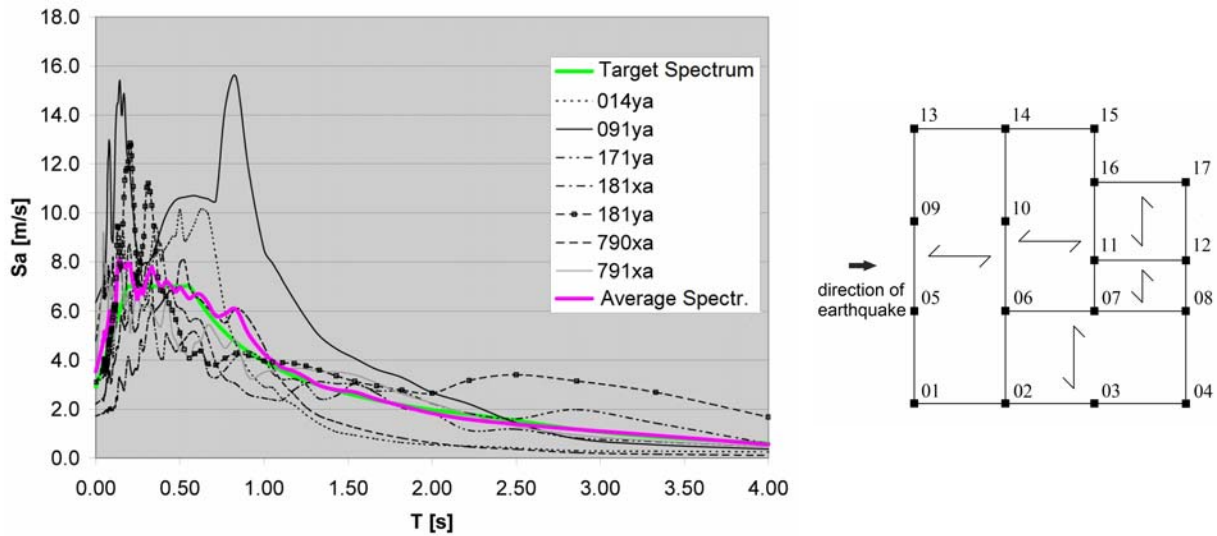
Figure 4. Elastic spectra of selected records and schematic plan of the building.

Table 1 shows the overall data of the selected records used for definition of seismic input, inclusive of peak accelerations in the x, y and z directions (Iervolino et al. 2009); it is underlined that only some of these components (x or y) were used for the construction of response spectra, as shown in Figure 4; in the same figure a schematic plan of the building has been reported, together with the column numbering and the assumed direction for the seismic action.
