# An experimental field plant for water flow monitoring and modelling in a vineyard terraced area (Lamole, Greve in Chianti, Italy)

## Abstract

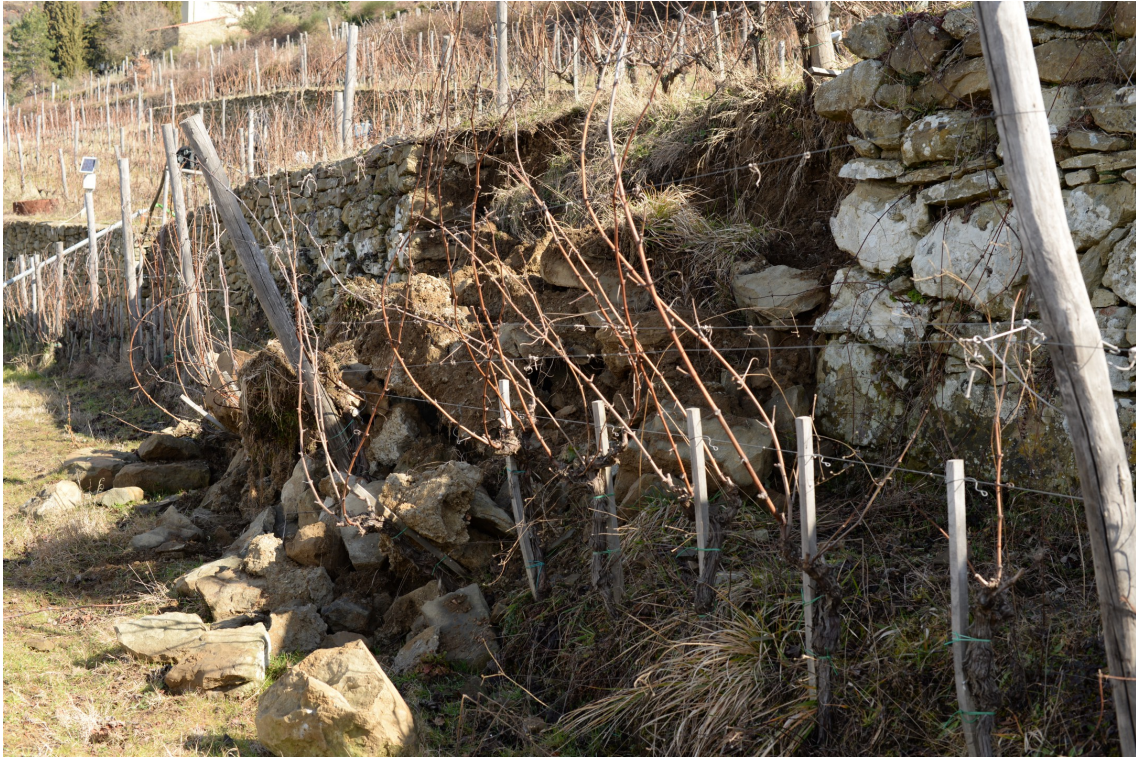
*figure 2: example of dry-stone wall collapsed after intense rainfall*

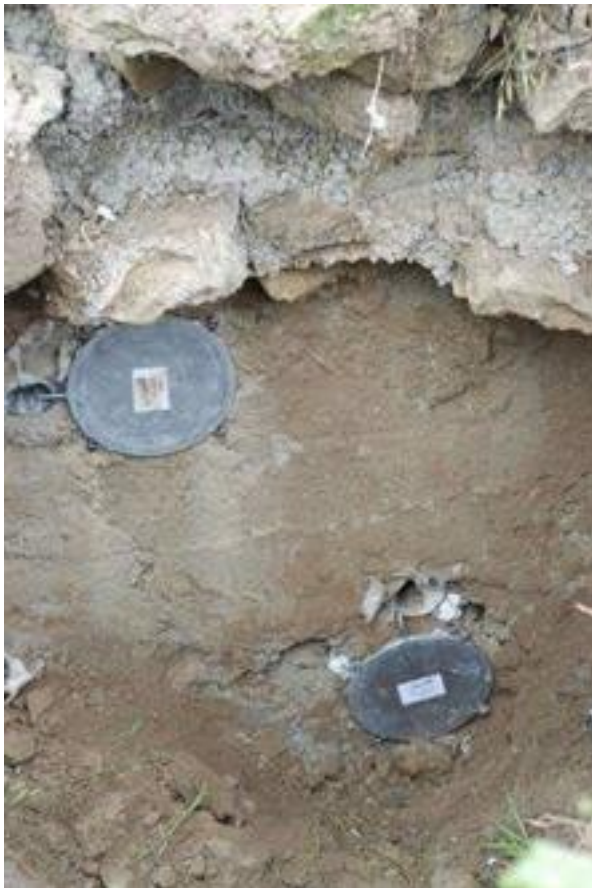
*figure 4: earth pressure cells installed behind the monitored dry-stone wall to monitor the total soil-wall pressure*

pressure cells placed 90 cm and 180 cm deep (fig. 4), the earth pressures at the soil-wall interface has been measured and recorded both in saturated and unsaturated states. Load tests have been undertaken filling a tank up to 1 m<sup>3</sup> of water placed on the soil just behind the wall in order to validate pressure measures from pressure cells.

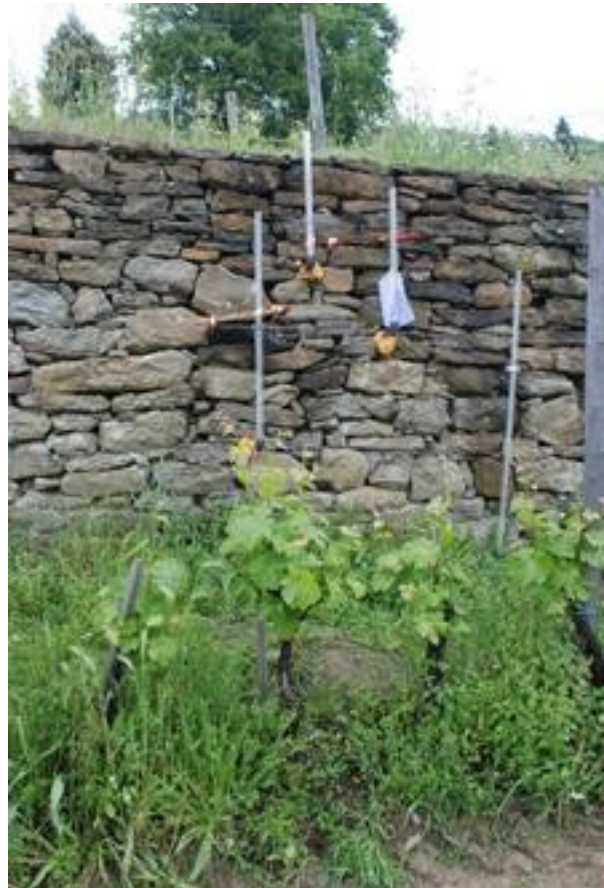
*figure 5: piezometers installed on the monitored dry-stone wall to measure the water level behind the wall itself*

Soil humidity and pressure data have been collected for the last two years during rainfall events: the volumetric water content and ground-water levels have been monitored through a capacitance probe (Sentek EnviroSMART®; 0.10, 0.20, 0.30, 0.50 e 0.70 m deep) and three vertical piezometers which reach different depths in the vineyard behind the dry-stone wall, while three supplemental horizontal piezometers were installed through the wall itself; atmospheric pressure data have been collected both from the SIR (Regional Hydrologic Service of Tuscany) data-base and by an electronic barometer placed on the wall.

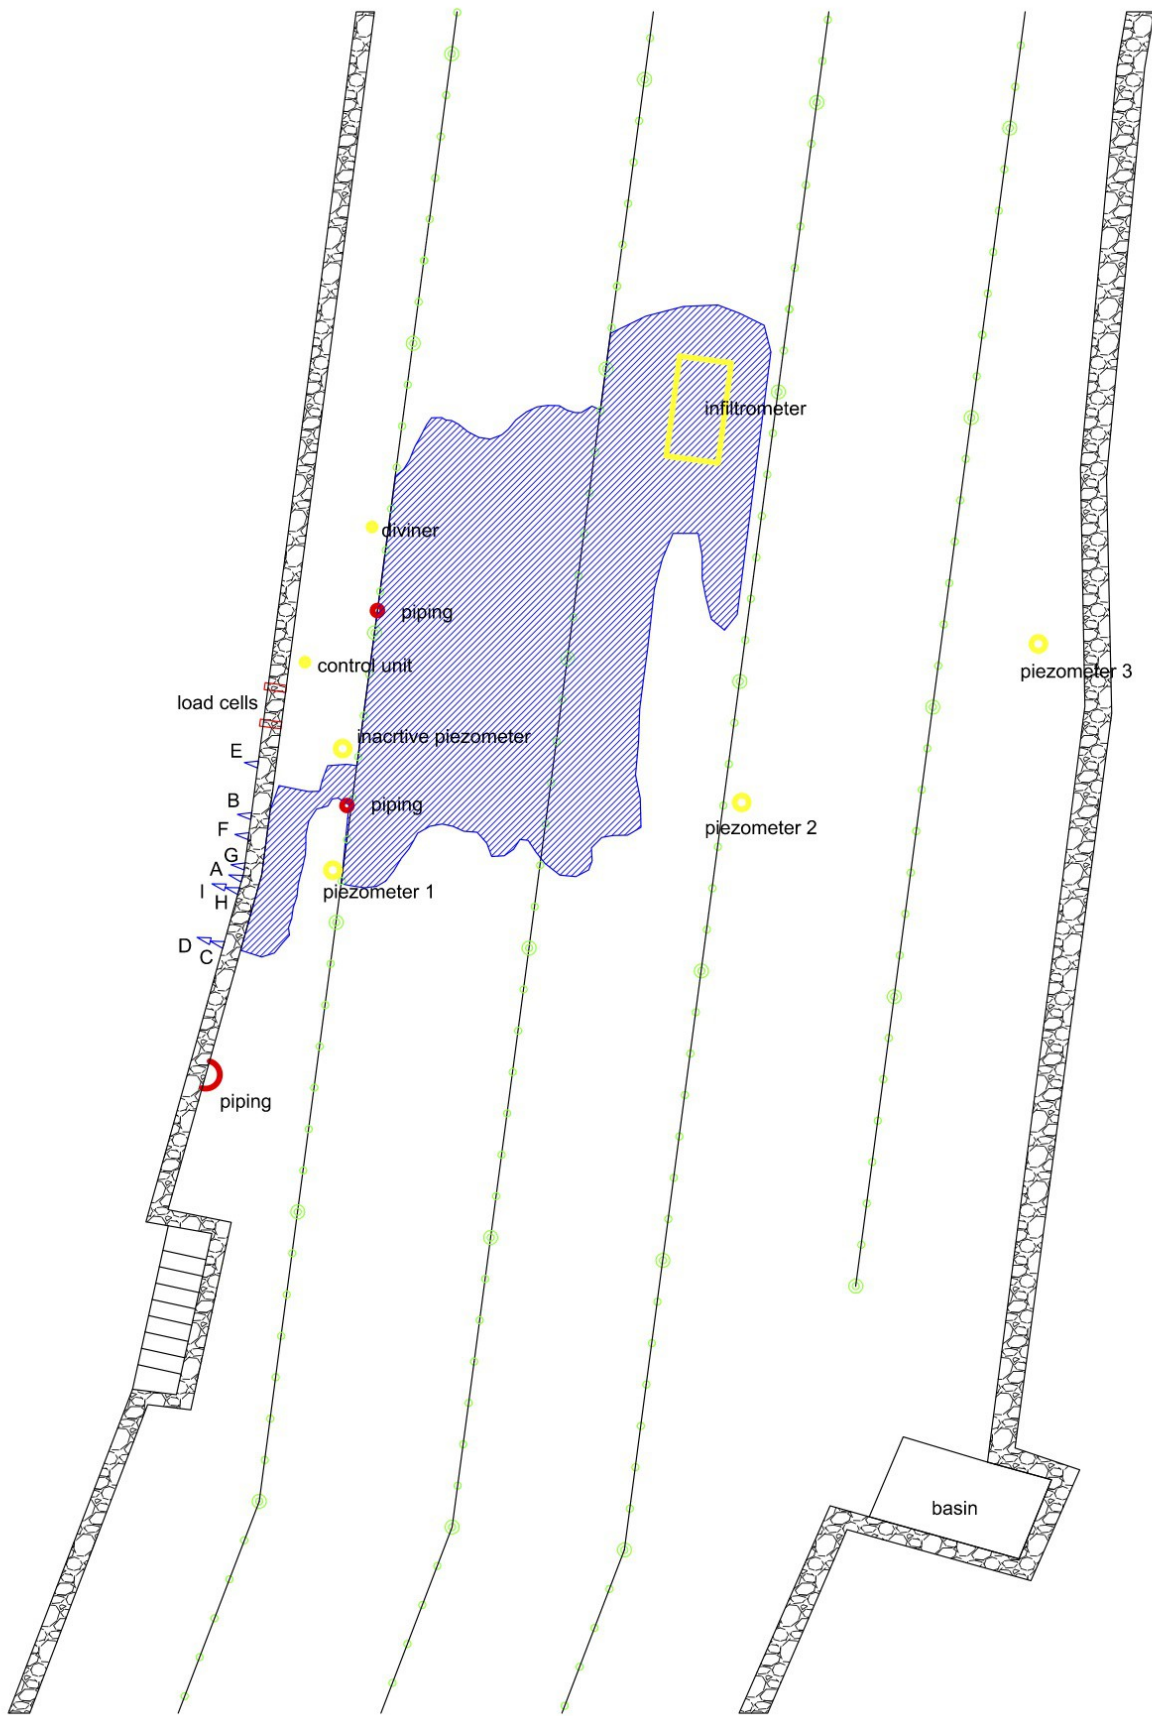
figure 6: field water expansion test on 4<sup>th</sup> march 2015; capital letters points to the water leakages through the retain wall in order of appearance

A field water expansion test has been performed on the following day (4<sup>th</sup> march 2015) through brimming over the infitrometer edge: flooded area expanded chiefly towards the main ditch, affecting the area upline the load cells. The maximum extension of the area has been reached in roughly 5 minutes, remaining quite stable until the end of the test.

During the large expansion test water disappeared due to natural piping and flowed through the valley-facing side of the wall: the water appeared first at the base of the wall and successively rose towards the top of the wall (this is particularly evident for points H-I and C-D), while in none of the piezometers located near the piping there were traces of water.

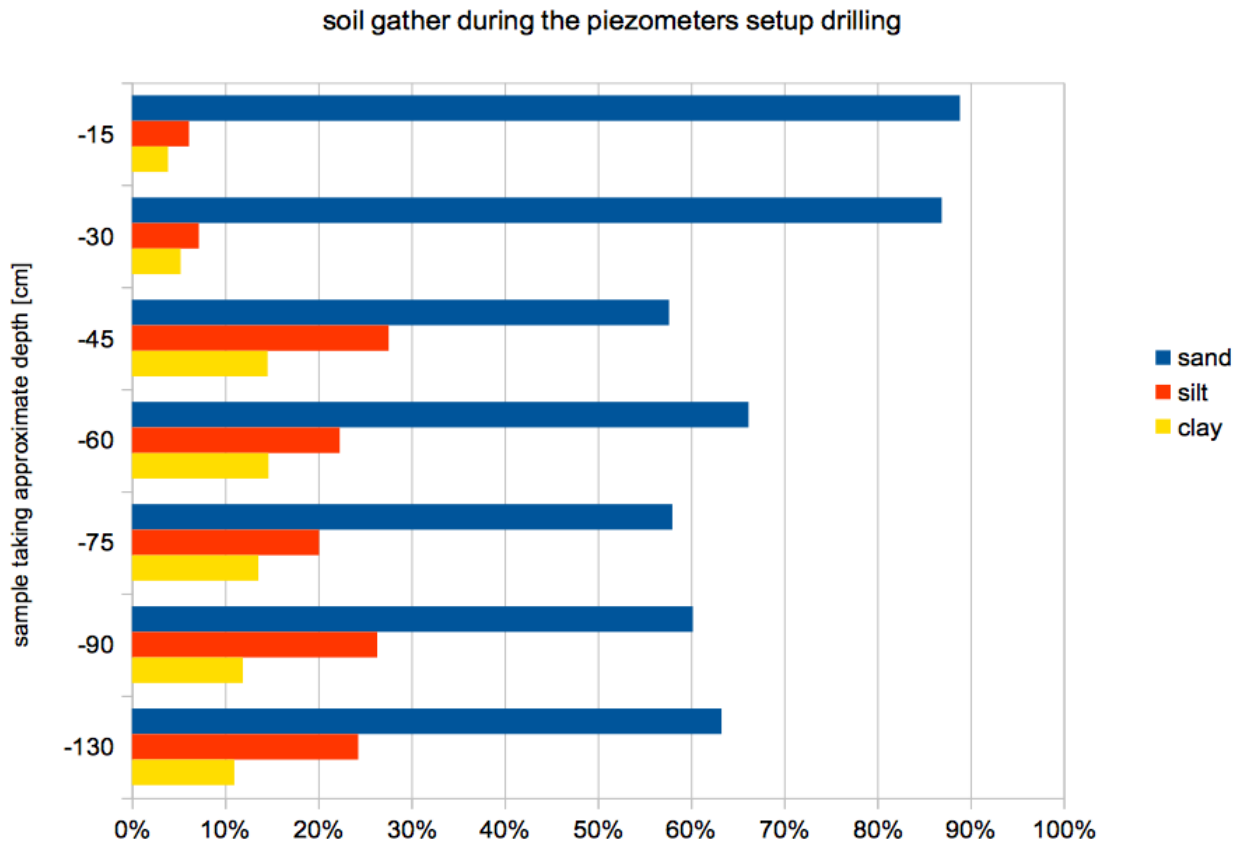
figure 7: soil texture obtained from specifically gathered samples (until 45 cm depth) and from drillings made in order to set three vertical piezometers between the vine rows; due to the different kind of sample the lithoid fraction valuation is misrepresented and thus it has not been reported in the graph

The soil is classified mainly as sandy gravel with little silt (fig. 7); the fine fraction is classified by USDA nomenclature as loamy sand in the tilled part and as sandy loam under the plow profile (40-50 cm deep).

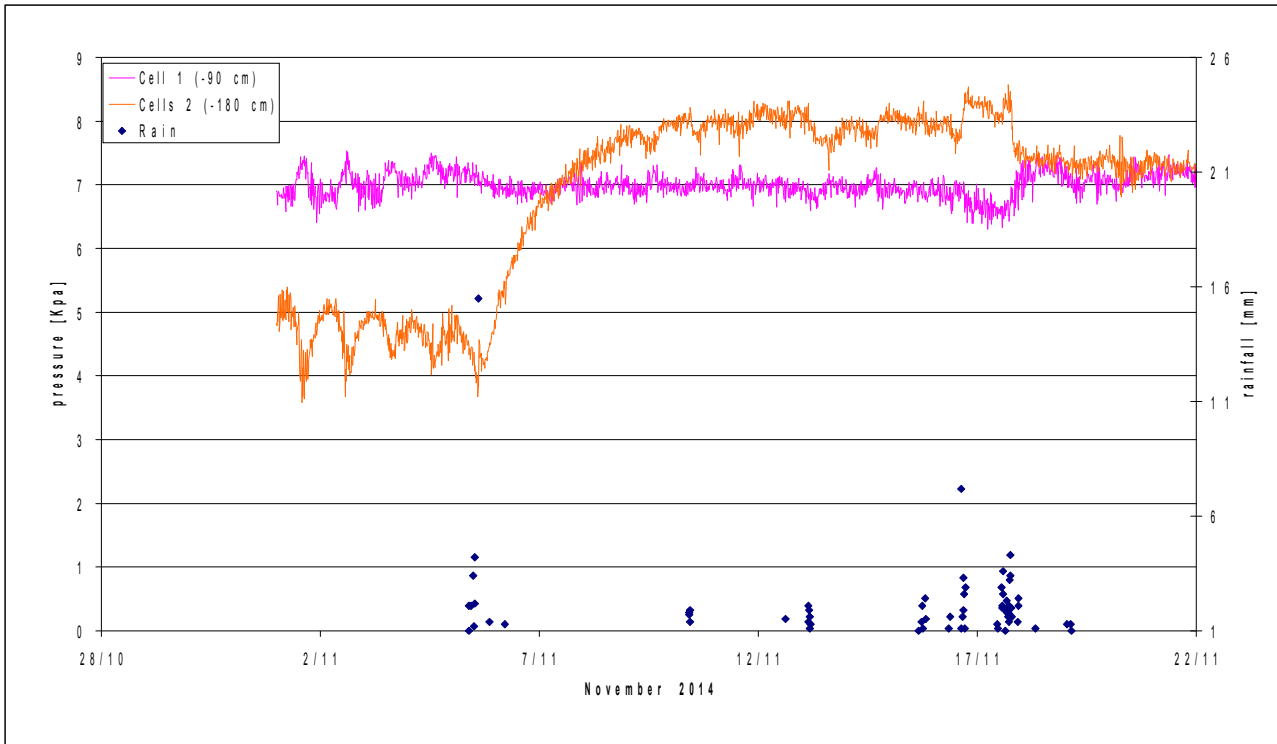
figure 8: pressure variation measured at two depths vs rainfall (november 2014), the blue points represent the rain related to the quarter hour

The pressures measured by the two load cells appear to be not immediately related with rainfall. Instead, the trend of atmospheric pressure is in direct relation with the load cells values trend. The variability effect due to atmospheric conditions has been purged from load cells data, obtaining a better correspondence between the pressure data and the rainfall. Instant pressure variability in the data registered by the load cells is related also with temperature variability, although on the long run the effect of rainfall is predominant in respect to the temperature effect; the load cells data have been corrected also in this aspect. Finally it has been possible to identificate different behaviour for the two cells, the deepest one responding clearly for more intense events while the upper one shows better correspondence with low rainfalls.

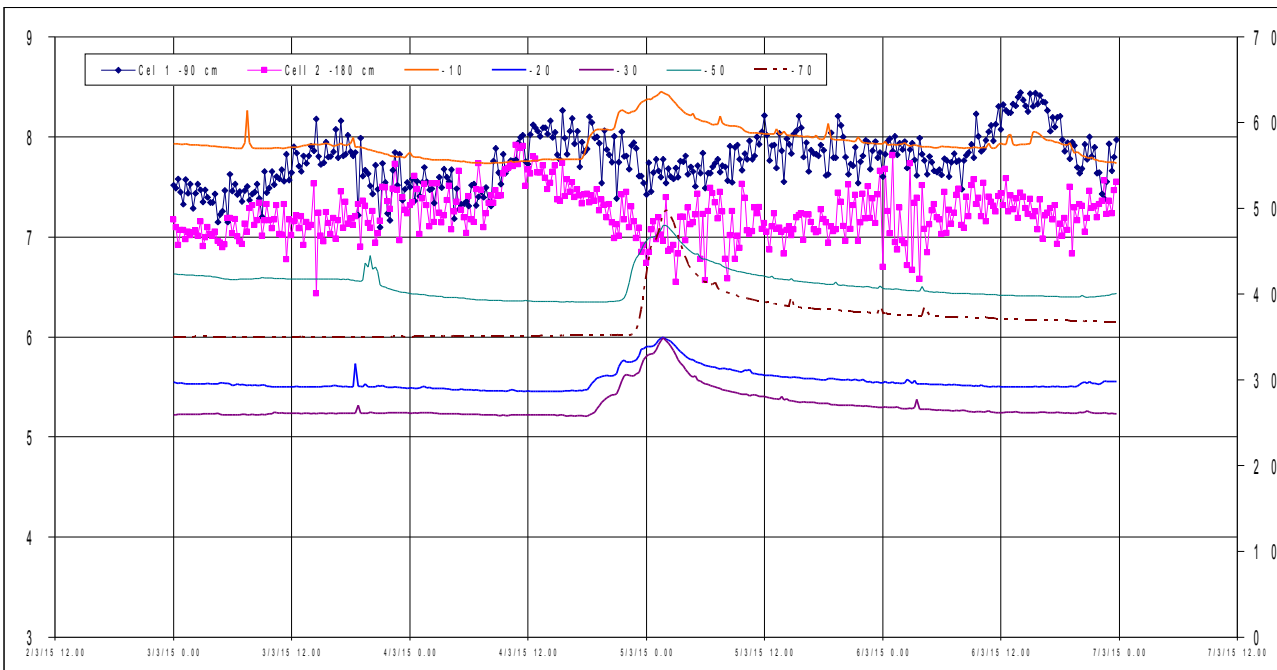
figure 9: pressure variation measured by the load cells and soil water content in percentage by volume recorded through the capacitance probe (-10,-20,-30,-50,-70 cm)

The trend of the pressure measured by the cells is related with the soil water content, usually showing and increase until the water content peak end. Sometimes is possible to note sudden decreases in correspondence to rainfalls that caused noticeable pressure increase: this can be explained with micro movements of some wall elements, probably responsible on the long run to the bulging (fig. 9).

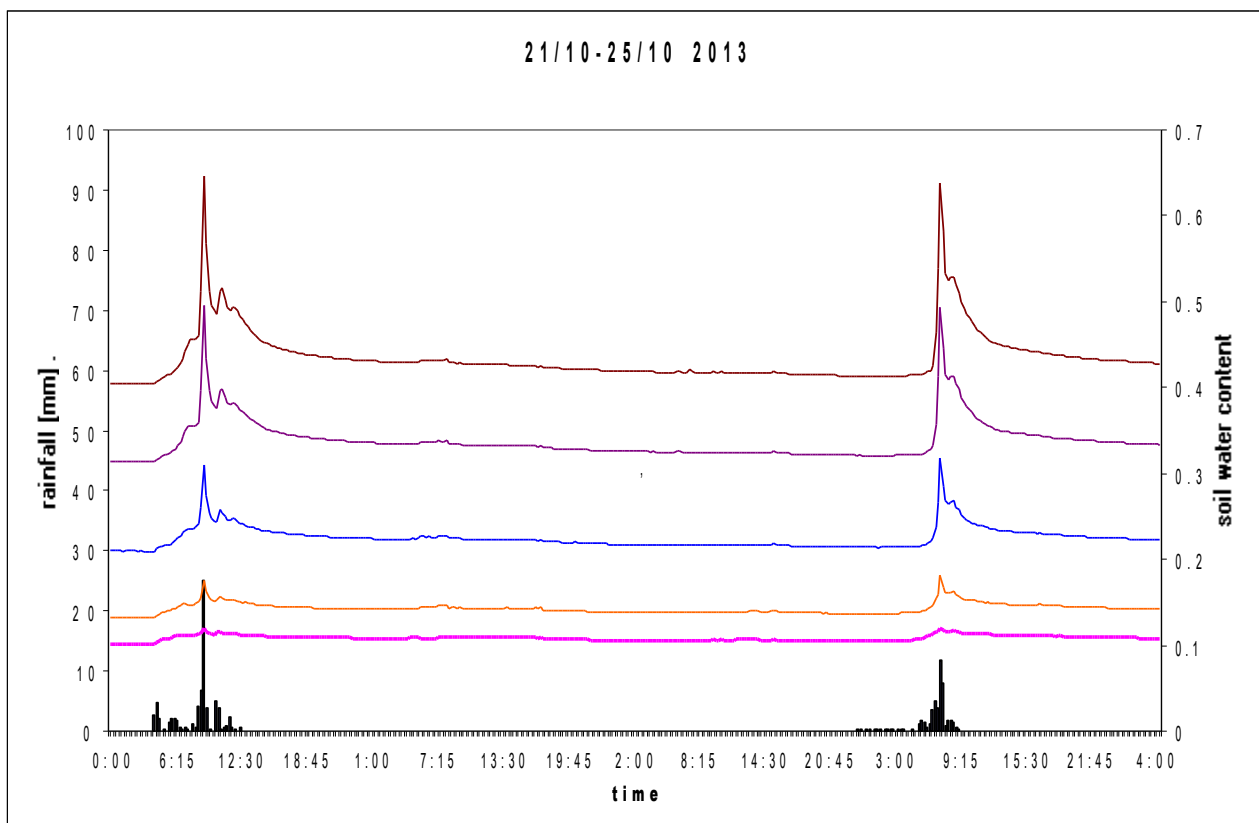
*figure 10: variation of soil water content by volume, measured at different depths, vs rainfall*

The collected soil moisture data highlight as water contents vary with depths; in the details high water levels are founded around 0,5 m deep, in correspondence with the plow profile, and in the 0,7 m deep layer, while the layers at 0,2 and 0,3 m lack in water storage. The upper layer is usually the most humid, collecting even the lightest rain and the dew.
