UNIVERSITÀ  
DEGLI STUDI  
FIRENZE

DOTTORATO DI RICERCA IN

*Landslide dams in Italy: analysis of main predisposing  
factors and damming susceptibility mapping*

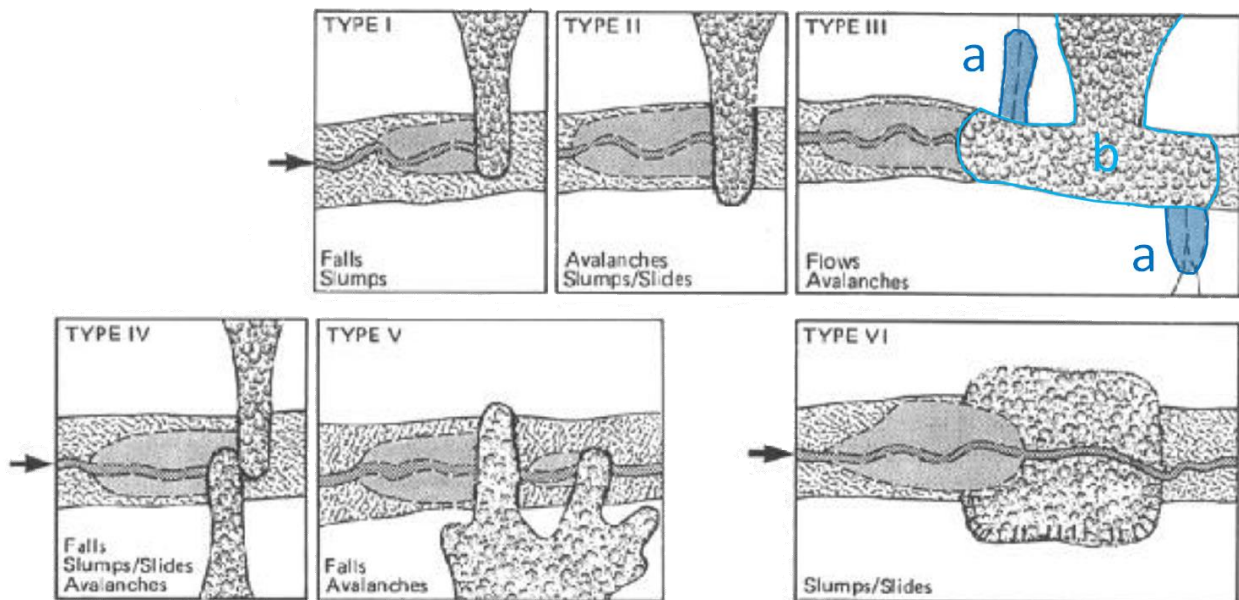
Figure 4 - Geomorphological classification of landslide dams (from Costa & Schuster, 1988 modified).

There are six classes identified by Costa & Schuster (1988), five of which are completely dedicated to dams caused by landslides and one in common with the latter and those originated by glacial tongues.

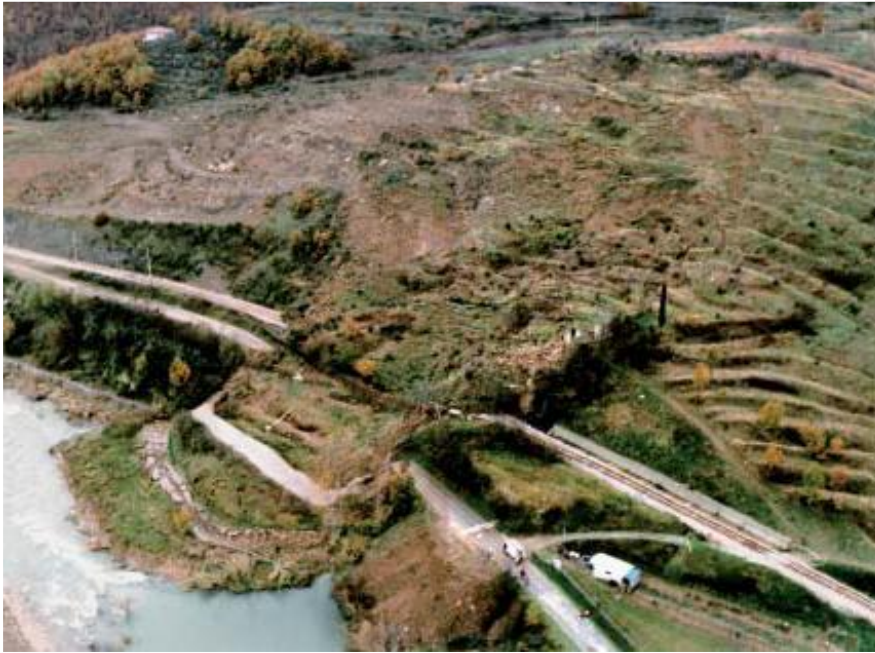
*Figure 5 - The reach of river bed affected by “Le Mottacce” landslide (Arezzo, Italy), taken immediately after the occurring of the event (from Cencetti et al., 2011).*

A typical example in Italy is the landslide of 1987 in the village of Mottacce (Figure 5, ID 53), in the Municipality of Subbiano (Arezzo), that, after destroying the provincial road and the railway for a distance 200 m long, stopped by blocking only half of the riverbed of the Arno River.

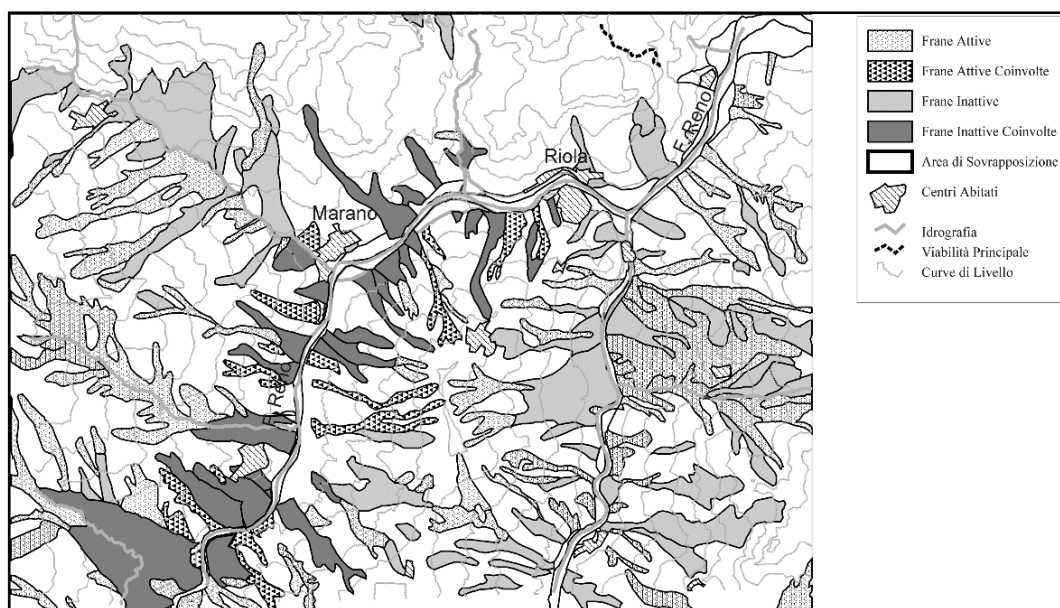
Figure 6 - Part of the basin of the Reno River, Municipality of Gaggio Montano (from Carboni et al., 2001).

An obvious example of this conditioning is given by the stretch of the Reno River (Figure 6) in the Gaggio Montano Municipality (Bologna), where much of these landslides are in a state of dormancy for most part of the time except for periodic reactivations (Carboni et al. 2001).

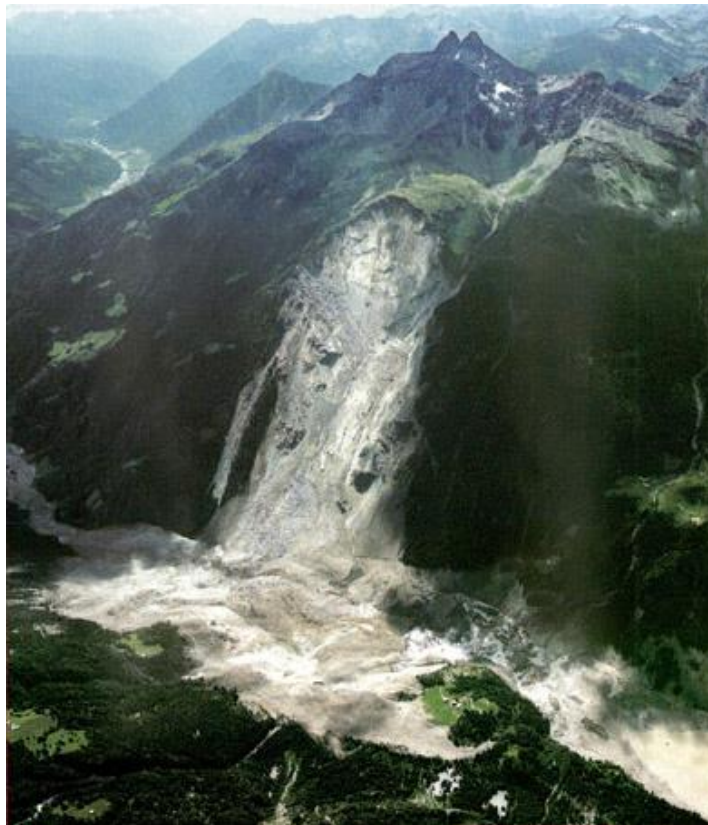
*Figure 8 - Landslide dam of Val Pola, Sondrio, Italy, in 1987.*

Typical examples in Italy are Lama Mocogno (ID 15), Modena in 1879 (Pantanelli & Santi, 1895) e Val Pola (ID 115), Sondrio, in 1987 (Crosta et al., 2004; Pirocchi, 1991). The Lama Mocogno landslide, Northern Italy, is a reactivation of other events that had occluded in the same place, not always fully, the Scoltenna stream, a tributary of the Panaro. The most important event is definitely the one of 1879. The landslide led to the complete closure of the river, forming a lake of 4 km in length, which then disappeared for silting after few years. The big Val Pola landslide (Figure 8), Northern Italy, which took place July 28, 1987, was the more important calamitous event in the last few decades for the economic and social consequences that caused (Crosta et al., 2004). Also in this case it is the reactivation of an oldest landslide, whose crown area is still visible (Pirocchi, 1991). The landslide body blocked the valley bottom of the Adda River for almost 2 km long, going up the other side for about 250 meters (equal to about 1/5 of the difference in height of the drop).

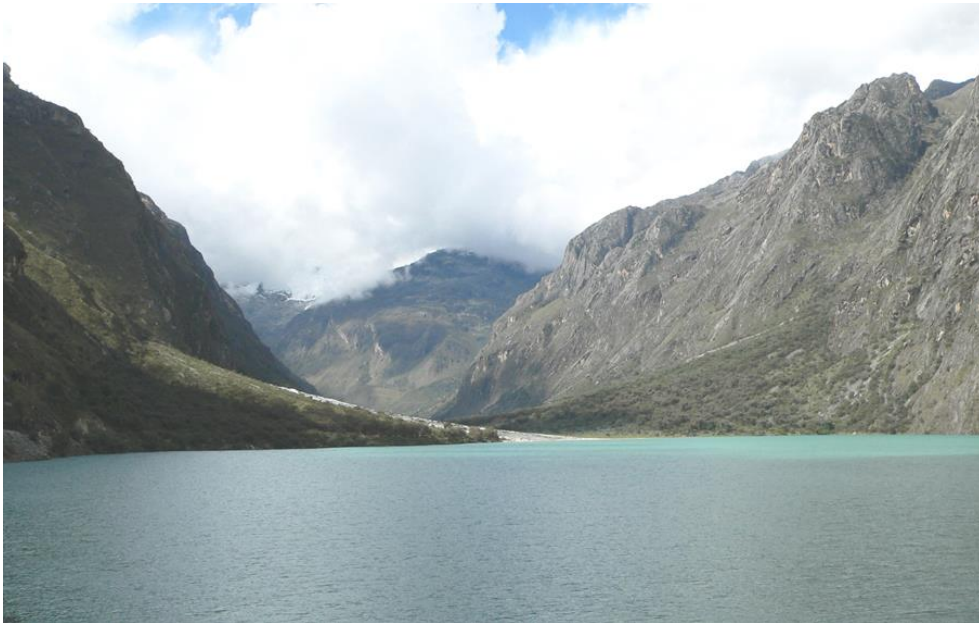
*Figure 9 - View of Llanganuco Alto dam, Ancash Province, Peru.*

Also in the rest of the world this type of landslide dam is not so recurring. A good example is the Llanganuco Lakes in Cordigliera Blanca in Ancash Province, Peru, formed by the coalescence of two debris cones from the opposite valley sides (Figure 9).

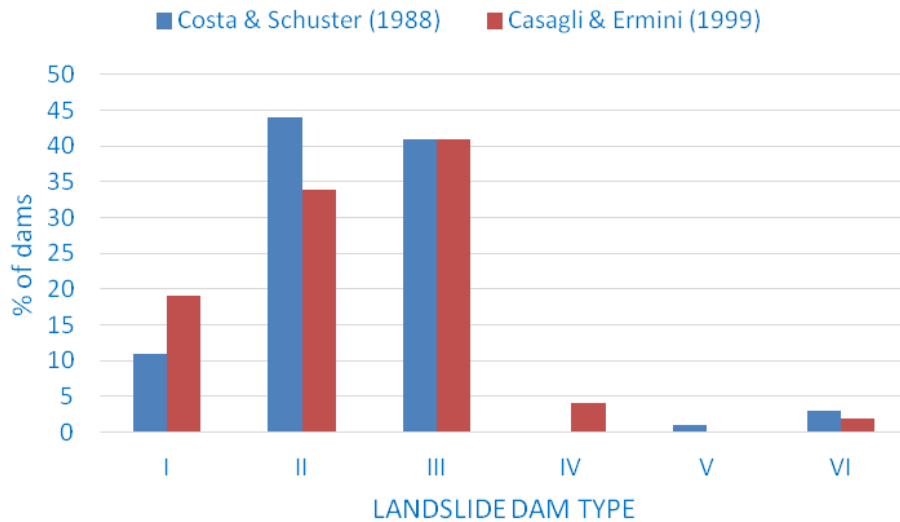
Figure 11 - Landslide dams type distribution (Costa & Schuster, 1988, in blue; Casagli & Ermini, 1999, in red).

According to Costa & Schuster (1988), landslide dam of type II are the most common and covers 44% of the cases, closely followed by the type III with 41%. The census conducted in the Apennines by Casagli & Ermini (1999) has led to substantially similar results, even if the most abundant dams are type III with 41% followed by type II with 34% (Figure 11).

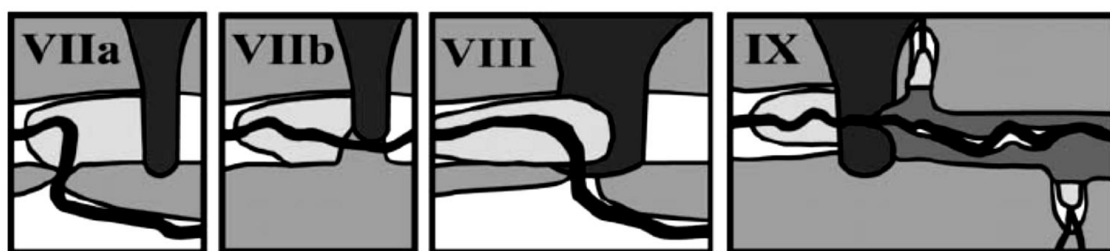
Figure 12 - Classification of landslide dam types VII – IX proposed by Hermanns et al. (2006) (from Hermanns et al., 2006 modified).

Based on surveys carried out along the Argentine Andes, Hermann et al. (2006) found that in some cases landslide dams can make substantial changes in the river system, diverting the normal flow of water. This has resulted in the need to add new classes to the classification that are given below for the sake of completeness, although not represented in any of the reported cases in Italy (Figure 12).

**Type VIIa:** the dam forms a barrier that causes the development of a new drainage network, diverting the stream into an adjacent valley through the rock in place.

**Type IX:** the dam break causes a huge debris flow that can spread up to 60 km away (as in the case of the landslide Barrancas Valley in Argentina in 1914), whose terraced deposits can affect the flow of the tributaries located downstream of the dam.

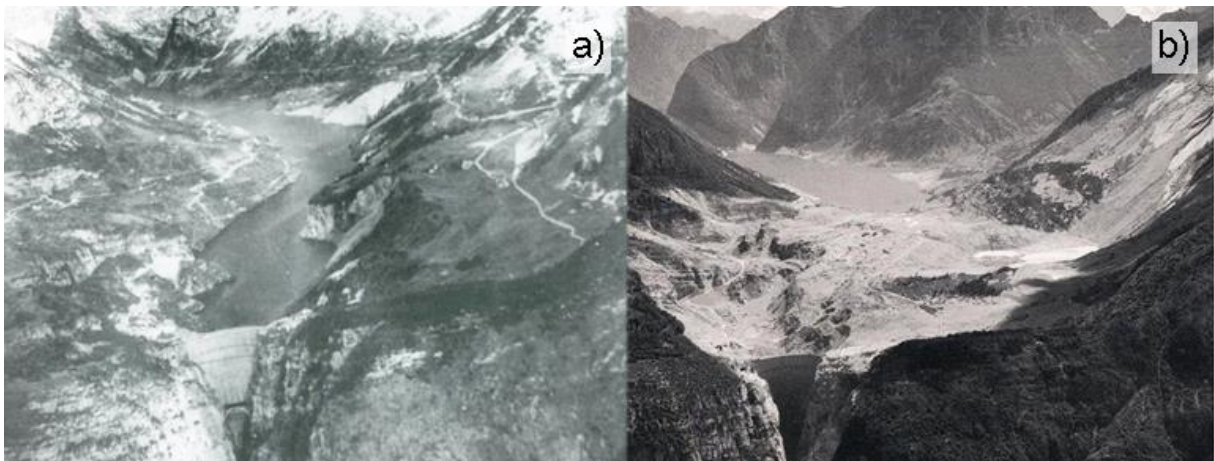
Figure 14 - Aerial views of Vajont valley (Pordenone, Italy), a) before, and b) after the disaster in 1963 (pictures from Wikipedia).

The waters of the reservoir reaches the spillway height of the dam and trigger an erosion process, resulting in the formation of a channel on the downstream side of the dam. Sometimes the overtopping of the dam can be triggered by a wave of water caused by the fall of a landslide in the reservoir, like in the October 9, 1963, at Vajont dam (Pordenone, ID 184) when a massive landslide of more than 200 millions of m<sup>3</sup> of material cause a huge wave that destroyed the Longarone village and killed more than 2'000 people (Figure 14).

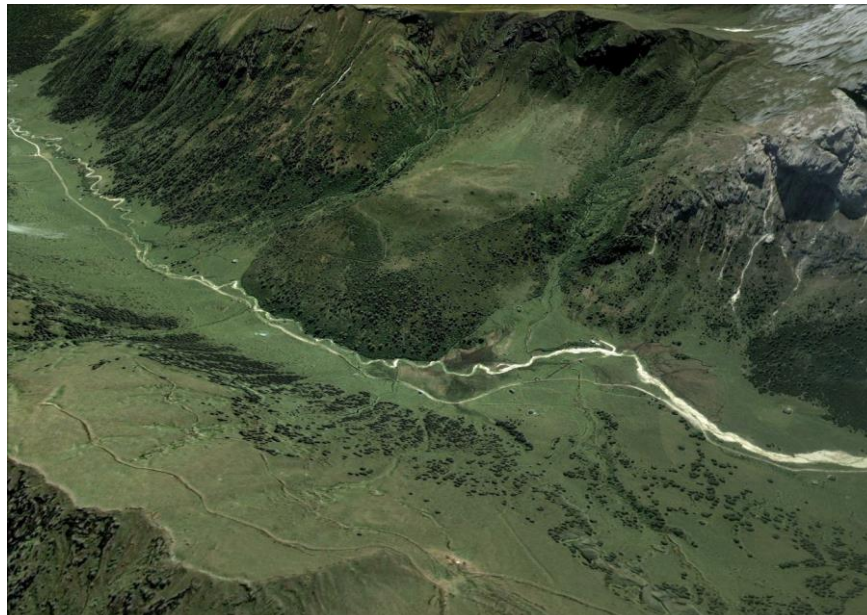
*Figure 19 - View of the ancient landslide of Campo di Grevena, Trento, Northern Italy (picture from GoogleEarth).*

This tool, combined with the 3D view of the ground (Figure 19), has allowed, through the comparison of images acquired in different times, to understand and reconstruct the evolution of a landslide dam (as the Costantino lake silting, ID 97, in Reggio Calabria, Southern Italy, showed in Figure 22) and its consequences on the upstream and downstream area.

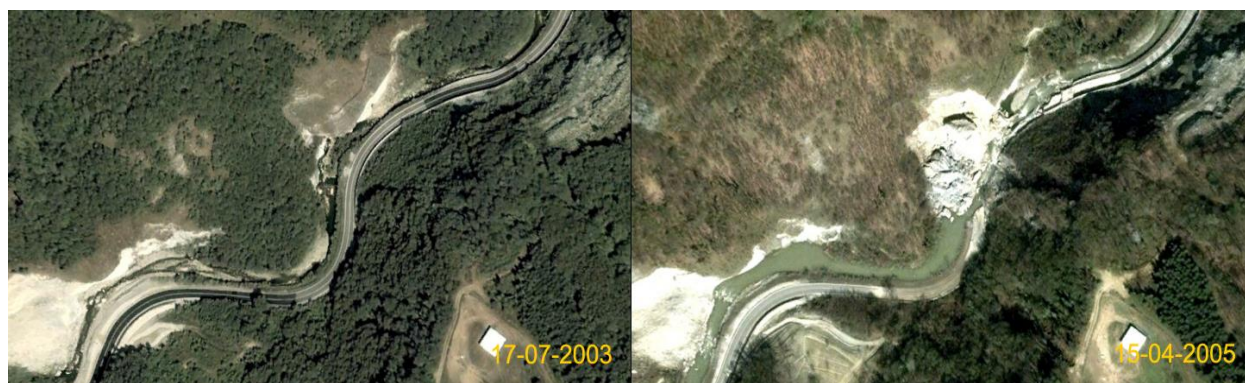
Figure 21 - The Scascoli case (ID 72), Bologna, before and after the landslide reactivation (pictures from GoogleEarth).

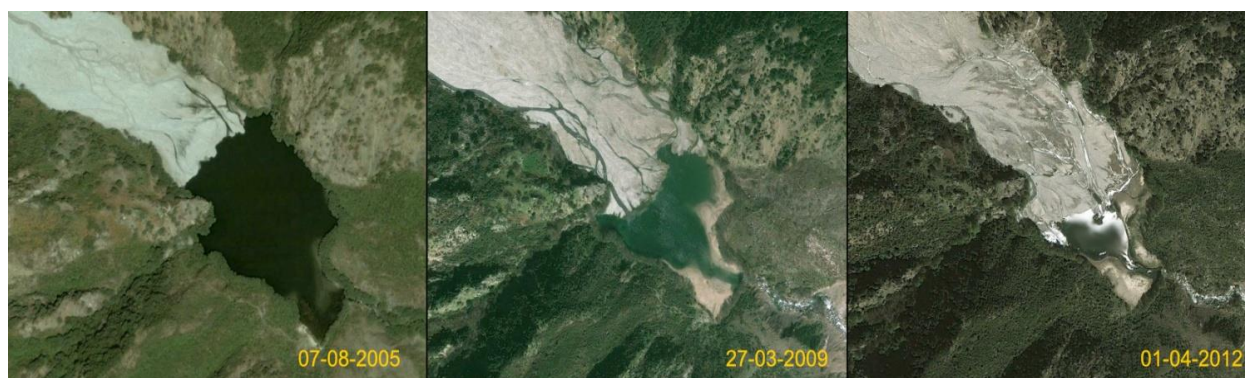
Figure 22 - Evolution from 2005 to 2012 of silting up of Costantino Lake (ID 97), Reggio Calabria, Southern Italy (pictures from GoogleEarth).

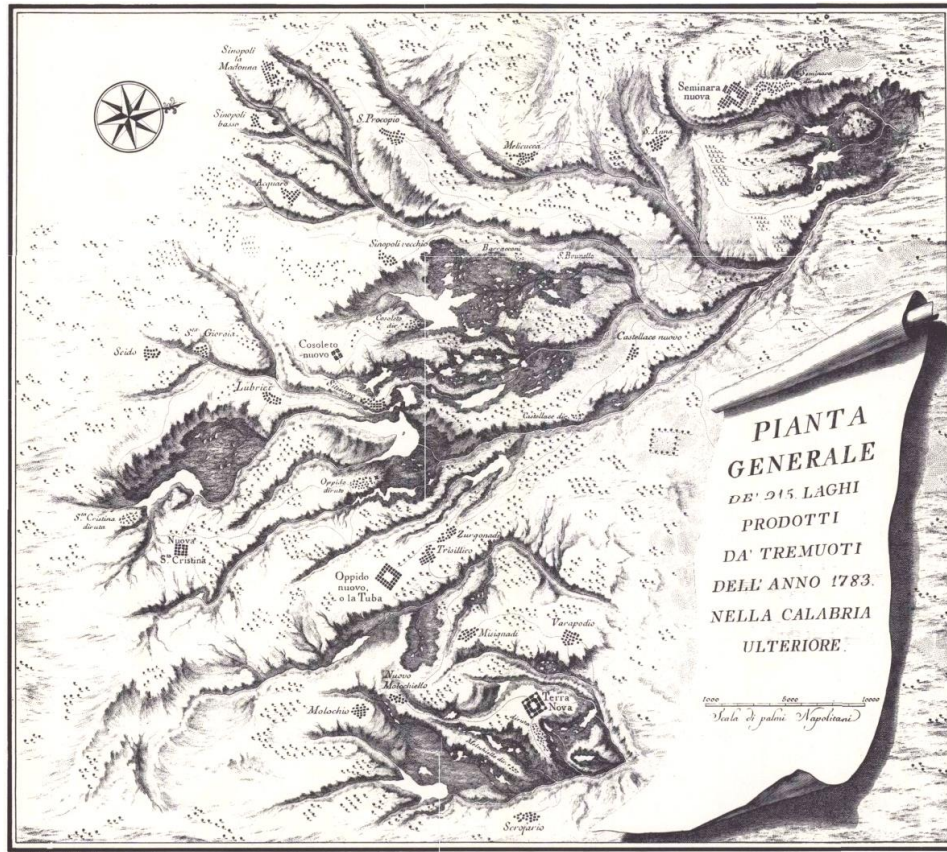
Figure 25 - Map of the 215 lakes formed by the earthquake of 1783 in Calabria, Southern Italy (from Sarconi, 1784).

Countless were the landslides, including several oversized which destroyed entire villages dragging them downstream. Rivers were diverted or dammed, with the formation of at least 215 lakes (Figure 25), as reported by Ruberti (1787):

Unfortunately it was possible to identify with certainty only about ten of the dams on the Calabrian territory product by landslides of larger size. The other approximately 200 dammed lakes produced by gravitational movements of lower dimensions were not detected by the lack of sufficiently obvious forms in the current morphology. A careful reading of the chronicles describing these lakes (Ruberti, 1787; Vivenzio, 1788) has allowed to understand that many of these were not the result of a river obstruction but were instead water basins located along counterslopes within the landslide.

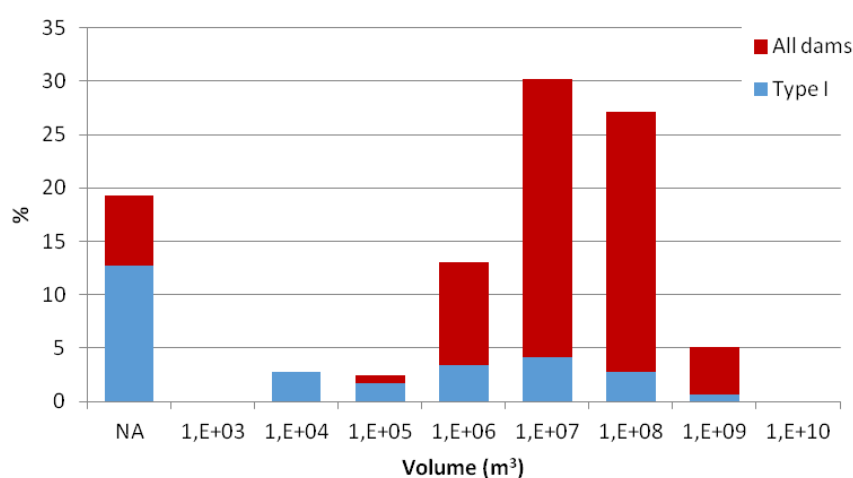
Figure 26 - Volumes distribution of landslide dams collected in Italy. The part of them represented by Type I dams (according to the classification proposed by Costa & Schuster, 1988) are highlighted in blue. (NA = Not Available).

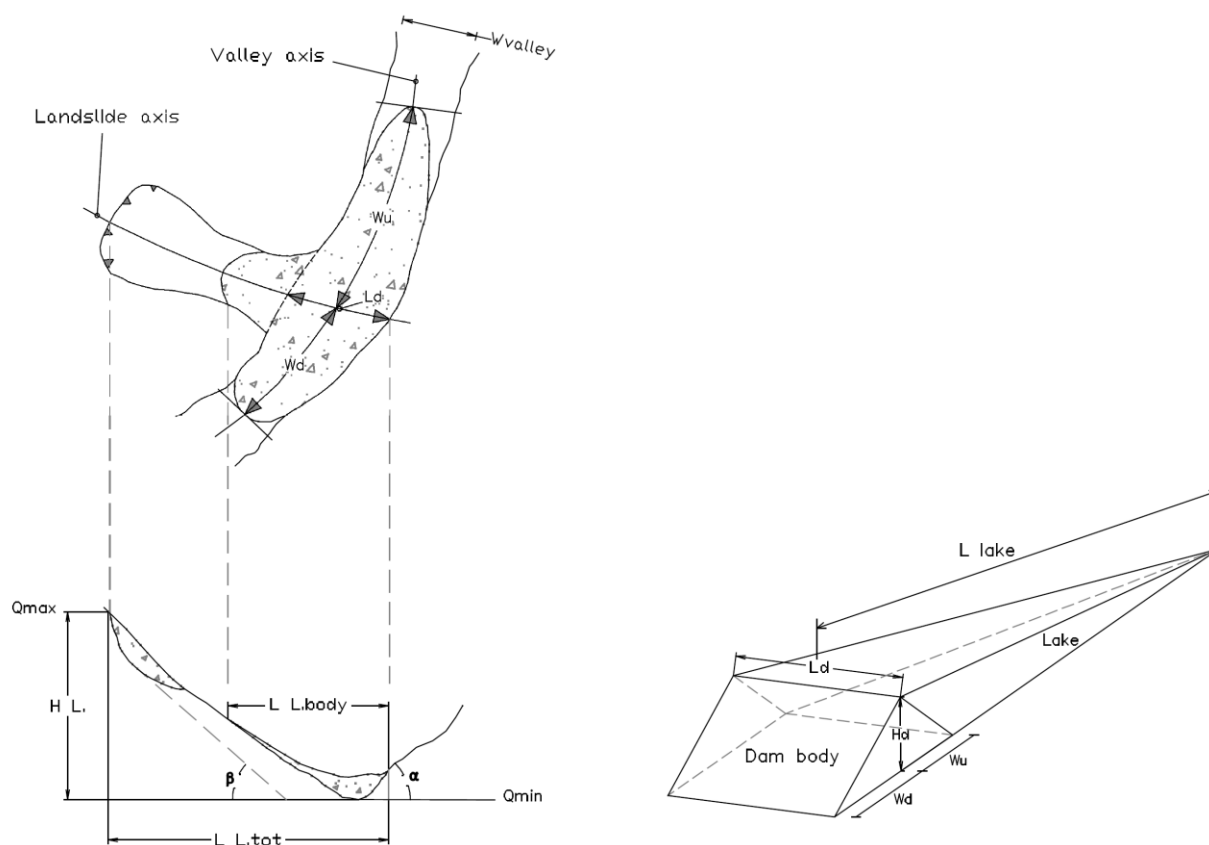
Figure 27 - Landslide dam geometry and morphometric parameters, see Table 1 for symbols correspondence (from Pirocchi, 1991, modified).

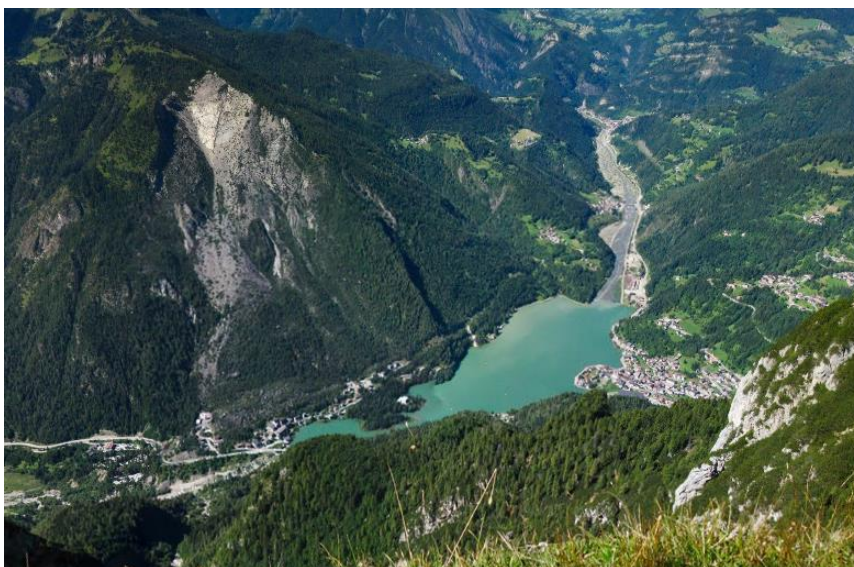
Figure 29 - View of the Alleghe, Northern Italy, Lake from the Est side.

5. *Stable – existing lakes*: in this class are included all stable landslide dams that originated dammed lakes still existing. Several cases, even if have had an evolution globally characterized by stability, still have an element of potential danger linked to the presence of the lake basin. For this reason a part of the existing dammed lake have suffered an human influence in order to make sure of their complete stability. There are many cases of landslide dam in Italy that led to the formation of beautiful natural lakes: for instance the Alleghe Lake (ID 116), Belluno, in Alps (Montandon, 1933) as showed in Figure 29, that formed in 1771, and the older Scanno Lake (ID 68), L’Aquila, in Abruzzo Region (Nicoletti et al., 1993). The knowledge of the rates of filling of an impoundment is of central importance for estimating the sediment-production rates in a drainage basin for planning purposes. Landslide dammed lakes provide precious chances of direct measurement of sediment yield.

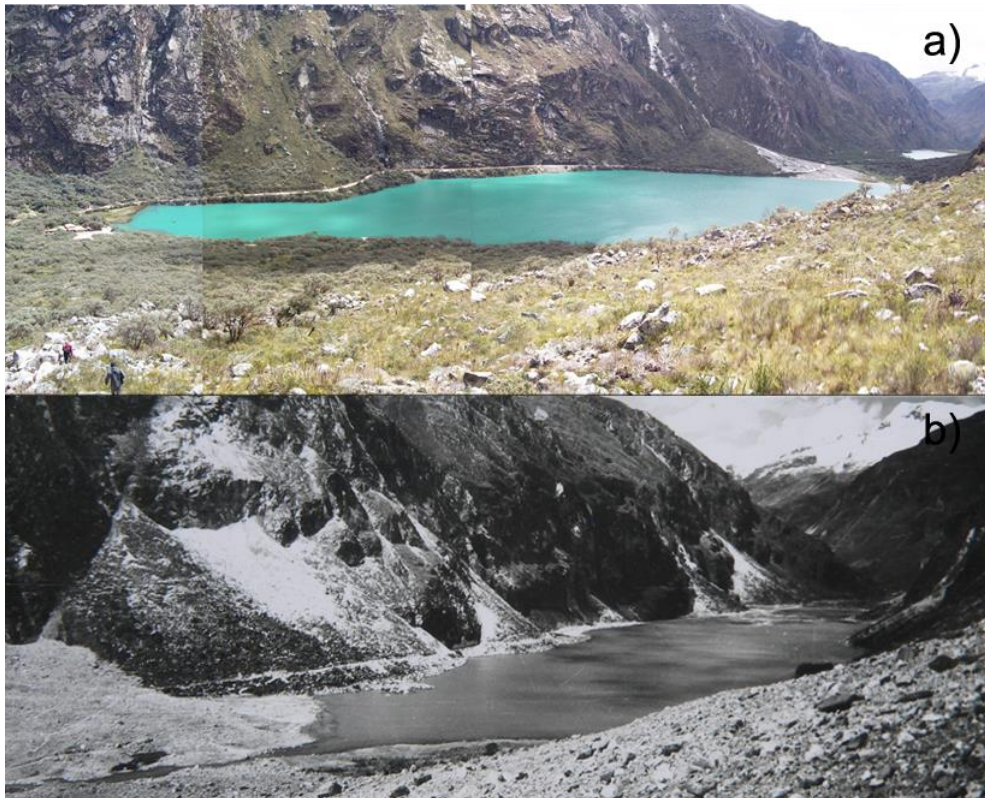
Figure 32 - Pictures of Llanganuco Lakes, Ancash Province, Peru: a) ID P2, “Laguna Baja” or “Chinanqocha” (Low or Female Lake) 3'850 m a.s.l. (2014); b) ID P1, “Laguna Alta” or “Orqonqocha” (High or Male Lake) 3'860 m a.s.l. (from Zapata, 1971).

In the Cordillera Blanca Mountains is also possible to find some landslide dam or the traces of extinct lakes. A total of 24 cases have been identified (Figure 31), but it was possible to realize a field survey just for four of them (as Llanganuco Lakes, shown in Figure 32), because the hard access conditions to the area due to the high mountains.

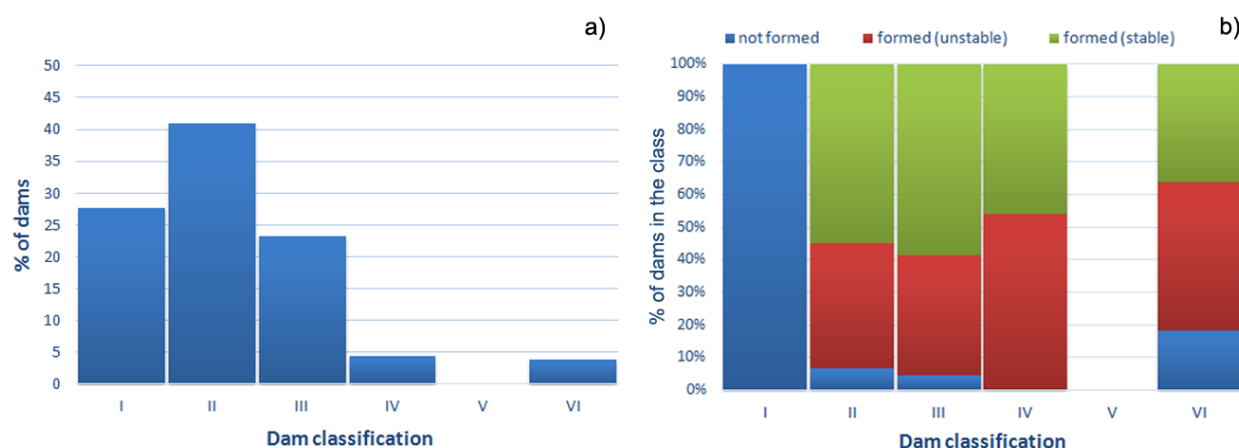
Figure 36 - Classification of landslide dams in Italy a) according to Costa & Schuster (1988) b) and their evolution classes distribution.

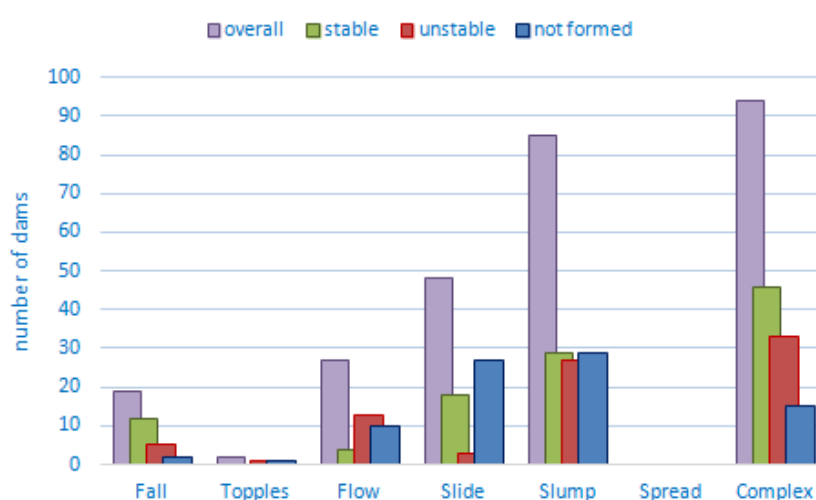
Figure 37 - Types of landslide movement compared with the evolution of the dam in Italy.

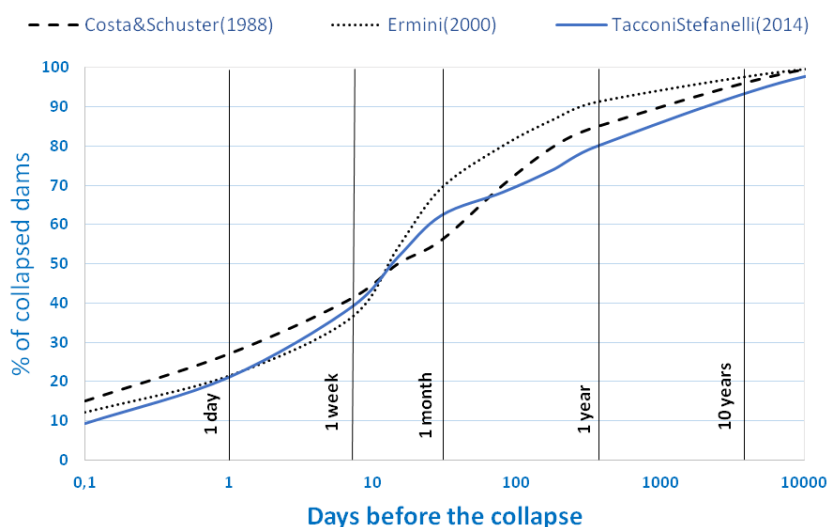
Figure 38 - Survival time before the failure of landslide dams.

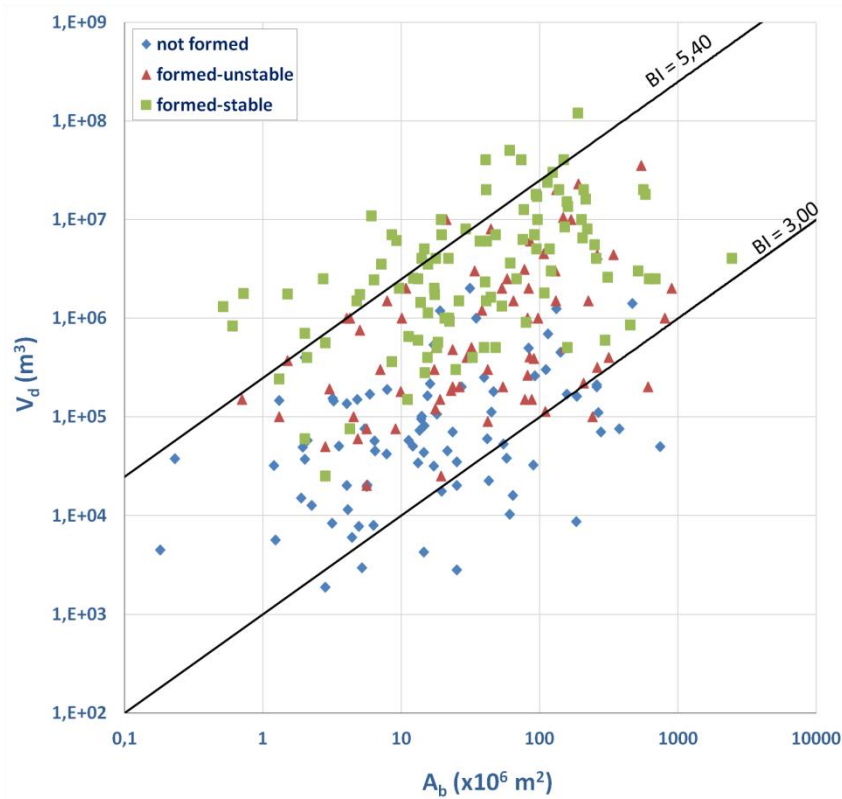
Figure 44 - Ratio between landslide dam volume and drainage basin area (Blockage Index, according to Canuti et al. (1998)) for the inventoried landslide dams, distinguished by type of evolution.

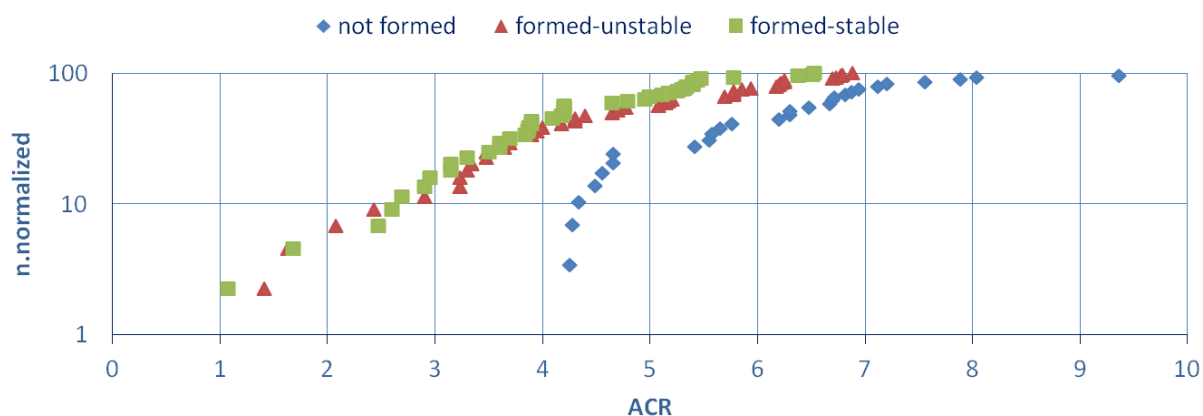
Figure 46 - Annual Constriction Ratio (Swanson et al., 1986) values distribution of the inventoried landslide dams according to the three evolution classes.

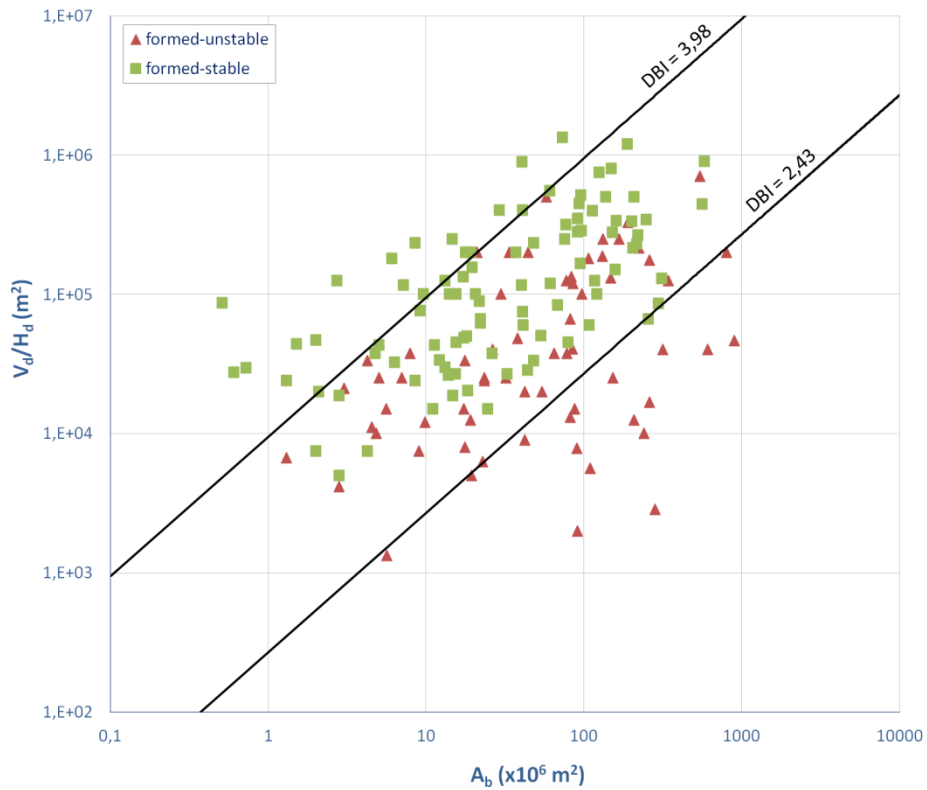
Figure 47 - Landslide dam volume and dam height plotted versus drainage basin area (Dimensionless Blockage Index, according to Ermini & Casagli (2003)) for the inventoried landslide dams, distinguished by type of evolution.

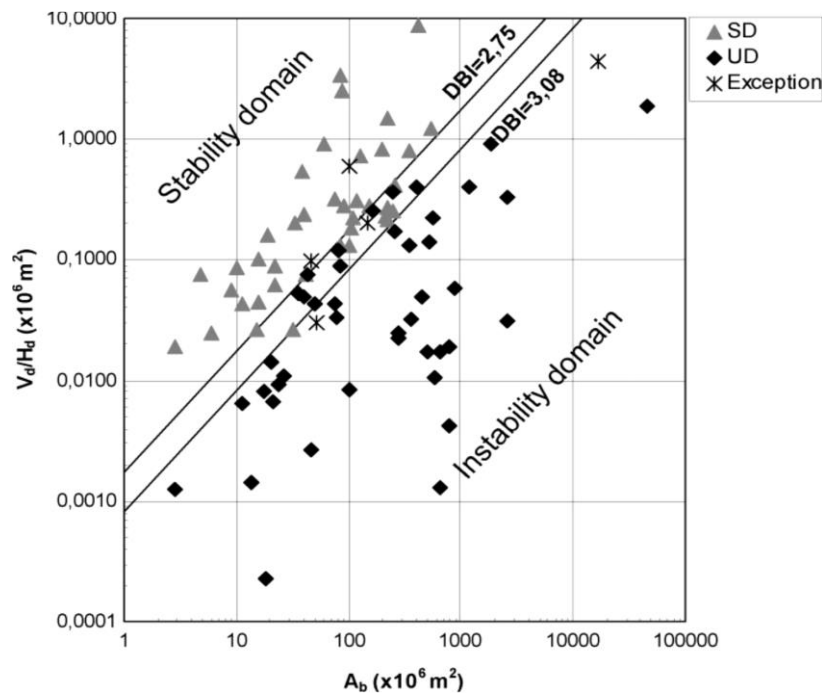
Figure 49 - Results of the dimensionless blockage index for 84 events inventoried worldwide by Ermini & Casagli (2003).

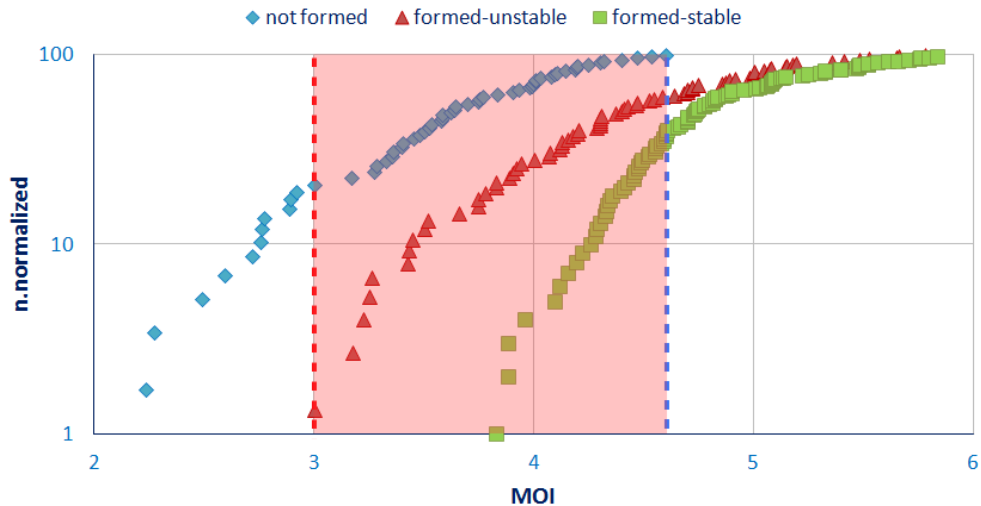
Figure 51 - Morphological Obstruction Index values distribution of the inventoried landslide dams according to the three evolution classes.

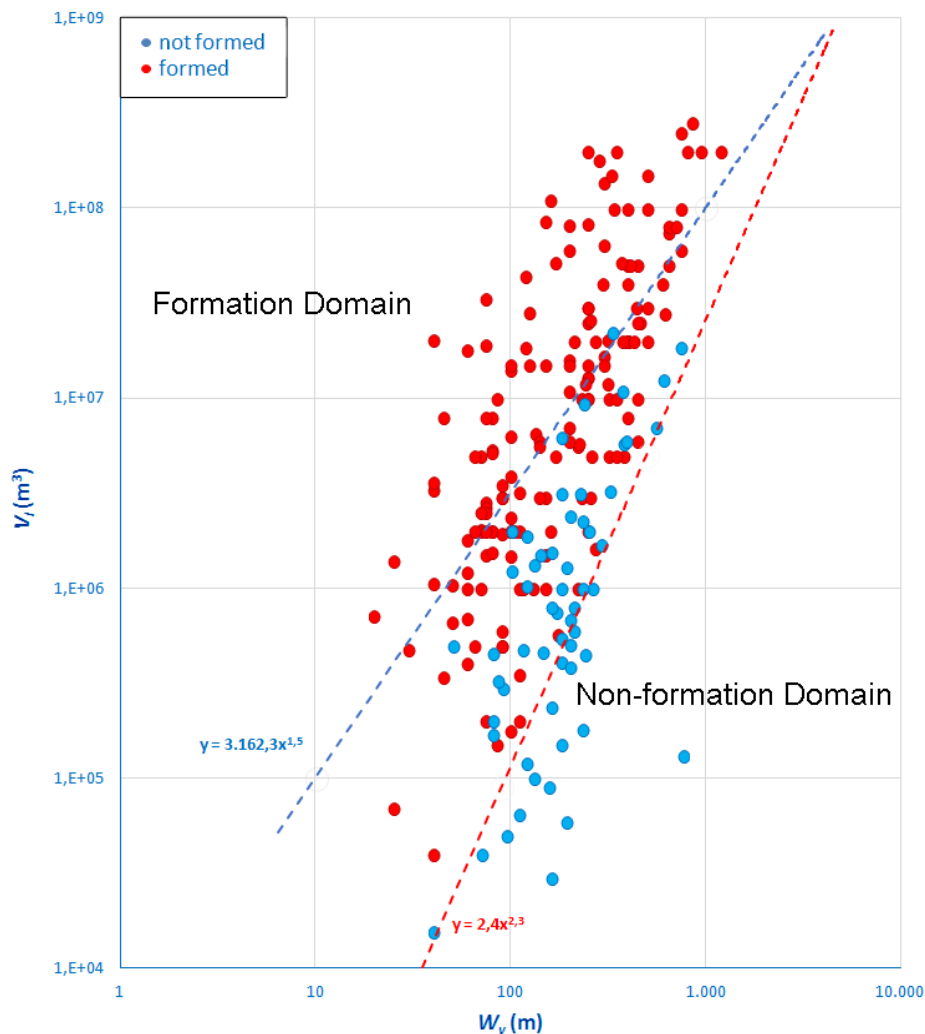
Figure 52 - Ratio between landslide dam volume and width of the dammed valley for the inventoried landslide dams, distinguished in formed and not formed.

From the geomorphological point of view and the evolution of the phenomenon, with the same boundary conditions, the ratio between the volume of the dam and the width of the dammed valley is determinant. In particular, low values of this ratio normally lead to the erosion of the landslide foot, while higher ratios lead to the diversion of the river.

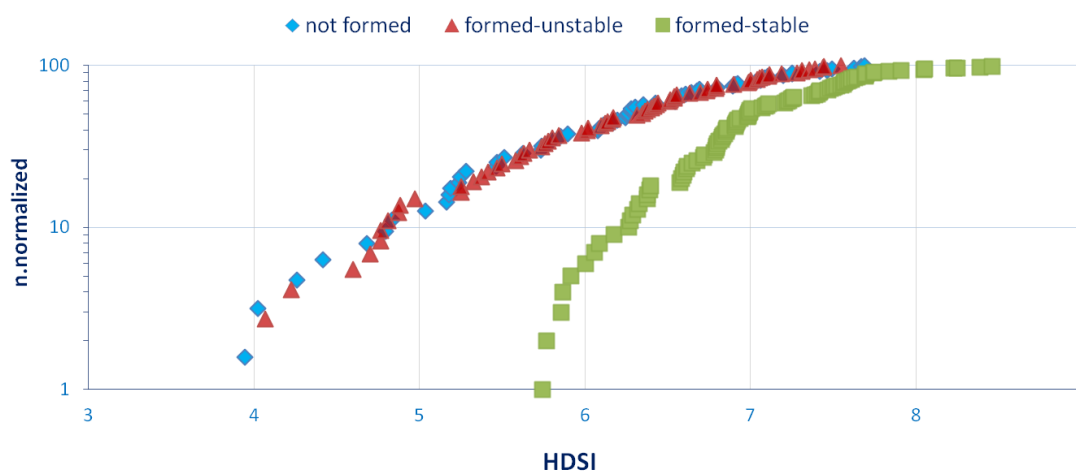
Figure 53 - Hydromorphological Dam Stability Index values distribution of the inventoried landslide dams according to the three evolution classes.

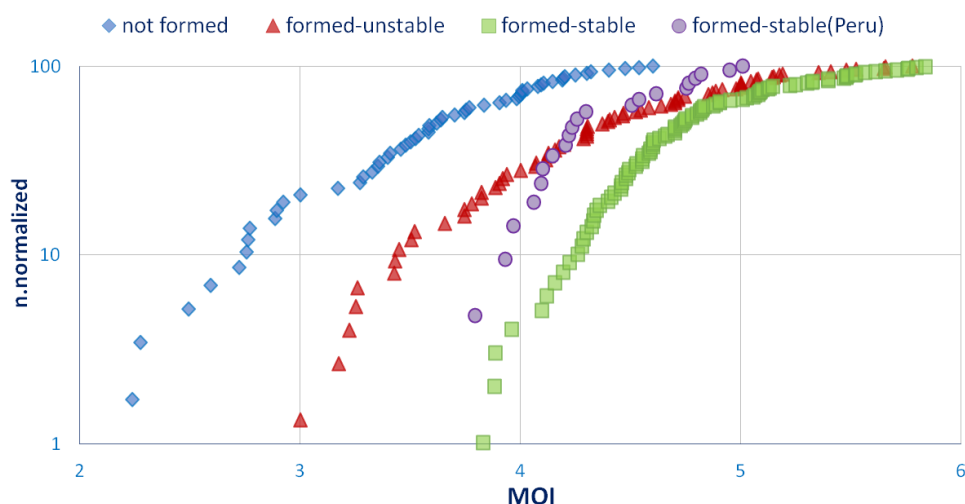
Figure 56 - Morphological Obstruction Index (MOI) values distribution of the inventoried formed-stable Peruvian landslide dams compared with the Italian cases.

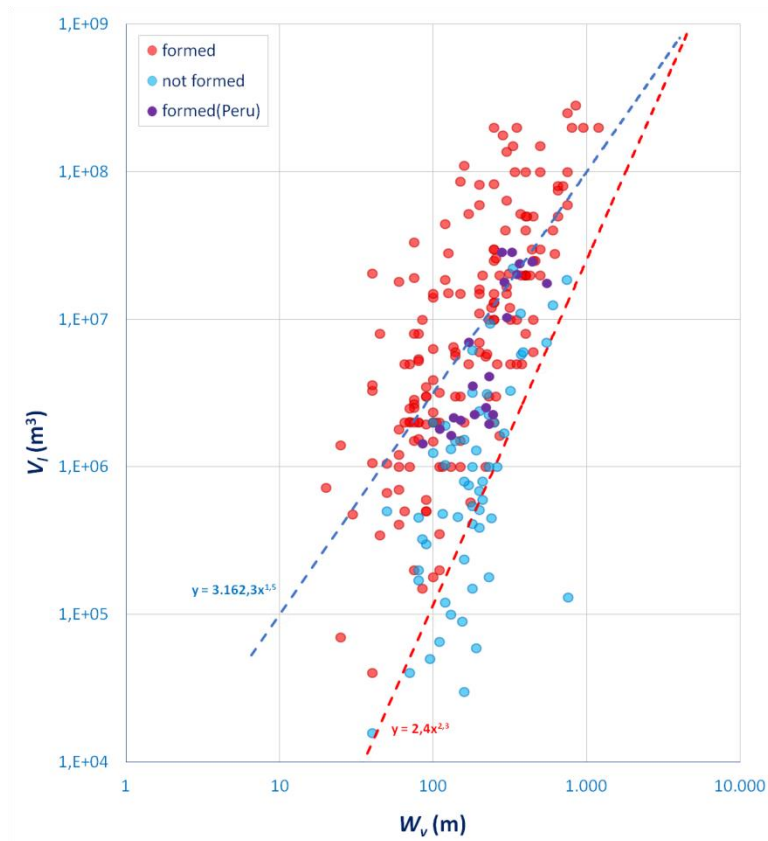
Figure 57 - Ratio between landslide dam volume and width of the dammed valley for Peruvian landslide dams, distinguished in formed and not formed, compared with the Italian cases.

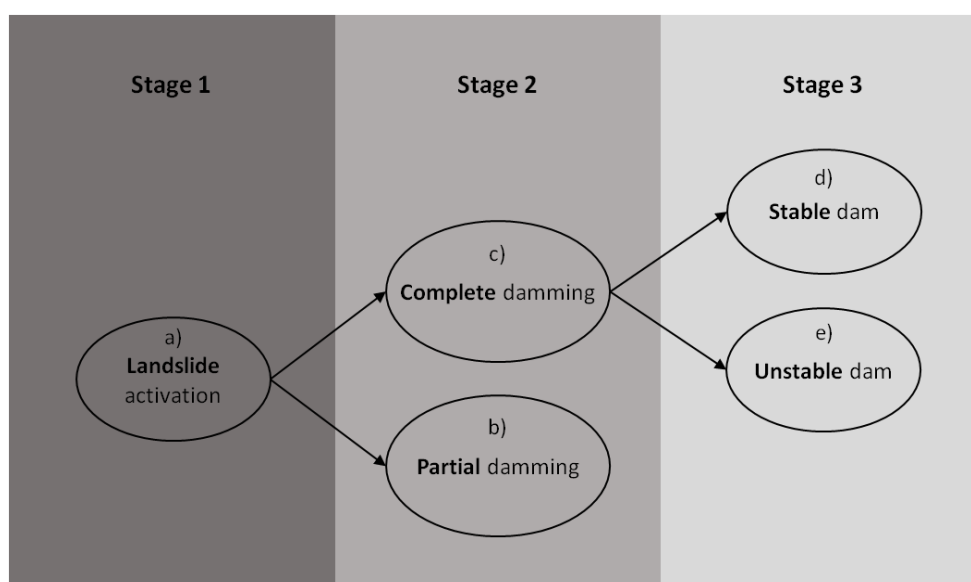
Figure 59 - Schematization of possible steps of a dam evolution.

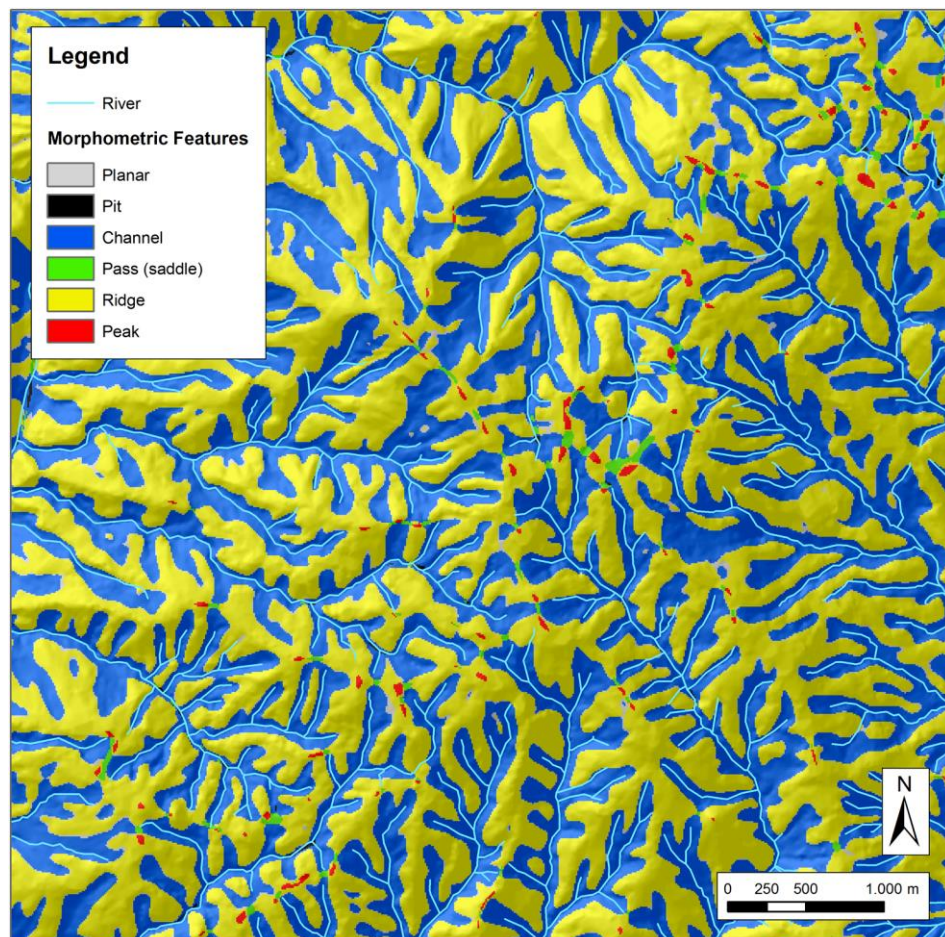
Figure 66 - Subdivision of the landscape in geomorphological units: creation of the Morphometric features.

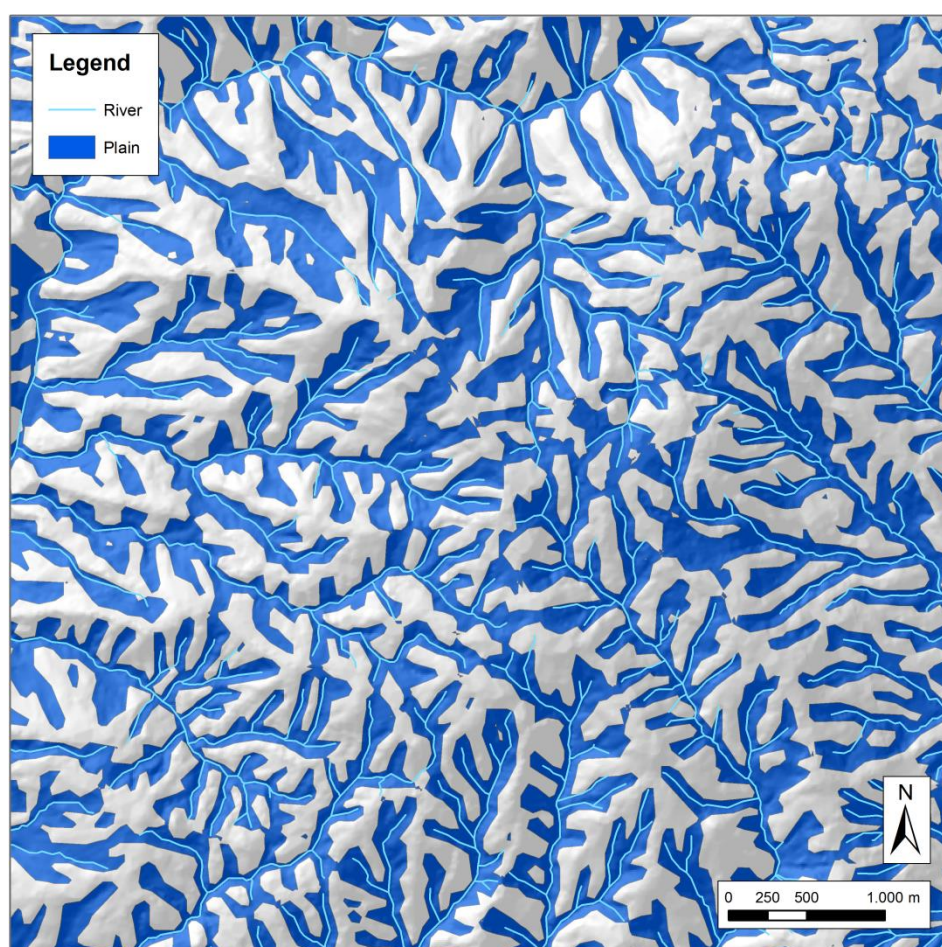
Figure 67 - Subdivision of the landscape in geomorphological units: valley floor polygons extraction.

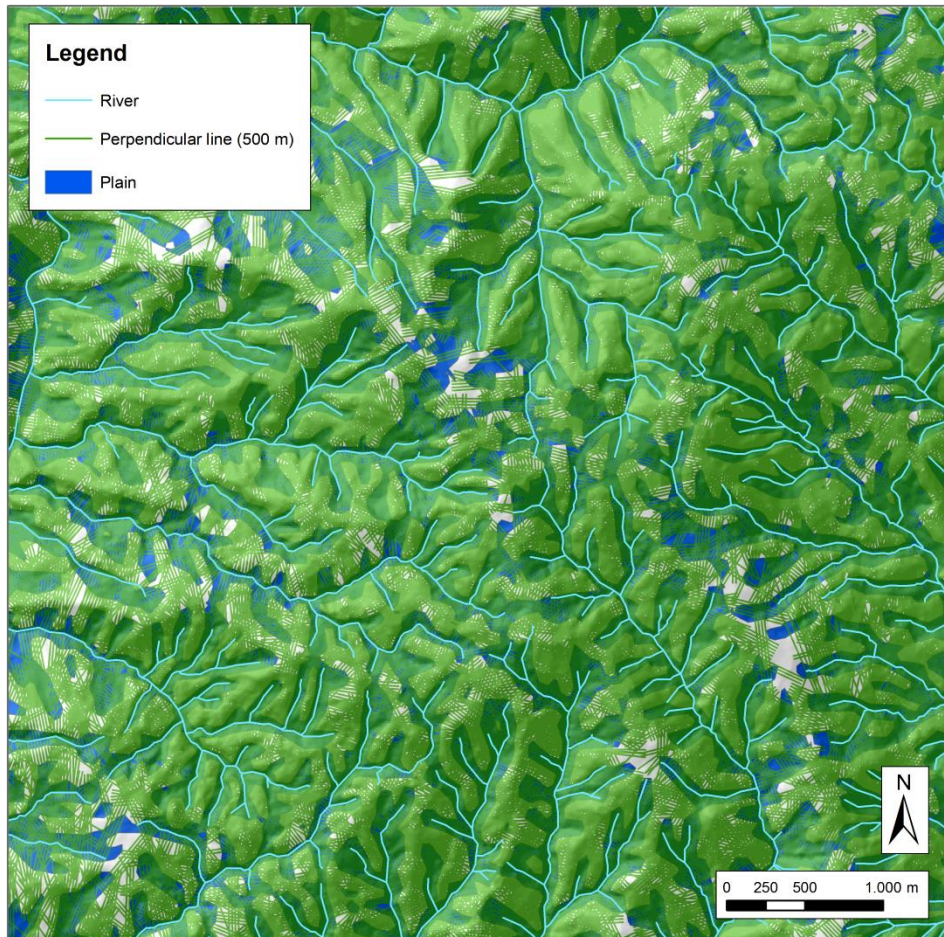
Figure 68 - Creation of lines, transects, 500 m long perpendicular to the river stretches.
