UNIVERSITÀ  
DEGLI STUDI  
FIRENZE

DOTTORATO DI RICERCA IN

*Landslide dams in Italy: analysis of main predisposing  
factors and damming susceptibility mapping*

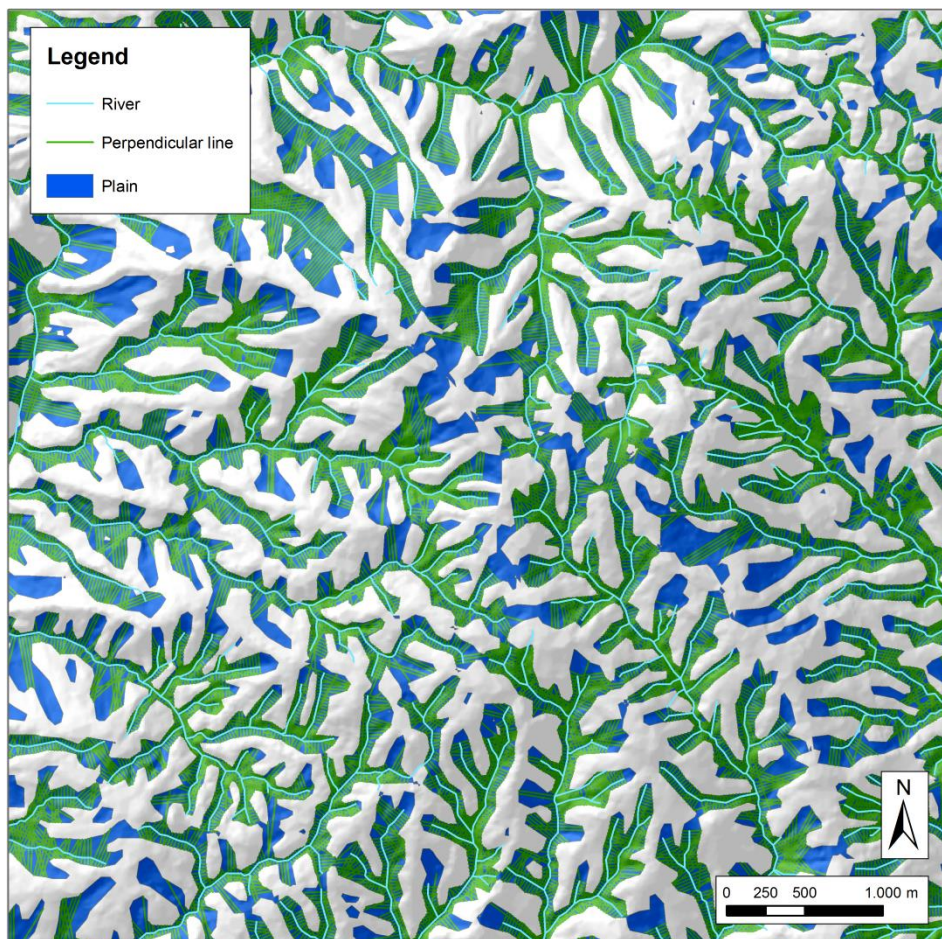
Figure 69 - Clip of transects on valley floor polylines.

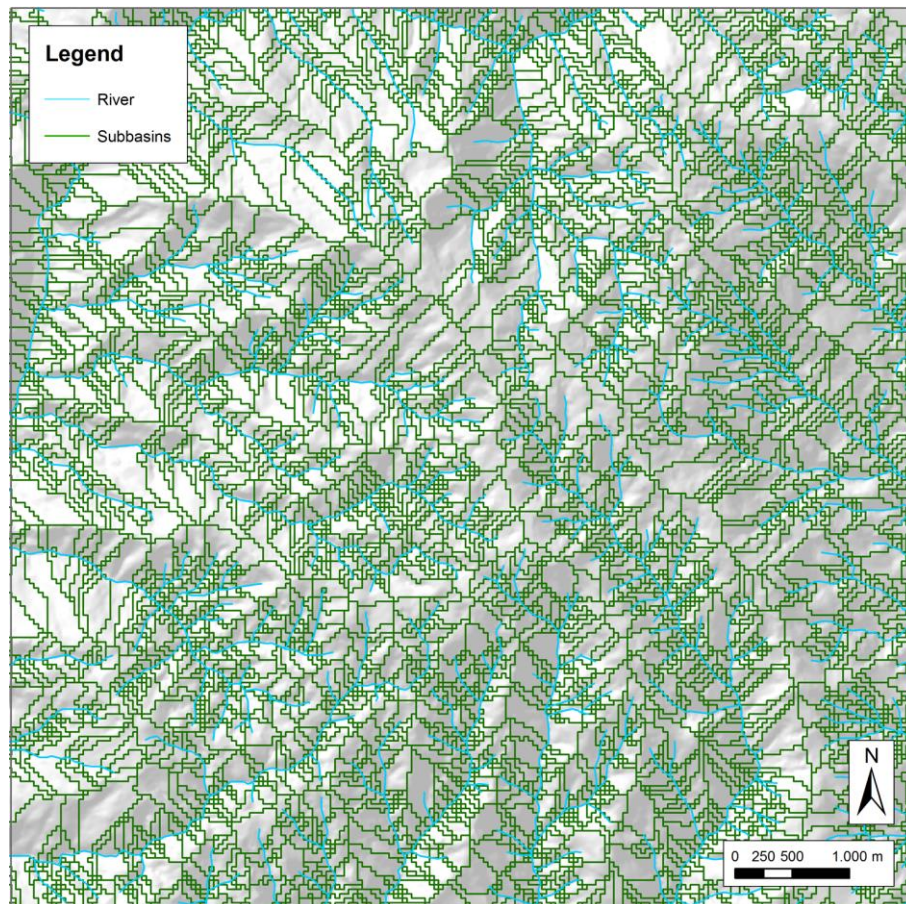
Figure 70 - Watershed sub-surface of single river stretches reconstruction.

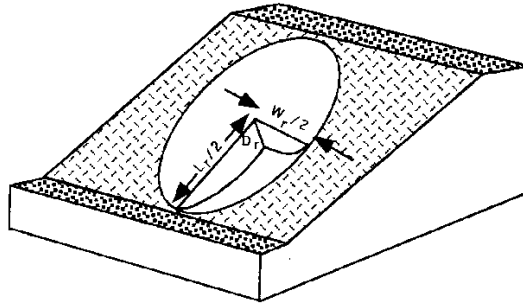
Figure 71 - Geometrical model for rotational slide, assuming a semi ellipsoidal shape (from Cruden & Varnes, 1996).

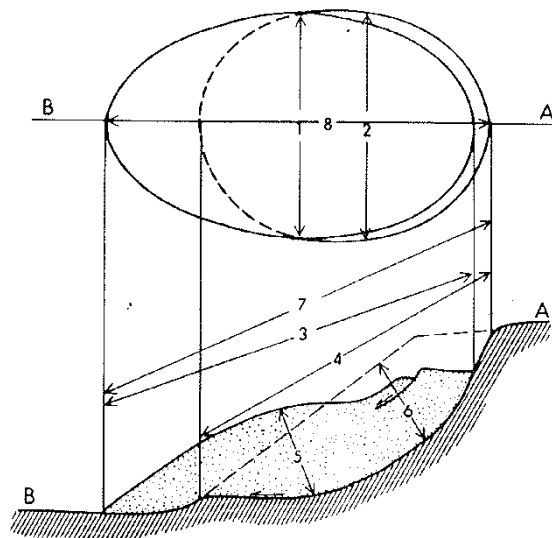
Figure 72 - Geometrical dimensions of a rotational slide (IAEG Commission on Landslides, 1990):

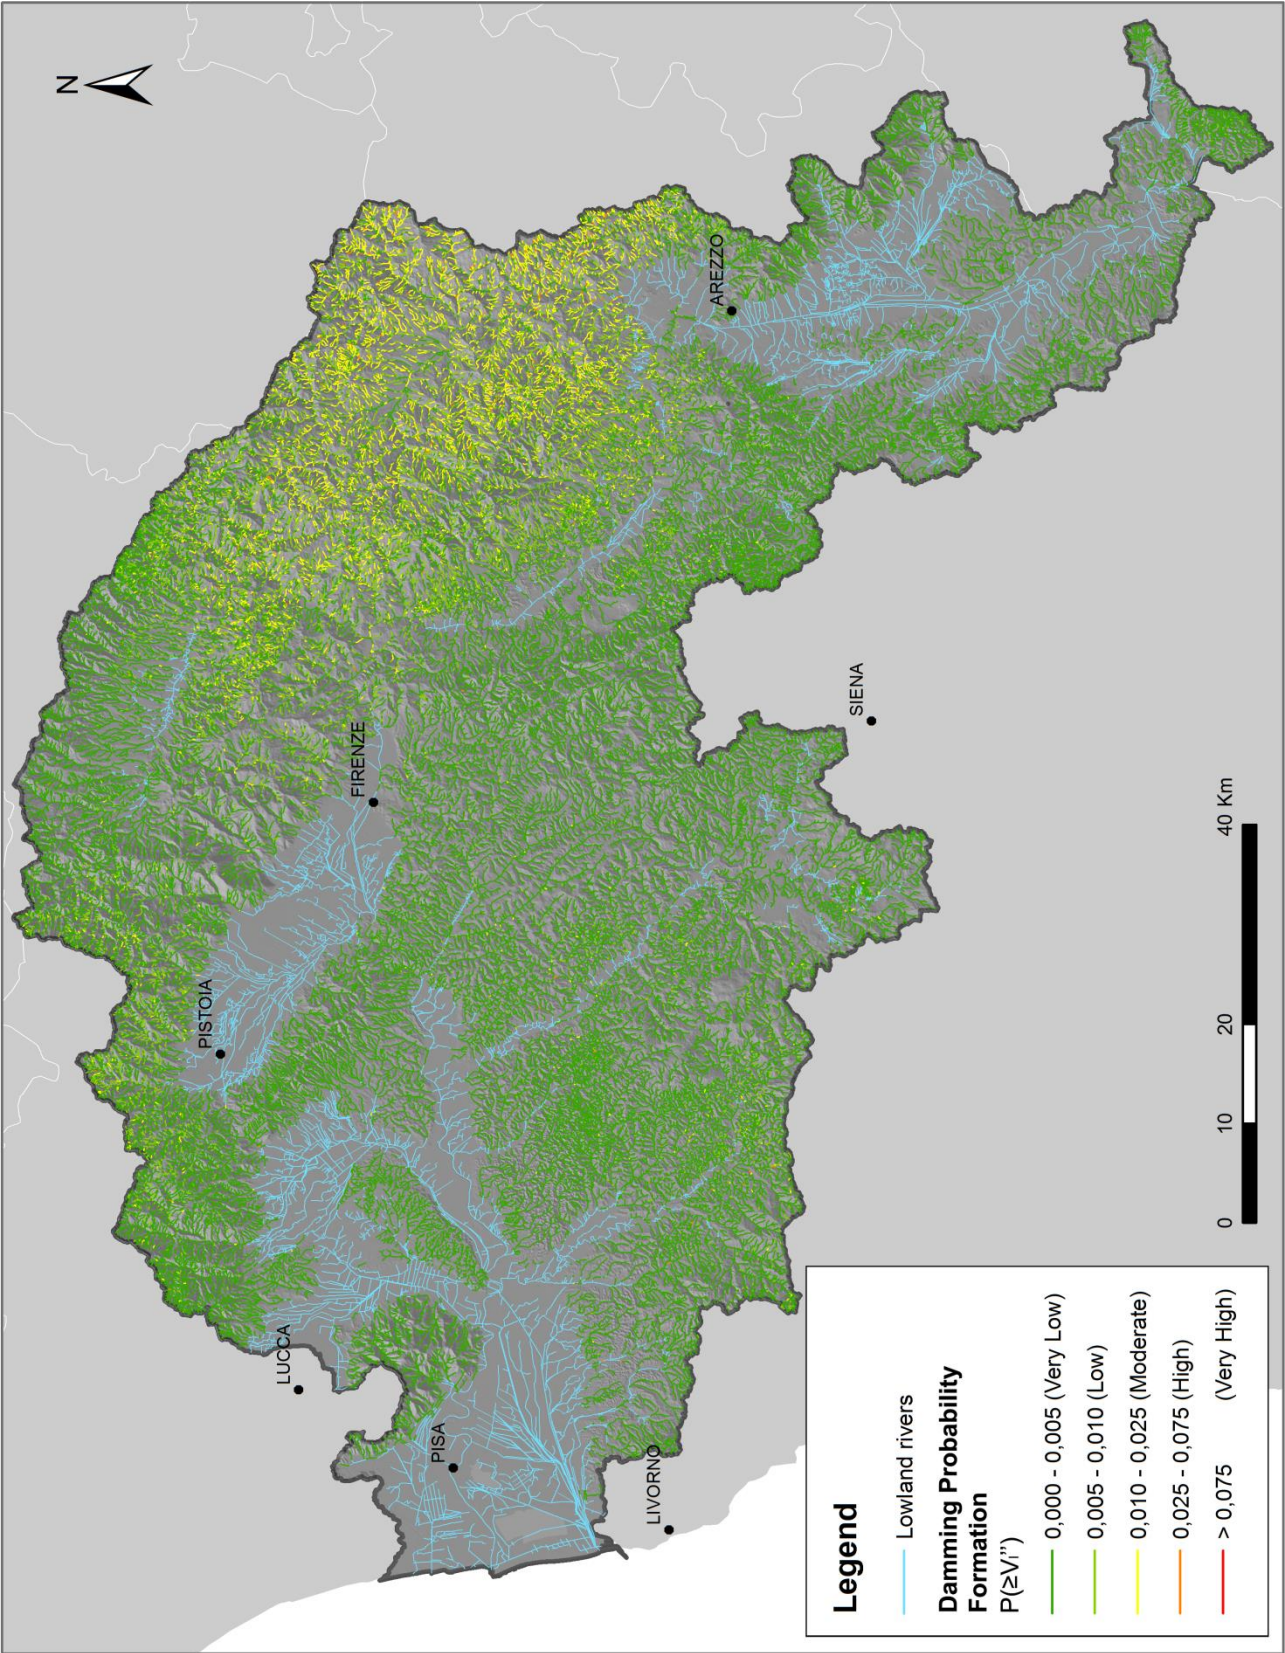
Figure 80 - Damming Probability Map of Formation of river stretches in the Arno River basin by new landslides.
