Landslides (2018) 15:489–505
 DOI 10.1007/s10346-017-0887-7
 Received: 9 February 2017
 Accepted: 28 August 2017
 Published online: 5 September 2017
 © The Author(s) 2017
 This article is an open access publication

Displacement of a landslide retaining wall and application of an enhanced failure forecasting approach

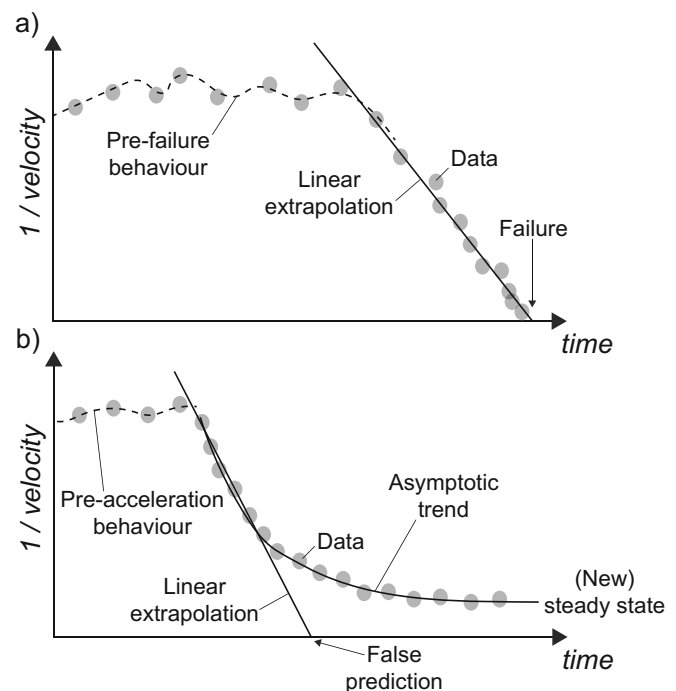
Fig. 1 Inverse velocity trends after onset of acceleration showing a a linear trend leading to slope failure and b an asymptotic trend leading to a steady state of constant deformation

The accelerating creep theory (Saito 1969; Fukuzono 1985; Voight 1988; Voight 1989) provides the basis for many of the methodologies that analyze trends in the displacement measurements, in terms of the inverse of velocity ($1/v$, where v is the velocity) over time. The intercept point on the time axis of the inverse velocity vs. time plot (i.e., point of infinite slope velocity) is assumed as the failure time prediction (Fukuzono 1990; Rose and Hungr 2007) (Fig. 1a). Experience has shown that the landslide

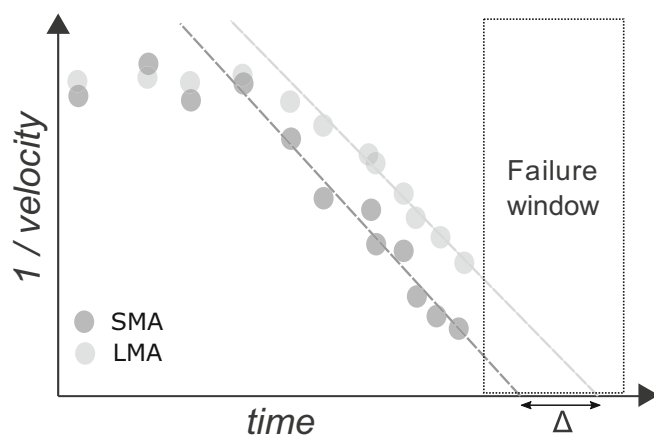
Fig. 2 Conceptual model of failure window analysis: SMA represents displacement data filtered by means of a short-term moving average and LMA by means of a long-term moving average. The width of the failure window is calculated on the basis of the Δ between the LMA and SMA failure time predictions

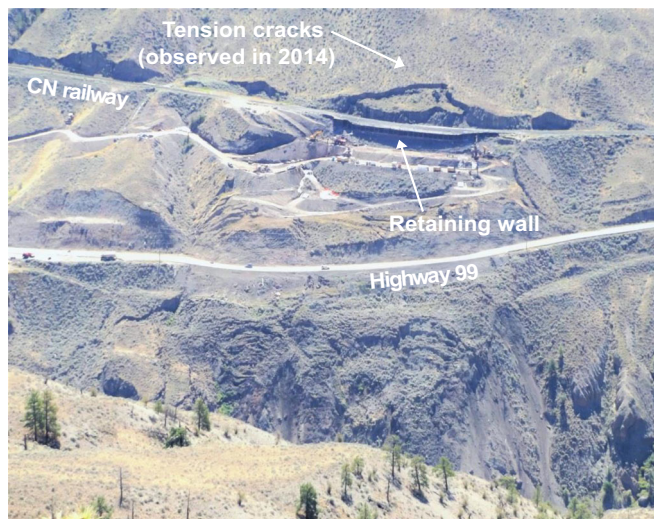
Fig. 4 Front view of the 10-mile Slide. Photo taken in July 2016

The 10-mile Slide is located in the Province of British Columbia, Canada, North of the town of Lillooet (Fig. 3). The slide is an active portion of the ancient Tunnel earthflow described by Bovis (1985), and its name is related to its location (10th mile board of Highway 99). A section of British Columbia's Highway 99 and a section of railway operated by CN cross through the landslide boundaries. The landslide and the retaining structures have been described before in Gaib et al. 2012 and in Macciotta et al. 2017a, b. The significance of the landslide is associated with the integrity of these structures, which connect localities in the interior of British Columbia. Figure 4 shows a front view of the landslide, as of July 2016.

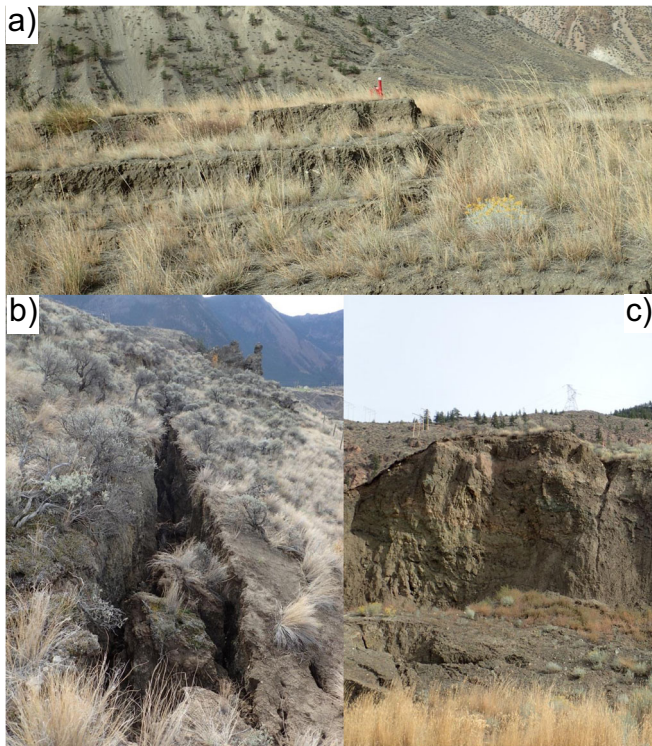
Fig. 6 Counter-slope scarps located between the railway track and Highway 99 (a), the uppermost tension crack observed above the railway track, as of April 2016 (b), and an 8- to 10-m-high scarp downslope from the railway track (c)

Figure 6 presents images of counter-slope scarps located between the railway track and Highway 99 (a), the back scarp observed above the railway track as of April 2016 (b), and an 8- to 10-m-high scarp downslope from the railway track (c). Tension cracks have been observed upslope of the back scarp in April 2016, suggesting stress relief of these areas and potential further retrogression.

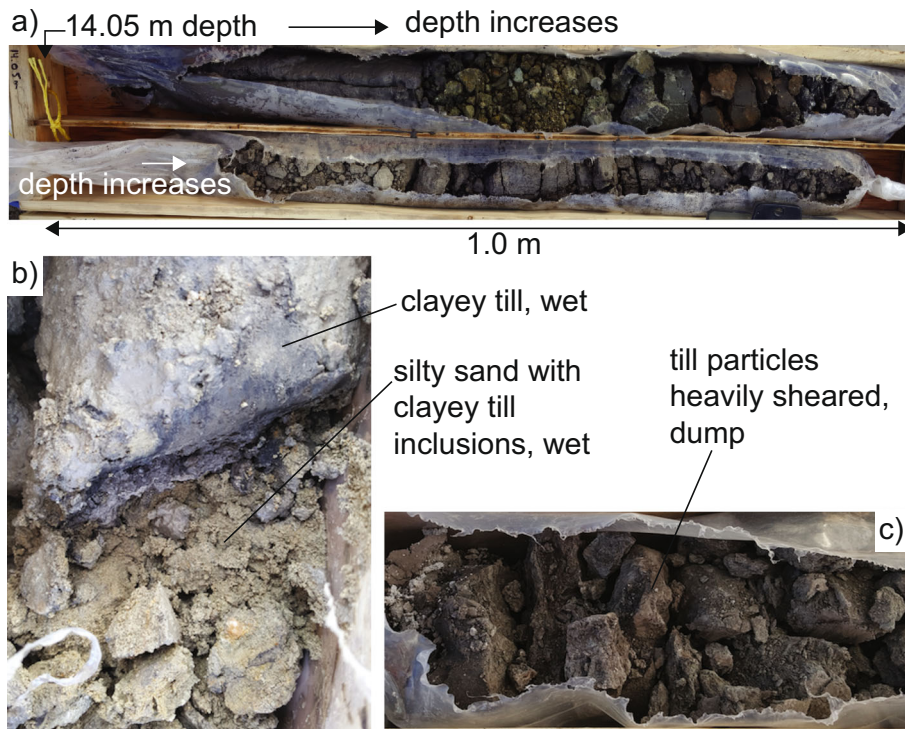
Fig. 7 Core material recovered from the landslide area at a depth between 14 and 16 m from the surface (a), detail of a sharp change between wet clayey till cohesive core and silty sand material with till inclusions (b), and core with heavily sheared till (c). After Macciotta et al. (2017b)

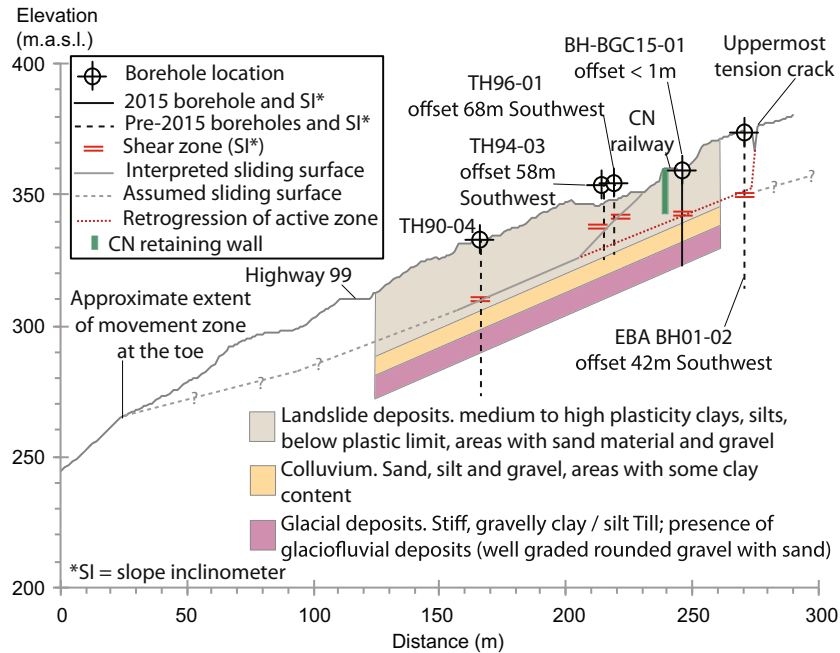
Fig. 8 Interpreted simplification of the cross-section of the 10-mile Slide (after Macciotta et al. 2017a)

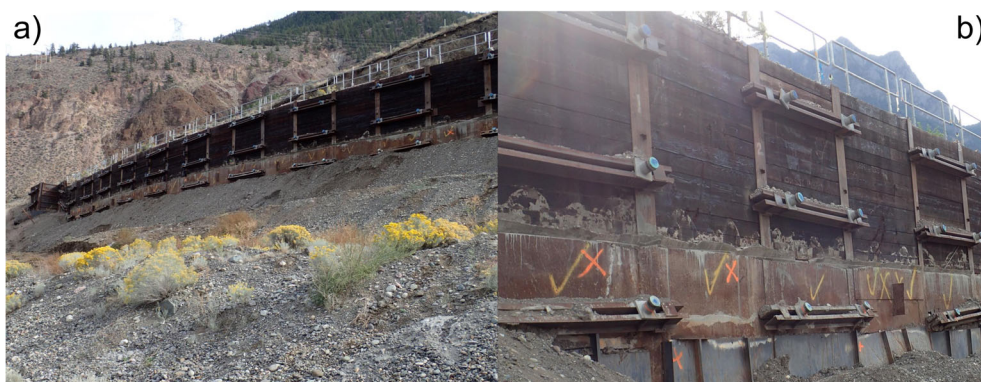
Fig. 9 View of the retaining wall from the northernmost area of the landslide (a) and close view of the anchoring system (b)

A retaining wall was installed in 2008 and was later extended in 2010 (Fig. 9). The wall was installed to prevent deformations caused by potential loosening of materials associated with the slope deformations and to delay possible landslide retrogression. The retaining wall is 128-m-long and consists of 43 H-piles driven to refusal, approximately 16.5 m into the ground, separated 3.05 m (10 ft), and with lagging in between. Three rows of 12-m-long anchors provide the active resistance of the wall (close view of the anchoring system in Fig. 9b). Depth of piles and anchors are above the sliding surface. In response to the reactivation of the landslide movements, 253 new shear piles were installed approximately between 20 June and 7 October 2016.

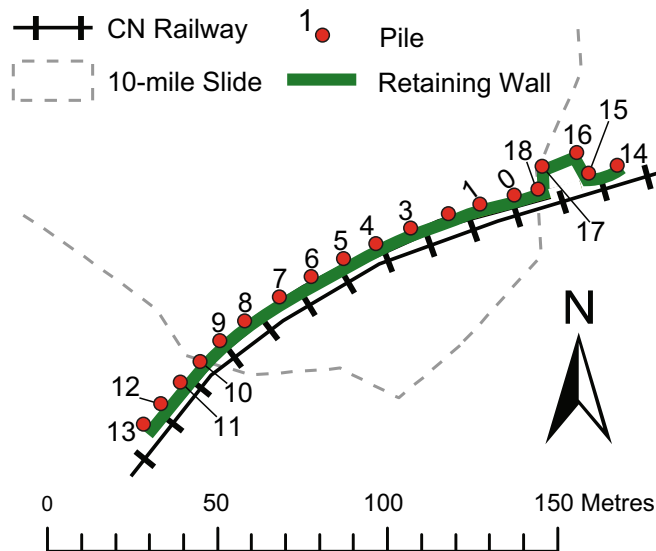
Fig. 10 Sketch with the location of the retaining wall piles being monitored for displacement

top of the piles, and the monitoring station was located northeast of the landslide site, about 300 m from the wall. A plain view with the location of the piles within the wall is shown in Fig. 10. Monitoring was carried out by a third party survey company. The station was considered stable relatively to the landslide displacement rates, and it was regularly checked as part of the surveyors QA/QC. For the distances between prisms and the total station, the expected single measurement accuracy was $\pm 2 - 3$ mm. This was considered adequate for the large displacement rates observed in the field. Initially, monitoring was performed with quarterly measurements (in average) and was then progressively enhanced up to weekly measurements by July–August 2015, reflecting the acceleration of the landslide and the perceived hazard levels. No significant pile displacements were recorded until early 2015, when displacement rates started to increase. Monitoring at Pile 17 had technical difficulties and was stopped prematurely; thus, no information was obtained for this pile.

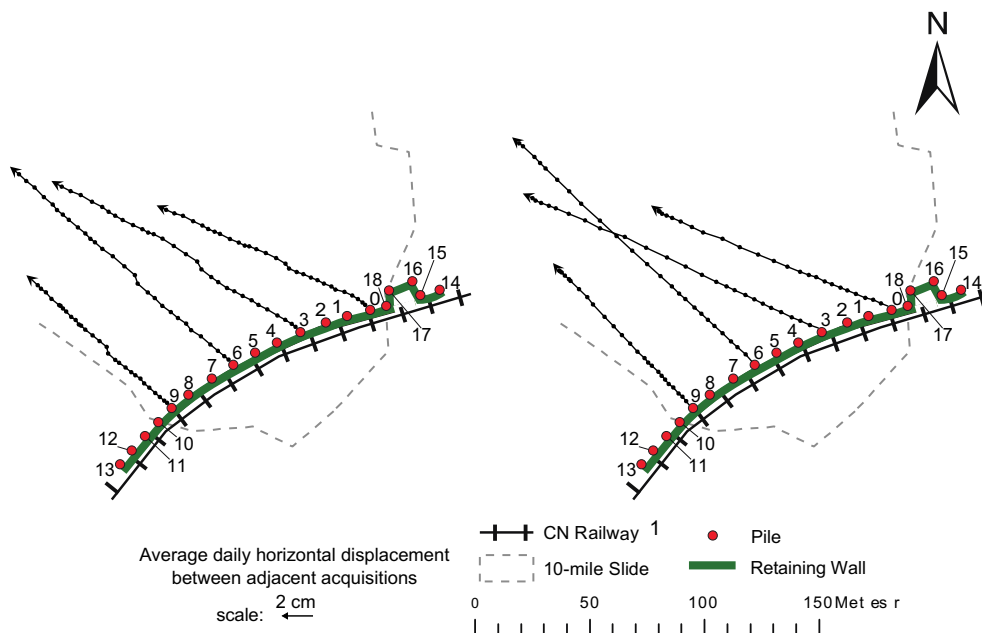
Fig. 13 Increments of horizontal displacement of selected central piles from January 2015 to March 2016 (left) and from April to September 2016 (right)

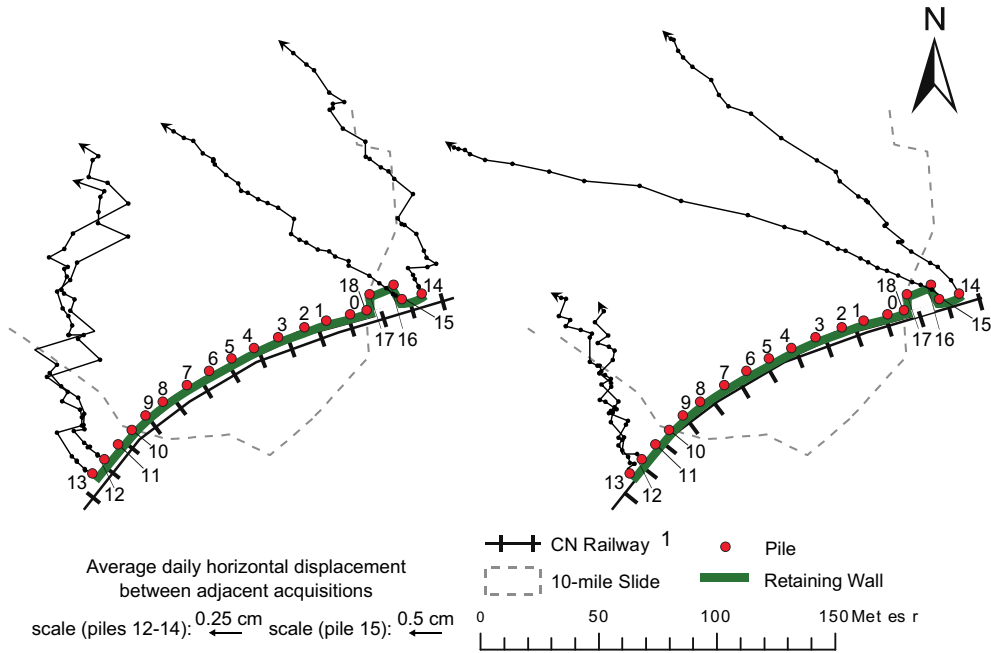
Fig. 14 Increments of horizontal displacement of selected lateral piles from January 2015 to March 2016 (left) and from April to September 2016 (right)

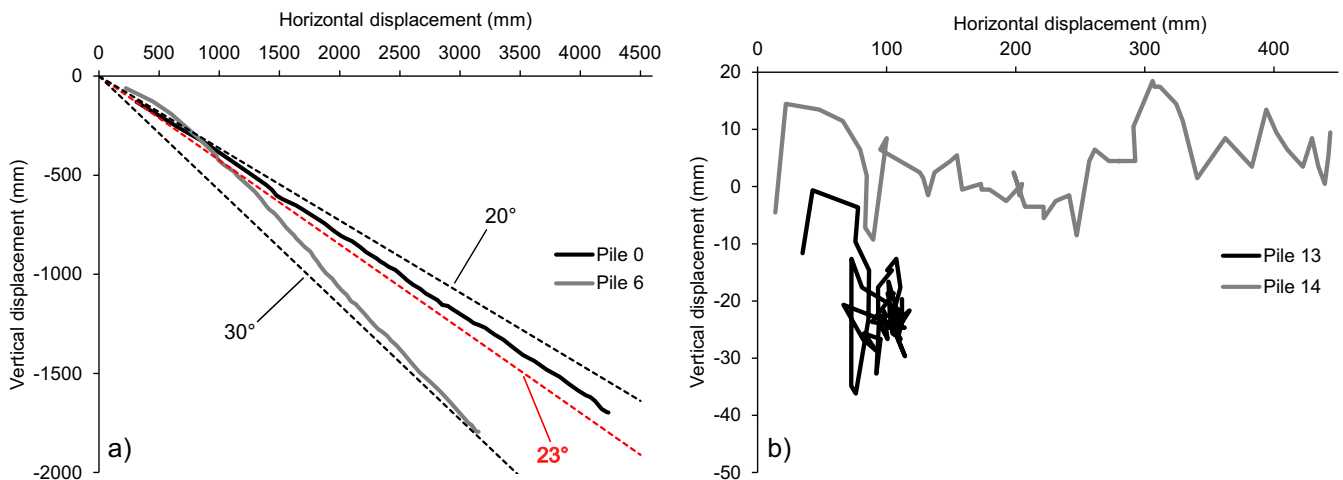
Fig. 15 Horizontal vs. vertical movements between January 2015 and September 2016 of piles 0 and 6 (a), and of piles 13 and 14 (b). In a, the black dashed lines represent movement over ideal surfaces of 20° and 30°, whereas the red dashed line over an ideal 23° surface

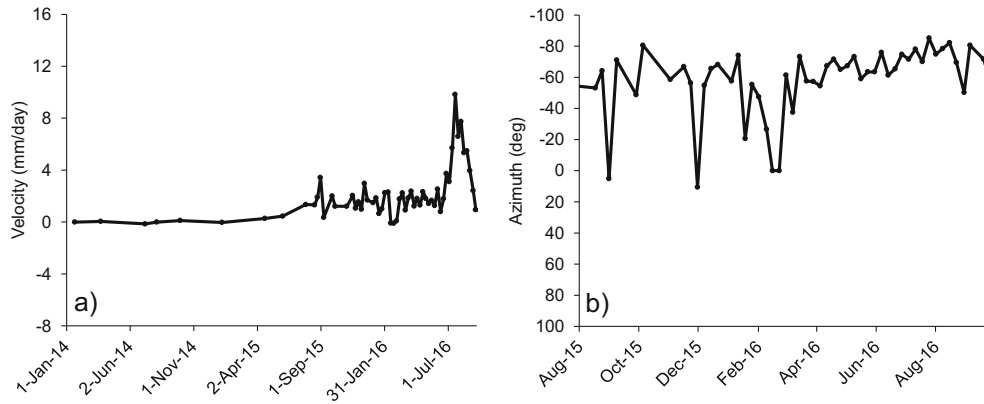
Fig. 18 a Horizontal velocity and b variation of azimuth angle with time of pile 15, showing a transition from Type 2 to Type 1 deformation behavior

In relation to the ongoing maintenance of the wall, in the latest part of the monitoring period, a change from Type 2 to Type 1 deformation behavior was observed concerning some of the piles located in proximity of the eastern boundary of the landslide. As mentioned preliminarily in Fig. 14, this resulted evident in particular in the case of pile 15, which displayed a progressive increase in velocity in July 2016 (values of up to 9 mm/day in horizontal

velocity) and a stabilization of the measured azimuth of movement starting from April 2016 (Fig. 18). This suggests that the boundaries of the 10-mile Slide are subject to further phases of active retrogression.

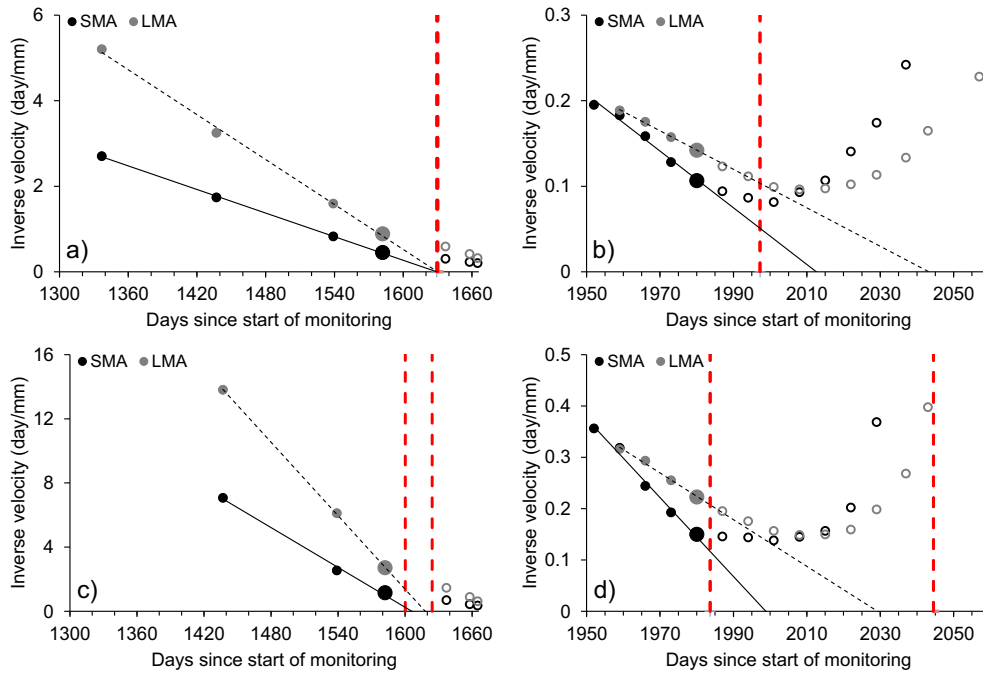
Fig. 20 Failure window approach applied to inverse velocity data of pile 0. **a** First acceleration phase, horizontal direction. **b** Second acceleration phase, horizontal direction. **c** First acceleration phase, vertical direction. **d** Second acceleration phase, vertical direction. The red dashed lines define the limits of the failure window, the larger points mark days no. 1582 and 1980 (i.e., T_c), and the hollow points represent measurements after T_c

Figures 20 and 21 present the failure window analysis applied to monitoring data of pile 0 and pile 6, considering both acceleration phases and both directions of movement (i.e., horizontal and vertical). Extrapolation of the trend toward the time axis of data filtered by means of SMA and LMA was conducted by considering the last linear part of the plot up to the previously defined points

In every instance (i.e., for both acceleration phases and for both directions of movement), T_c occurred several days before the projected first limit of the failure window. Since at every point of trend change INV analyses should be restarted considering only data included in the new trend (Rose and Hungr 2007; Dick et al. 2014), the failure window plots in Figs. 20 and 21 represent the closest instants to a theoretical condition of failure of the 10-mile Slide for the available dataset.
