# Experimental study of riverbank protection with bio-engineering techniques

Sara Posi<sup>1</sup>, Lucas Montabonnet<sup>2</sup>, Alain Recking<sup>2,\*</sup>, André Evette<sup>3</sup>, Hervé Belloc<sup>2</sup>, Frédéric Ousset<sup>2</sup>, Xavier Ravanat<sup>2</sup>, Guillaume Piton<sup>2</sup> and Luca Solari<sup>1</sup>

<sup>1</sup>University of Florence, Department of Civil and Environmental Engineering (DICEA), Florence, ITALY

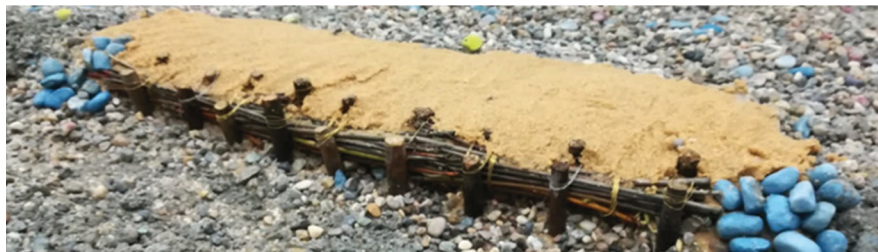
**Fig.2A** fascine with ripraps upstream and downstream

The bank protection technique tested was fascines, which consists in an arrangement of materials made with *salix* and fixed in the river bed against the erodible bank with wood sticks (Fig. 2).

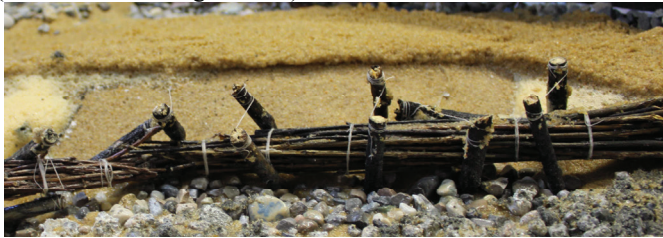
**Fig.5** Top erosion (test: connection present, high discharge, full protection).

- Top erosion due to a flow overtopping the fascine when the water depth is sufficiently high (Fig. 5);
- Erosion at the base of the fascine leading to scouring and local bank collapse (Fig. 6).
- Back erosion affecting the downstream part of the erodible bank (Fig.7);
- Total collapse when back erosion is combined with local bank collapse caused by basal scouring (combination of Fig.6 and 7)
