# DECAY OF RED PIGMENTS ON A WALL PAINTING ADORNING THE CHURCH OF 'SAN FRANCESCO DEI CAPUCCINI' IN RACCONIGI (ITALY): ARCHAEOMETRIC SURVEY AND RESTORATION INTERVENTION

**KEYWORDS:** wall painting, pigment, hematite, magnetite, sulfation, particulate.

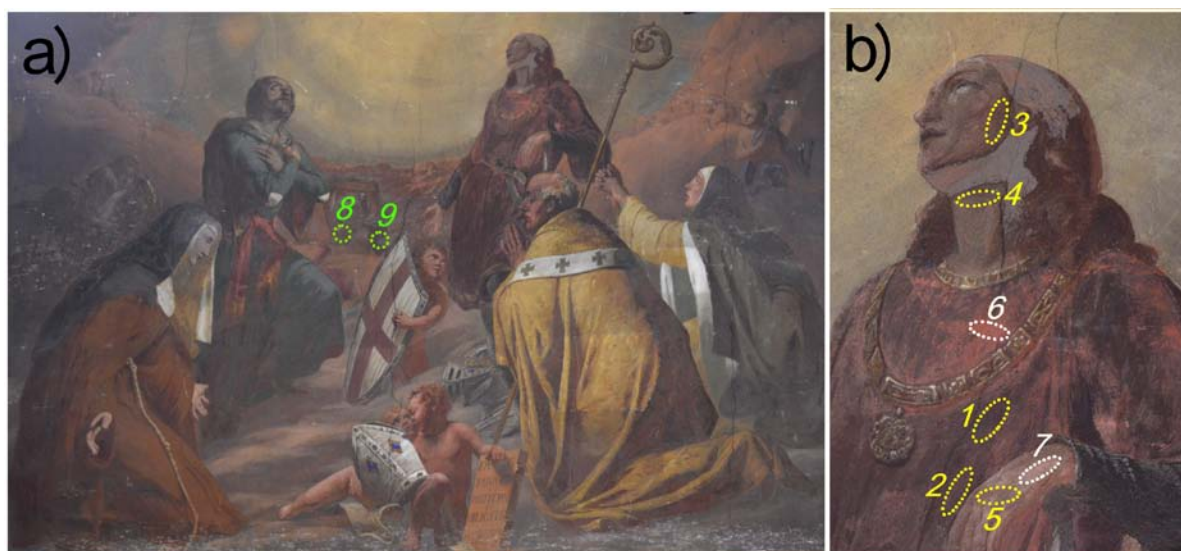
**Figure 2.** 'The divine adoration of King St. Louis IX' fresco, as it appeared before restoration. a) global view: a general dimming is observed on the whole artwork surface, presumably due to the deposit of soot, ashes and dust. b) magnification of St. Elizabeth of Hungary, in which the specific blackening of the red pigments on the tunic and flesh, as well as the severe pigment loss on the visage (under the chin and ear) and hair, can be better appreciated. Areas subjected to sampling are contoured by dashed lines (numbering detailed in the text).

samples. For comparative purposes, specimens from clean portions of the same areas were also collected (white dashed areas, labelled ‘6’ and ‘7’ in Fig. 2.b), adopting the same precautionary methods described above. Moreover, samples from some ‘*a secco*’ retouches were also extracted (green dashed areas, labelled ‘8’ and ‘9’ in Fig. 2.a), so to compare their pigment distribution with that of the rest of the painting. All specimens were placed in sterile tubes before analyses, in order to avoid possible contamination.

As far as the tunic of St. Elizabeth of Hungary is concerned, the diffraction patterns of those samples extracted from the clean area (labelled '6' in Fig. 2b), marked by a vivid red colour and lack of darkening (thus apparently not subjected to decay), show an indisputable presence of predominant hematite ( $\text{Fe}_2\text{O}_3$ ). Traces of cinnabar ( $\text{HgS}$ ) were also possibly detected, thus contributing to enhance the brilliancy of the red hue on the garment. Marked reflections of another reddish-to-yellowish agent were also observed – namely 'Naples Yellow' (or lead antimonate),

Samples extracted from the 'a secco' areas (labelled '8' and '9' in Fig. 2a) evidenced presence of hematite as above – and possibly also cinnabar. However, no 'Naples Yellow' was detected, but rather a significant amount of goethite [FeO(OH)]. In addition, weddel-

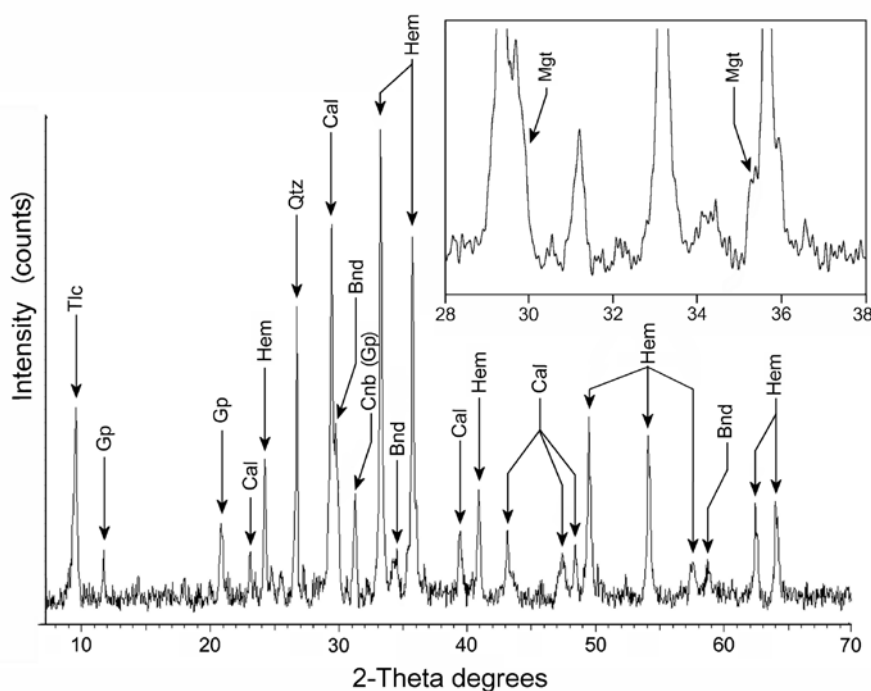
Figure 3. XRPD pattern collected on a specimen extracted from the darkened areas of St. Elizabeth's red tunic [mineral abbreviations reported, whenever possible, according to Siivola and Schmid (2007) as follows: Tlc = talc; Gp = gypsum; Cal = calcite; Hem = hematite; Qtz = quartz; Bnd = bindheimite ('Naples Yellow'); Cnb = cinnabar]. Presence of slight amounts of magnetite (Mgt:  $\text{Fe}_3\text{O}_4$ ) is highlighted in the pattern magnification reported in the upper right corner.

Weak reflections related to magnetite are visible in the XRPD pattern of the darkened areas of St. Elizabeth's tunic (Fig. 3). Analogous signals – though markedly weaker – apparently appear also in those regions not yet affected by darkening (Table 1), testifying that probably such an incipient decay was spreading on the whole tunic of St. Elizabeth. In the seemingly clean areas, the amount of magnetite is almost unnoticeable to the naked eye – though probably close to the technique detection threshold. As far as Raman is concerned, the signals of magnetite were detected on some brown-to-blackish pigment grains, located close to other reddish ones that clearly showed also the Raman bands of hematite (Fig. 5b). Such a coexistence confirms that the presence of magnetite has to be interpreted as the result

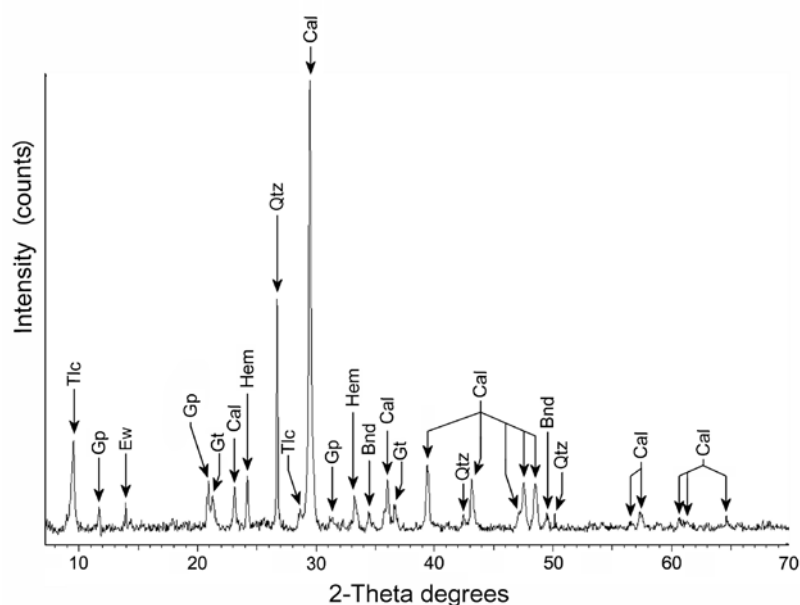
Figure 4. XRPD pattern collected on a specimen extracted from the clean areas of St. Elizabeth's flesh [mineral abbreviations reported, whenever possible, according to Siivola and Schmid (2007) as follows: Tlc = talc; Gp = gypsum; Cal = calcite; Hem = hematite; Qtz = quartz; Bnd = bindheimite ('Naples Yellow'); Ew = ewaldite; Gt = goethite].

The exam of the flesh-coloured areas of the fresco, unaffected by evident darkening (labelled '7' in Fig. 2b), proved that by diluting the predominant hematite (possibly mixed to the other red-to-yellowish pigments) with  $\text{CaCO}_3$  a pink colour was obtained, used to render the hue of the skin (Mazzocchin *et al.*, 2003). The degree of this dilution is marked by a systematic decrease in the intensity of those reflections related to hematite (if compared to the XRPD patterns of the tunic), accompanied by an enhancement

in those of calcite (Fig. 4). Again, presence of 'Naples Yellow' is evident whereas that of cinnabar dubious – as is that of goethite [ $\text{FeO}(\text{OH})$ ]. Use of talc as a filler is confirmed. The XRPD patterns of the darkened rose-pink areas on the flesh (labelled '3', '4' and '5' in Fig. 2b) show no evident difference from the clean ones: the same minerals are detected, together with modest amounts of gypsum and anhydrite, which account for an incipient sulfate attack (Table 1).

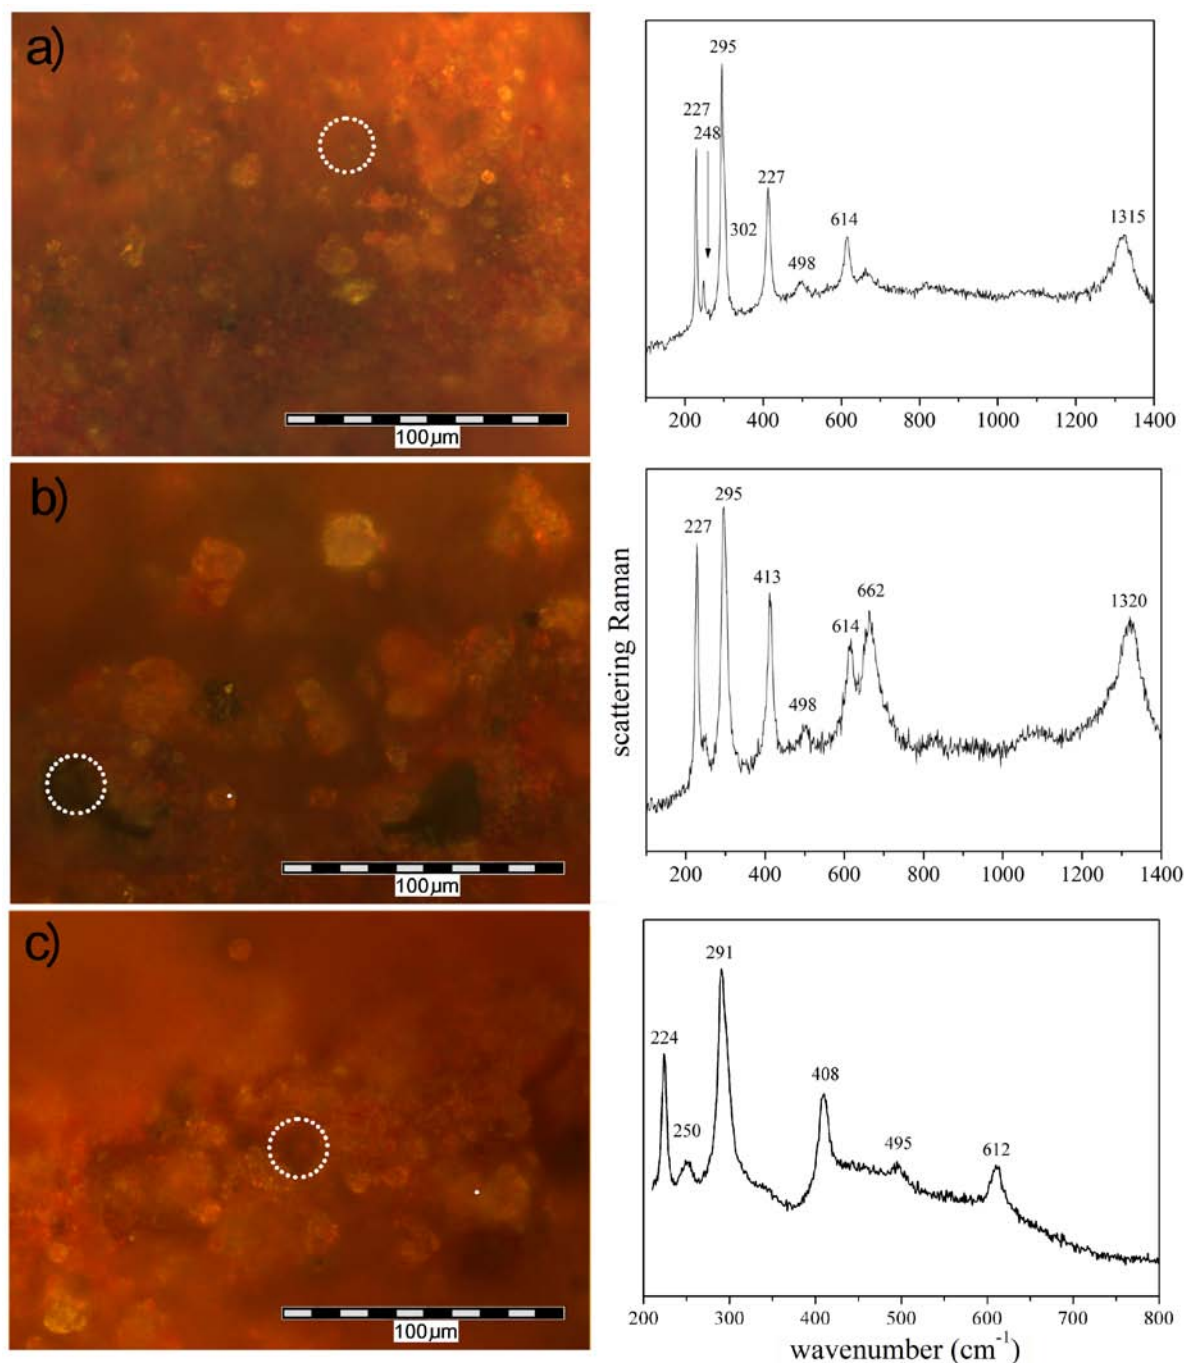
Figure 5. Microphotographs of red pigment grains sampled from the artwork surface, coupled to the related  $\mu$ -Raman patterns (spot analyses contoured by dashed circles): a) a homogeneous red coat, showing most of the typical phonon signals and magnon band of hematite ( $Fe_2O_3$ ); b) in those areas where distinct brown-to-blackish grains are visible, an additional band at  $662\text{ cm}^{-1}$  appears amidst the modes of hematite, which has to be related to presence of magnetite ( $Fe_3O_4$ ); c) at times, a broad signal at  $250\text{ cm}^{-1}$  is detected on the surface of some red pigment grains, related to presence of cinnabar ( $HgS$ ).

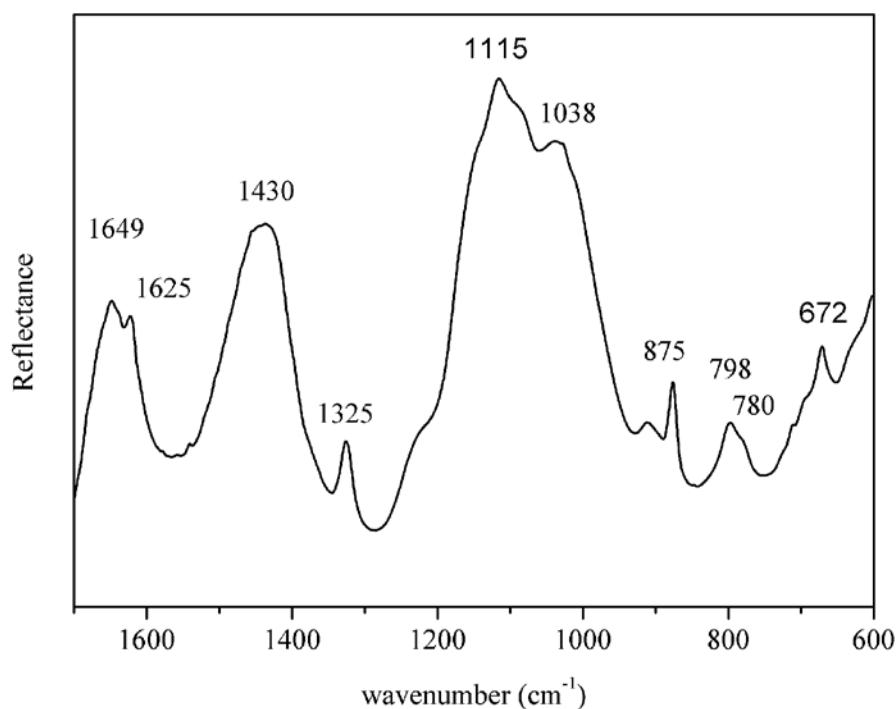
All recorded spectra show quite a homogeneous and repetitive pattern (Fig. 6). In particular, strong signals attributable to a carbonate (namely calcite,  $\text{CaCO}_3$ ) are clearly detected. Besides, evident pres-

ence of Ca-sulfate, in the form of gypsum ( $\text{CaSO}_4 \cdot 2\text{H}_2\text{O}$ ) is testified by the systematic detection of the related modes at 1115 (very strong band), 1625 and 672  $\text{cm}^{-1}$  (medium-strong signals).

Figure 6. ATR FT-IR pattern collected on a grain sampled from the artwork surface, showing the signals typical of gypsum (672, 1115 and 1625  $\text{cm}^{-1}$ ), calcite (875, 1430  $\text{cm}^{-1}$ ), quartz (780 and 798  $\text{cm}^{-1}$ ) and oxalates (1325 and 1649  $\text{cm}^{-1}$ ).

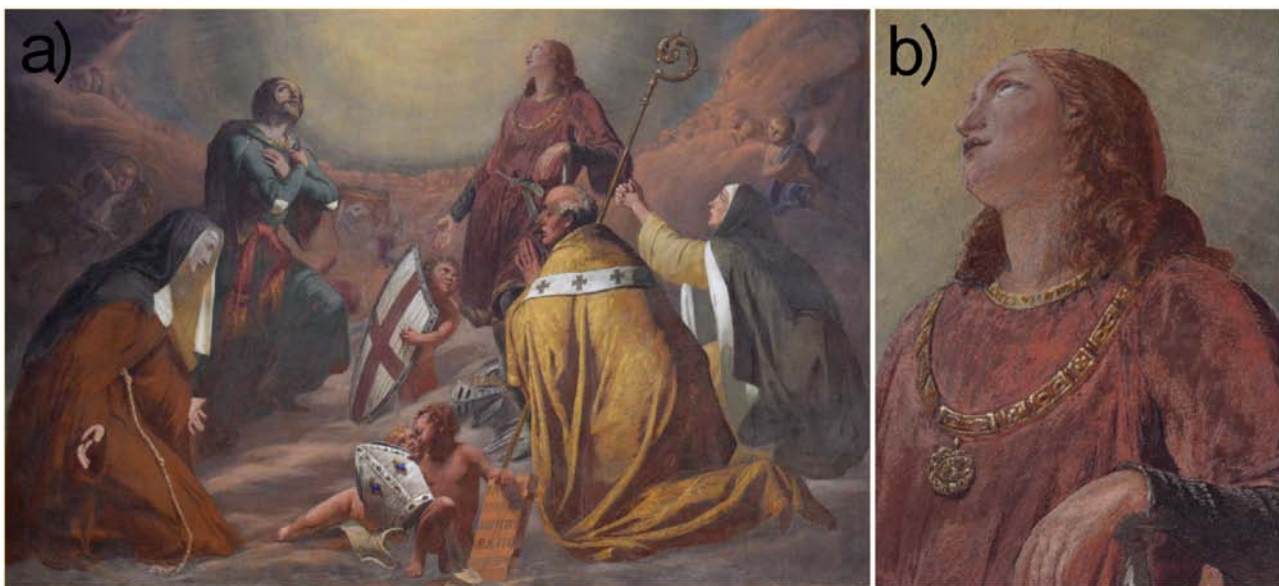
Figure 7. 'The divine adoration of King St. Louis IX' fresco, as it appears after restoration: a) global view of the artwork; b) magnification of St. Elizabeth of Hungary; a significant reduction of the 'blackening effect' on the tunic and flesh is observed, as well as the presence of 'undertone' retouches in those area where severe pigment loss had occurred (e.g., on the visage - under the chin and ear - and hair).

swab embedded in distilled H<sub>2</sub>O, gently rotated on the painted surface. Once the effectiveness of these preliminary tests was acknowledged, a global cleaning was undertaken on the whole artwork surface, following the above mentioned procedure; such an operation rendered at best the brightness of the original colours (Fig. 7a). In addition, some 'undertone' retouches were performed in those areas where the original pigments had inevitably been lost (i.e., on the visage, under the chin/ear, and on the hair of St. Elizabeth of Hungary; Fig. 2b), so to improve the global appearance of the artwork with an eye towards respecting the artist's rendition (Fig. 7b).

Obviously, such a plain intervention - basically aimed at removing this surface incoherent particulate while preserving the underlying pigments - was ineffective about removing the superficial discontinuous film of magnetite, selectively distributed on the tunic of St. Elizabeth. Besides, the transformation from hematite to magnetite is known not to be reversible in the conditions under which the artwork is conserved. The reverse process (oxidation from Fe<sub>3</sub>O<sub>4</sub> to Fe<sub>2</sub>O<sub>3</sub>), in fact, occurs only by annealing in air at T ≥ 400 °C - the exact value depending on the system composition and O<sub>2</sub> partial pressure (Mozanam *et al.*, 2014). As a result, these darker, black-to-brownish areas - due to presence of a surface thin layer of magnetite - are still visible even after restoration (see the brownish portions in Fig. 7b). Despite this, the adopted protocol was able to mechanically

clean the dirt (not yet consolidated) and the gypsum deposits (highly soluble in H<sub>2</sub>O) from the fresco surface, thus rendering to the artwork (at the best, at least) its original chromatic aspect. The principle of the best obtainable result with the minimum less invasive effort was therefore adopted, and the effectiveness of such a treatment has been acknowledged by no further decay having been reported so far, more than three years after completion of the intervention.
