**SEISMIC PERFORMANCE ASSESSMENT AND  
STRENGTHENING TECHNIQUES FOR EXISTING  
REINFORCED CONCRETE BUILDINGS IN NEPAL**

Dissertation submitted to the Faculty of Engineering of the University of Porto in fulfilment of the requirements for the degree of Doctor in Civil Engineering.

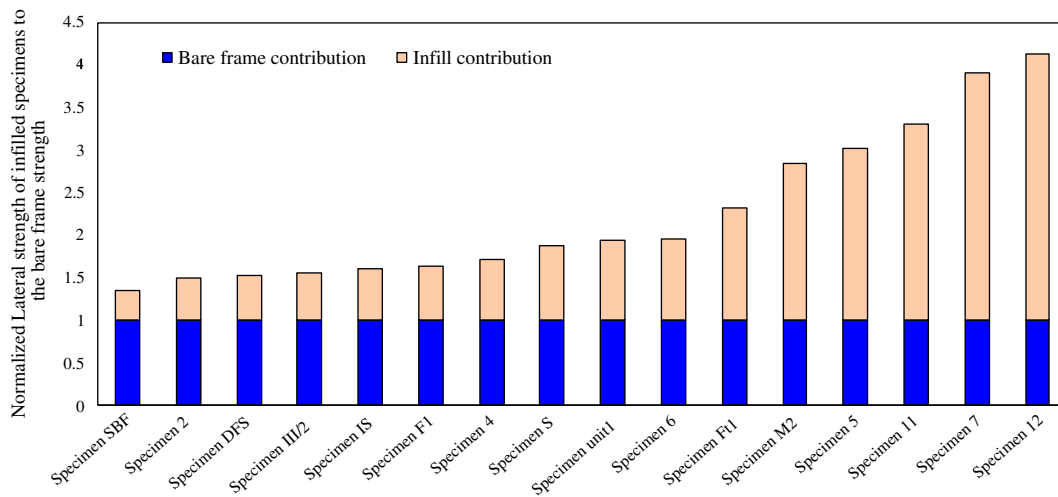
Figure 1.1 – Examples illustrating the contribution of the infill panels for the global infilled RC frames (after Hossameldeen, 2017 [12])

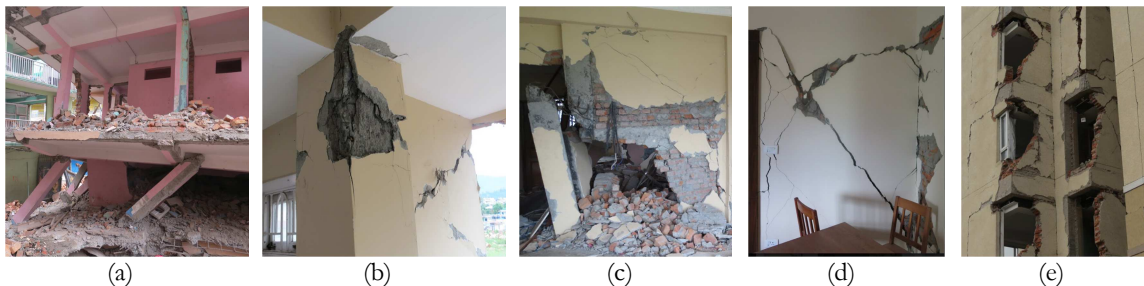
Figure 1.2 – Examples of infill wall negative contributions on infilled RC buildings; (a) Soft-storey, (b) Shear in column, (c) Short-column, (d) In-plane and (e) Out-of-plane failure of infill walls

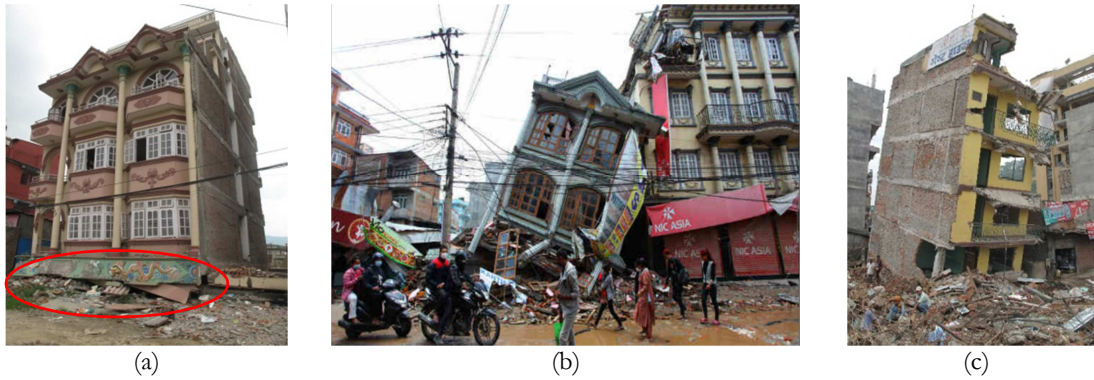
Figure 2.3 - Examples of buildings subjected to soft-storey collapse during the Nepal earthquake; (a) and (c) Building collapsed due to soft-storey at the ground floor and (b) Soft storey followed by pounding

During field reconnaissance, most of the non-engineered and pre-engineered buildings were found to possess irregular distributed infill panels. Similarly, buildings near highways are without infill panels in a complete bay. And in some cases, whole ground floor is without infill panels. This type of construction practice is more common in commercial, high rise, office buildings, etc., where such spaces are usually used for parking and storage purposes. Such buildings are provided with heavy masonry infill walls and other dead and live loads at the consecutive upper floor resulting large stiffness and strength variations between storeys; as a result soft-storey can be expected at the ground floor or at the basement. Soft-storey increases flexibility on that storey, thus decreases the lateral resistance compared to the adjacent floors against earthquakes. Therefore, the overall side to side drift is concentrated on soft-storey, eventually causing the collapse of the structure. This type of infill walls distribution contributes to negative effects in the building. The site survey found that most of the collapsed RC buildings were due to soft-storey effect, mainly on the ground floor and, in some cases, it was detected in the first or second storeys. The soft-storey followed by pounding is also recorded during Gorkha earthquake; some of the collapsed buildings due to this failure mechanism are demonstrated in Figure 2.3.

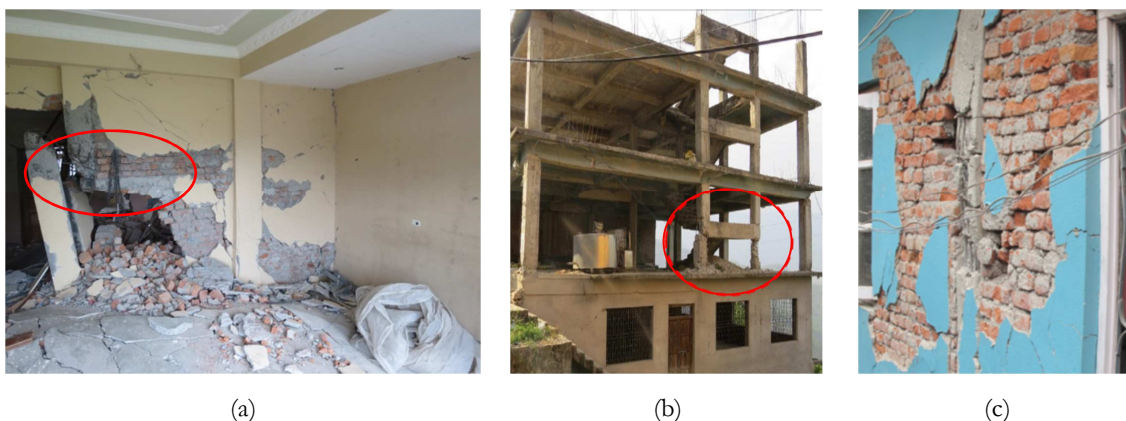
Figure 2.4 – Examples of short-column failure due to the existence of (a) Staircase landing and infill, (b) Stair landing beam and (c) Infill panels with openings

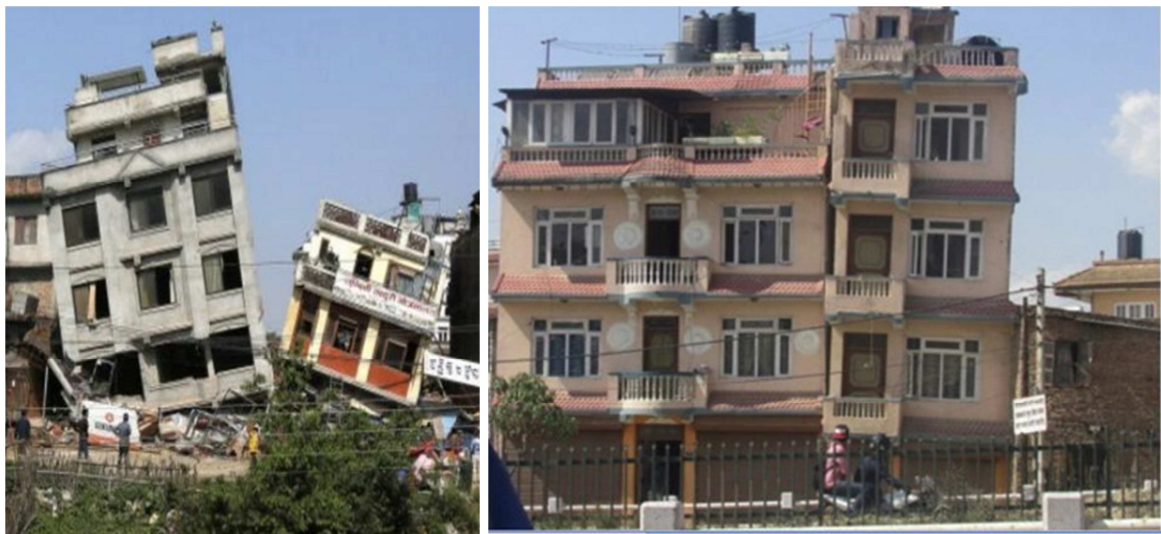
Figure 2.5 - Examples of buildings failure; (a) Pounding followed by soft-storey and (b) Interaction between the buildings due to lack of seismic gap

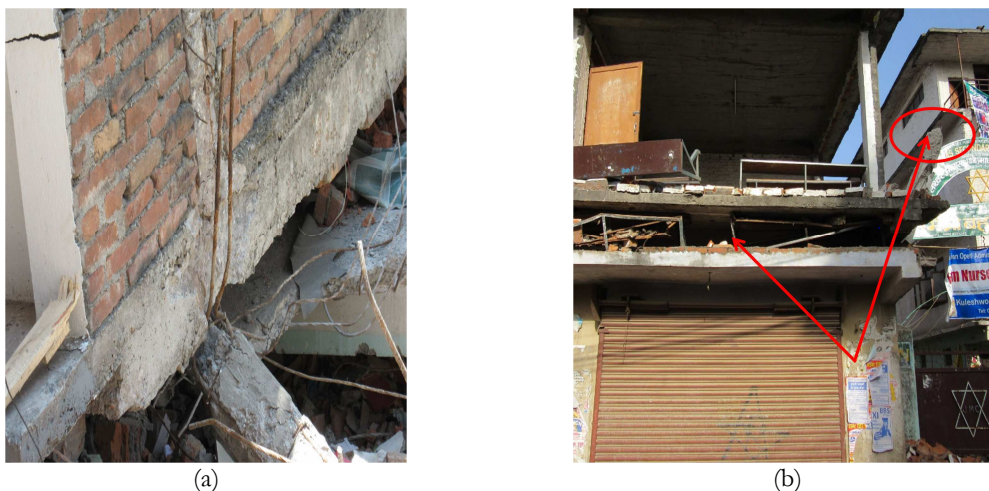
Figure 2.6 - Failure caused by weak beam-column joint; (a) Poor beam-column reinforcement detailing and (b) Pancake collapse

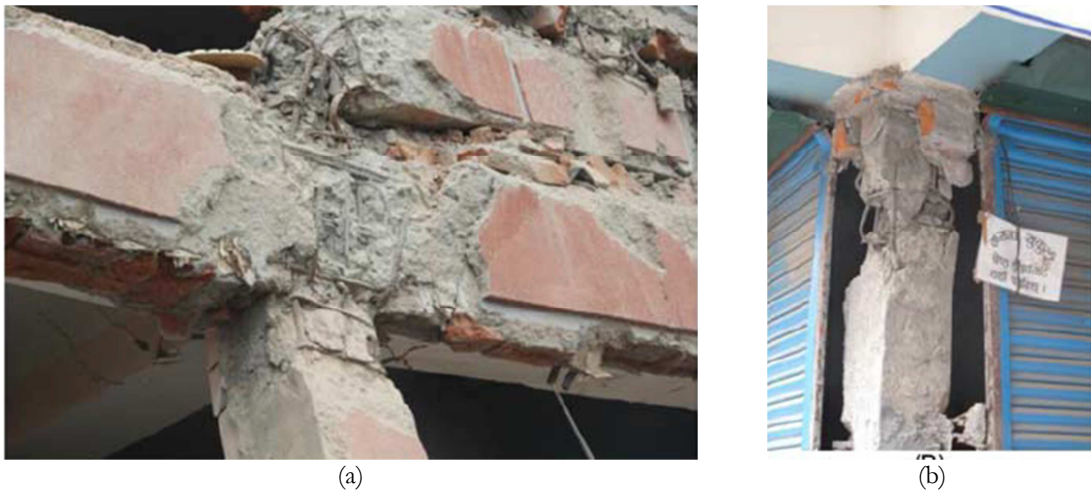
Figure 2.7 – Failure caused by column rebar buckling; (a) Strong-beam and weak-column and insufficient lateral ties detailing and (b) Poor reinforcing steel bar detailing

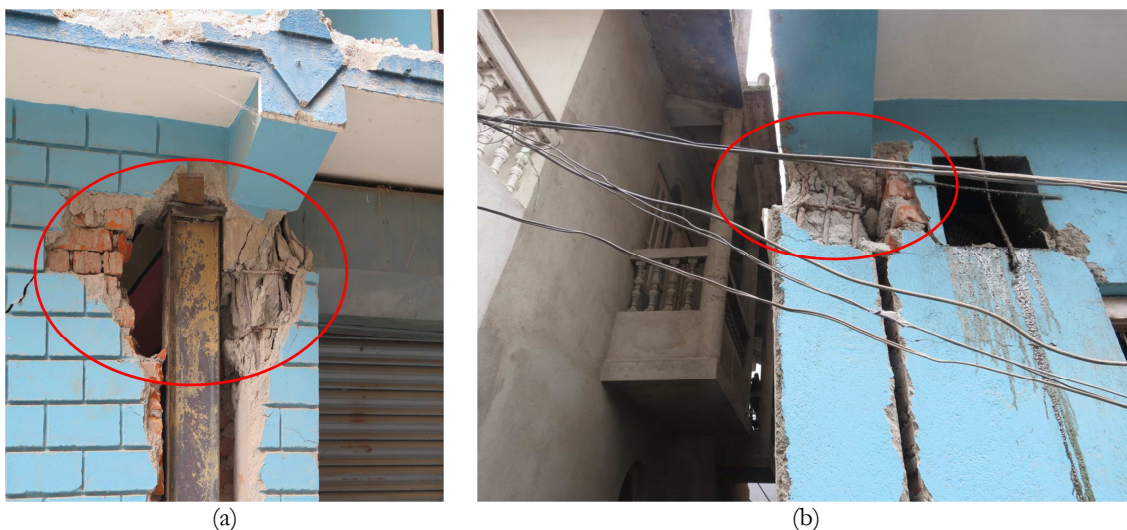
Figure 2.9 – Examples of shear failure at top of column induced by masonry infill panel; (a) Initiated by the strength difference of the adjacent column and (b) Shear failure at the corner column

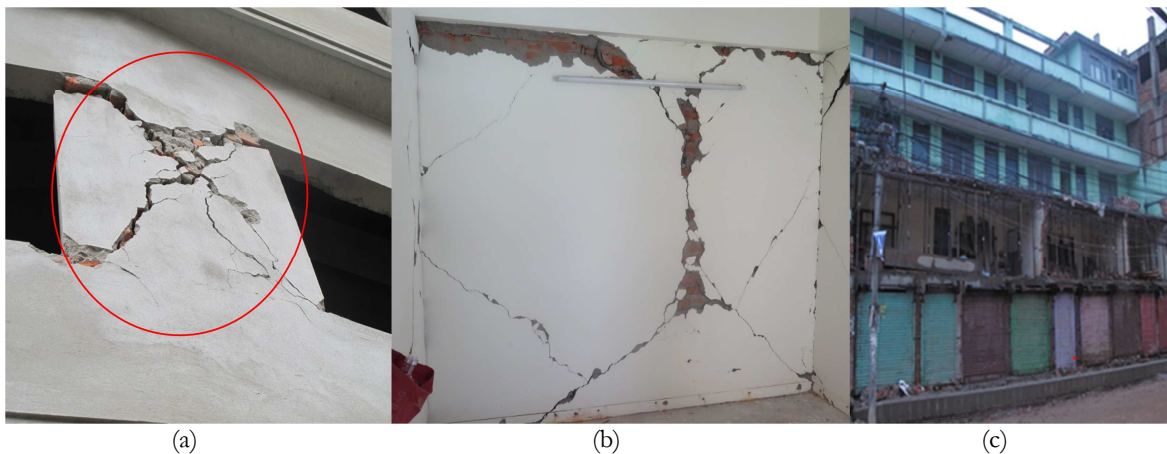
Figure 2.10 – Examples of infill masonry failures due to Gorkha earthquake; (a) and (b) In-plane and (c) Out-of-Plane

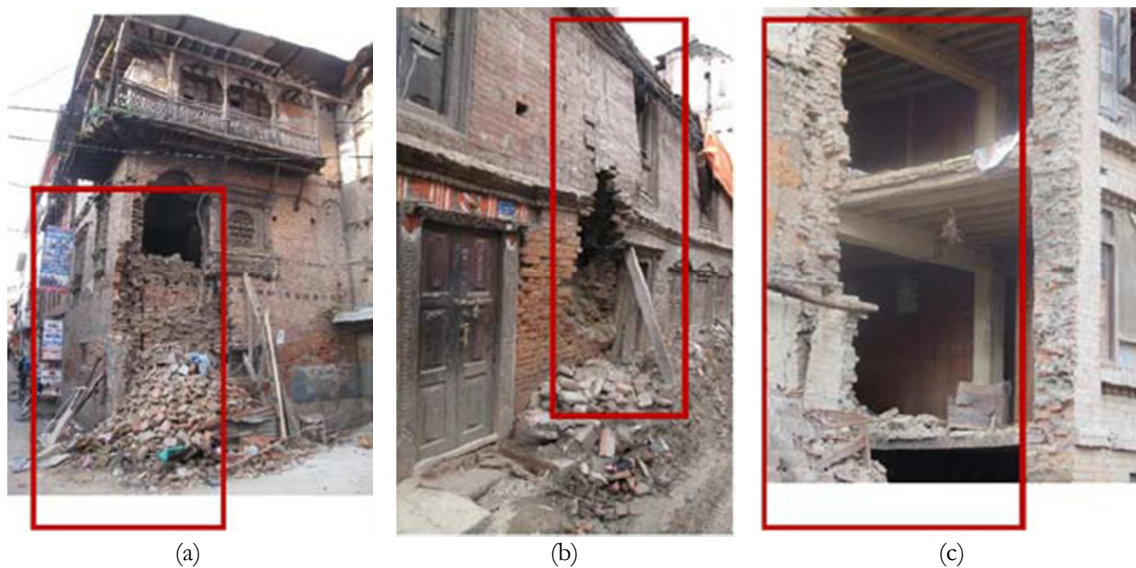
Figure 2.11 - URM earthquake damages and failure modes; (a) Out-of-plane collapse of the façade wall and insufficient connection between timber floor and the masonry walls, (b) Out-of-plane collapse of façade wall with bulging of exterior walls, and (c) Insufficient connection between the floors and the masonry walls and out-of-plane collapse of the façade wall of a 3-storey building

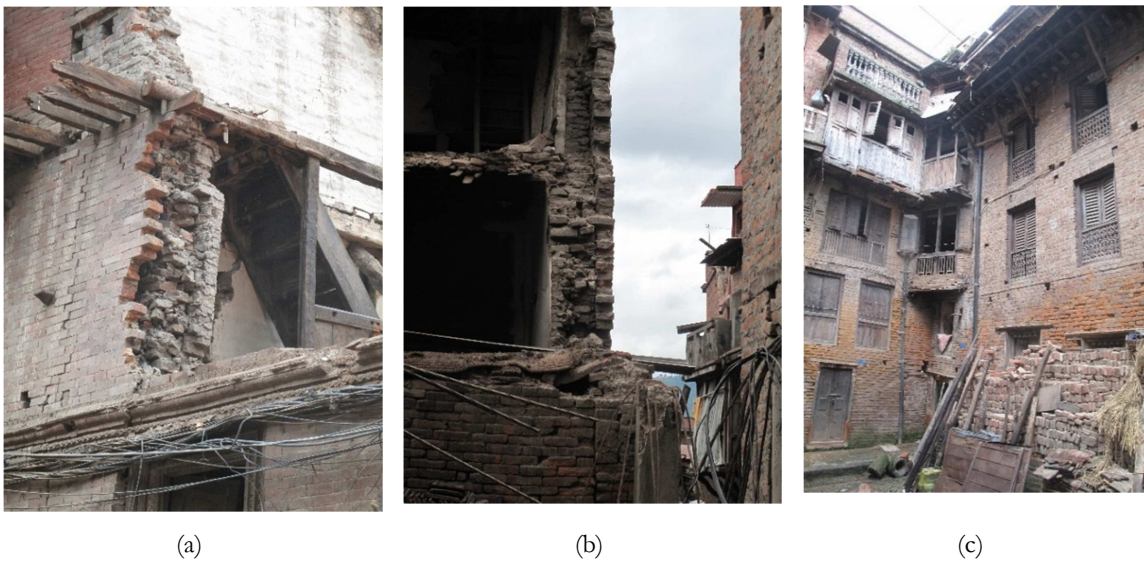
Figure 2.12 - URM buildings construction details; (a) Masonry wall leafs disposition, (b) Connection between the timber floor and the transversal wall and (c) Buildings block

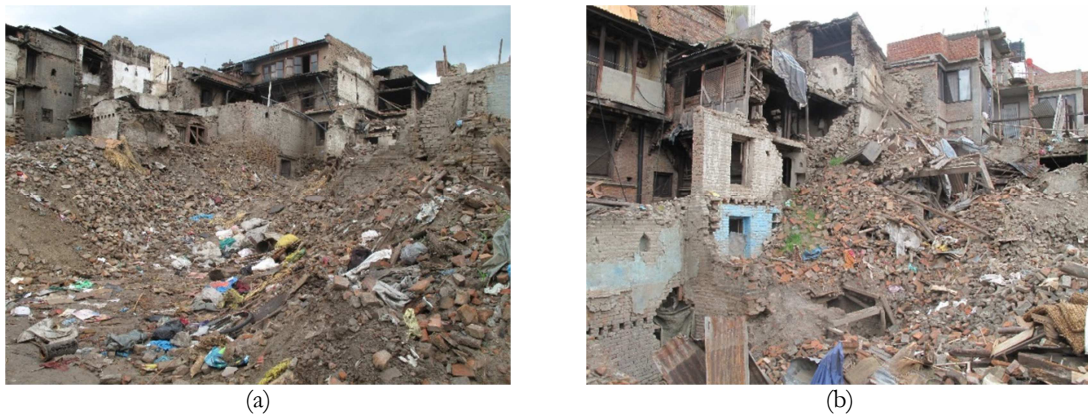
Figure 2.14 - URM earthquake damages and failure modes; (a) and (b) Partial or total collapse

Partial and total collapse of buildings was observed in many areas in Bhaktapur, as illustrated in Figure 2.14, where entire neighbourhoods were destroyed due to the accumulation of various phenomena, such as in- and out-of-plane failures, corner effects, pounding, torsion, and warping failure caused by building irregularities in plan and elevation, reduced space between two adjacent buildings, imbalance in the sizes and positions of openings in walls, and improperly tied roofing material [34].

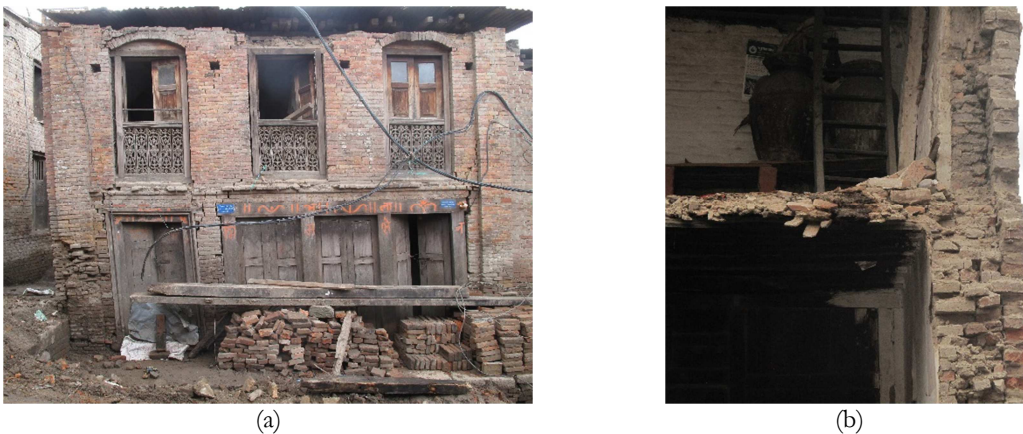
Figure 2.15 – Earthquake damages and failure modes; (a) concentration of the damage in the ground floor due to the openings disposition and (b) Total collapse of the building's façade due to the inadequate anchorage of the floor diaphragm to the wall

Finally, as was the case for RC structures, the use of the ground floor for commercial purposes was also observed in URM buildings, creating vertical irregularity in terms of the existence of openings and the placement of interior walls, and leading to the concentration of earthquake damage in this floor, in what is known as the soft-storey failure mechanism, as demonstrated in Figure 2.15 (a). In some cases, this phenomenon also resulted in the total collapse of many buildings across the Kathmandu Valley region. A combination of factors such as the poor quality of material used in construction, building type and lack of structural integrity, resulted in building vulnerability to severe damage and collapse. In addition, walls inadequately anchored to the floor or roof diaphragm exhibited large cracks and in some cases, had collapsed entirely (see Figure 2.15 (b)).

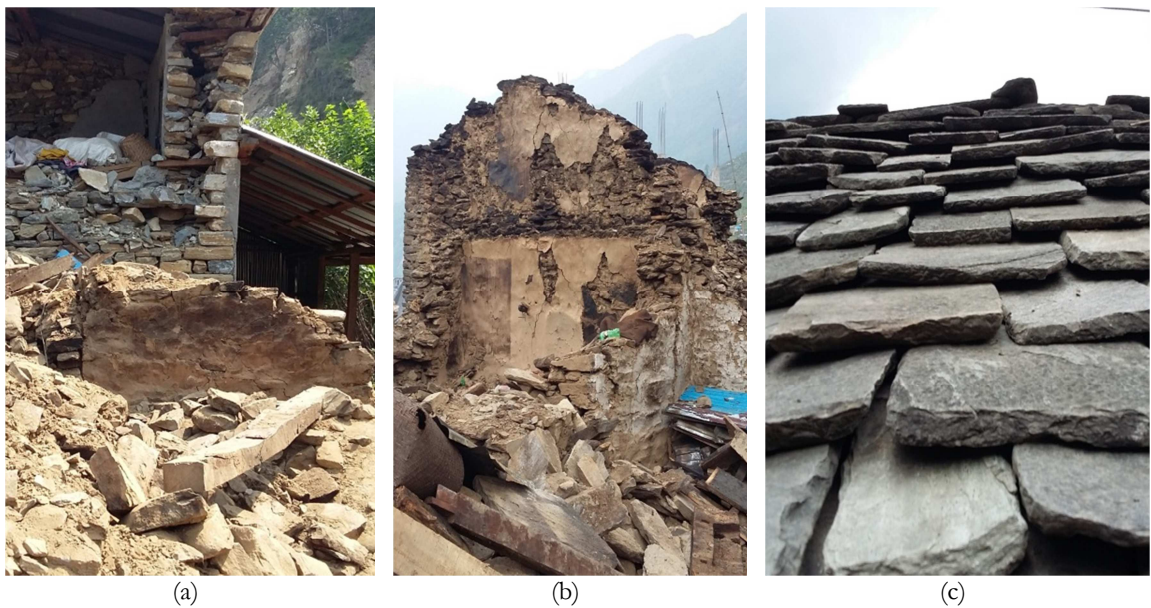
Figure 2.16 - Typical features of rural buildings; (a) Heavy dry stone masonry wall, (b) Two-storied building subject to in- and out-of-plane collapse and (c) Heavy roofing stones

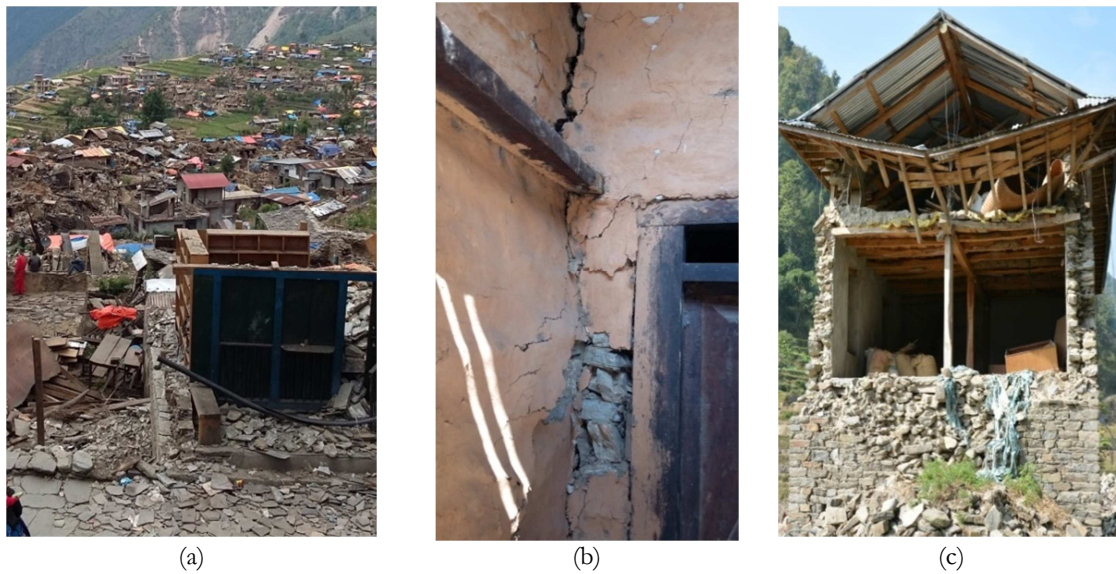
Figure 2.17 - Damage in rural stone masonry buildings; (a) More than 95% of building collapsed in the epicentral Barpak village, (b) Separated orthogonal walls and (c) Out-of-plane collapse of structural and gable end walls

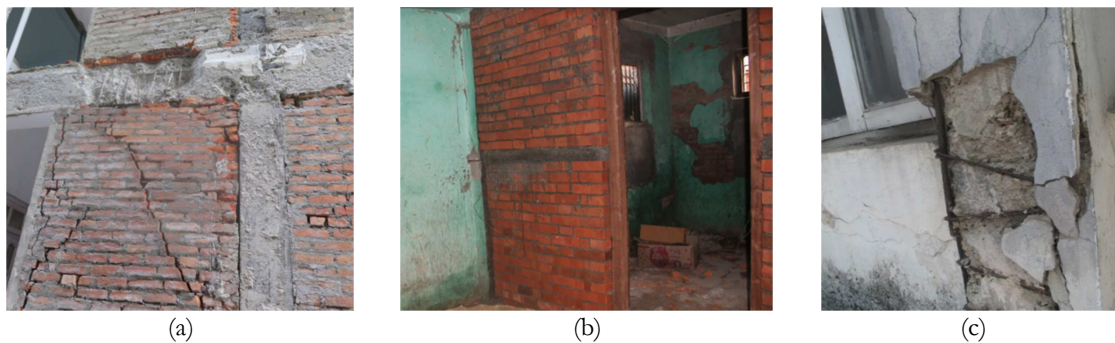
Figure 3.2 – Typical state of structural and non-structural elements observed during visual inspection; (a) Diagonal cracking, corner crushing and shear cracking on the infill panel, (b) Construction of new infill panel on the open ground storey and (c) Poor concrete quality, poor stirrup spacing and its distribution, and poor concrete compaction

In the first stage, an exhaustive field survey was carried out and existing buildings were selected that met the research objective. This was followed by visual inspection through which the information on the state of the building was acquired; the inspection included the present condition of RC elements, concrete quality, reinforcements, state of infill panels, and so on, as illustrated in Figure 3.2. Generally, slight to moderate damage was clearly visible in the masonry infill panels, mainly in non-engineered and pre-engineered buildings and few in well-designed buildings. Similarly, in-plane and out-of-plane failure of infill walls was observed in some non-engineered buildings and a few in engineered buildings. This type of infill behaviour could potentially lead to the failure of buildings, mainly under the soft-storey mechanism. Figure 3.2 (a) presents various cracking patterns observed in the masonry infill walls, which include diagonal cracking of the infill wall, corner crushing, and shear sliding. Figure 3.2 (b) presents prevailing construction practices

such that new infill panels were built at the basement at the time of construction. This building was without infill walls at the basement before the earthquake and corner columns suffered extensive damage, most likely due to the irregular arrangement of infill walls. Figure 3.2 (c) shows the state of reinforcement details in the structural elements resulting from insufficient effective cover, poor concrete confinement, poor material quality and poor workmanship. These reflect only some representative damage observed in the existing buildings to justify the need for and significance of the present study. The detailed condition and state of each building will be discussed in the following sections.

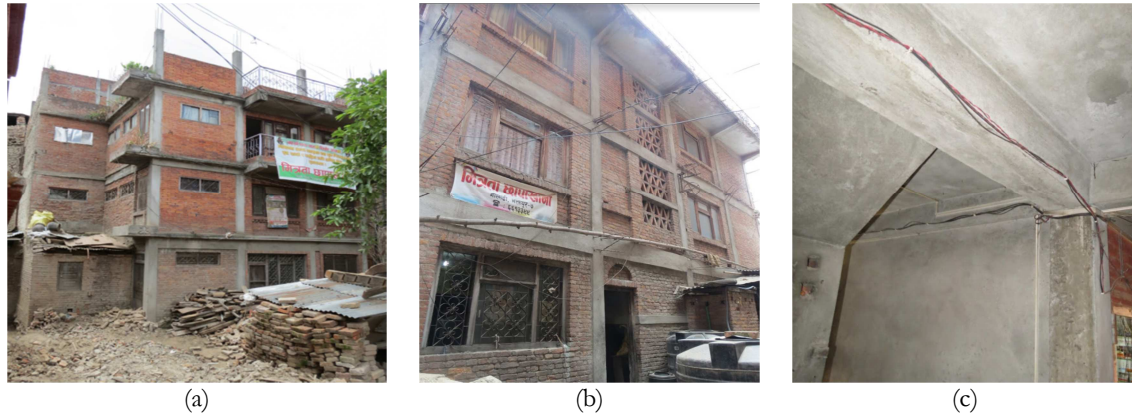
Figure 3.6 – CCP1 building recorded during the reconnaissance after the Gorkha earthquake; (a) and (b) North and South facing, respectively, and (c) State of infill panel and frame elements and their connections

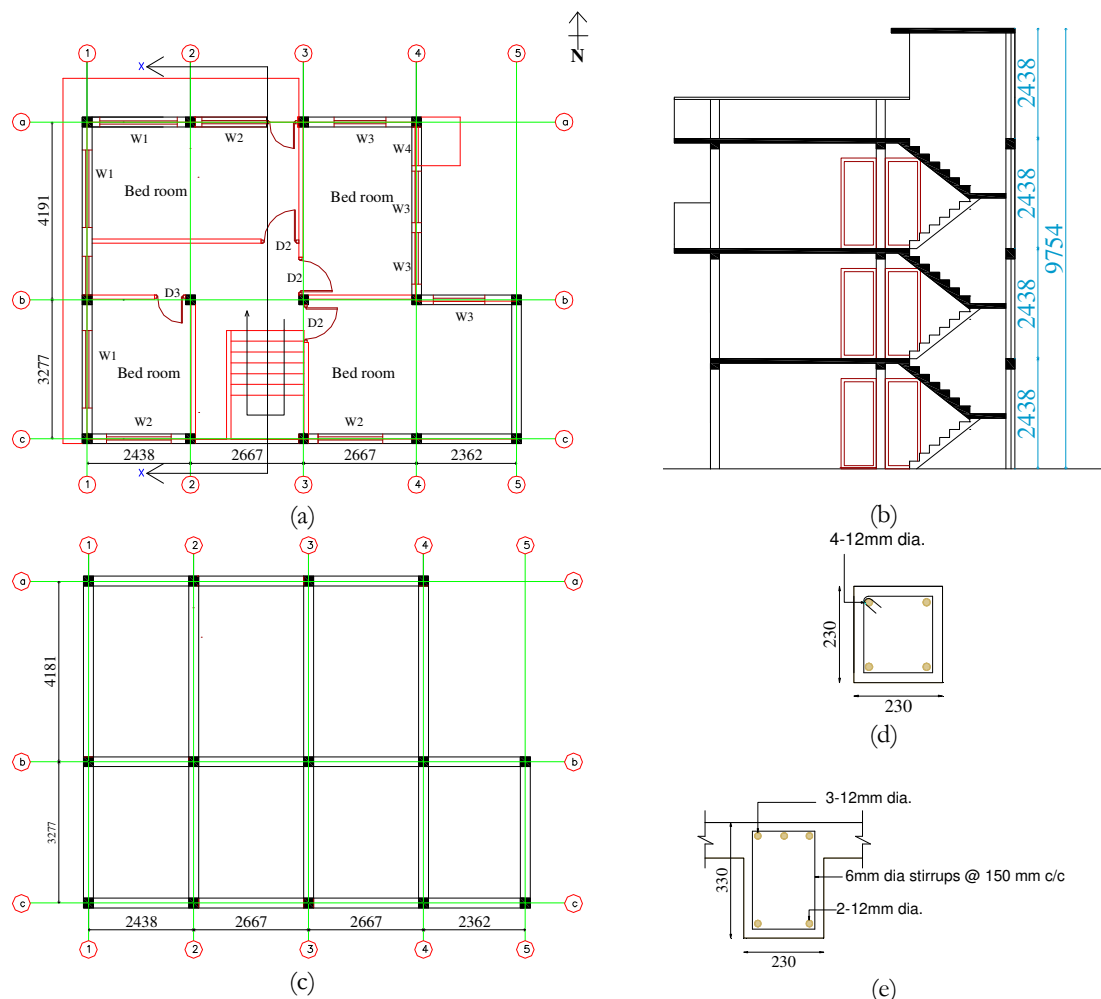
Figure 3.7 – Geometrical details and section layout of the CCP1 building; (a) Typical floor plan, (b) Cross-section, (c) Typical beam and column layout, (d) Typical column section and (e) Typical beam section (all dimensions are in mm)

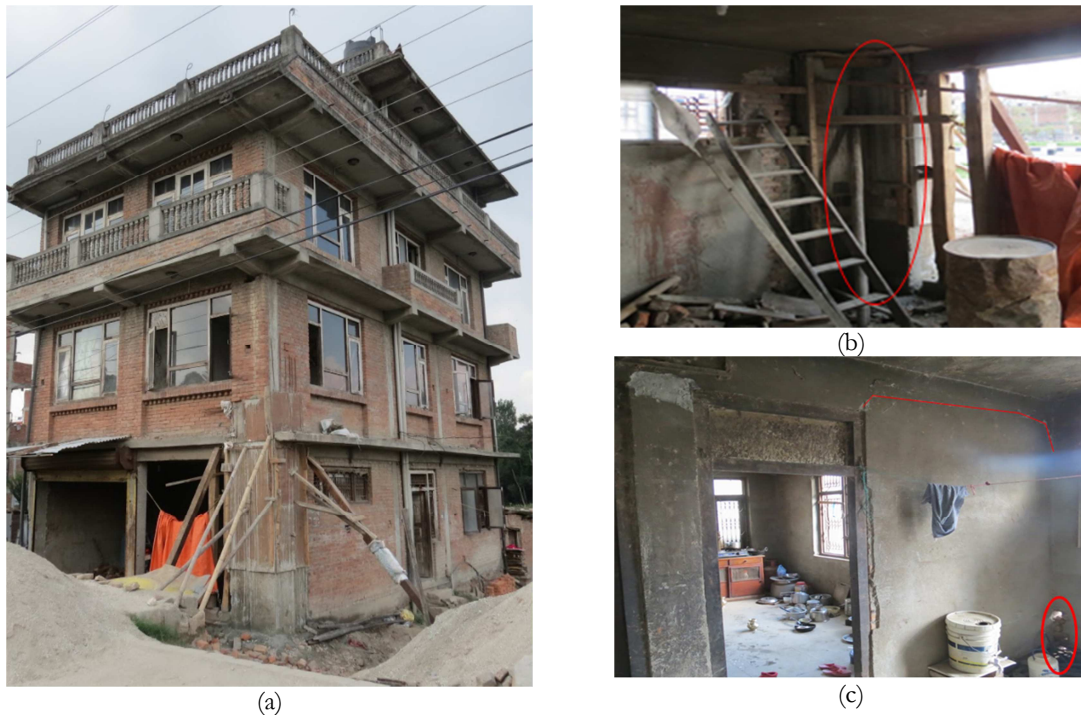
Figure 3.10 – CCP2 building during the site inspection; (a) Geometrical 3-D view, (b) Maintenance work on damaged corner column and (c) Crushing of infill panel and separation of infill panel at the beam interface

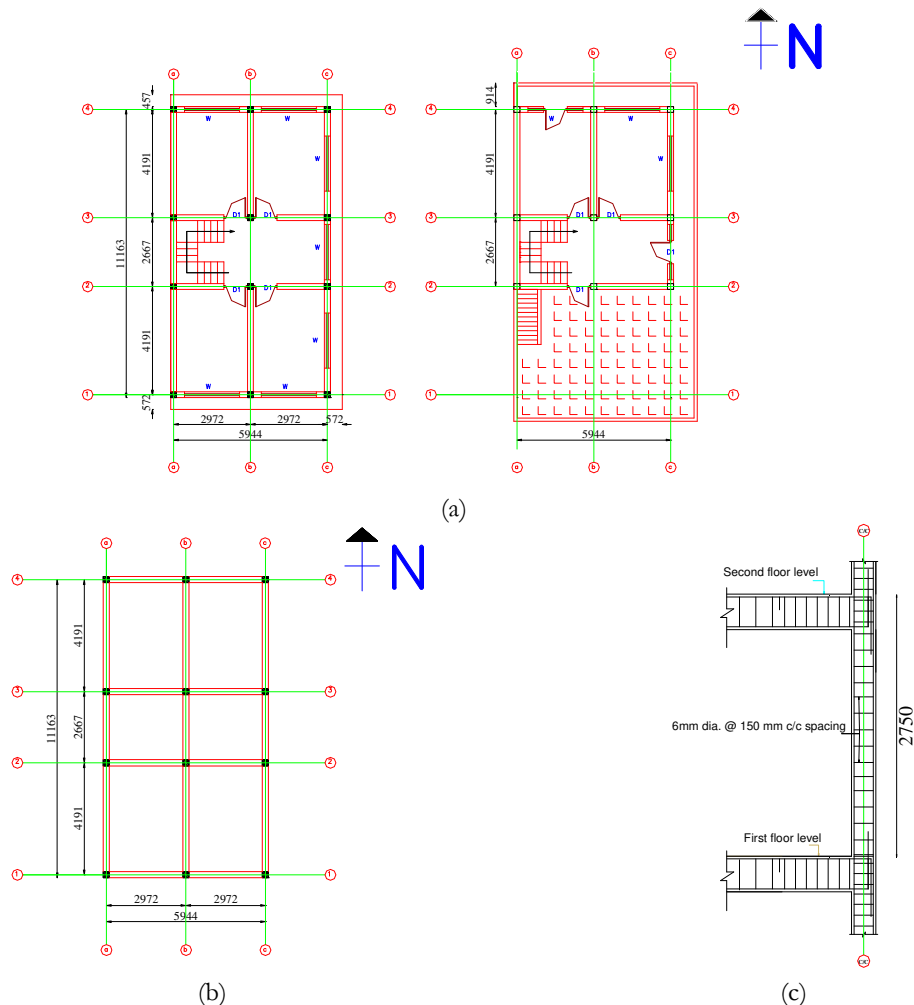
Figure 3.11– Geometrical layout and structural details of the CCP2 building; (a) Typical first and roof floor plans, (b) Column and beam layout and (c) Representative detailing of stirrups in column (all dimensions are in mm)

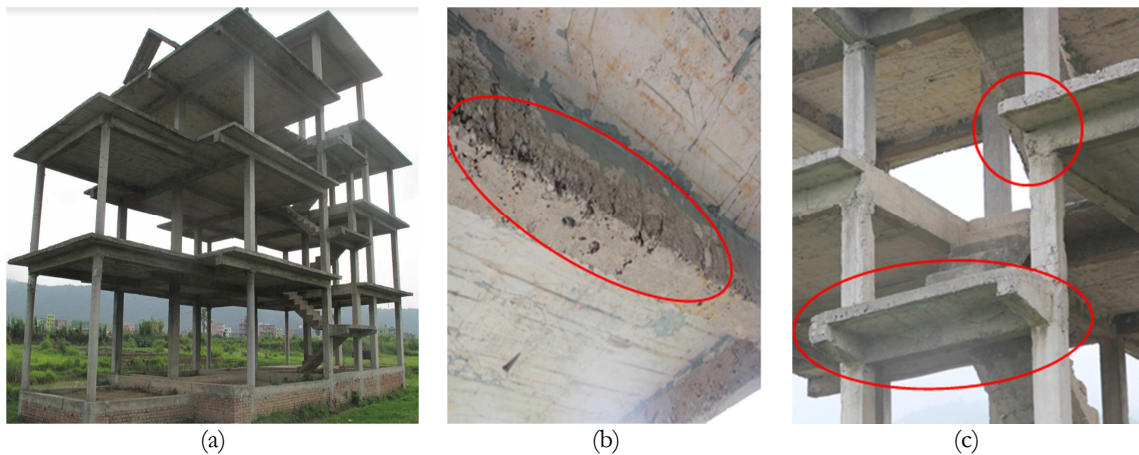
Figure 3.14 – Description of the MRT1 building as observed in site survey; (a) 3-D view, (b) Reinforcement exposed on the beam and poor concrete quality and (c) Short-column at the staircase landing and improper connection at beam-column joint

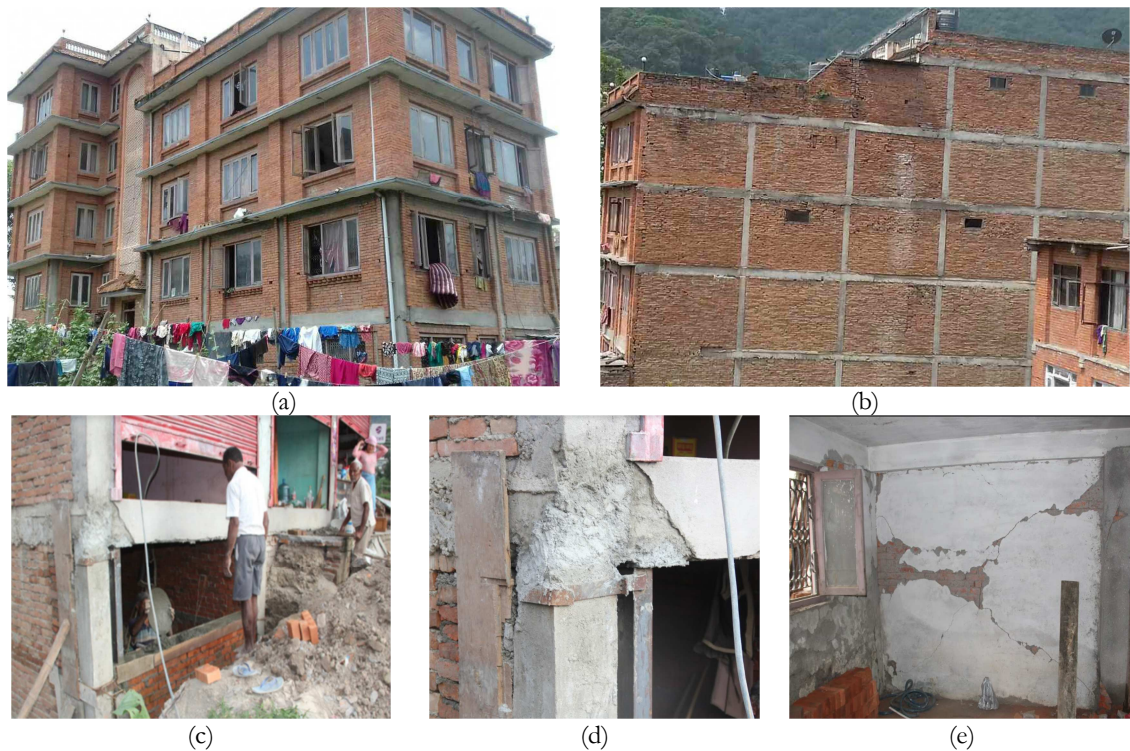
Figure 3.18 – MRT2 building scenario observed in site survey; (a) East-South elevation, (b) North elevation, (c) and (d) Repair and maintenance works on the beam-column joint and (e) Diagonal cracking on infill panel

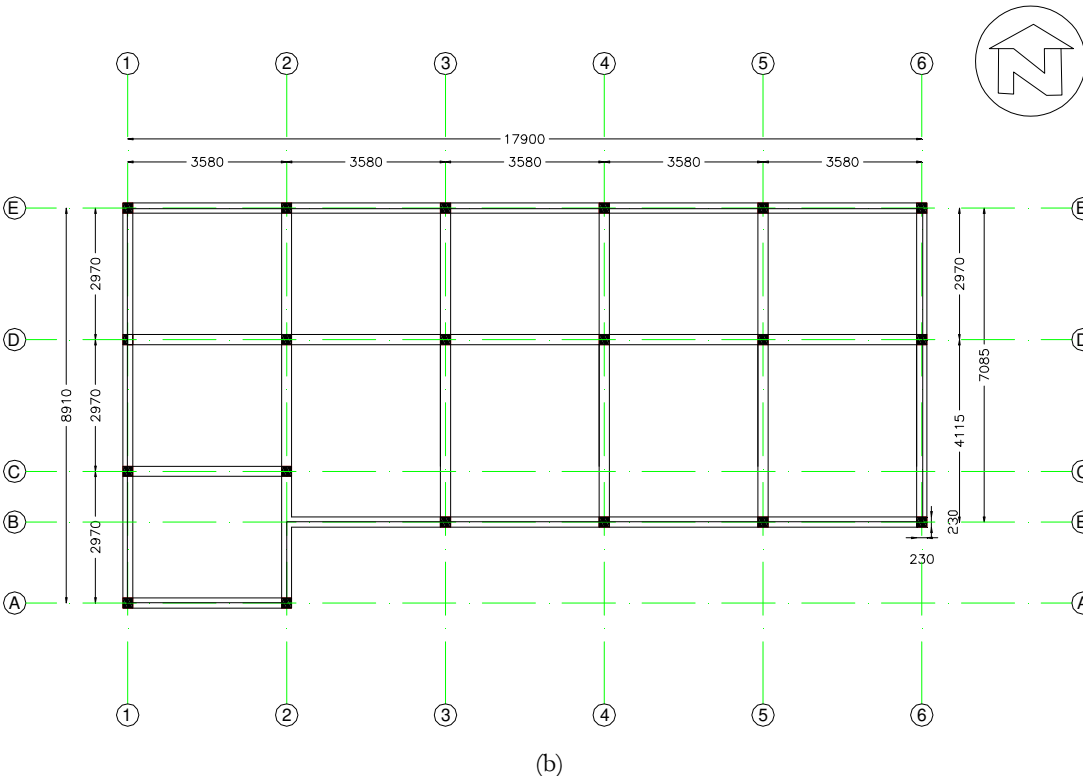
Figure 3.19 – Structural floor layout of the MRT2 building; (a) Representative layout of the floor plan and (b) Typical beam and column layout (all dimensions are in mm)

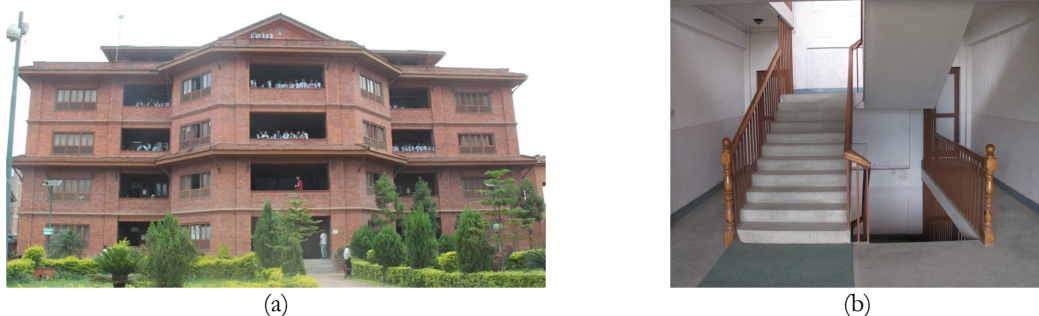
Figure 3.22 – WD1 building observed in the course of field survey; (a) and (b) No structural damage and insignificant or hair line cracks on few infill panels

The Khwopa Engineering College Block ‘C’ is a five-storey building located in Libali-02, Bhaktapur, Nepal. The building was built in 2005. It is the first community-based engineering college undertaken by the Bhaktapur Municipality and is used for institutional purposes. The building was built in such a way that it attempts to combine new technology with old construction philosophy. The former adapts the concept of RC frame skeleton and the latter uses a façade, representative of a traditional building, as shown in Figure 3.22. The building is used by the engineering students and faculty members affiliated with Purwanchal University. Approximately 400 people use it during weekdays. The building was designed as a special moment-resisting frame (SMRF), whose structural elements were designed as a seismic-force-resisting system, following several design guidelines, such as NBC 105: 1994, IS 1893 (Part I): 2002, and IS 4326: 1993 [24, 30, 50] and numerical analysis using design software SAP 2000. It was designed considering response reduction factor ( $R$ ) as 5 [30] and importance factor ( $I$ ) as 1.5 [30], which also depends on the functional use, post-earthquake functional needs and economic importance. The ductile detailing of the structural elements was carried out using IS 13920:1993 [51]. Considering all these design considerations and philosophies, the building was classified as well-designed and named as WD1. The WD1 building possesses two types of URM as infill walls: external infill wall of 350 mm thickness and internal partition wall of 230 mm thickness. Almost all external infill walls possess wide openings for doors and windows, and the building has a slanting roof with brick tiles. The building did not suffer any structural damage, but the infill walls sustained insignificant or minor hairline cracks resulting from the Gorkha earthquake. Therefore, the building was sub-categorized as non-damaged.

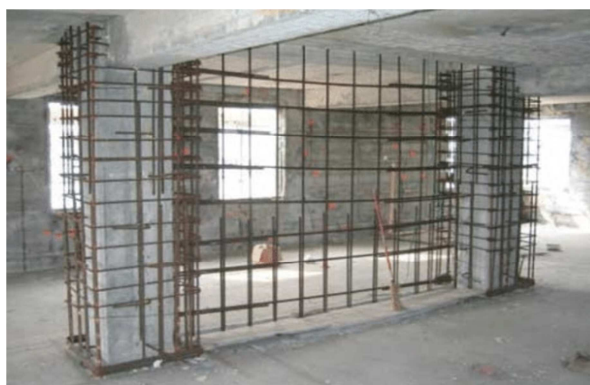
Figure 4. 29 – Shear wall constructed in the existing building

The main objective of the addition of RC shear wall as a strengthening technique is to increase the lateral strength of the structure and correct eventual irregularities. The addition of the RC shear wall was one of the most common strengthening techniques used in Japan after 1968 Tokachi-Oki and 1978 Miyagiken-Oki earthquakes, where increase the lateral strength of reinforced concrete buildings was the primary objective (as referred in Rodriguez and Park, 1991 [125]). Later, this method was also used in the Mexico City for strengthening structures after 1985 Mexico earthquake but in less extent [137]. Although this method reveals many advantages, one main disadvantage is the increase in lateral resistance of the structures that is only concentrated at few places and also extremely increase in overturning moment, as a result strengthening of the existing foundation might be mandatory. This procedure increases own dead loads, therefore is not feasible where strengthening of foundation is not possible or the strengthening cost for foundation is unbearable, and in some cases where the existing information on foundation and original design is not known. In this section, some of the experimental works performed, their results and some design guidelines related to the RC shear wall strengthening are reviewed. Figure 4. 29 illustrate the reinforcement details for shear wall in the existing building.

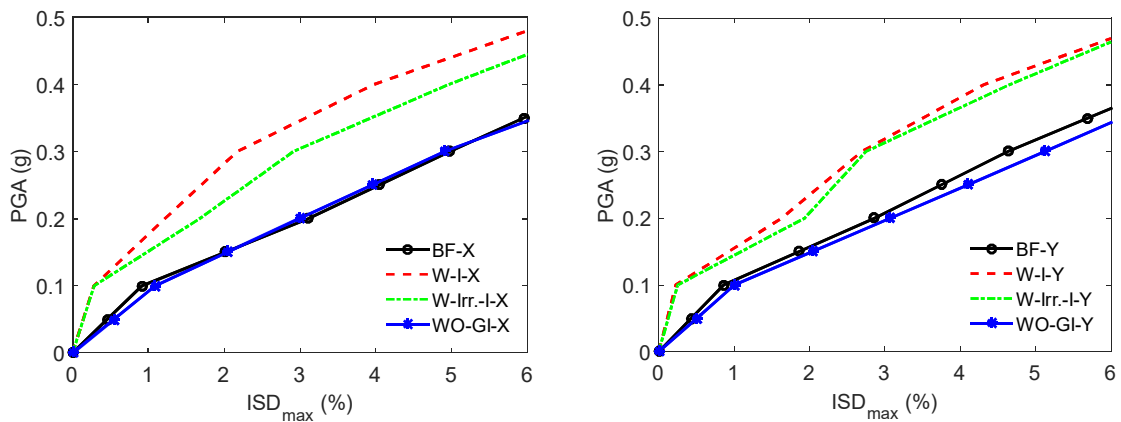
Figure 5.9 – Comparative study of mean IDA curves for the modified MRT1 buildings in the X and Y directions, respectively

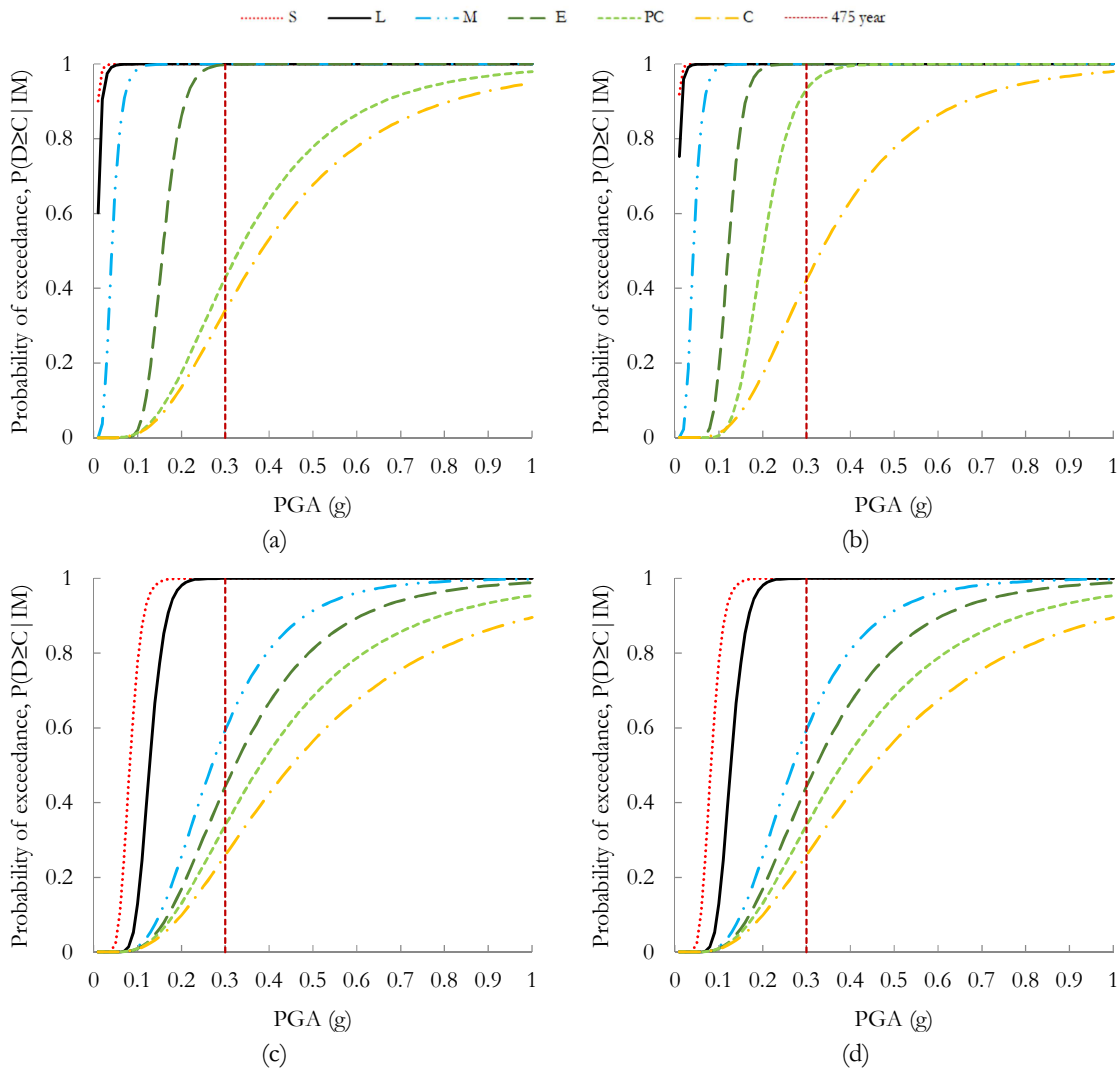
Figure 5.10 – Fragility curves; (a) MRT1, (b) MRT1-WO-GI, (c) MRT1-W-Irr.-I and (d) MRT1-W-I buildings. S – slight, L – light, M – moderate, E – extensive, PC – partial collapse, C – collapse

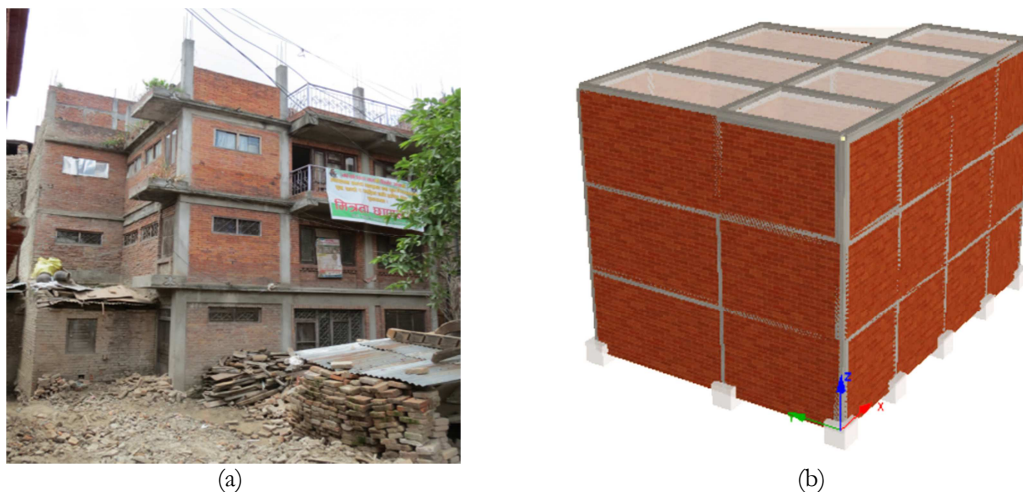
Figure 5.12 – CCP1 building; (a) Real building, and (b) Numerical model

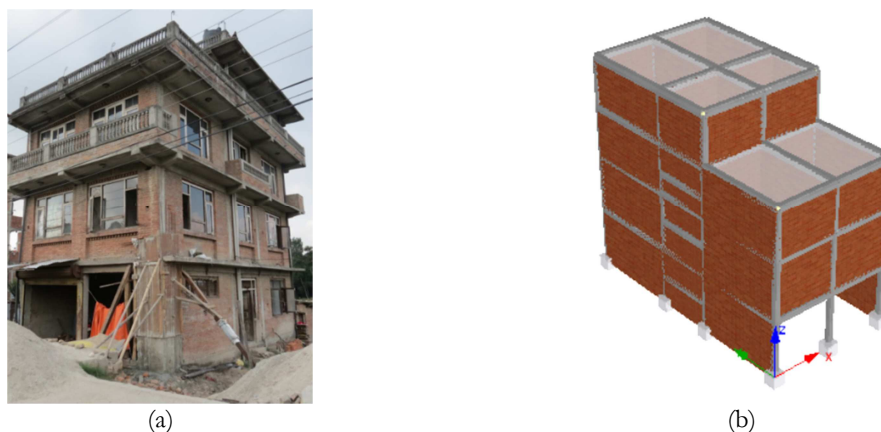
Figure 5.20 – CCP2 building; (a) Real building and (b) Numerical model

Initially, the building was modelled in SeismoStruct software [22], as discussed for the previous case study buildings. Various standard material properties and other parameters were assigned, except for the concrete compressive strength, which was measured in-situ. Therefore, the first step was the numerical model adjustment through parametric study. The main limitation of this software is the inability to model observed cracks in the infilled wall, which were integrated through the model calibration. The dimensions of the structural elements and their detailing were assigned in a similar way as for those measured in-situ, as discussed in detail in Chapter 3. In addition, the location and dimensions of the internal and external infilled walls were identically assigned, as observed and measured in-situ. The dead loads and live loads were assigned in the respective beam elements. All live loads acting on the building were considered to be  $2.5 \text{ kN/m}^2$ ; thus, only 25% of the live loads were considered in the seismic load calculation. Figure 5.20 presents the existing CCP2 building and its three-dimensional numerical model developed in the SeismoStruct [22], in which the E-W orientation of building was represented along the X-axis and N-S orientation along the Y-axis.

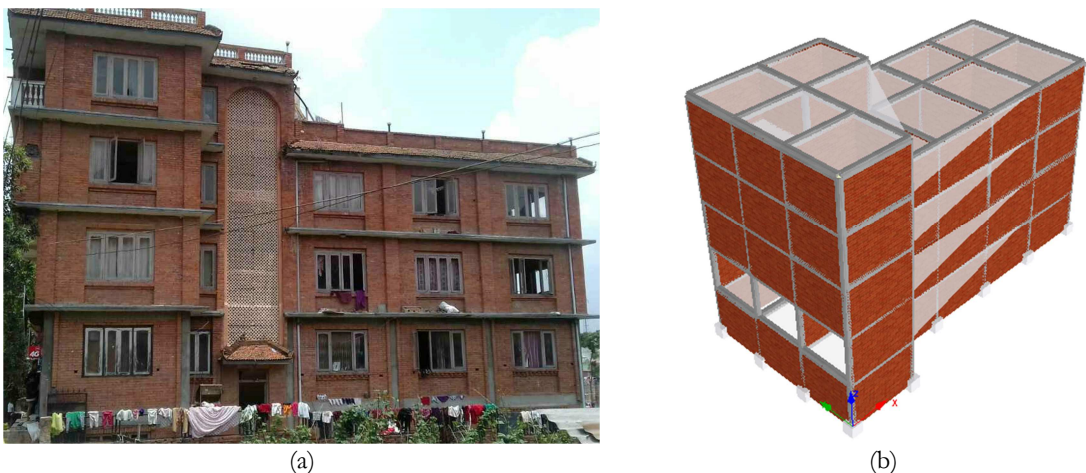
Figure 5.29 – MRT2 building; (a) Real building and (b) Numerical model

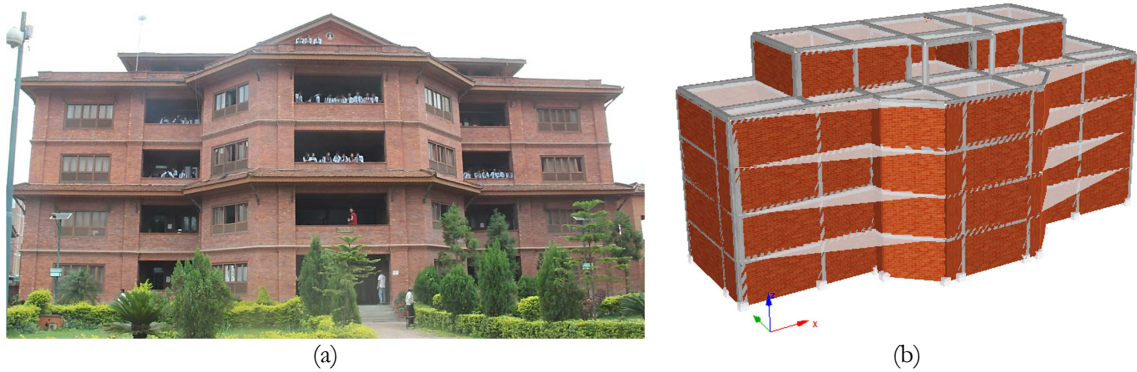
Figure 5.38 – WD1 building; (a) Real building and (b) Numerical model

In the previous sections, the detailed seismic performance assessment of both non-engineered and pre-engineered buildings was performed and presented. The present section describes the detailed seismic performance of a well-designed building, namely WD1 that was classified as non-damaged to identify the level of damage states that is likely in this type of building. Initially, the building was input into the SeismoStruct software [22], and the existing building and its numerical model are presented in Figure 5.38. The building’s east-west orientation was represented along the X-axis and the north-south orientation along Y-axis. The calibrated characteristic strength of the concrete was 20 MPa, the crushing strength of the infilled walls set to 7 N/mm<sup>2</sup> and the other standard material properties, as discussed in Chapter 4, were initially assigned as a reference, which were adjusted after the model calibration. The geometrical layout and structural sections and locations were similar to the authorized drawings. The dead loads of the assigned elements, such as beams, columns and the infilled walls were estimated by the program through defined sections and the corresponding unit weight of the materials. Whereas other dead loads, such as the slabs, cantilever walls, parapet walls, staircases, etc. were assigned to the
