**SEISMIC PERFORMANCE ASSESSMENT AND  
STRENGTHENING TECHNIQUES FOR EXISTING  
REINFORCED CONCRETE BUILDINGS IN NEPAL**

Dissertation submitted to the Faculty of Engineering of the University of Porto in fulfilment of the requirements for the degree of Doctor in Civil Engineering.

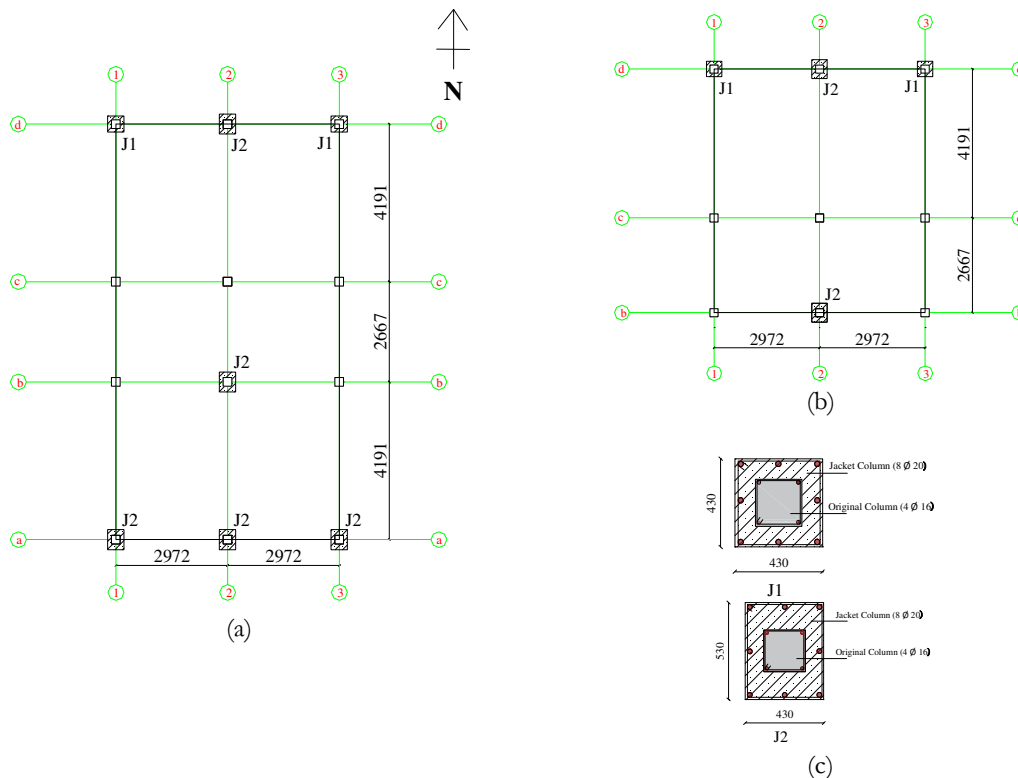
Figure 6.12 - Jacketing layout and reinforcement detailing in the CCP2 building; (a) Ground, first and second floors plan, (b) Top floor plan and (c) Section and reinforcement details (all dimensions are in mm)

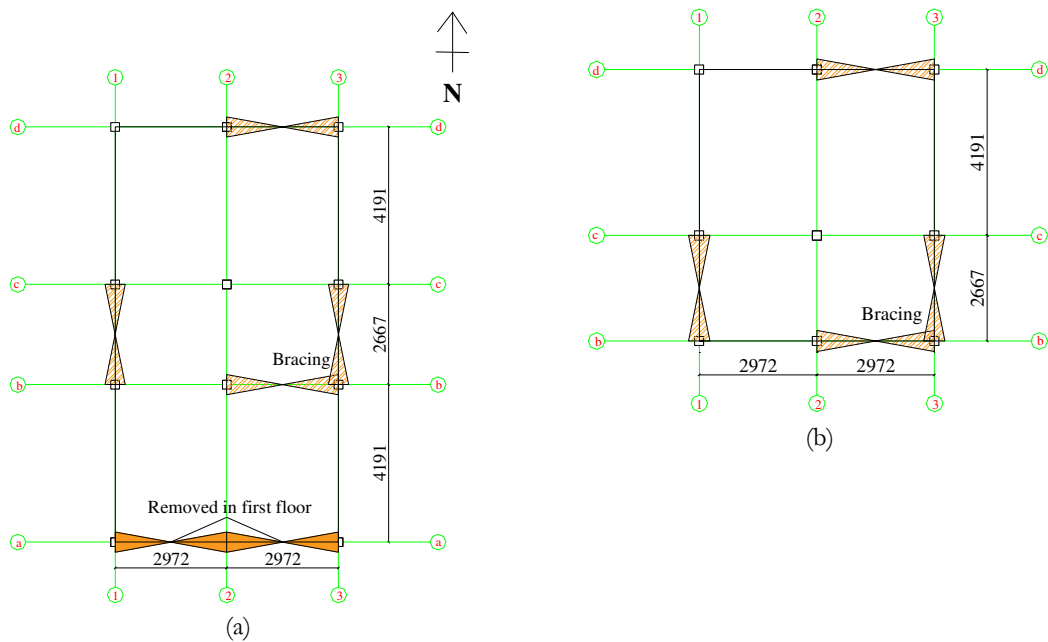
Figure 6.13 – Cross steel bracing layout in the CCP2 building; (a) Ground, first and second floors plan, (b) Top floor plan (all dimensions are in mm)

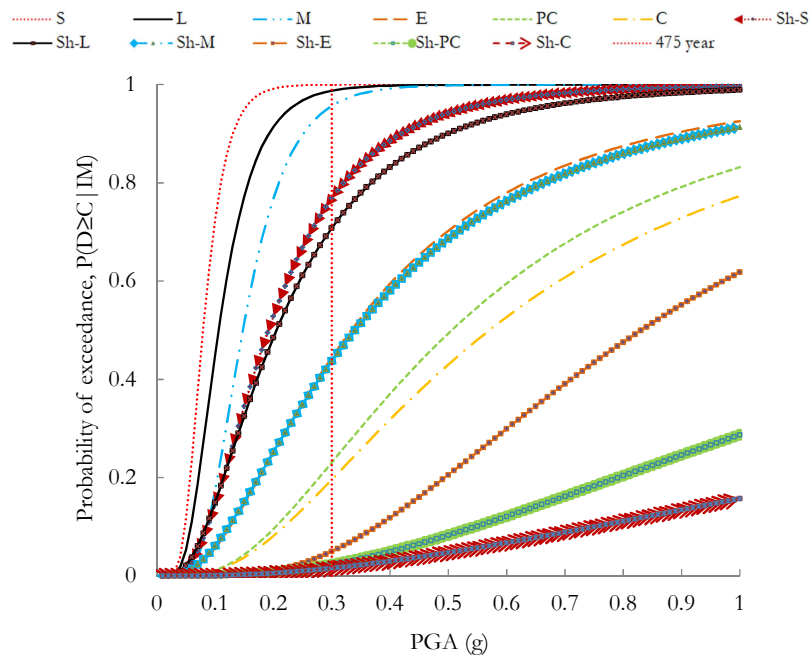
Figure 6.20 - Fragility curves for the CCP2 building with Shear wall. J – jacketing, Br. – bracing, Sh – shear wall, S – slight, L – light, M – moderate, E – extensive, PC – partial collapse, C – collapse

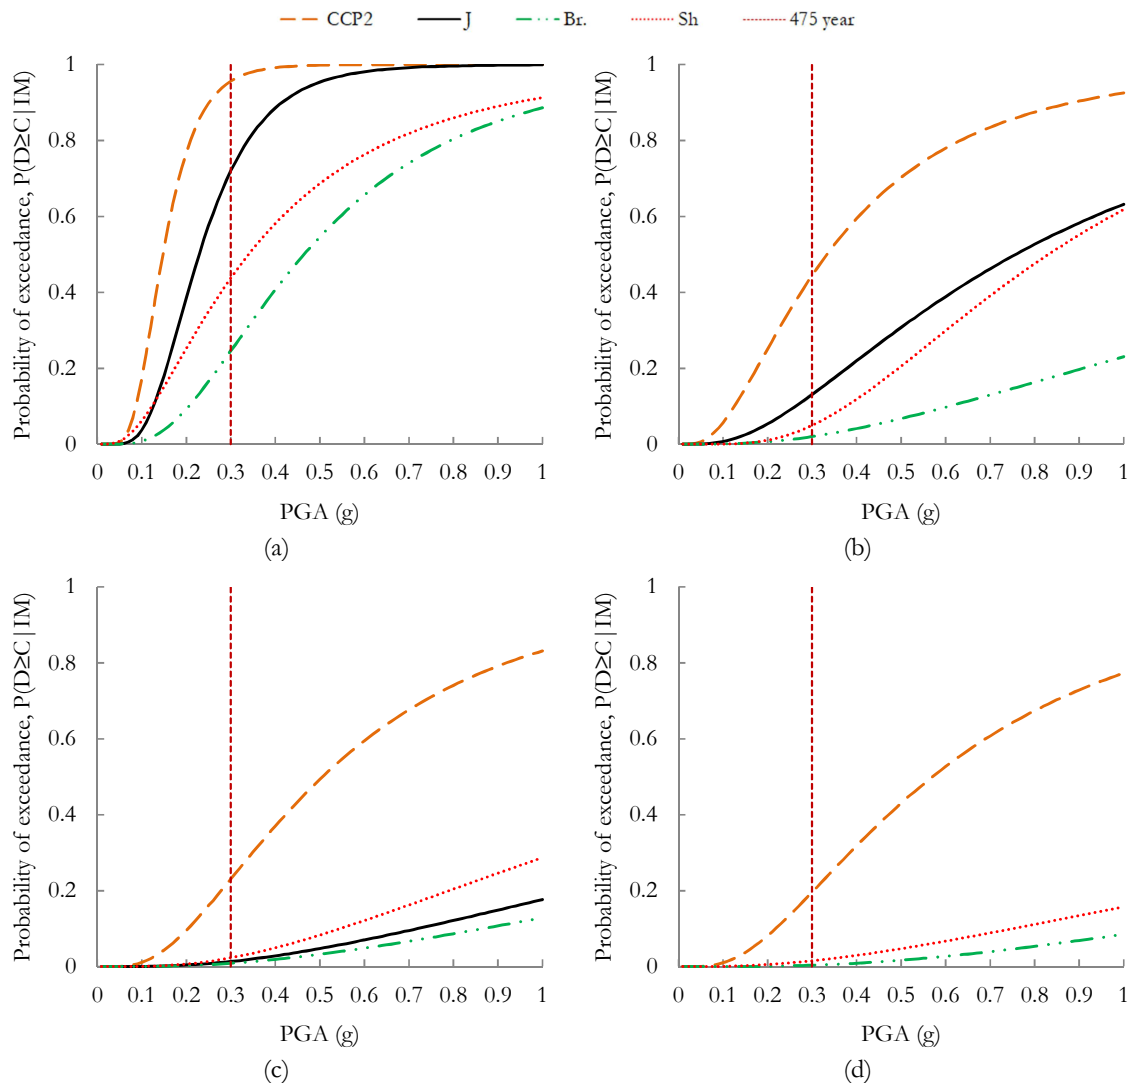
Figure 6.21 - Comparative fragility curves for the CCP2 building with various damage states; (a) Moderate, (b) Extensive, (c) Partial collapse and (d) Collapse. J – jacketing, Br. – bracing, Sh – shear wall

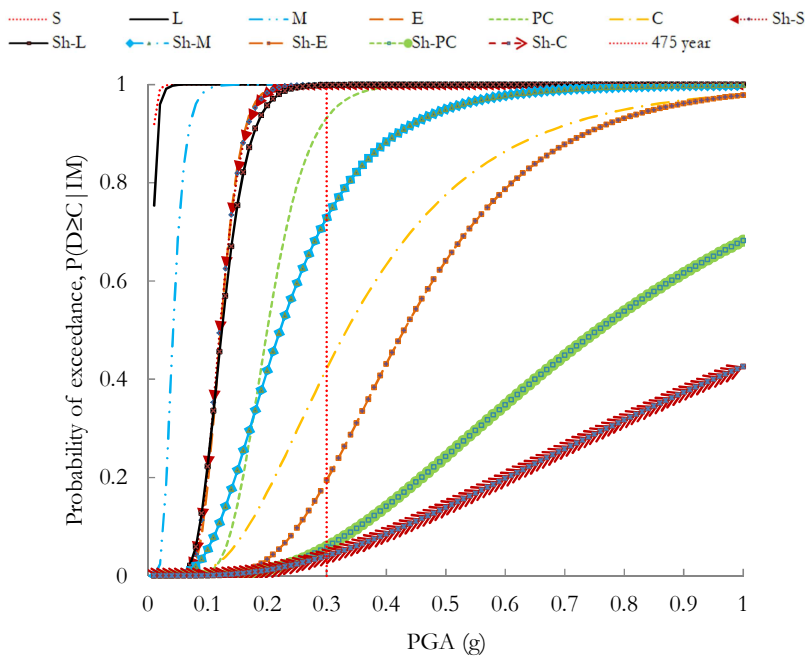
Figure 6.30 - Fragility curves for the MRT1-WO-GI building with Shear wall. J – jacketing, Br. – bracing, Sh – shear wall, S – slight, L – light, M – moderate, E – extensive, PC – partial collapse, C – collapse

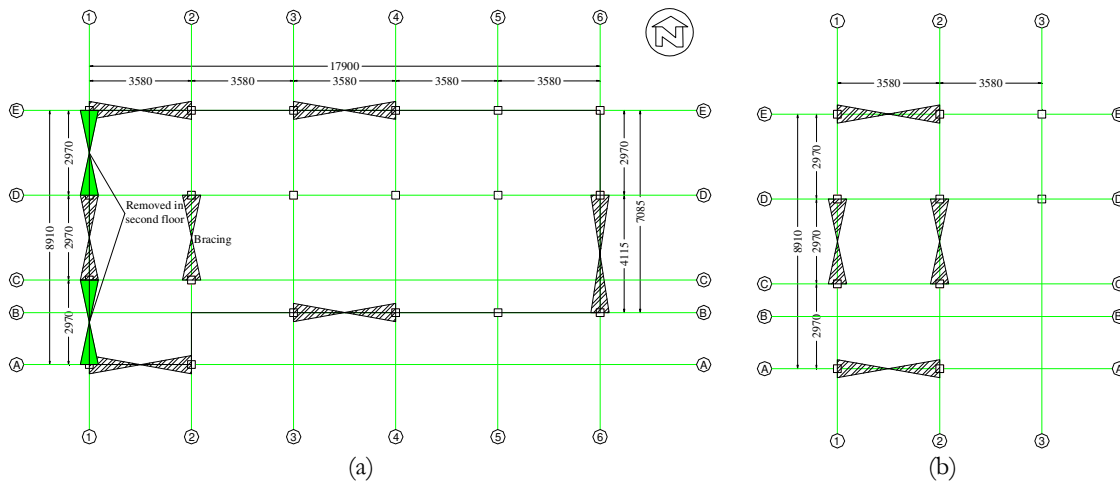
Figure 6.33 - Bracing layout in the MRT2 building; (a) Plan for the basement, ground, first and second floors, (b) Top floor plan (all dimensions are in mm)

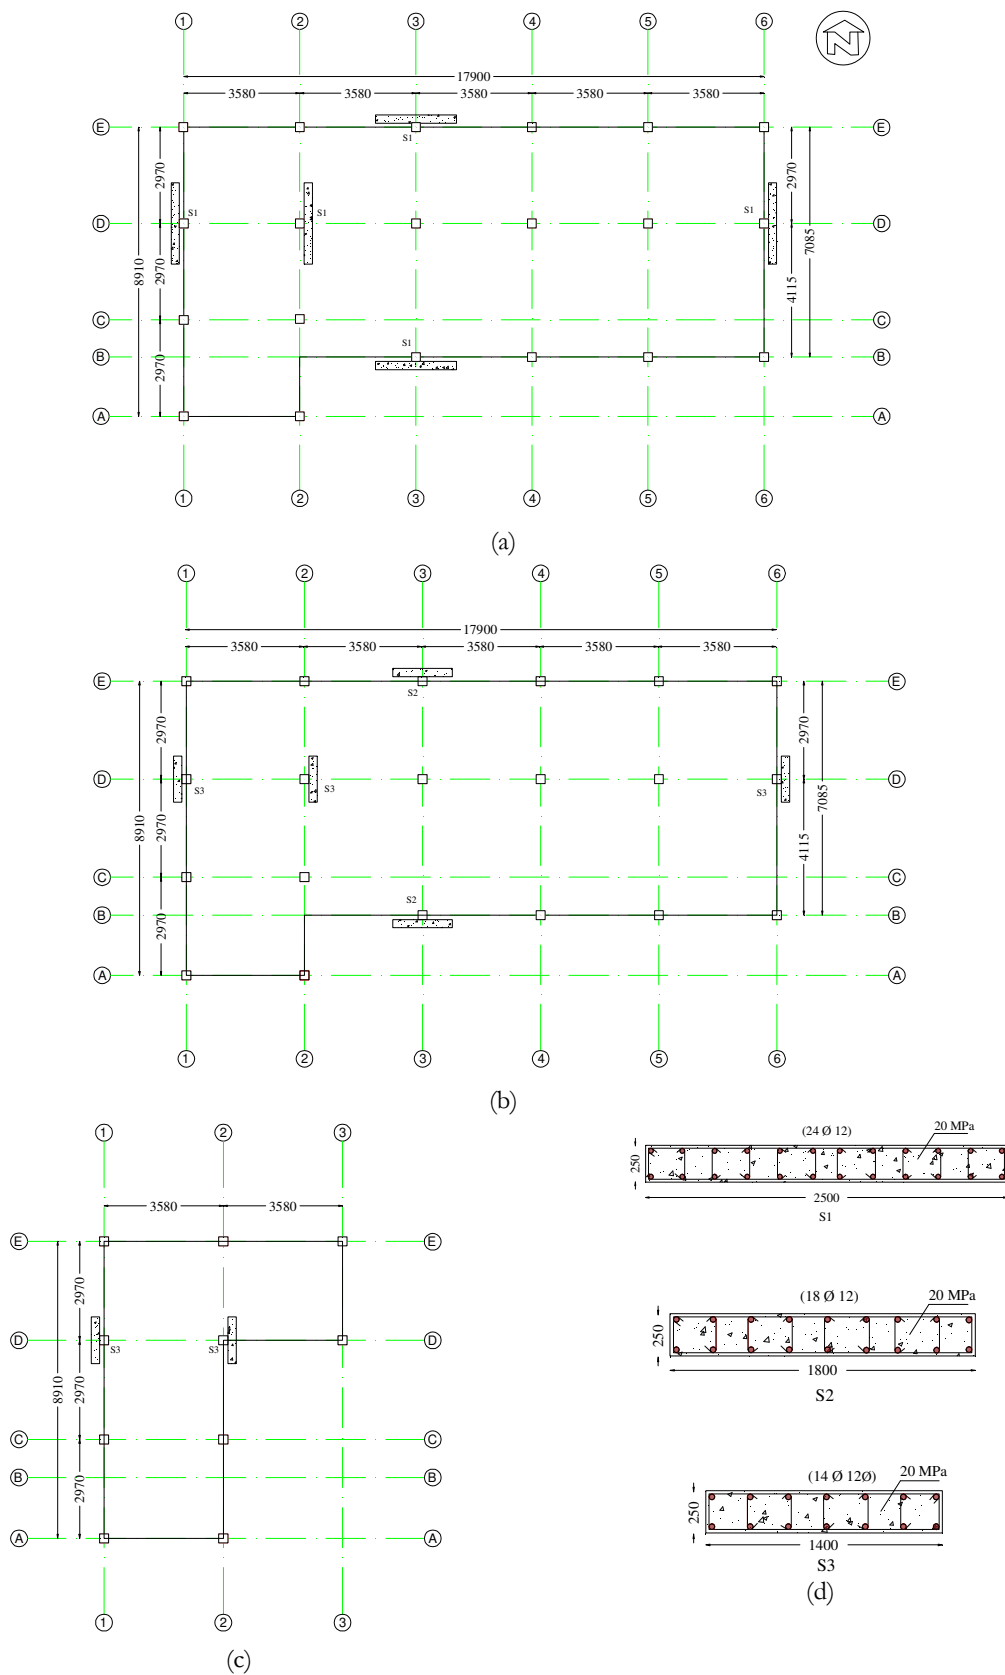
Figure 6.34 - Shear wall layout and section details in the MRT2 building; (a) Plan for the basement and ground floors, (b) Plan for the first and second floors, (c) Top floor plan and (d) Detailing of shear walls (all dimension are in mm)

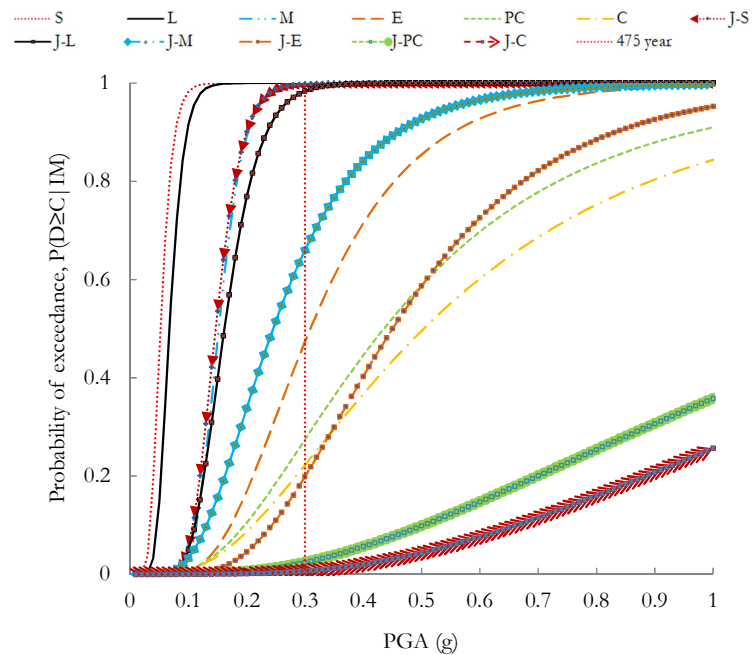
Figure 6.39 - Fragility curves for the MRT2 building with Jacketing. S – slight, L – light, M – moderate, E – extensive, PC – partial collapse, C – collapse

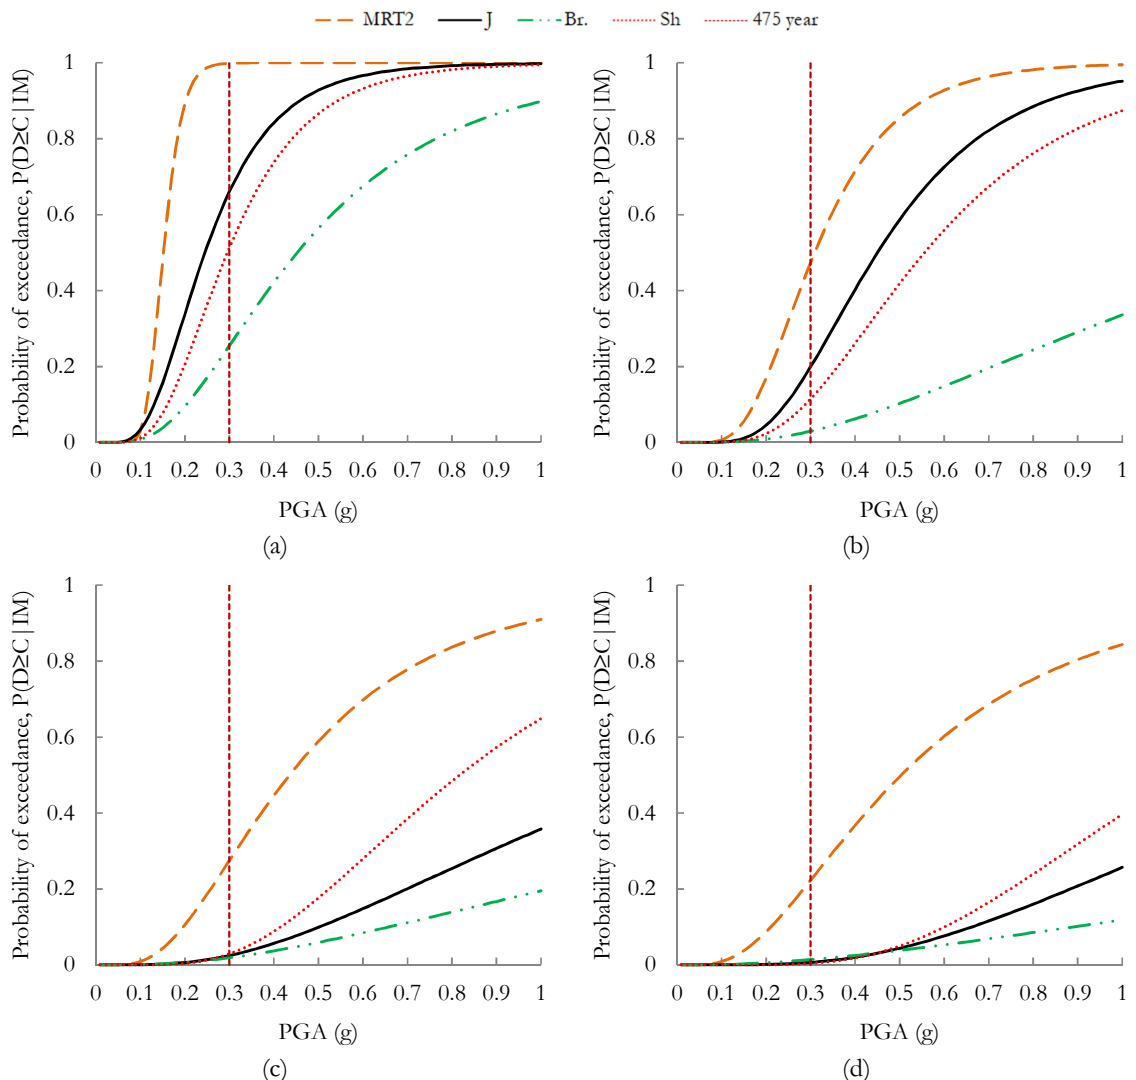
Figure 6.41 - Comparative fragility curves for the MRT2 building with various damage states; (a) Moderate, (b) Extensive, (c) Partial collapse and (d) Collapse. J – jacketing, Br. – bracing, Sh – shear wall

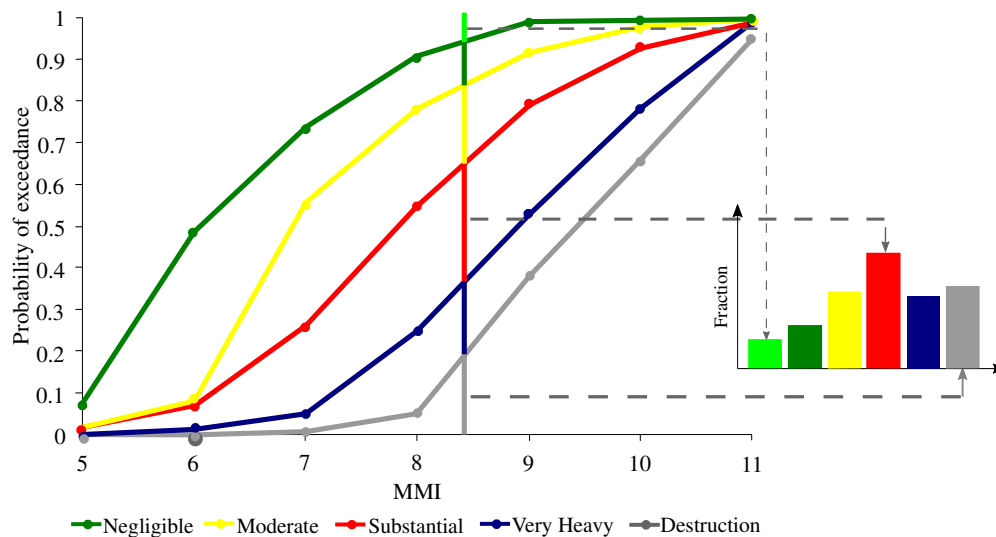
Figure 7.5 – Fragility proportions for each damage state at particular intensity level (Romao, 2014 [243])

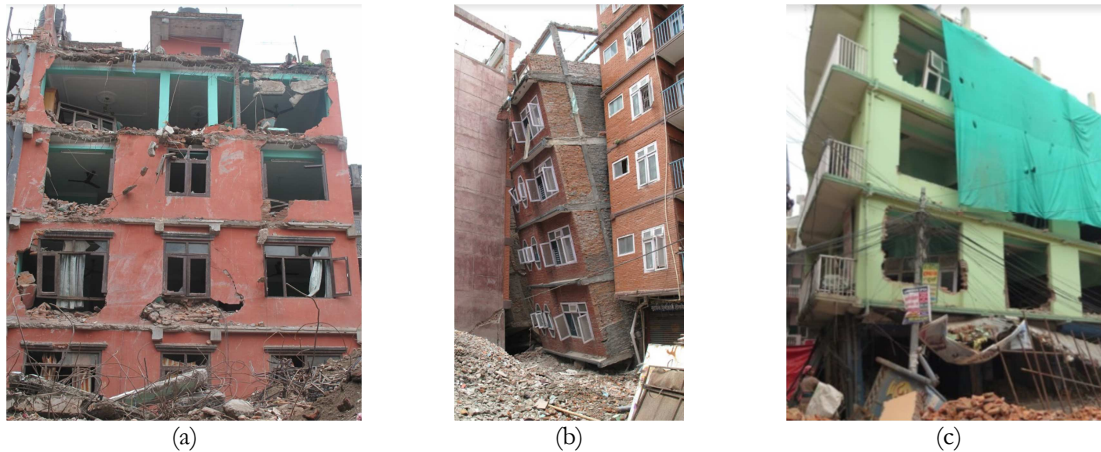
Figure 8.1 – Representative damaged buildings due to the distribution of infill walls observed after Gorkha earthquake; (a) Total in-plane crushing of the infill walls, (b) Soft-storey building along with pounding mechanism and (c) Soft-storey mechanism and out-of-plane failure of the infill walls

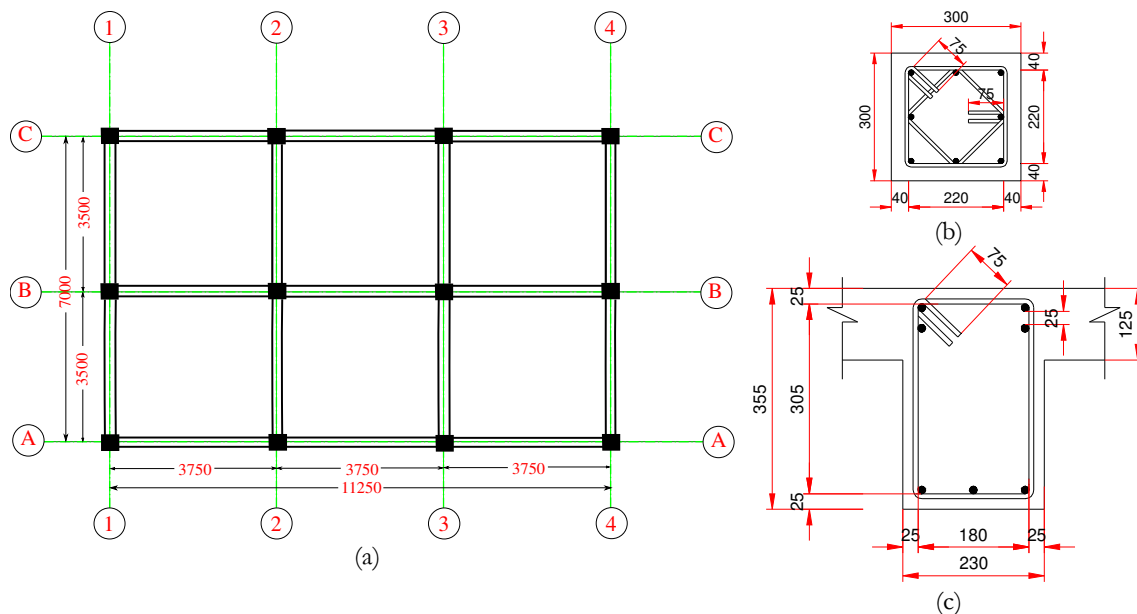
Figure 8.3 - Typical floor layout and structural details; (a) Beam and column, (b) Column detail and (c) Beam detail (all dimensions are in mm)
