Aliasghar BEHNAMGHADER, D. NAJJAR, Alain IOST, Stéphane BENAYOUN - Mechanical behavior study of plasma sprayed hydroxyapatite coatings onto Ti6Al4V substrates using scratch test - Materials Science Forum - Vol. 638-642, p.641-646 - 2010

# Mechanical behavior study of plasma sprayed hydroxyapatite coatings onto Ti6Al4V substrates using scratch test

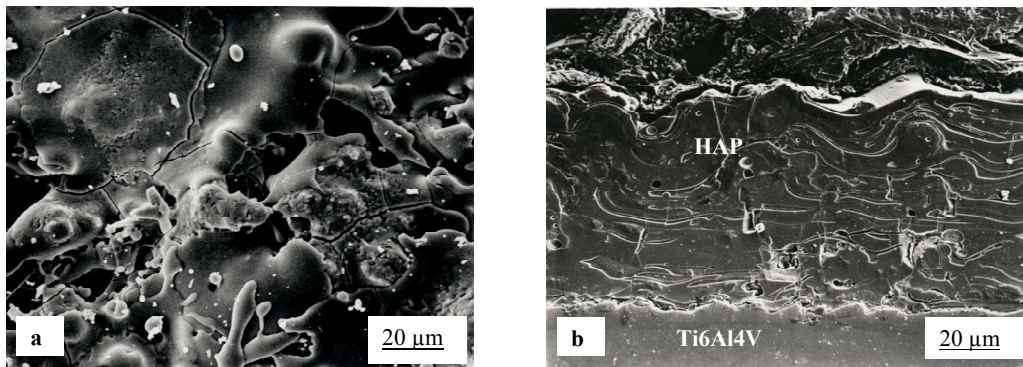
Figure 1: SEM micrographs showing: a) a typical top view of an HAP coating surface produced by air plasma spraying (coating thickness  $CT = 105 \mu\text{m}$ , substrate  $Ra = 2.29 \mu\text{m}$ ), b) a typical microstructure of the plasma-sprayed HAP through a coating cross-section ( $CT = 75 \mu\text{m}$ , substrate  $Ra = 1.23 \mu\text{m}$ ).

**Microstructure.** In a preliminary study, the X-ray diffraction reveals that HAP is the principal phase of coatings [8]. SEM observations of the plasma-sprayed coatings reveal typical features presented in numerous other studies [13-17]. The as-sprayed coating surface is characterized by unmelted or partially melted particles, fully molten splats, pores and emerging cracks that propagate in the molten areas (Fig. 1a). A lamellar microstructure with an orientation closely parallel to the coating/substrate interface is observed on cross-sections (Fig. 1b).

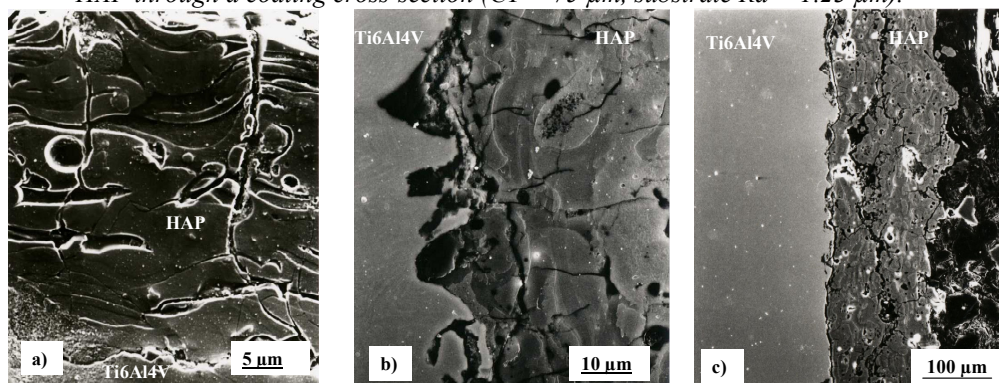
Figure 2: HAP coating cross sections showing: a) large perpendicular cracks emerging at the top surface ( $CT = 50 \mu\text{m}$ , substrate  $Ra = 1.23 \mu\text{m}$ ), b) fine perpendicular cracks ( $CT = 165 \mu\text{m}$ , substrate  $Ra = 2.29 \mu\text{m}$ ), c) interfacial and interlamellar cracks ( $CT = 150 \mu\text{m}$ , substrate  $Ra = 2.29 \mu\text{m}$ ).

The lamellar microstructure arising from the accumulation of the well-flattened molten splats contains also partially melted particles and various cracks. Some of the cracks are normal and others are parallel to the coating/substrate interface. Two kinds of normal cracks can be detected: large ones that emerge and open on the top surface of coating in the molten areas (Fig. 2a) and fine ones localized near the coating/substrate interface (Fig. 2b). It must be mentioned that the density of fine normal cracks increases when thickness of the coating increases. The parallel cracks are either localized in the interfaces of melted splats (interlamellar cracks) or in the interface between the coating and the substrate (interfacial cracks). For coatings deposited on the substrate having the

higher arithmetic average roughness parameter, cracks propagating in the interface are always detected when thickness is above  $105 \mu\text{m}$  (Fig. 2c) and a good interfacial bonding is obtained when thickness is less or equal to  $90 \mu\text{m}$ . Coatings deposited on the substrate having the lower arithmetic average roughness parameter  $R_a$  generally show the worse bonding quality with an increasing interfacial cracking propensity when thickness increases. It must be outlined that pores and cracks lower the coating mechanical performance on one hand but support the ingrowth of the tissue into the ceramic material on the other hand.

If the existence of pores can be related to entrapped gases, poorly melted particles and poor bonding between adjacent splats, cracking is the result of relaxation of the residual stresses developed in the ceramic coating during the deposition process [14-16, 18]. In this study, while the largest cracks normal to the coating/substrate interface are very probably the result of the relaxation of the residual tensile stresses [16], the parallel cracks are mainly promoted by in plane compressive stresses producing induced through-thickness tensile stresses [19, 20]. Finally, since the thermal expansion of HAP is above that of Ti-6Al-4V, the finest perpendicular cracks detected near the coating/substrate interface is thought to be the result of tensile stresses due to the thermal expansion mismatch. As mentioned by Yang et al. [20], the mechanism of residual stress generation and the impact of these residual stresses are so complicated that only few works are devoted to the quantitative prediction of the magnitude stress.

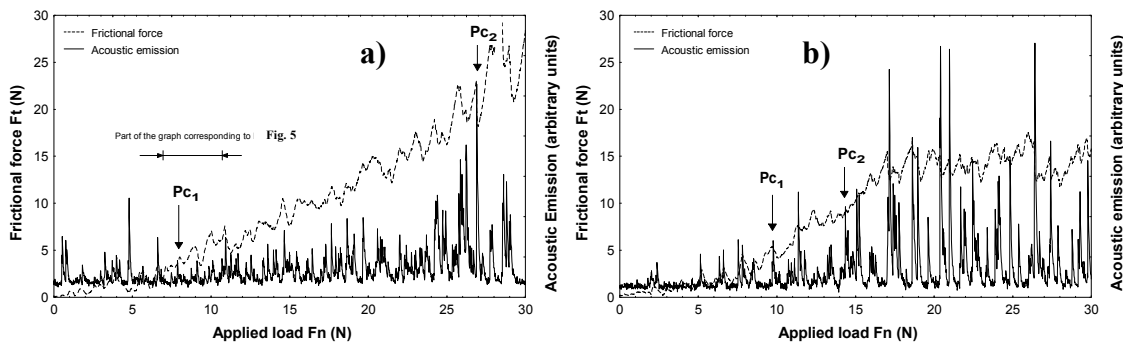
Figure 4: Typical acoustic emission and frictional force variations during a scratch test in the case of: a) a thick coating ( $CT = 105 \mu\text{m}$ , substrate  $Ra = 1.23 \mu\text{m}$ ), b) a thin coating ( $CT = 50 \mu\text{m}$ , substrate  $Ra = 1.23 \mu\text{m}$ ).

Determination of the critical load  $P_{c1}$  for crack initiation was delicate. In fact, it is impossible to estimate directly and thoroughly  $P_{c1}$  considering only the graph of the frictional force or the graph of the acoustic emission because no significant change in these curves is observed (Fig. 4). Indeed, the frictional force does not change significantly for this critical load since cracks are produced behind stylus according to the Hertz theory [9]. As to the acoustic emission, microcracks initiating at  $P_{c1}$  produce only short single peaks hidden in the noisy background. The critical load  $P_{c1}$  was finally determined from numerous and attentive scanning electron microscopy observations of all coatings. These observations based on a comparative study of crack length revealed that the normal load value, for which a microcrack reaches a length of 50% of the scratch track width, may be a satisfactory criterion to evaluate  $P_{c1}$ . An example of the microcracks formed in a range of applied loads near the  $P_{c1}$  value is presented on Fig. 3b.

emission curves combined simultaneously with a local sharp decrease of the frictional force at high loads (Fig. 4a). However, secondary pulses especially on acoustic emission curves may prevent to find the true peak and hence to estimate precisely  $P_{c2}$ . The secondary pulses appear at high loads and are mainly due to local coating failures that occur when the stylus interacts with pores or preexisting thermal cracks due to the plasma-spraying process. Sometimes, the stylus can cross over the largest defects associated with large and sharp discontinuities of surface topography resulting in significant sharp pulses on frictional force without significant effect on acoustic emission signal. The presence of such secondary pulses hampers the precise estimation of  $P_{c2}$  directly from the acoustic emission or the frictional force curves. This fact emphasizes the very usefulness of microscopic observations even if the lack of sufficient contrast of imaging between the coating and the substrate can be also an obstacle. In fact, the major problems encountered to estimate thoroughly  $P_{c2}$ , due either to the interaction between stylus and initial flaws generated during the plasma-spraying process in the coatings or to the lack of sufficient contrast of imaging, have been already mentioned by other authors [10, 12, 21].

Fig. 4b presents a typical graph of frictional force evolution and acoustic emission of a thin coating tested in this work. In this case, the higher critical load was assessed from microscopic observations and corresponds to the normal load for which the contact between the stylus and the substrate occurs. At first sight, it seems that the normal load value  $P_{c2}$  determined by these microscopic observations is not so far as the abscissa corresponding to the inflexion point on the frictional force graph. However, as mentioned by Stephanopoulos et al. [22], such a behavior is more representative of the interaction between the stylus and the substrate after the occurrence of contact rather than coating/substrate adhesion. As a consequence, it can be suspected that our experimental conditions of scratching may be no longer probing to predict adhesion of the HAP coatings which thickness is less or equal to 90  $\mu\text{m}$ .

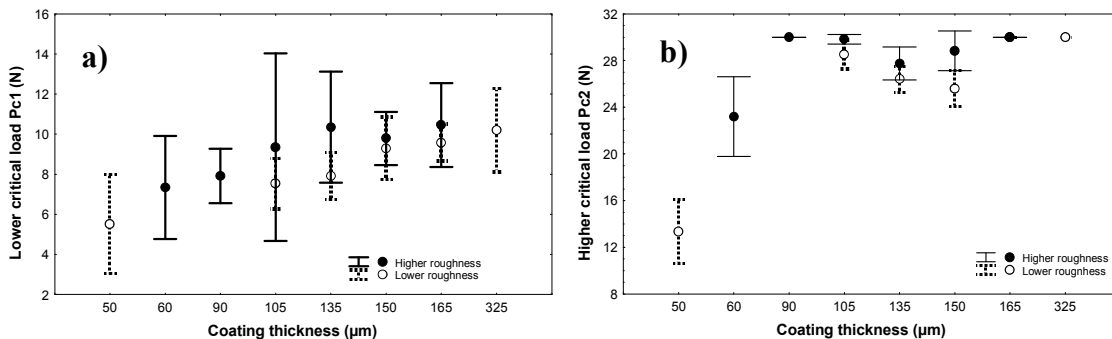
Figure 5: Lower (Left) and higher (Right) critical loads  $P_{c1}$  and the associated standard errors as a function of coating thickness for the two studied substrate roughness. Results correspond to 5 and 8 measurements whatever the experimental conditions.

Critical load  $P_{c1}$  is plotted versus coating thickness in Fig. 5 for the two values of the arithmetic average roughness of the substrate considered in this study. Whatever the substrate roughness, the mean of this lower critical load increases with thickness. This result can be explained taking into consideration the observed increasing propensity of microcracking that occurs during the cooling process when coating thickness increases. Since microcracking is considered to be the main relaxation process of residual stresses during cooling of plasma sprayed coatings, short cracks due to the scratch testing may be expected to initiate more easily in the studied thin coatings. Moreover, for a given coating thickness, Fig. 5 reveals a trend showing that the substrate having the higher arithmetic average roughness parameter induces a better coating resistance to microcrack initiation since the mean of the lower critical loads recorded are higher than that of the substrate having the lower arithmetic average roughness parameter.

$P_{c2}$  critical load values versus coating thickness are plotted in Fig. 5b for the two values of the arithmetic average roughness of the substrate considered in this study. It must be noted that it was not possible to determine the higher critical load for some of the thick coatings because of the upper experimental device loading limit (30 N). The higher  $P_{c2}$  values for specimens having the substrate roughness  $R_a$  of 2.29  $\mu\text{m}$  can be related to a better adherence. It must be outlined that the scratch test do not allow to obtain an absolute measure of coating adhesion because numerous extrinsic and intrinsic parameters influence the testing results [12].
