Data Collection Methodology to Assess Road Pavement Condition Using GNSS, Video Image and GIS

To cite this article: Bertha Santos *et al* 2019 *IOP Conf. Ser.: Mater. Sci. Eng.* **603** 042083

Bertha Santos ¹, Pedro G. Almeida ², Leonor Maganinho ³

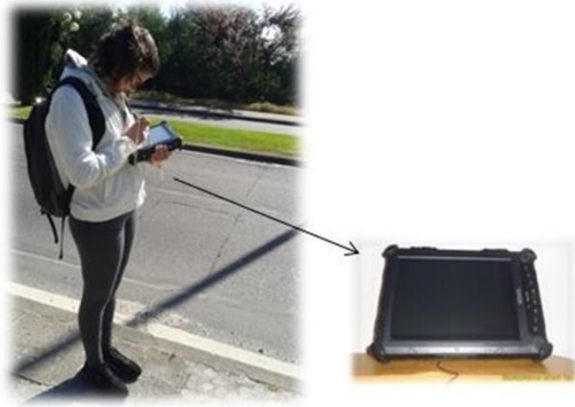
Figure 2. Data collection in visual inspection performed on foot

The visual inspection on foot was considered for validation of the results obtained by the proposed in-vehicle system and can be used as a complementary system for data acquisition. For the case of inspections conducted on foot, collection and input of data in the SDB can be performed directly on the field, using a laptop with an installed mobile GIS (such as ArcPad®) and a built-in GNSS. To perform these operations, the operator walks along the network under study, on the sidewalk or shoulder of the road, to ensure his safety and non-interference with the traffic movement (see Figure 2). The information related to each occurrence (type, level of severity and geo-referenced data) is automatically recorded and stored in a shapefile (vector geospatial data file format used by GIS).

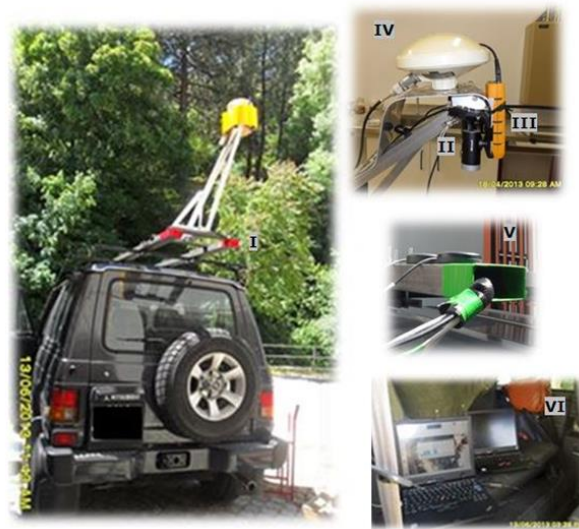
Figure 3. Equipment for the in-vehicle inspection (I – Metal structure, II – HD webcam, III – EDM, IV – GPS to collect position data, V – GPS for temporal synchronization of data, VI – Laptop computers)

Data collection (pavement distresses and surface drainage assets) using a vehicle, GNSS and image capture video equipment was developed to support the creation of the SDB. The data collection system comprises the following equipment: 1 metal structure; 1 HD webcam for image capture of the pavement surface; 1 EDM (electronic distance meter) for measuring the vertical distance to the pavement surface; GNSS receivers, for relative post-processing mode used on precision positioning and for webcam and EDM temporal synchronism of data; and 2 laptop computers to storage the data collected. Figure 3 shows how the equipment is placed in the vehicle used in the data collection.

To ensure data quality, in-vehicle inspections with the system proposed must be carried out at a speed of approximately 20 km/h. This type of inspection requires a driver and an operator to control the data acquisition. The real-time visualization of the data collected by the operator, ensure the homogeneity of the process of image capture.

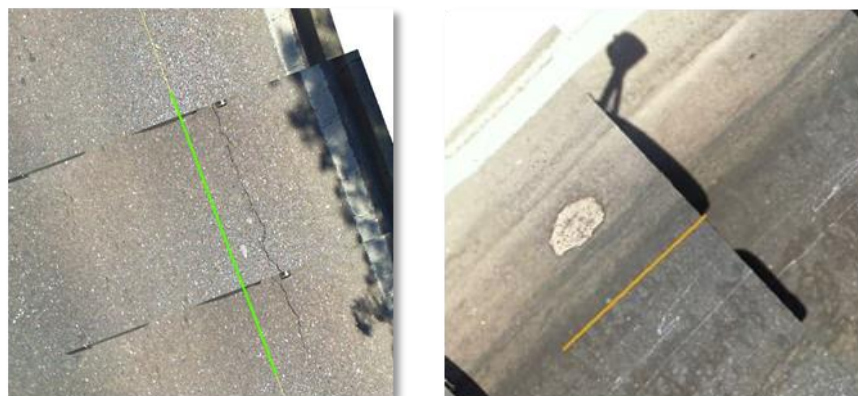
Figure 4. Visualization and image analysis examples obtained with the in-vehicle inspection

The outcome of the data collection campaign is a set of images and geographic coordinates that can be associated, allowing the visualization of the pavement surface in a GIS (such as ArcGis® or QGis®). The synchronization of different data sets (images and geographical coordinates) as well as the correct orientation of the images is performed using software developed by the authors for this purpose (see Figure 4).
