# Condition monitoring of the cam chain tensioner in the motorcycle engine

**Abstract.** Timing gear systems of motorcycle engines are equipped with chain tensioners, which are subject to premature damage in certain engine models. Early detection of such damage is essential, as it may protect the user from unexpected engine failure while the motorcycle is running. This paper presents the results of research whose purpose was to use the measurements and analyses of vibration signals for the diagnosing of damage to the hydraulic tensioner in the timing gear system. Stand tests were conducted of the motorcycle engine in which new, used or damaged tensioners were installed. The research results allow to conclude that a change in the technical condition of the tensioner caused by wear contributes to an increased level of engine vibrations and that it is possible to detect damage to the timing gear system tensioner by means of measurement, processing and analysis of vibration signals.

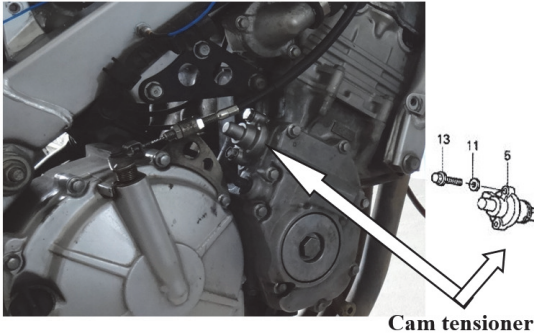
**Fig. 1.** Location of the cam tensioner installation      **Fig. 2.** Simplified schematic diagram of the timing gear system

The research object was a Honda CBR 600 F2 motorcycle in a good technical condition, equipped with a combustion engine marked as PC 25 (Fig. 1). With a cam chain driven engine, the motorcycle was also equipped with two camshafts in the head (Fig. 2). The element of the system that is exposed to damage is the hydraulic chain tensioner (Fig. 3), which shows a tendency for a momentary decrease of the required pressure. During the tests the engine was equipped with a new, used or damaged tensioner.

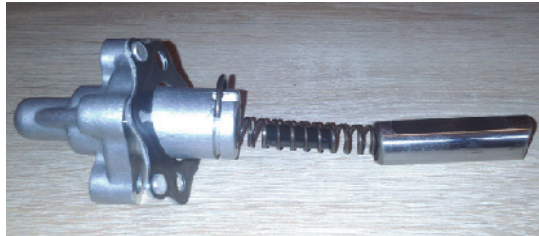
**Fig. 3.** View of the tensioner with a washer

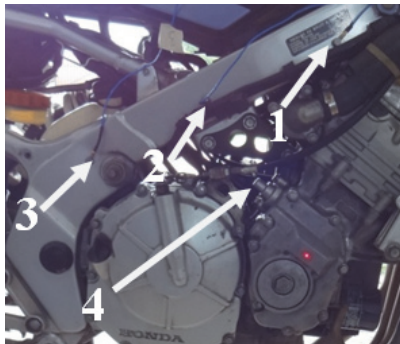
**Fig. 4.** Distribution of measurement points: 1 – accelerometer no. 1, 2 – accelerometer no. 2, 3 – accelerometer no. 3, 4 – point of contactless measurement with a laser vibrometer

The measurement system used in the tests consisted of: an Ometron laser vibrometer, 3 accelerometers (Fig. 4), a National Instrument Data Acquisition Card NI 4472 and a computer with the LabView 8.6 software. Signals were recorded at a frequency of 20 kHz. Matlab-Simulink Signal Processing software was used for processing. The measurements were taken at an idle speed of ca. 1400 rpm and at a speed of ca. 2500 rpm.

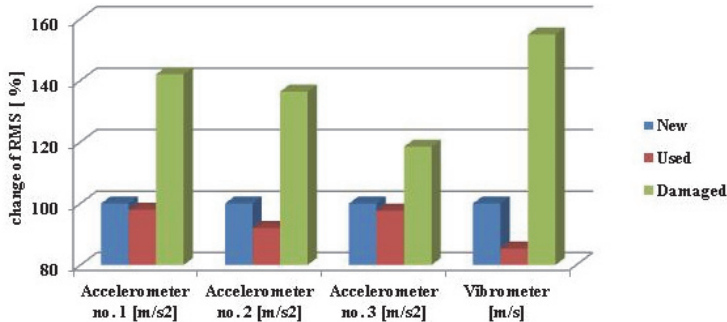
Fig. 5. RMS changes of the recorded vibration acceleration and velocity signals at the engine's rotational speed of 2,500 rpm

Experimental results indicate that a change in technical condition of the tensioner contributes to a change in the vibration level, however, its dynamics depends on the rotational speed of the engine. The most significant change in the level of engine vibration caused by damage of the tensioner occurs at a rotational speed of ca. 2,500 rpm. Fig. 5 presents the calculated RMS values of the acceleration or velocity of the recorded vibration signals at the aforementioned rotational speed of the engine.

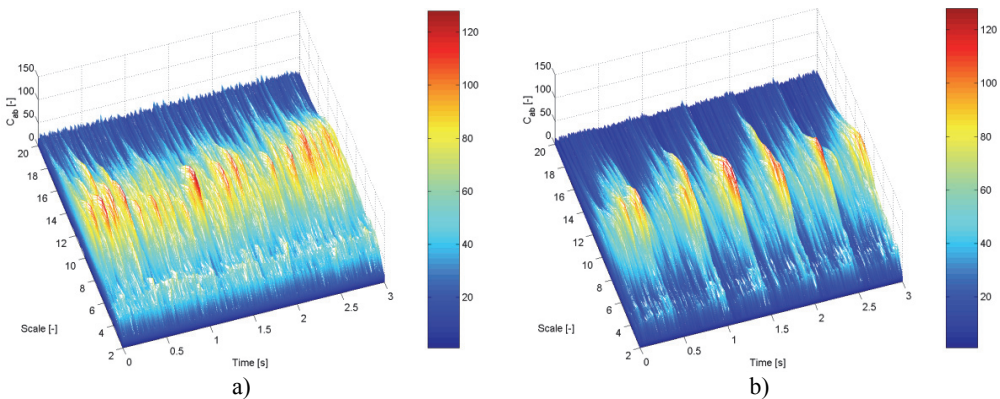
Fig. 6. Time-scale frequency distribution of the vibration acceleration signal recorded with accelerometer no. 1 at a speed of 2,500 rpm: a) new tensioner, b) damaged tensioner

In assessing the application of early damage detection for the tensioner in the timing gear system of the motorcycle engine, a local change of the vibration amplitude was determined in frequency bands by calculating the time-scale frequency distributions by means of a continuous wavelet transform. Fig. 6 presents sample calculation results for an engine equipped with a new or a damaged tensioner.
