The possibility to use a vibration signal to estimate a state of rolling bearings after operation

Abstract. In the article the construction of the test bench for the durability test of the friction couplings was showed. The properties of the tested tribological pairs are fully described, i.e. chemical constitution, kind of material and the results of the surface topography tests of basic material and with lubricant micropockets. The methodology and scope of the preliminary tests, including observation of course of changes in vibration signals on the housing of the pin-on-disc tester, for different load values and tribological couplings, i.e. with textured or non-textured surface. The vibroacoustic research was carried out with industrial unit CSI 2130 by Emerson and with vibration sensor A0760GP. Comparative analysis of vibration signals and amplitude-frequency spectrums was performed for chosen work conditions of the tribological pair. Finally, the possibility to use the measurement of vibration signal to predict a seizure of the tribological pair was described and directions for further research were given.

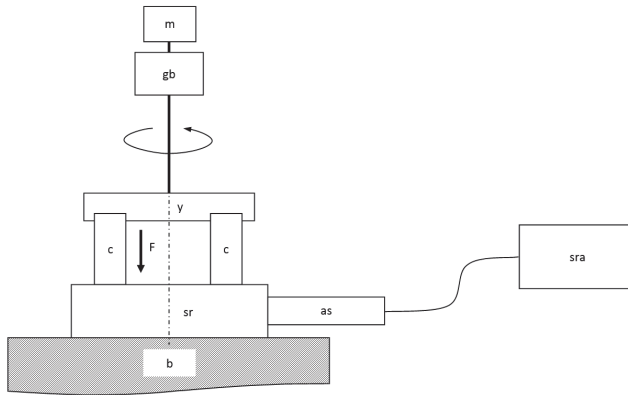
Fig. 1. The scheme of the test stand: m – electric motor, gb – gearbox, y – holder, c – roller, sr – sliding ring, b – base, as – acceleration sensor, sra – recorder and signal analyzer, F – load acting on the rollers and the rings surface

The simplified scheme of the test stand is showed in the Fig. 1 achieved differences, leaving this issue for any further research. The simplified scheme of the test stand is showed in the Fig. 1.

Plain sliding rings s_r were fixed rigidly on the horizontal base of the test stand. The rings were made of the same material, i.e. 100CrMnSi6-4 bearing steel, volume hardened (hardness of 60 HRC), finished to the identical surface roughness $R_a \sim 0.16 \mu\text{m}$, but one of the rings made by laser texturing surface method lubricant micropockets [1, 2], filled with mineral bearing lithium grease LT-43 produced. Two roller shaped identical counterparts sliding on the surface of the tested rings had the similar hardness and surface roughness as the rings. The rollers were fixed in a holder propelled by power unit at the rotational speed of 500 rpm. Pressure on the surface was within the range of 13 MPa to.

The measurements were performed with equipment Emerson CSI 2130 combined with unidirectional accelerometer A0760GP. The sensor was fixed with permanent magnet to the tested ring and vibration acceleration in a surface perpendicular to the ring was measured.

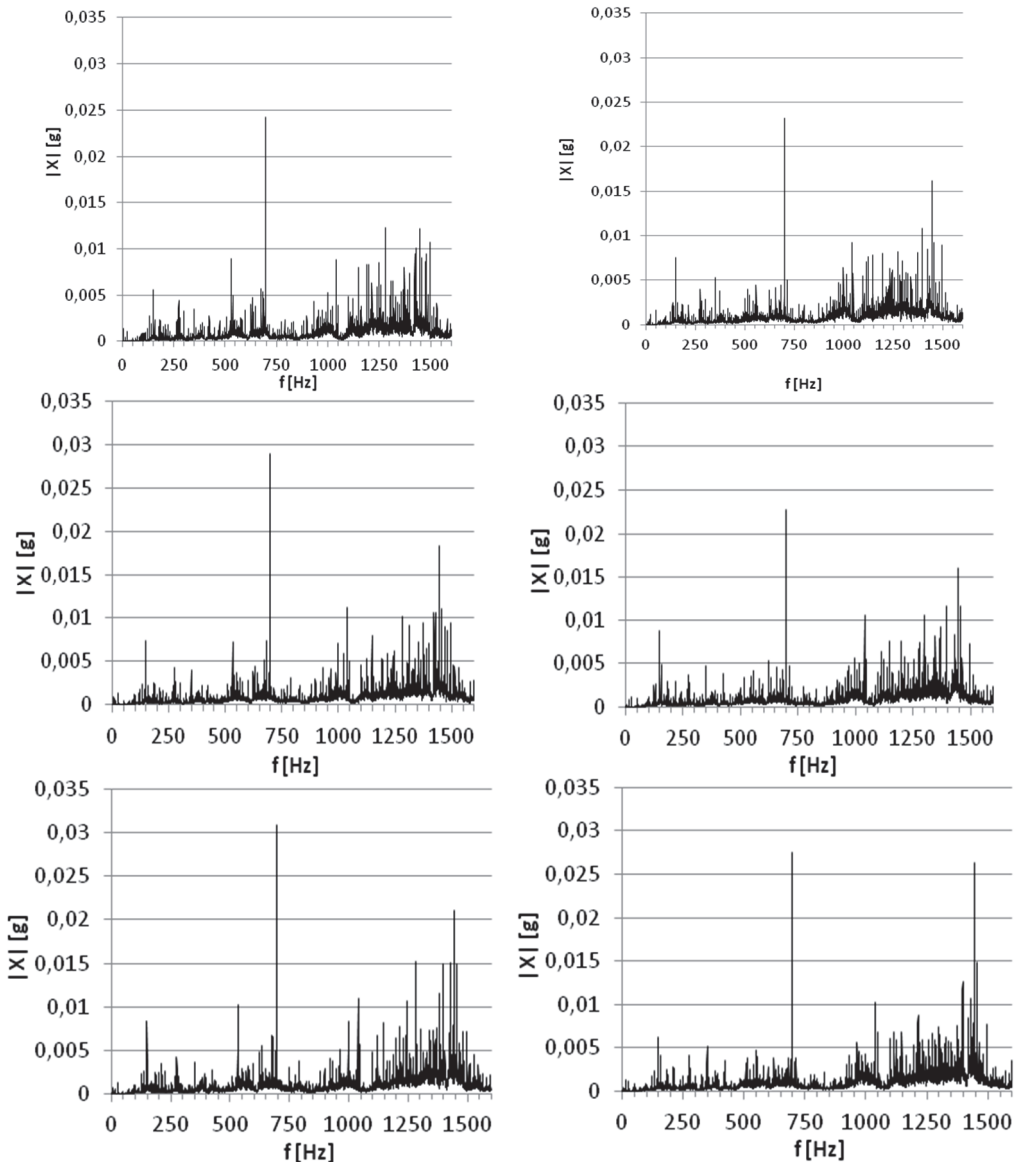
Fig. 2. Comparison of achieved signal spectrums recorded at the test stand: for lower load (upper line) and higher load (middle line) of the coupling after startup and for the coupling after 10 minute operation under higher load (bottom line) – the ring without lubricant micropockets (left column) and the ring with lubricant micropockets (right column)

In the Fig. 2 chosen examples of the recorded signals are presented. It is clearly seen that vibration signals consist of a whole range of components of the strongest in the considered frequency range is the component of frequency about 699 Hz. The other frequency values are also detected about 150, 275, 349, 998, 1040, 1098, 1148, 1281, 1397 ($\approx 2 \cdot 699$), 1447 and 1498 Hz. Nevertheless, at this stage of the study the observed frequencies were interpreted as disturbances of a signal from power unit, as with the tested coupling evidently could be associated only small components of frequency about 8.25, 16.5 and 24.75, being three harmonic frequencies of the holder with the rollers (f_w).

At this stage of the preliminary program the recognized differences between spectrums could be described as: – the presence of the strong component of a frequency about 523.25 Hz in the spectrums recorded only from the signals of the sliding ring without lubricant micropockets (dry lubrication mechanism within the coupling), – the presence of the clear component of a frequency about 424 Hz in the spectrums recorded only from the signals of the sliding ring with lubricant micropockets under higher load, – the presence of the weak component of a frequency about 1447 Hz in the spectrums recorded only from the signals of the sliding ring without lubricant micropockets under lower load.
