Vibration characteristics analysis of a centrifugal impeller

Abstract. Crack fault of a centrifugal impeller occurred while working. The finite element model of the impeller was established and vibrational characteristics were analyzed for to find the reason of the crack fault in this paper. The resonance frequencies of the impeller were identified with the help of Campbell diagrams. The modal experiments were carried out with hammering method, the modal parameters were obtained and the correct of the simulations was verified under the same constraints with the FEM model. Computation effort was saved while accuracy was retained making use of the cyclic symmetry technique in ANSYS. The results showed that simulating results agreed well with that of the experiments.

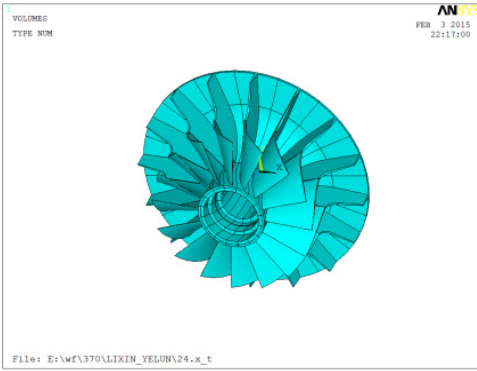
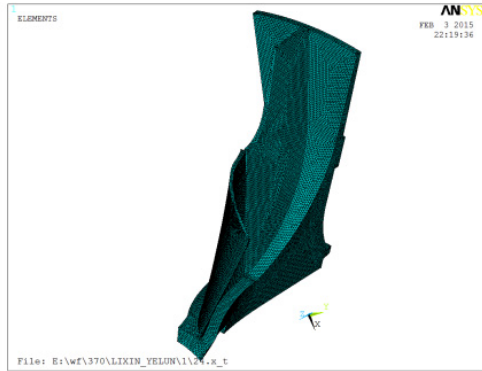
Fig. 1. Model

The finite element model was established for the 1/16 of centrifugal impeller basing on actual centrifugal impeller structure. The vibration characteristic analysis was completed for whole of centrifugal impeller with cyclic symmetry method in this paper [5]. The impeller modals were calculated basing on the basic sectors with the help of large general structural analysis software ANSYS. The model was divided into 981522 elements and 192280 nodes and Solid 185 element was adopted in ANSYS. The inner diameter about front face and end face of the disk were constrained axially and circumferentially. The model about 3-D and grid of basic sector were shown as Fig. 1 [6].

a) 3-D model

b) Grid of the basic sector

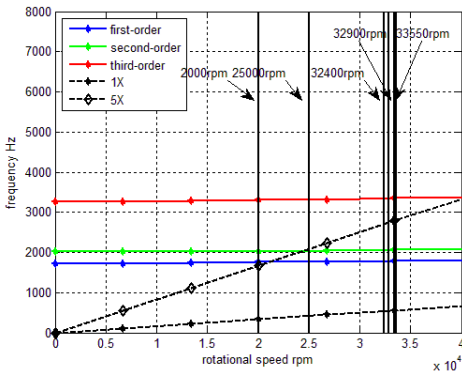
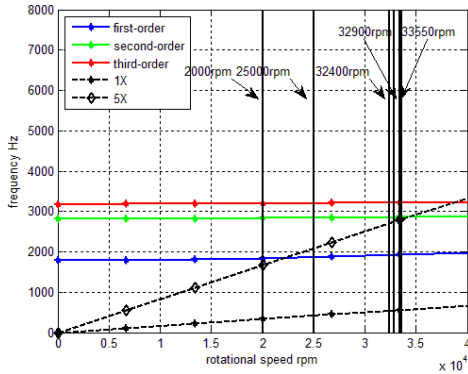
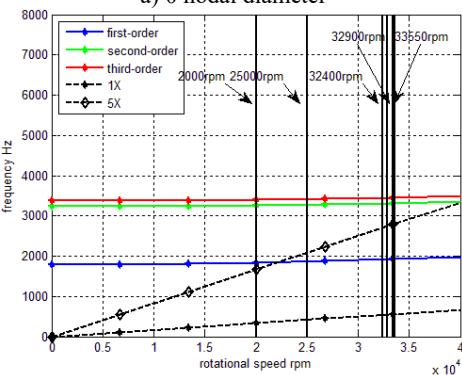
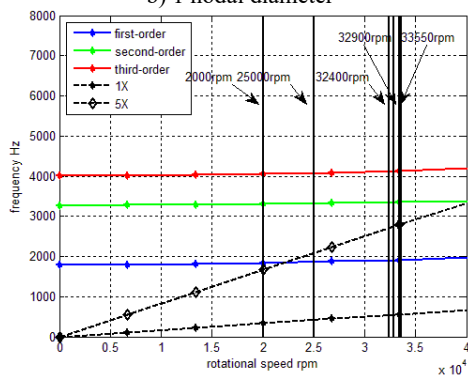
Fig. 2. Campbell diagram

The Block-Lanczos method was applied to extract eigenvalues and eigenvectors. The natural frequencies changed as the rotating speed due to the rotating stiffening effect. The centrifugal force was applied by the prestress analysis in ANSYS to consider the rotating stiffening effect. Modal analysis were conducted under 700 rad/s, 1400 rad/s, 2100 rad/s, 2800 rad/s, 3500 rad/s, 4200 rad/s, respectively. The results were listed according to the number of nodal diameter. Campbell diagrams were shown as Fig. 2. The horizontal axis was the rotational speed and the vertical axis was the natural frequency [7-10].

a) 0 nodal diameter

b) 1 nodal diameter

c) 2 nodal diameter

d) 3 nodal diameter

From the results of Campbell diagrams, there is no dangerous resonance frequency of 1X while there are some dangerous resonance frequencies of 5X. The dangerous frequencies occurred in the first natural frequencies of 0 nodal diameter and the second natural frequencies of 1 nodal diameter. The Fig. 2 showed that the discrepancy between resonance speed 34440 rpm and operating speed 33550 rpm was 2.65 %. Corresponding mode shapes were similar to centrifugal impeller crack failure shape, shown as Fig. 3.

In addition, the common speeds operated on 20000 rpm (333.3 Hz, 2093.3 rad/s), 25000 rpm (416.7 Hz, 2612.5 rad/s), 32400 rpm (540 Hz, 3391.2 rad/s), 32900 rpm (548.3 Hz, 3443.5 rad/s), and 33550 rpm (559.2 Hz, 3511.6 rad/s) for the centrifugal impeller. According to Campbell diagram, first-order and second order of 0 nodal diameter resonant frequency occurred near by the 21000 rpm and 24000 rpm respectively. At the same time, second-order of 1 nodal diameter resonance frequency occurred near by 34000 rpm. The extreme difficulties existed for to avoid the resonance frequency. These rotating speeds likely resulted in resonance.

1) The resonance frequencies of the impeller were closed to multiple operating frequencies according to the Campbell diagrams. It was possible that the resonances occurred nearby the rotating speeds of 21000 rpm, 24000 rpm and 34000 rpm. Especially, the crack failure shape of the impeller was similar to the shape of the maximum strain position about second natural frequencies of 1 nodal diameter, it was possible to lead to fatigue crack failure if the impeller worked at above rotating speeds.

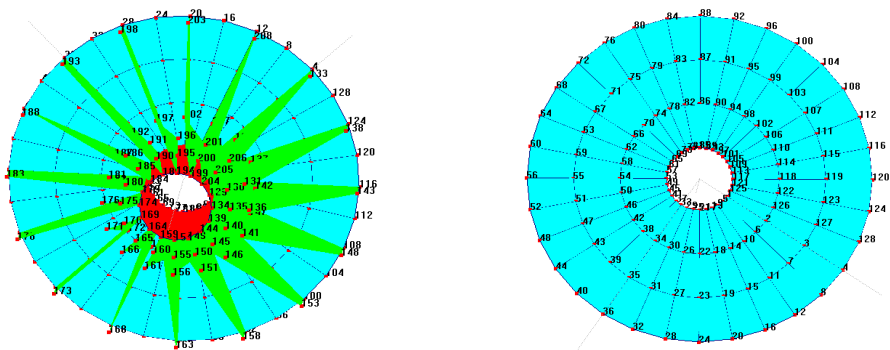
Fig. 4. Test mode

The correctness of the calculation results were verified by the model analysis test with hammering method. Geometry model which needed to correspond with the transfer function was the basis of the modal animation display. The geometric structure figure, which had 208 geometric points, was shown as Fig. 4 for the impeller disk basing on experiment scheme. Every point should be measured at least 5 times and the measured mean value was used as the data of analyzing transfer function to improve the measuring accuracy in modal test. According to the defined geometric relations and directions of force, experimental data collection was completed under the

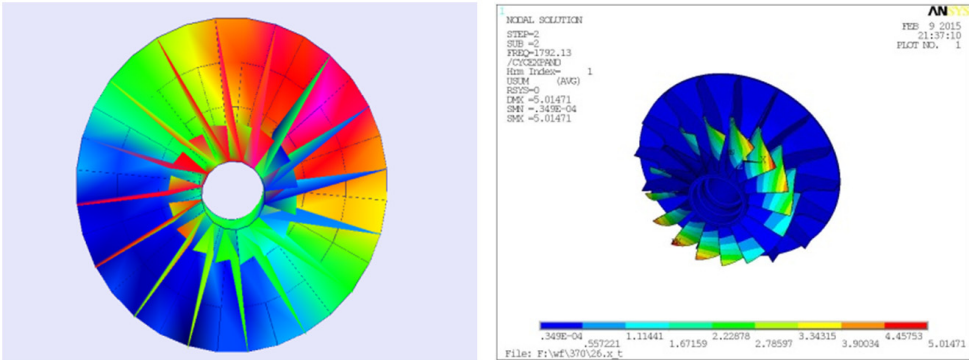
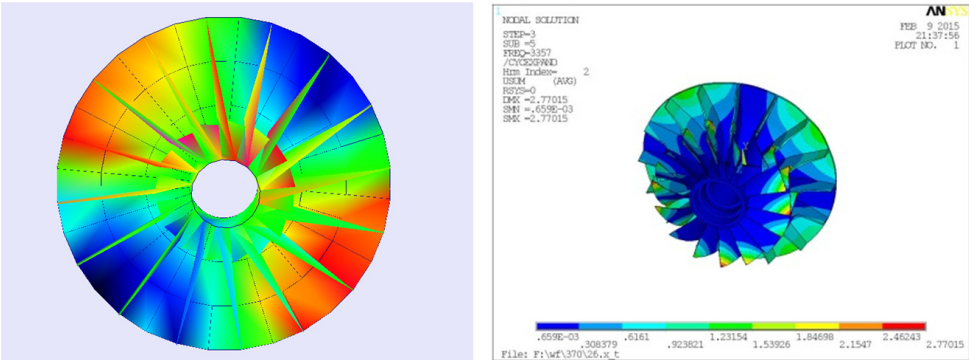
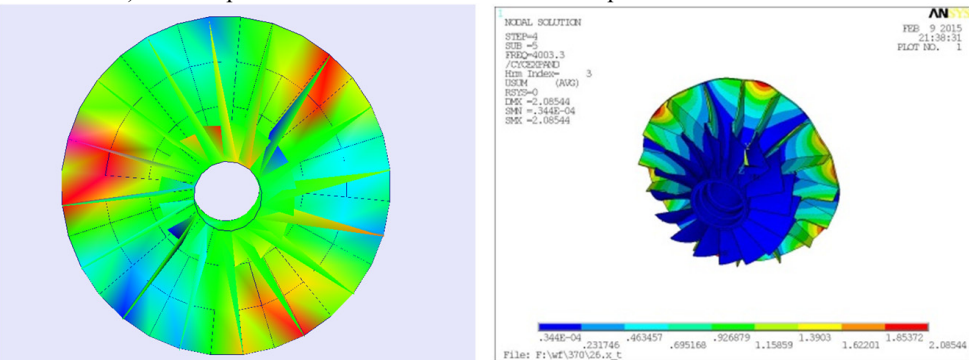
Fig. 5. The comparison of test modes and theoretical modes

same constrained condition. Every point's input force and output response signal was calculated under the analyzing window, which could get relevant transfer function. Frequency domain method was used in the process of modal fitting. Frequency and vibration mode comparison results were shown as Fig. 5 and Table 1.

a) The comparison of test and theoretical mode shape about 1 nodal-diameter

b) The comparison of test and theoretical mode shape about 2 nodal-diameter

c) The comparison of test and theoretical mode shape about 3 nodal-diameter

The errors of results between calculating and testing excited -8.6 %, 3.6 % and 7.6 %

separately about the impeller in the static frequency condition from Table 1 and Fig. 5. The calculating accuracy was verified by the modal test for cyclic symmetry method applied FEM in ANSYS.

2) The modal parameters and mode shapes obtained by modal test about static frequency were basically agreed with the simulating results under the same constraints. The accuracy of simulating method was verified.
