Quality test of clamping connection of transmission lines across tensile line

Abstract. This paper develops a new technology for the quality inspection of the transmission line that is important across the tensile clamp. The new technology mainly based on the ultrasonic pulse echo thickness measurement mechanism tests the thickness of the aluminum sleeve after crimping the tensile clamp to reflect the relative position of the aluminum sleeve and the steel anchor after the crimping, thereby judging whether there is a crimping positioning defect. At the same time, it is supplemented by steel anchor model comparison, crimping position length comparison, and crimping to margin detection to determine whether the transmission line crimping quality is qualified.

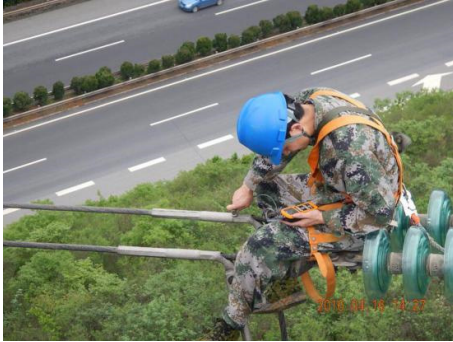
Fig. 3. Ultrasonic inspection of the thickness of the aluminum layer on the crimping surface

In the ultrasonic testing, firstly, the ultrasonic thickness measuring device is calibrated, and one of the six crimping planes of the steel anchor aluminum sleeve is selected, and the paste coupling agent is evenly applied on the pressure bonding surface. On the basis of the above preparatory work, the probe of the ultrasonic thickness measuring device is lightly pressed on the center line of the crimping plane of the aluminum sleeve, and the thickness of the detecting crimping surface is slowly moved from the head to the tail along the longitudinal axis direction, and recording is performed. After replacing the other crimping surface of the clamp, measure the thickness of the crimped portion of the aluminum sleeve and record it in the same way. Finally, the thickness data is analyzed. If the thickness of the crimping surface is changed from 2 to 3 times greater than 1 mm in the longitudinal direction, it can be judged that the crimping position is accurate. The thickness of the two grooves is dissected as shown in Fig. 2. If the thickness in the longitudinal direction does not correspond to the change in the number of grooves, it can be judged that the crimping process is poor, and there is a crimping positioning defect. Ultrasonic field detection is shown in Fig. 3.

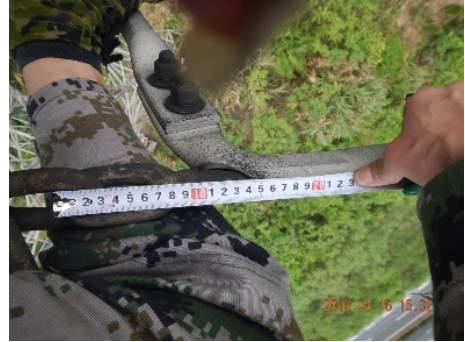
Fig. 4. Length measurement of steel anchor ring and crimp terminal

By measuring the length of the crimping terminal of the steel cap ring and the aluminum tube on the side of the iron tower, and then comparing with the design size of the steel anchor, it is also possible to determine whether the crimping position at the groove is accurate. The on-site inspection is shown in Fig. 4. Selecting the same product that is identical to the model, batch, and manufacturer of the steel cap in the transmission line can also be used to determine whether the crimping position at the groove is accurate. Steel anchor comparison shown in Fig. 5, the steel anchor has a groove that is not crimped into place. The aluminum casing is hydraulically crimped

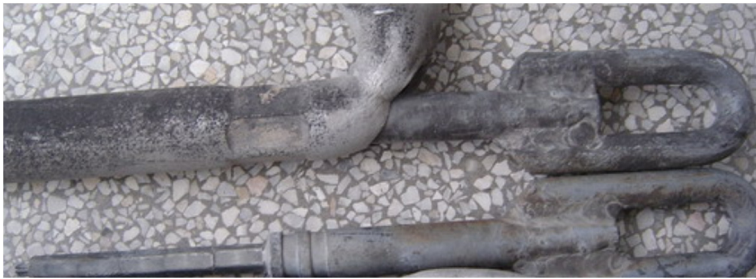
Fig. 5. Steel anchor comparison

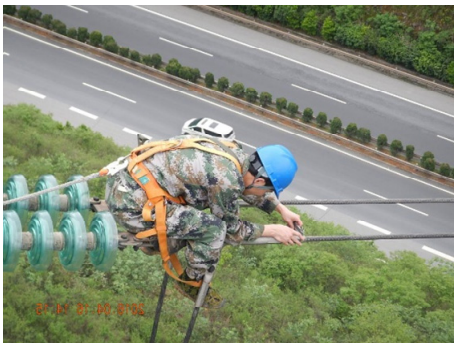
Fig. 6. Aluminum casing hydraulic crimping to margin detection

by the side of the wire and the side of the steel anchor ring. The two can be detected by using a vernier caliper to measure the margin, and then compared with the calculation formula of DL/T5285-2013. This method can judge the quality of crimping and the on-site inspection is shown in Fig. 6. In order to check whether the aluminum casing and the steel anchor have defects in “small generation” or “big generation”, the steel printing numbers on the two bodies can be compared. For example, if the steel stamp number matches the model of the wire in operation, it can be judged as no defect, otherwise the model error can be judged. Fig. 7 shows the steel anchor steel stamp.

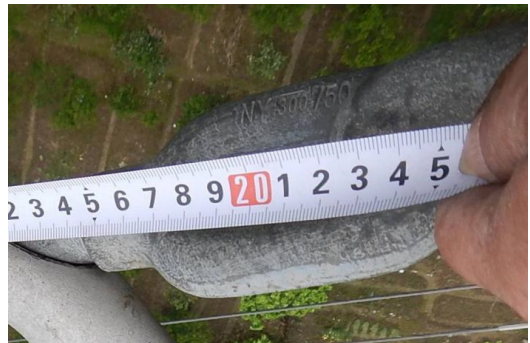
Fig. 7. Steel anchor steel number comparison
