How Can a Cutting-Edge Gallium Nitride High-Electron-Mobility Transistor Encounter Catastrophic Failure Within the Acceptable Temperature Range?

Abstract—Commercial gallium nitride (GaN) high-electron-mobility transistors used for power electronics applications show superior performance compared to silicon (Si)-based transistors. Combined with an increased radiation hardening properties, they are key candidates for high-performance power systems in a harsh environment, such as space. However, for this purpose, it is key to know the potential failure mechanisms (FMs) of the devices in depth. Here, we demonstrate how the repeated thermomechanical stress in a power cycling (PC) test within specified operating conditions destroys the GaN device. Based on leakage current localization analysis, we identify an FM with a yet unknown root cause. Utilizing emission microscopy, focused ion beam cutting, and scanning electron microscope techniques, it is revealed that multilayer cracks of a GaN die are triggered by a commercial leading package structure, which shows excellent capability under frequent thermomechanical stress. Through multiphysics simulations, it is shown that the structural f

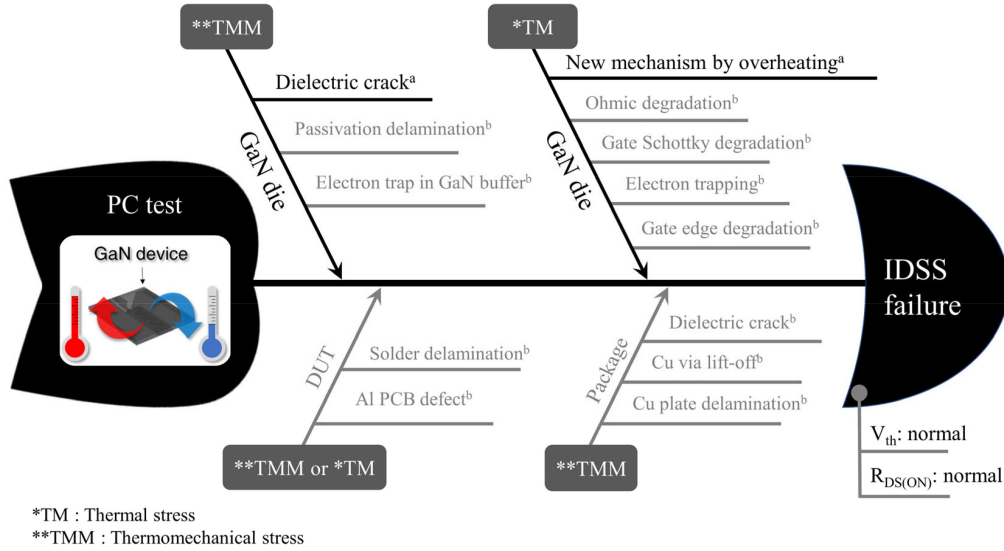
Fig. 1. Fishbone diagram for hypotheses to be able to induce the IDSS failure in a PC test classified by locations and stress conditions [21]: When IDSS failure was confirmed, threshold voltage (V_{th}), and the on-state resistance ($R_{DS(ON)}$) were in the normal range. These three parameters were characterized in the room temperature. (Words^a: remaining possible failure mechanisms to lead to the IDSS failure in the PC test, words^b: proven failure mechanisms that cannot be the cause of the IDSS failure in the PC test.)

Among various potential root causes, only a few candidates were identified to be consistent with observation [27]. The mechanisms are summarized in Fig. 1 and the analysis points to as if yet unclarified FM, the overheating, or dielectric crack. The previous study had not been able to pinpoint the cause of the failure because of test conditions beyond the allowed maximum operating temperature range 150 °C and limit of analysis technique to be able to analyze deep defect location inside a complex package [28]. To find the root cause of this failure, we have here tried to conduct an additional PC test within acceptable temperature ranges and high-level analysis techniques that can visualize deep cracks inside the package without destruction.

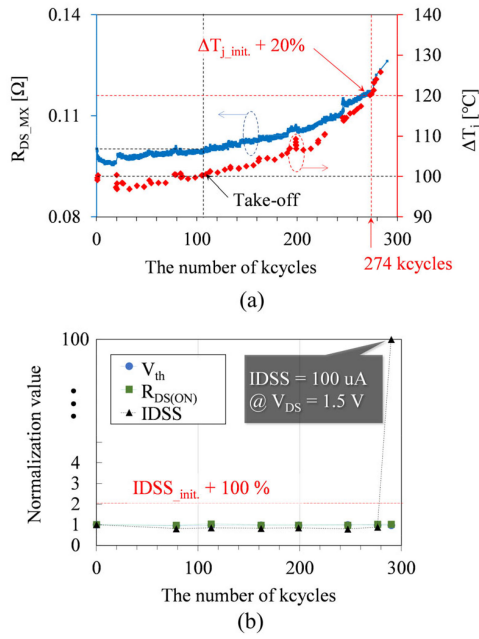
Fig. 2. Power cycling test results with $\Delta T_{meas} = 24.1 \sim 124.1$ °C. (a) Online parameters monitored during the PC test: R_{DS_MX} and ΔT_{meas} . Confirmed failure mode is the initial $T_{meas} + 20\%$. (b) Normalized offline parameters characterized in a curve tracer at the room temperature: V_{th} , $R_{DS(ON)}$, and IDSS. The failure criteria to determine the failure of the Device Under Test (DUT) are summarized in Fig. S3. The initial values of V_{th} , $R_{DS(ON)}$, and IDSS are 1.3 V, 44.8 mΩ, and 0.77 μA. Offline parameter curves and parameter definition conditions are displayed in Fig. S4.

In the result, two failure phenomena are observed; thermal conductivity degradation and IDSS failure. Fig. 2(a) and (b) exhibits two online parameters (R_{DS_MX} and ΔT_{meas}) monitored in a PC circuit and offline parameters (V_{th} , $R_{DS(ON)}$, and IDSS) measured by a curve tracer at the room temperature, respectively. The details of the measurement are elaborated in Fig. S2. The first failure phenomenon can be explained by the ΔT_{meas} and R_{DS_MX} increase after the take-off point in Fig. 2(a) and no change of $R_{DS(ON)}$ in Fig. 2(b) [25], [26] at the end of test. In line with previous studies, the cause of this failure is the solder joint fatigue. Fig. 3(b) and (c) shows the solder joint images confirmed by scanning acoustic microscope (Model: KSI V-8 from IP Holding). In a comparison of them, it can be seen there is solder delamination underneath TPAD where the most heat is concentrated during the test. It is worth noticing, that the temperature swings employed are well within the acceptable operating conditions but still, the leakage current failure develops, which corroborates that the overheating scenario in Fig. 1 cannot explain the IDSS failure. Thus, the remaining dielectric crack hypothesis in Fig. 1 will be investigated extensively with additional structural FA.

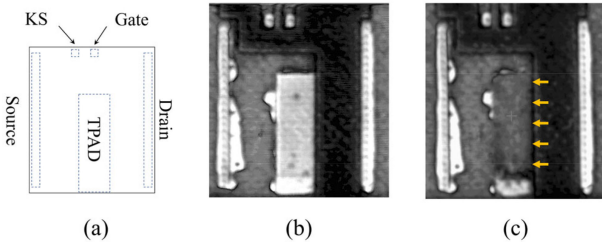
Fig. 3. SAM analysis result. (a) Footprints of a discrete GaN device: drain, source, gate, kelvin source, and thermal pad. (b) SAM image of a solder layer between a GaN device and Al PCB before PC test. (c) SAM image of the solder layer after PC test. Arrows point to the delamination area. Accurate structure information of a DUT is exhibited with a cross-sectional image in Fig. S5.

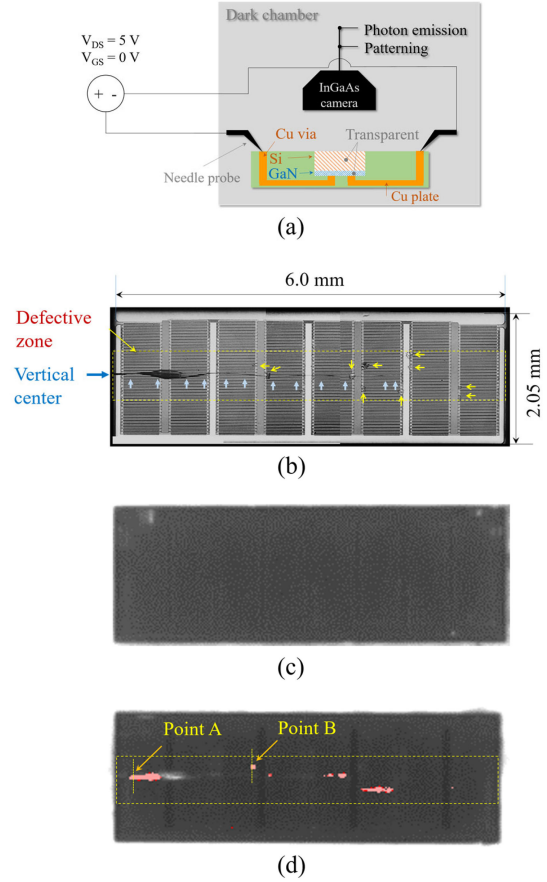
Fig. 4. Defect localization analysis. (a) Backside EMMI analysis environment with partially decapsulated GaN device. Three probe needles (gate, source, and drain) are used for electrical connection between the sample and measurement equipment. The analysis is conducted with an InGaAs camera in a dark chamber. (b) Patterning image of the failure GaN device in backside EMMI analysis with a die size, a long horizontal defect marked by blue arrows (↑), and dot-like defects marked by yellow arrows (↑). (c) Photon emission analysis of a normal GaN device without PC test under $V_{DS} = 5$ V, and $V_{GS} = 0$ V. (d) Photon emission analysis with two cross-sectional points of the failure GaN device by the PC test under $V_{DS} = 5$ V, $V_{GS} = 0$ V. IDSS curves of both Fig. 4(c) and (d) are displayed in Fig. S7.

Fig. 4(b) shows a patterning image of the defective device analyzed in the backside EMMI. The various abnormal patterns suspected as defects are observed in this image. The abnormal patterns are classified into two types. The first conspicuous defective pattern is a long horizontal crack marked with blue arrows in Fig. 4(b). This crack at the vertical center of the GaN die is continued from the center of the die to left edge. Moreover, several of dot-like defect patterns marked with yellow arrows on Fig. 4(b) are observed around the horizontal crack. They are also placed in around the vertical center of the die. All defects

found in the patterning process are placed in the defective zone marked in Fig. 4(b). They might be directly related to the IDSS failure. The results will be argued with photon emission analysis conducted under IDSS measurement conditions.

Fig. 4(b) visualizes the defective positions directly contributing to the IDSS failure. Generally, the photon emission may occur even in normal operation so that the analysis of the defective device should be compared to a normal device without a PC test. Fig. 4(c) and (d) shows the photon emission images of the normal and the defective devices, respectively. In Fig. 4(c), there is no photon emission and $I_{\text{DSS}} = 0.45 \text{ nA}$ at $V_{\text{DS}} = 5 \text{ V}$, whereas in Fig. 4(d) (the defective device), certain photon emission and $I_{\text{DSS}} = 0.122 \text{ mA}$ were observed. Moreover, it is shown that the lighting positions are matched with the abnormal cracks in the patterning image [Fig. 4(b)]. The overlapping positions of the crack patterns and photon emission in these two images inform where the direct cause of the IDSS failure is. Cross-section analysis will then be performed at in Points A and B marked in Fig. 4(d) to understand the mechanism of IDSS failure in the following sections.

The locations of cracks found in the previous FA can be discussed with the FEM simulation. We can divide the cracks found in Fig. 4(b) into two groups: the long crack propagated from the center of the chip to the left edge and dot-type cracks scattered around the center. For the long crack, first we can inversely predict there was a strong vertical mechanical stress in the PC test. Fig. 7(a) shows the distribution of temperature swings at the die top surface height during PC. The different temperature distribution by the area of a homogeneous body can generate mechanical stress [45]. In Fig. 7(a), the center of the die has the highest temperature swing, while the upper left end has the lowest temperature swing. This imbalance can produce the overall thermomechanical stress of the die during the PC test. The Cu vias are not symmetrical at the left and right edges of the die in Fig. 7(b), which leads to a temperature imbalance between the upper and bottom at the edges of both sides. This imbalance induces stress on the surface of the die, which can lead to defects such as the first long crack.

The second crack group dot type defects in Fig. 4(b) can be analyzed by combining the EMMI patterning image [Fig. 4(b)],

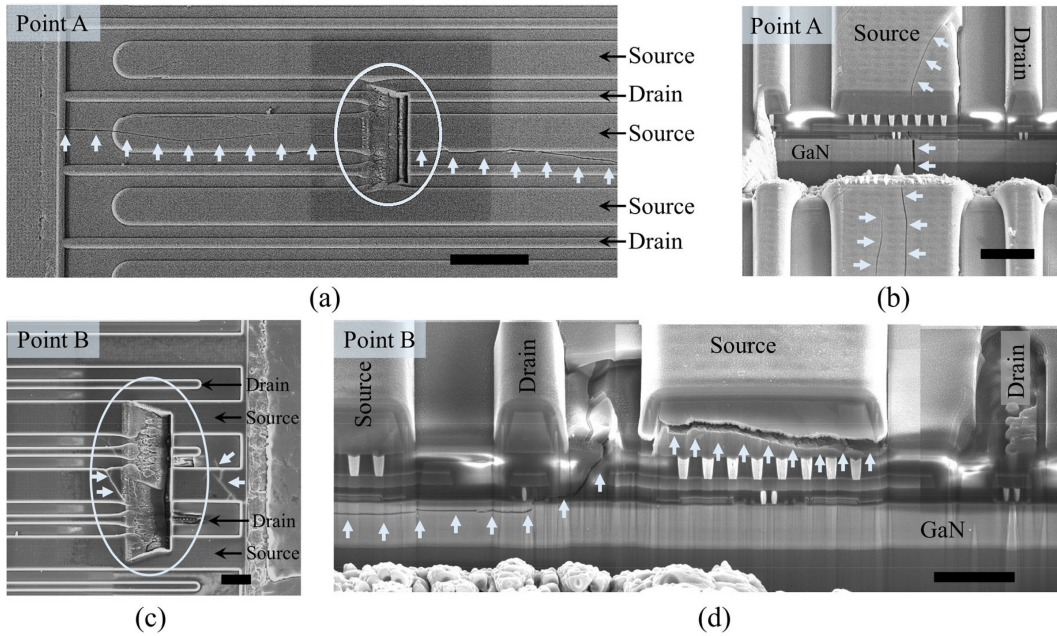
Fig. 5. Cross-sectional analysis results. (a) Top view with the FIB cutting of Point A (the cracks marked with blue arrows). (b) Cross-section image of Point A (the cracks marked with blue arrows). (c) Top view with the FIB cutting of Point B (the cracks marked with blue arrows). (d) Cross-section image of Point B (the cracks marked with blue arrows). Black scale bars: (a) 50 μm ; (b) 10 μm ; (c) 20 μm ; (d) 8 μm .

In the results of the cross-sectional analysis, defects relevant to the IDSS failure had been found in both selected points. Fig. 5(a) and (b) displays a top view image and a cross-sectional image around FIB-cut Point A, respectively. The horizontal long crack observed in Fig. 4(b) is also seen in Fig. 5(a). In Fig. 5(b), we can identify the vertical crack extended from a GaN HEMT core structure to multiple dielectric layers. Fig. 5(c) and (d) shows a top view image and a cross-sectional image at FIB-cut Point B, respectively. This location was a dot-like pattern observed in the EMMI patterning image [Fig. 4(b)]. In Fig. 5(d), we can see also the severe cracks horizontally extended from multiple metallization layers to a GaN HEMT structure. Even though the propagation direction of the Point B crack is horizontal in the cross-section image unlike the crack in Point A, both cracks are directly crossing from drain to source of GaN HEMTs. These severe cracks can be a critical leakage path in IDSS measuring.

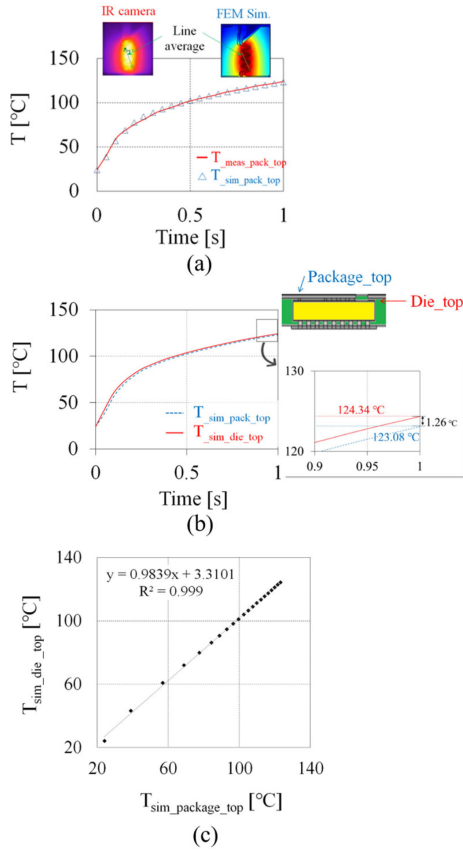
Fig. 6. Temperature analysis in a PC test based on FEM simulation (COMSOL Multiphysics software). (a) Line temperature average curve during 1 s heating period between IR camera measurement of the DUT and FEM simulation on the top surface of the package. (b) Temperature profile comparison in FEM simulation between package top surface and die top surface. (c) Correlation of temperatures between the package top surface and on the package top surface. The temperatures mentioned Fig. 6(a) and (b) are equally defined as the average value of a line across the upper left to lower right of the die on the top surface of the package, which is the same as the way to monitor device temperature in the PC test [26, 27]. The lines for temperature measurement are shown in Fig. 6(a).

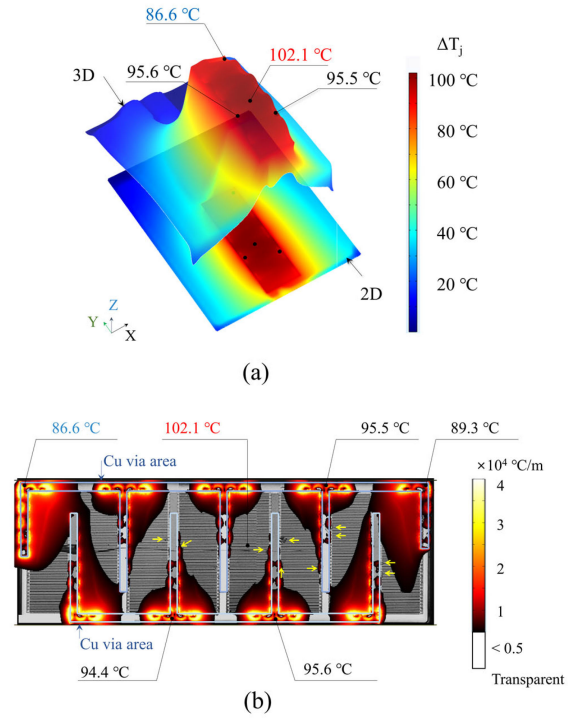
Fig. 7. FEM simulation analysis with defective patterns in the EMMI analysis. (a) 2-D and 3-D ΔT_{die_sim} distribution of the entire GaN device at the height of die top surface in FEM simulation during the PC. (b) Overlap image among the EMMI patterning image [Fig. 4(b)], Cu via areas directly bonded to the die, T_{die_sim} at 1 s in six points and T_{die_sim} gradient (°C/m) plot in the die top surface area.
