Documentation of the performance gap

Søren Østergaard Jensen, Danish Technological Institute
Kim Wittchen and Jørgen Rose, Danish Buildings Research Institute

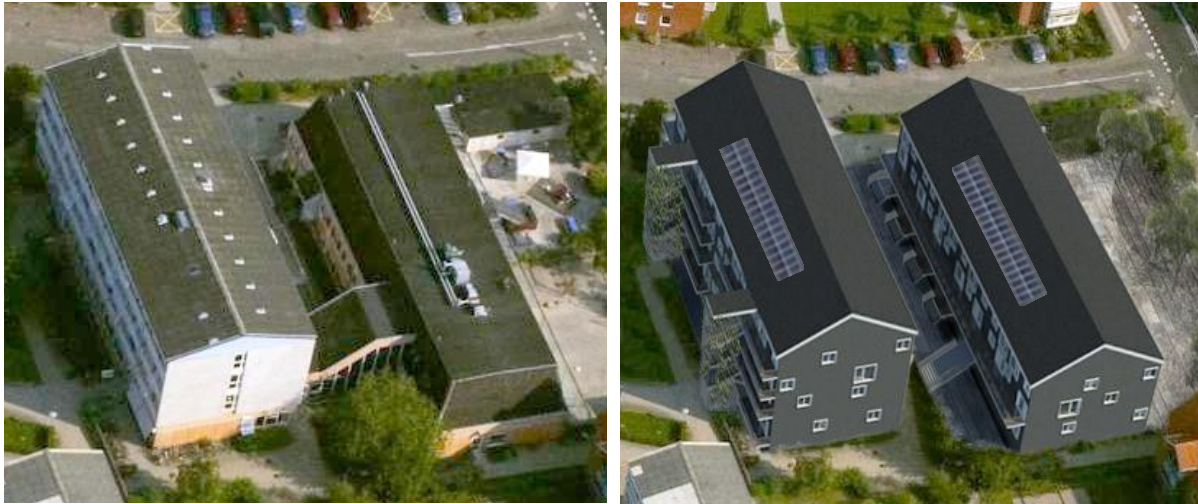
Figure 1. Sems Have/House of youth before (left) and after (right) the renovation. Not only the interior but also the exterior went through a major renovation.

Sems Have was originally constructed in 1970-72 under the name “House of youth”. The two buildings were a four-story building with a dormitory at the first to fourth floor, and an activity centre for school-children at the ground floor. The other building contained a day-care centre for small children at the ground floor and two smaller concert halls at the first floor. In 2011 the buildings were totally worn down and the housing association had to decide if the buildings should be demolished or refurbished. Based on economical calculations it was decided to refurbish the buildings and turn them into 30 modern low energy apartments. Figure 1 shows the buildings before and after the renovation.
