**Assessment of In-situ Corrosion Conditions at Nevada  
Mechanically Stabilized Earth Wall Sites:  
Using Electrochemical Soil Characteristics and Linear Polarization Resistance**

A thesis submitted in partial fulfillment of the  
Requirements for the degree of Master of Science in  
Civil and Environmental Engineering

Nelson Pearson

May, 2015

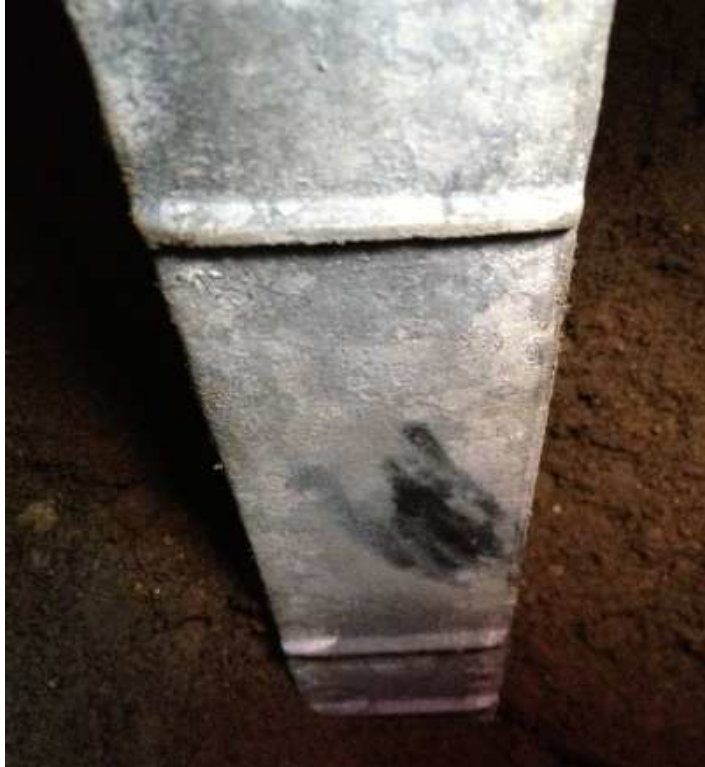
**Figure 0-2:** In-service galvanized reinforcement, a layer zinc carbonate can be seen along the surface. (ALT US 95 and ALT US 50, W1-SB-E1)

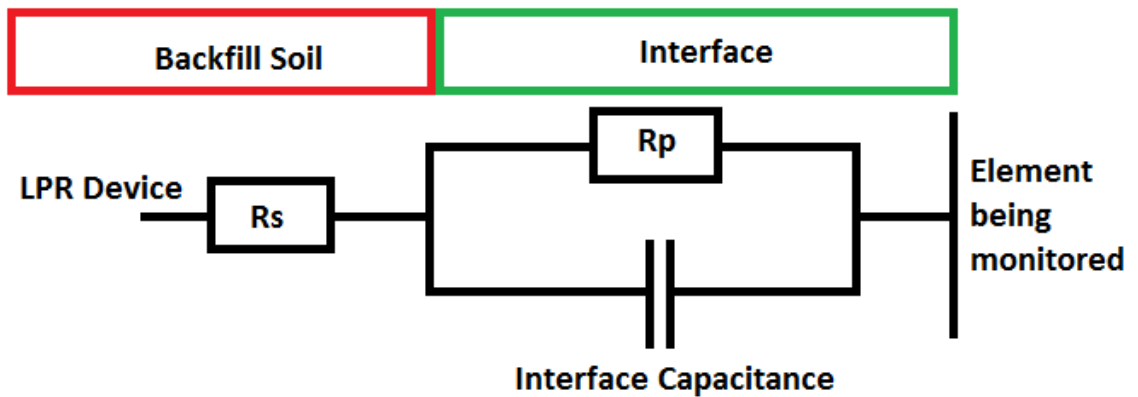
**Figure 0-4:** Idealized LPR monitoring circuit

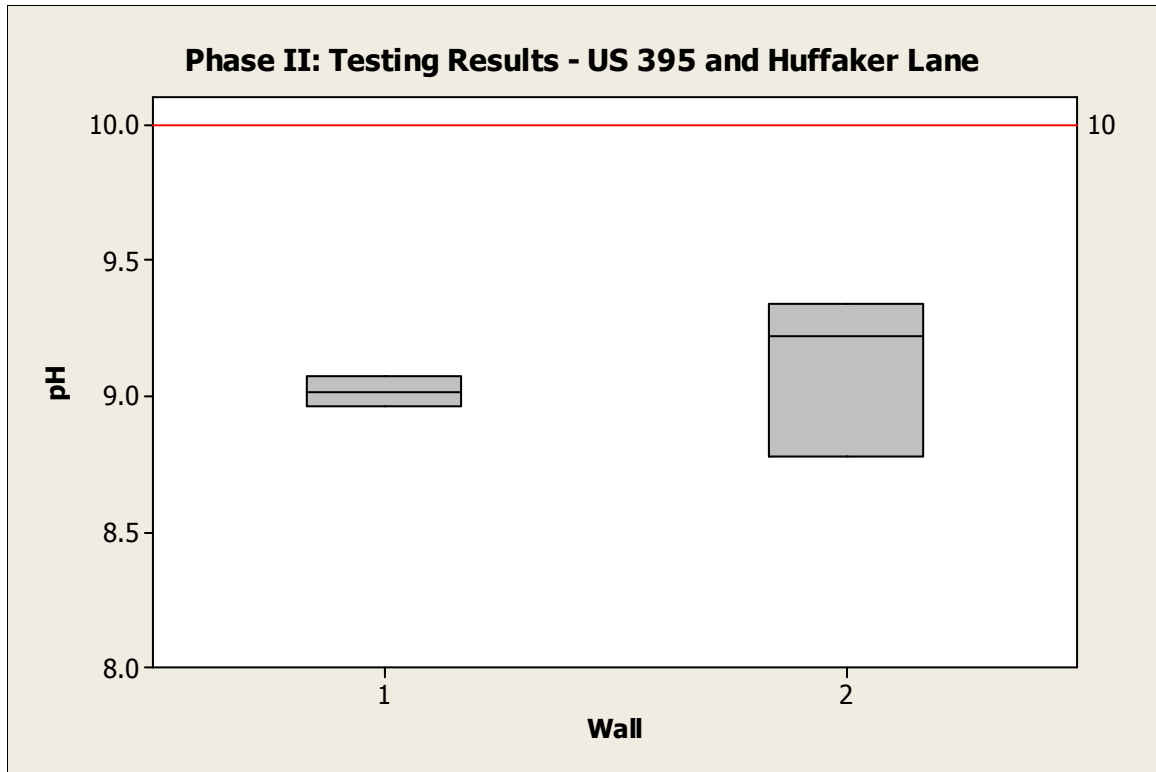
Figure 2-4: Phase II pH results for US 395 and Huffaker Lane, separated by wall

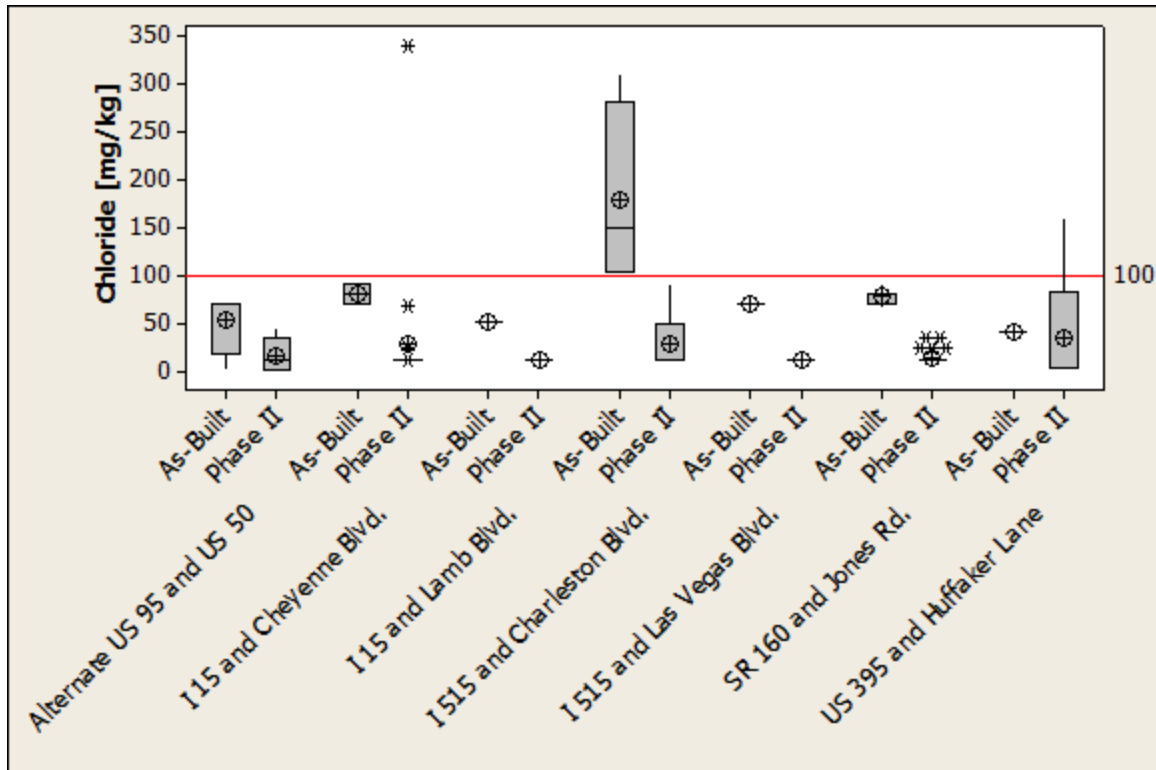
Figure 2-21: Comparison of As-built and Phase II soil testing results for chloride content, the majority of all data is below specification.

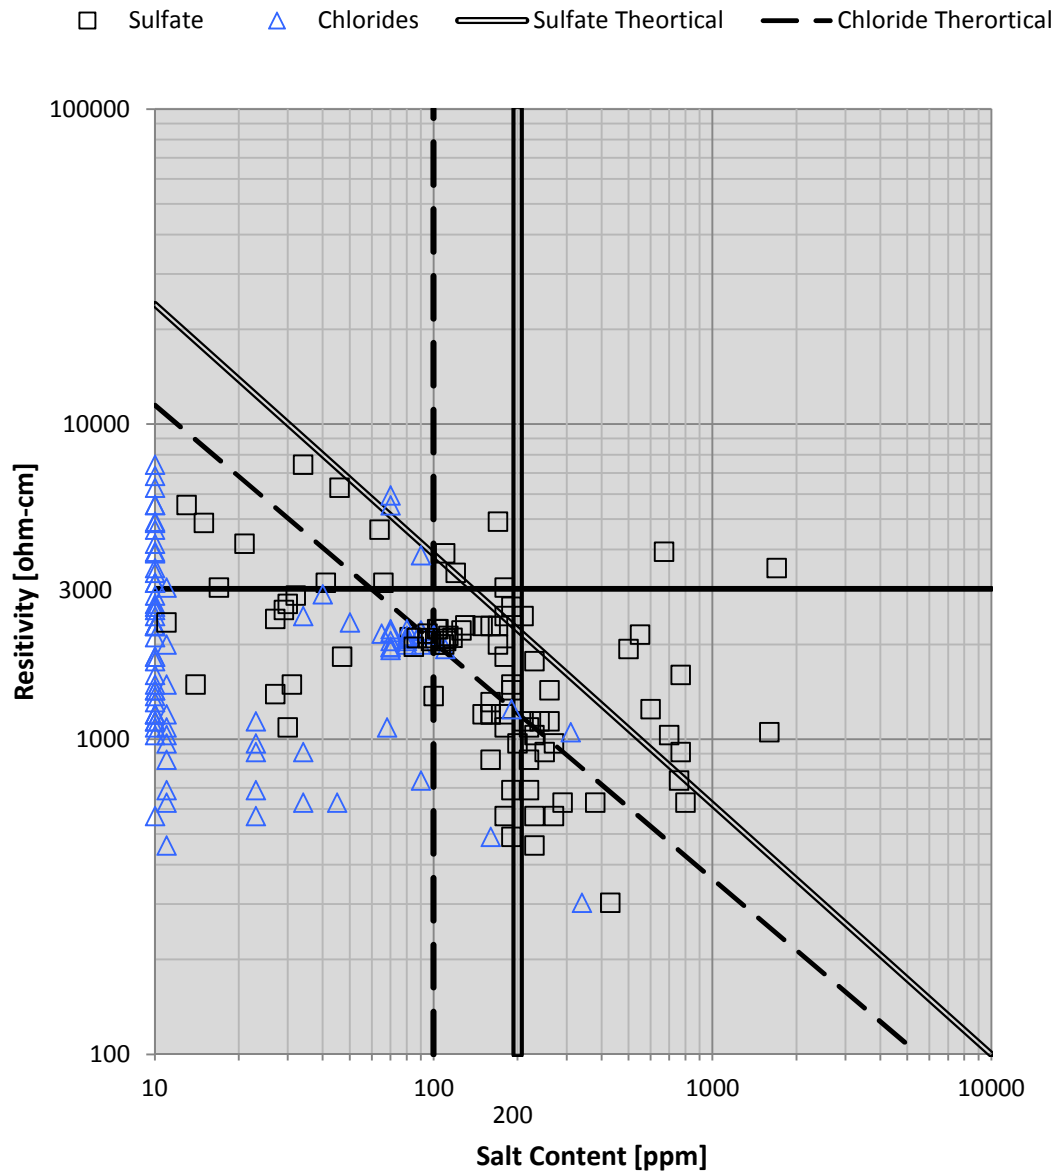
**Figure 2-33:** Phase II salt and resistivity data overlaid on the theoretical resistivity values based on salt content, it is seen that the general trend is for resistivity values measured in Nevada backfills that the resistivity value is below what is predicted using the NACE relationships (solid lines represent specification limits)

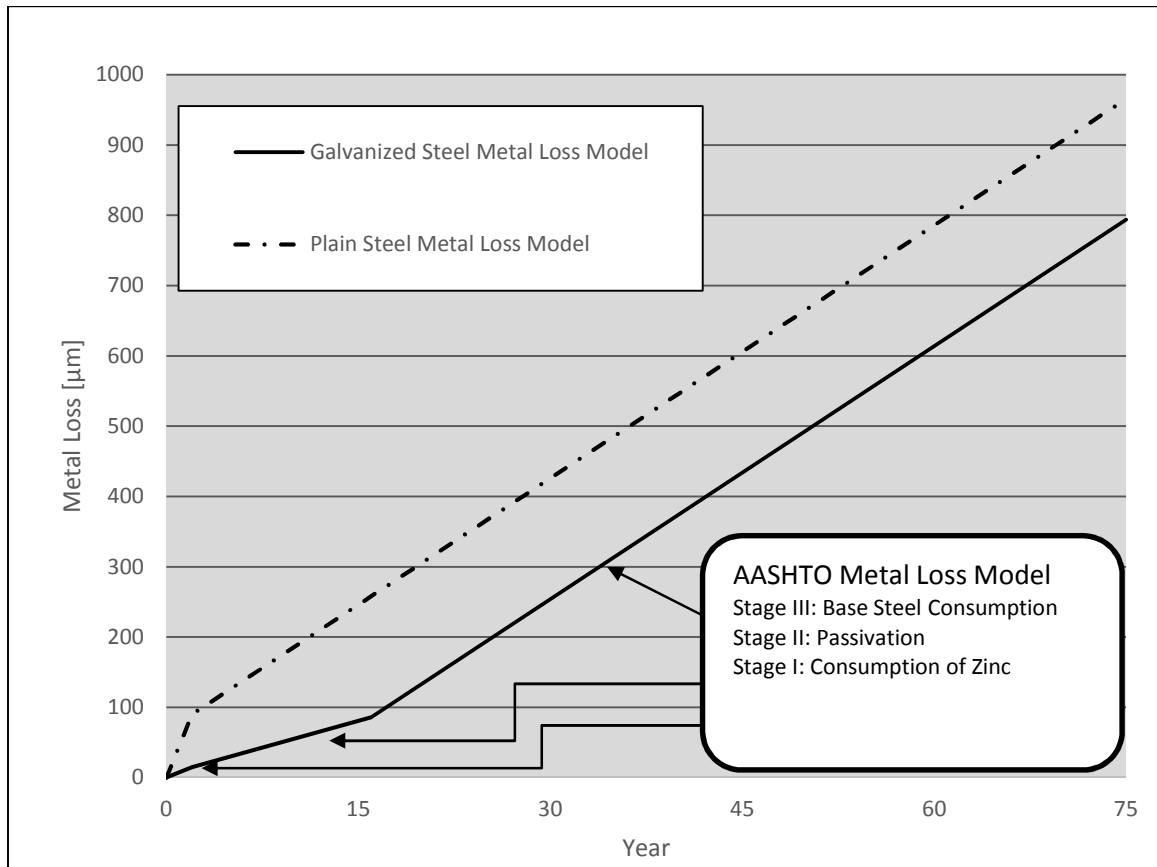
**Figure 0-1:** Nation metal loss models used for the design of sacrificial reinforcement thickness to compensate for metal loss due to corrosion

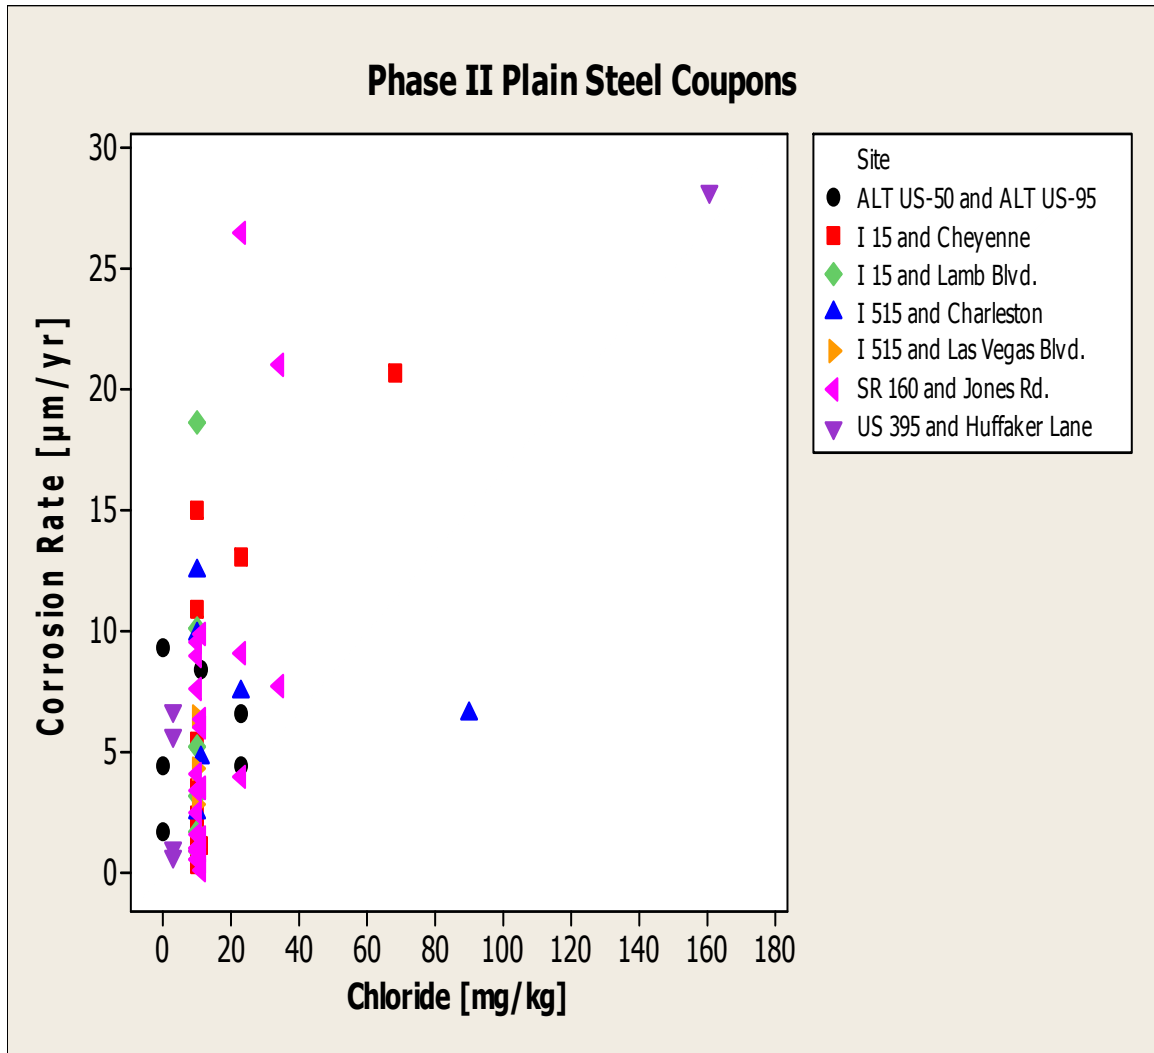
Figure 0-27: Phase II carbon steel coupon LPR corrosion rates with respect to backfill chloride content.

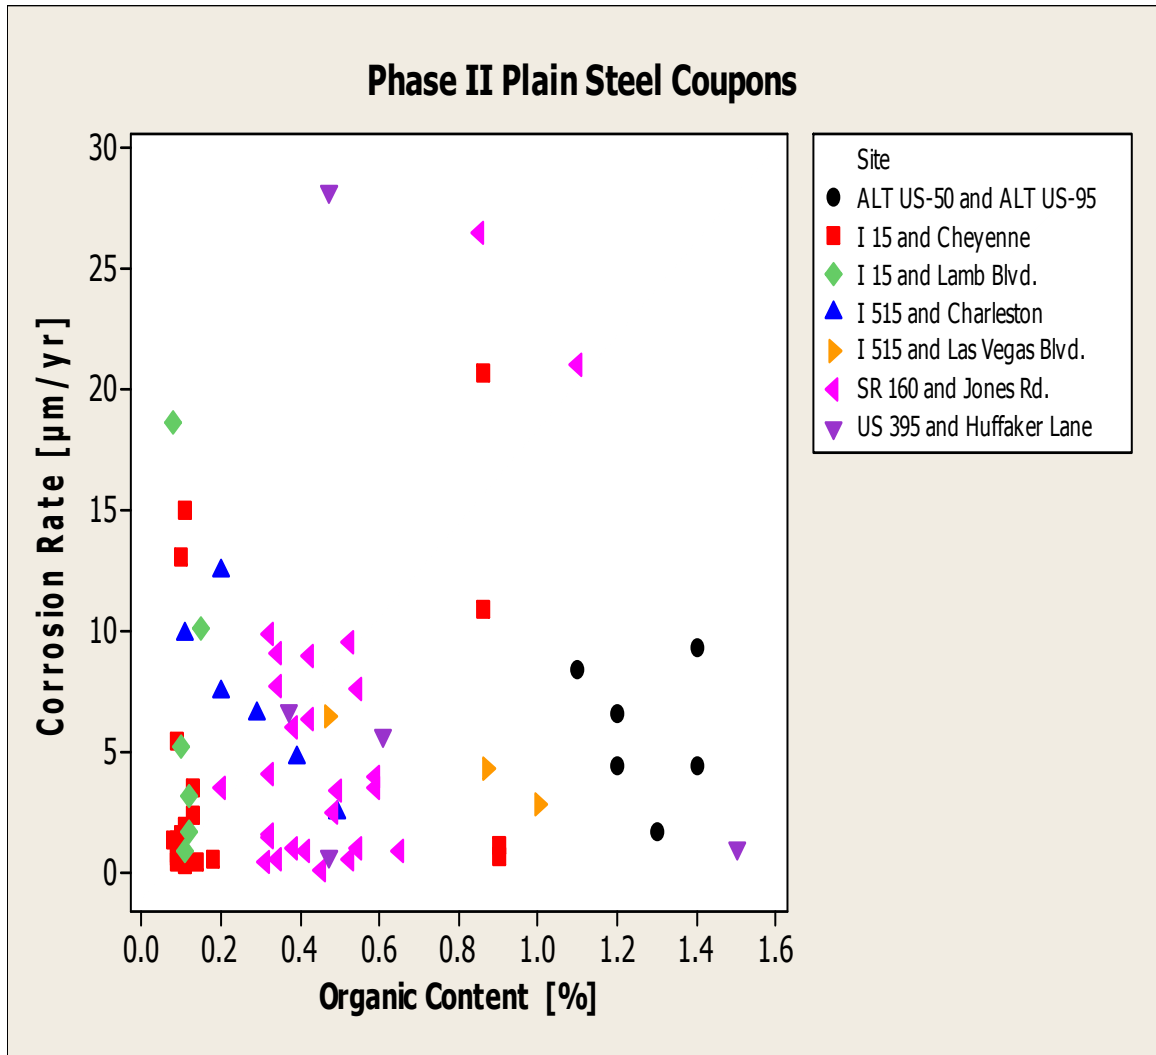
Figure 0-31: Phase II plain steel coupon LPR corrosion rates with respect to organic content of MSE wall backfill

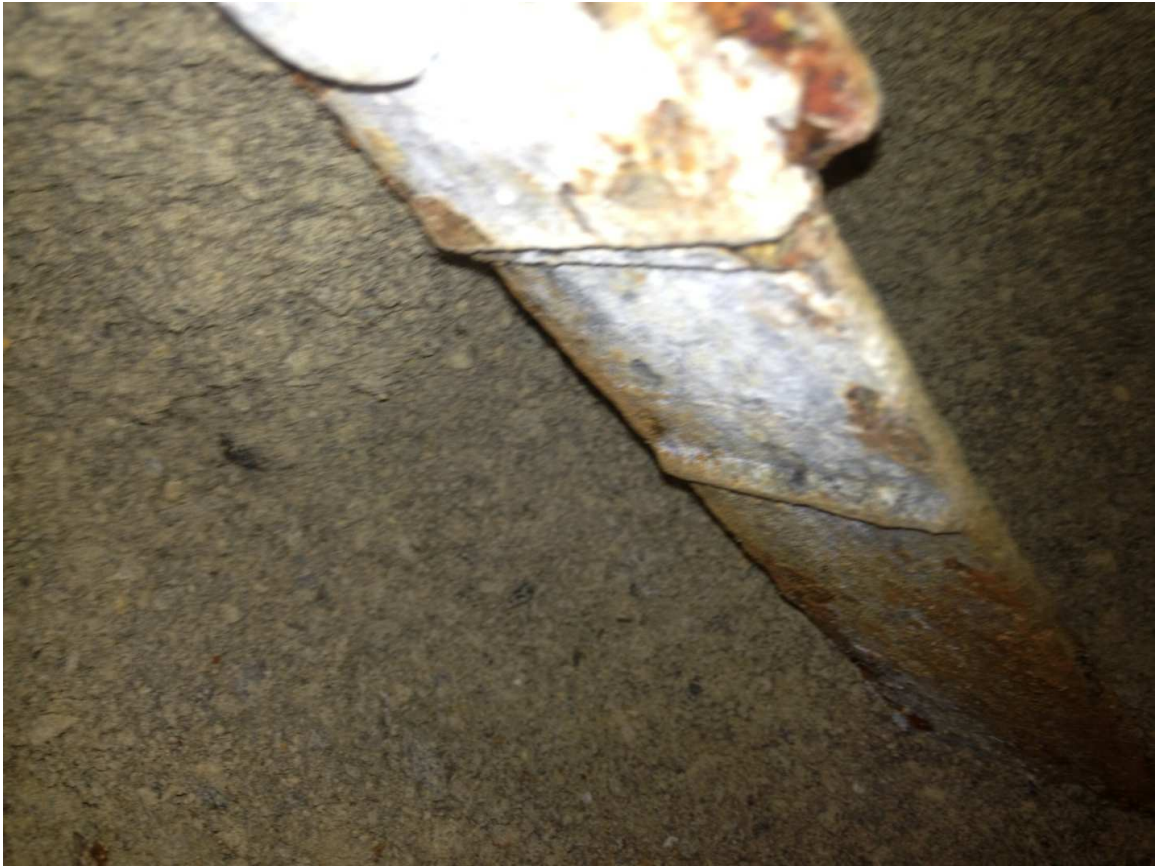
**Figure 3-12:** In-service galvanized soil reinforcement for I-15/ Cheyenne Blvd. Wall 1, 15 years old.

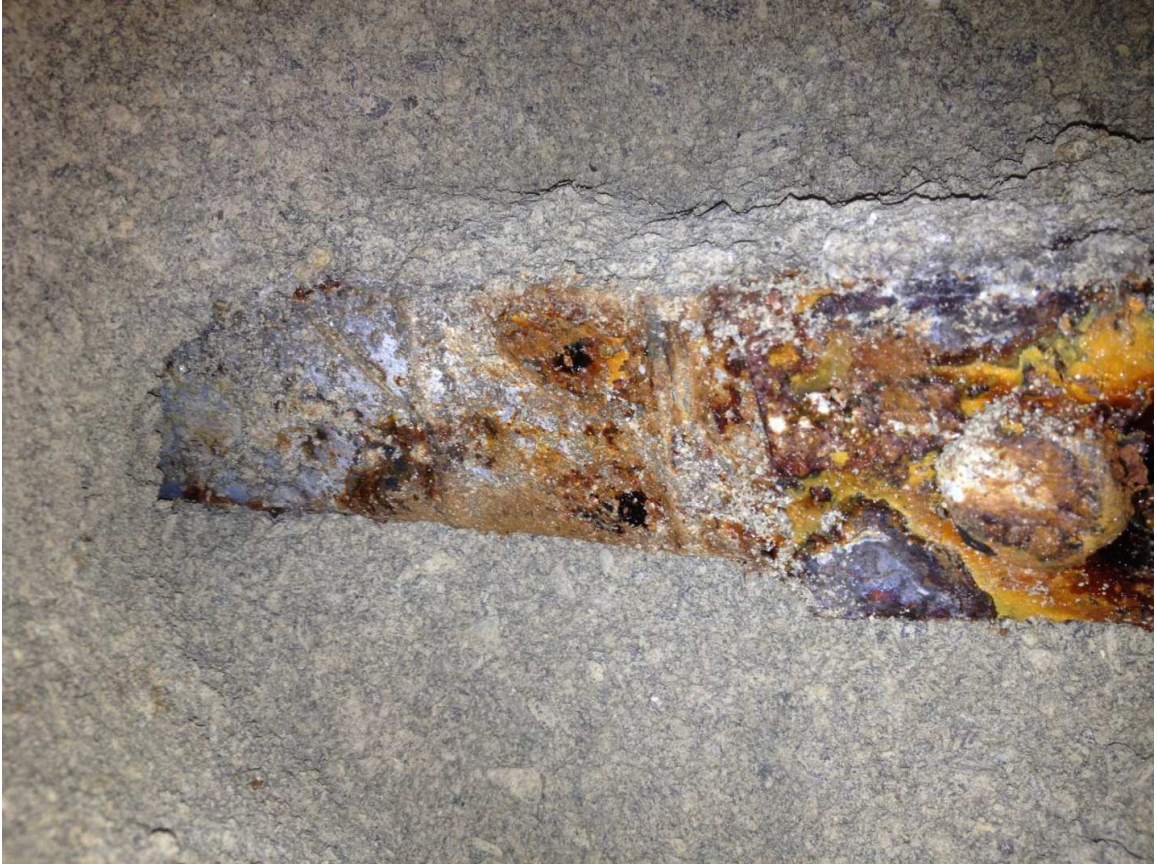
**Figure 3-13:** In-service galvanized soil reinforcement for I-15/ Cheyenne Blvd. Wall 1, 15 years old.

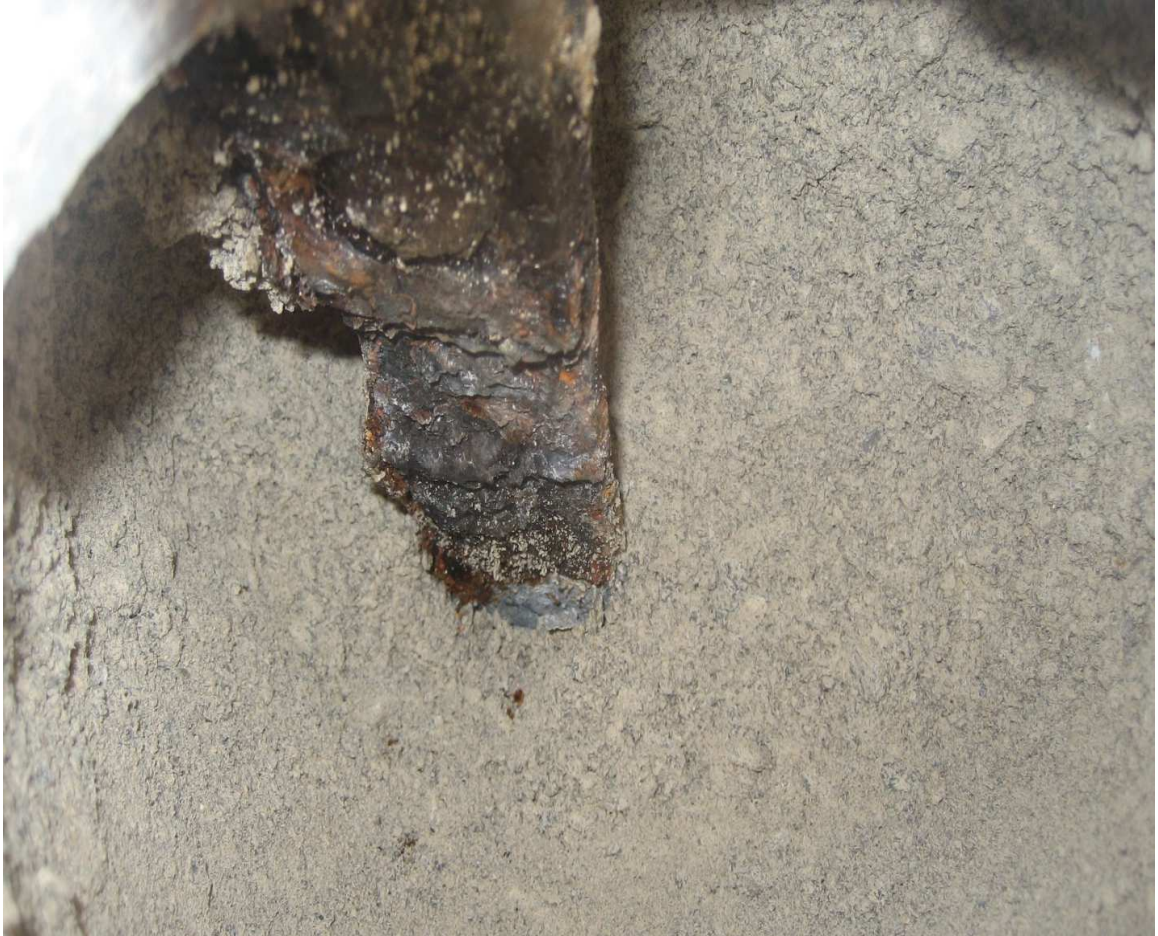
**Figure 3-14:** In-service galvanized soil reinforcement for I-15/ Cheyenne Blvd. Wall 1, 15 years old.  
(E1)

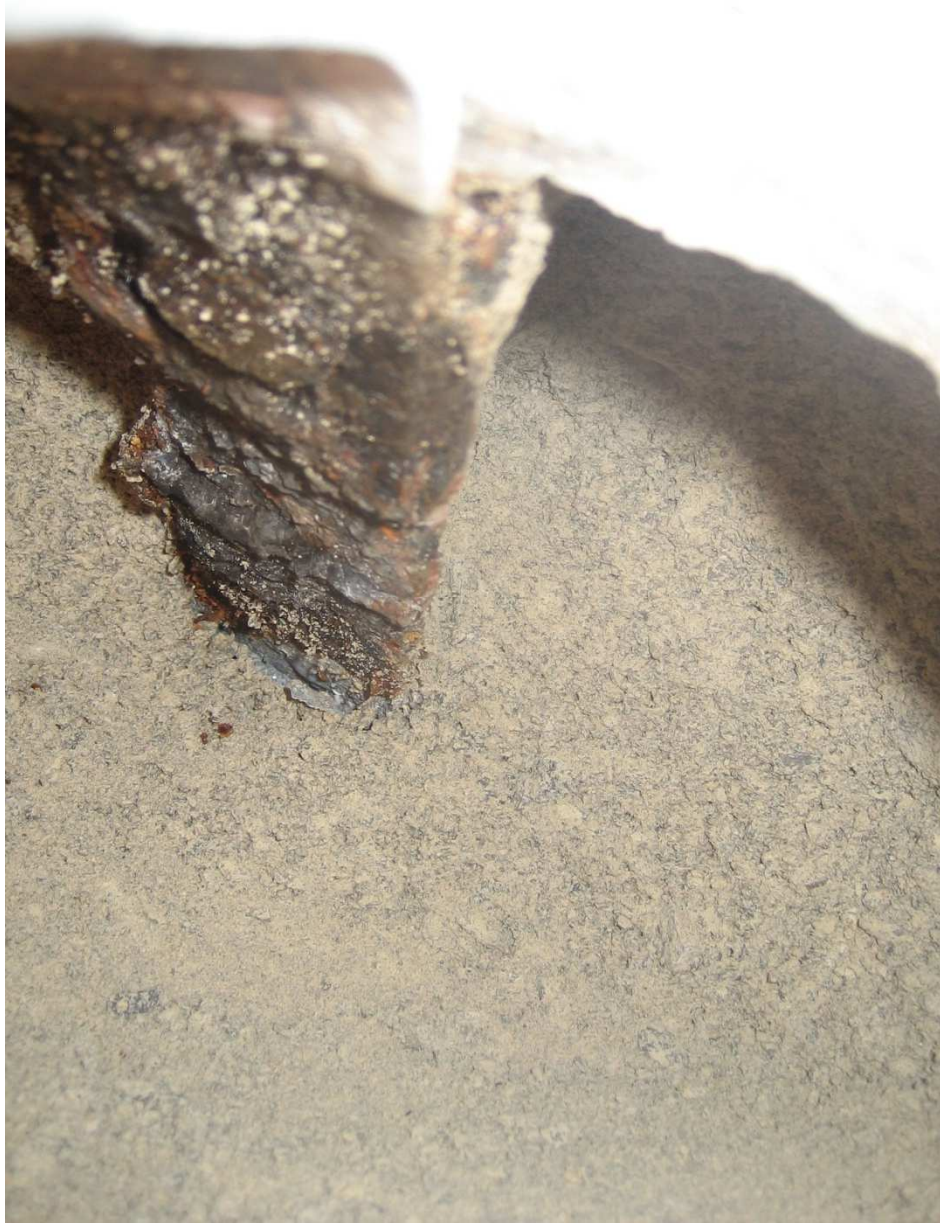
**Figure 3-15:** In-service galvanized soil reinforcement for I-15/ Cheyenne Blvd. Wall 1, 15 years old.  
E2)

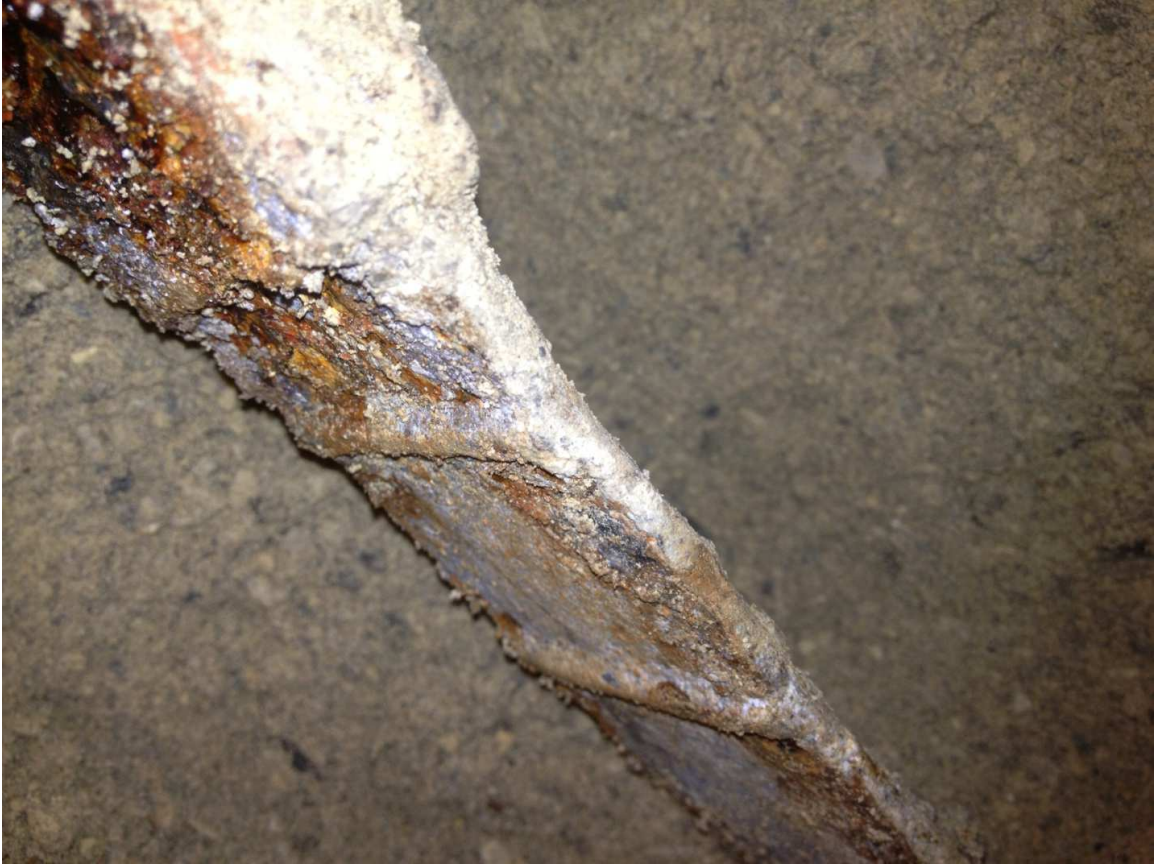
**Figure 3-16:** In-service galvanized soil reinforcement for I-15/ Cheyenne Blvd. Wall 1, 15 years old.

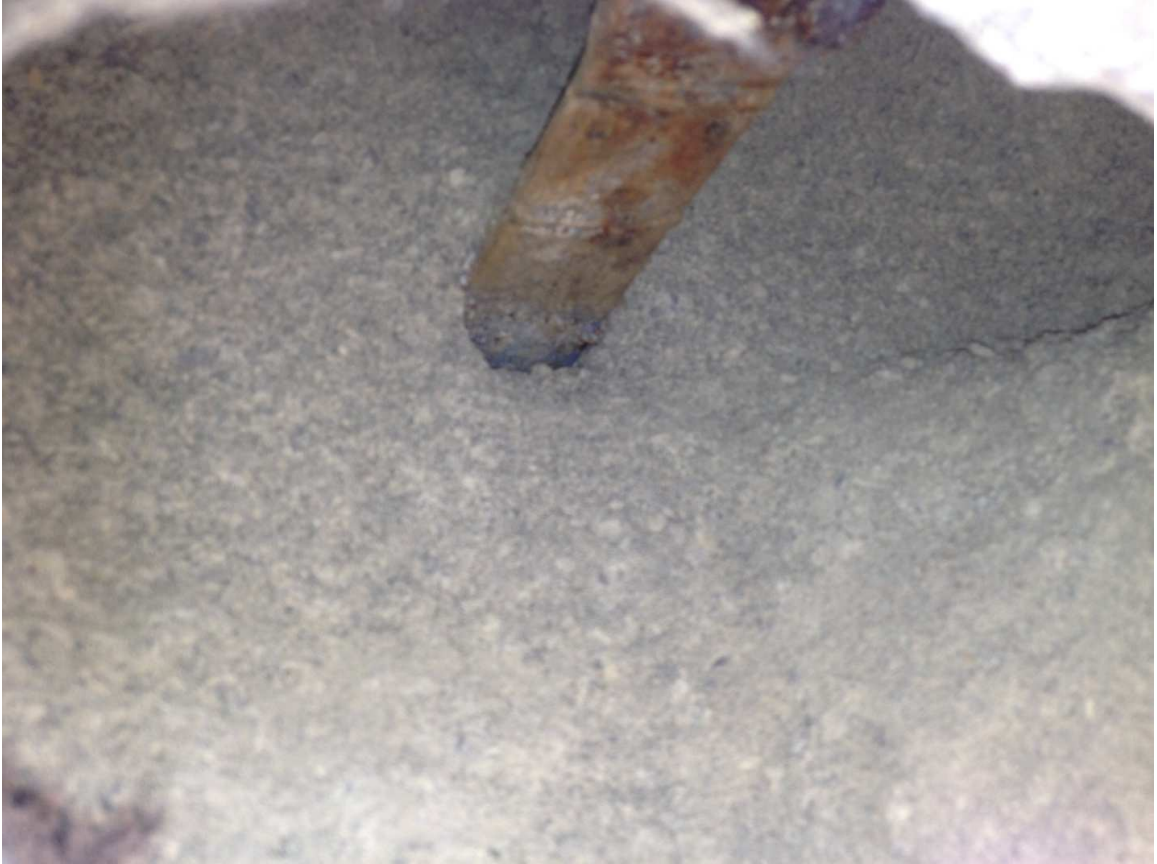
**Figure 3-17:** In-service galvanized soil reinforcement for I-15/ Cheyenne Blvd. Wall 2, 15 years old.

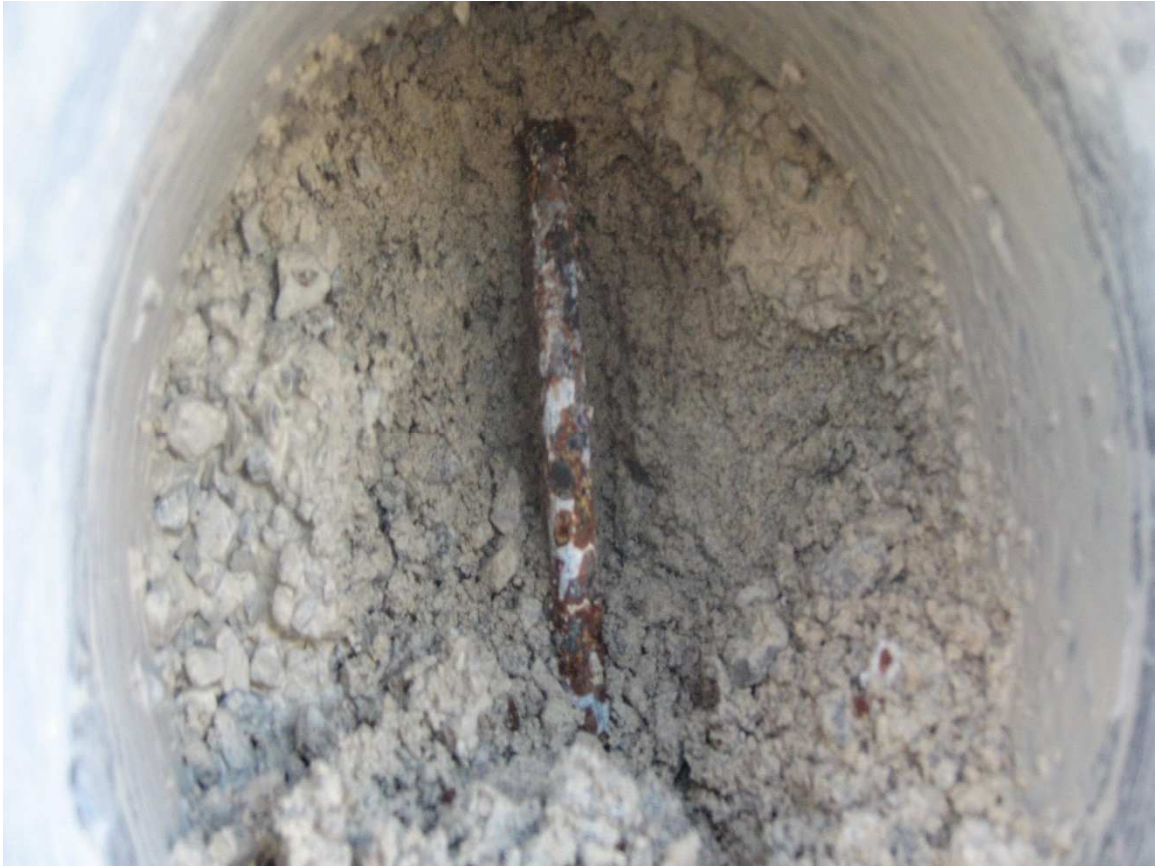
**Figure 3-18:** I-15/ Lamb Blvd. in-service reinforcement WA-SA-E1

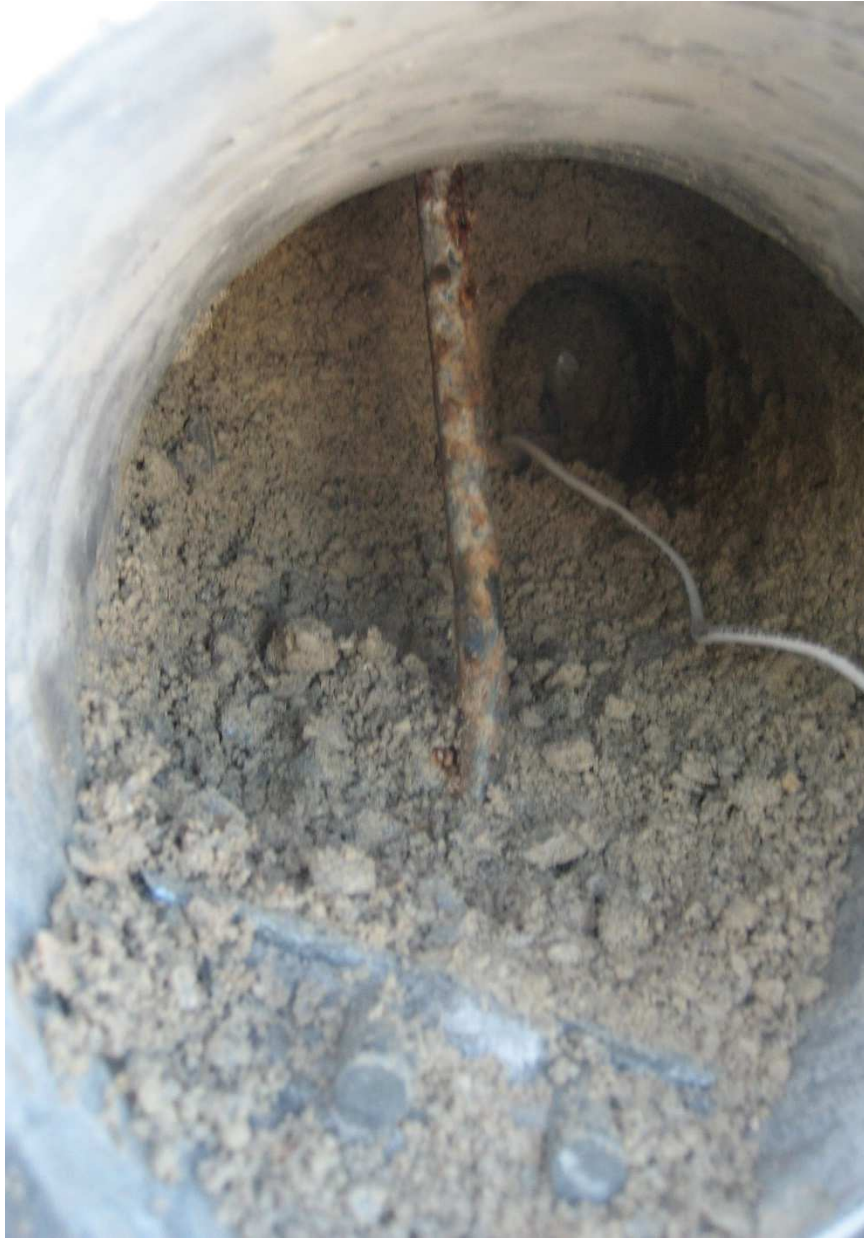
**Figure 3-19:** I-15/ Lamb Blvd. in-service reinforcement WA-SA-E2

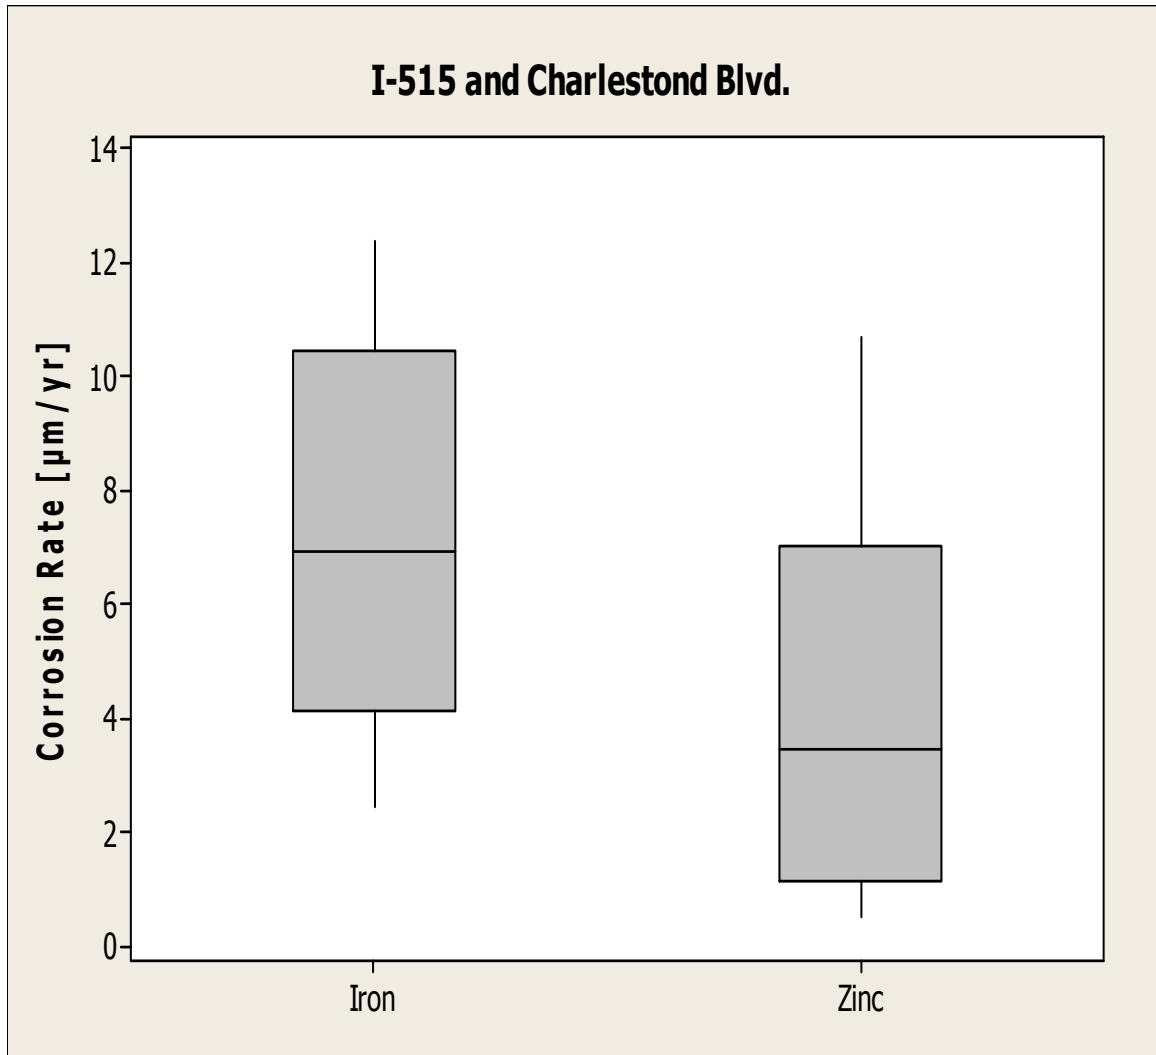
**Figure 3-21:** Phase II LPR corrosion rate box-plots by element type for I-515/ Charleston Blvd.

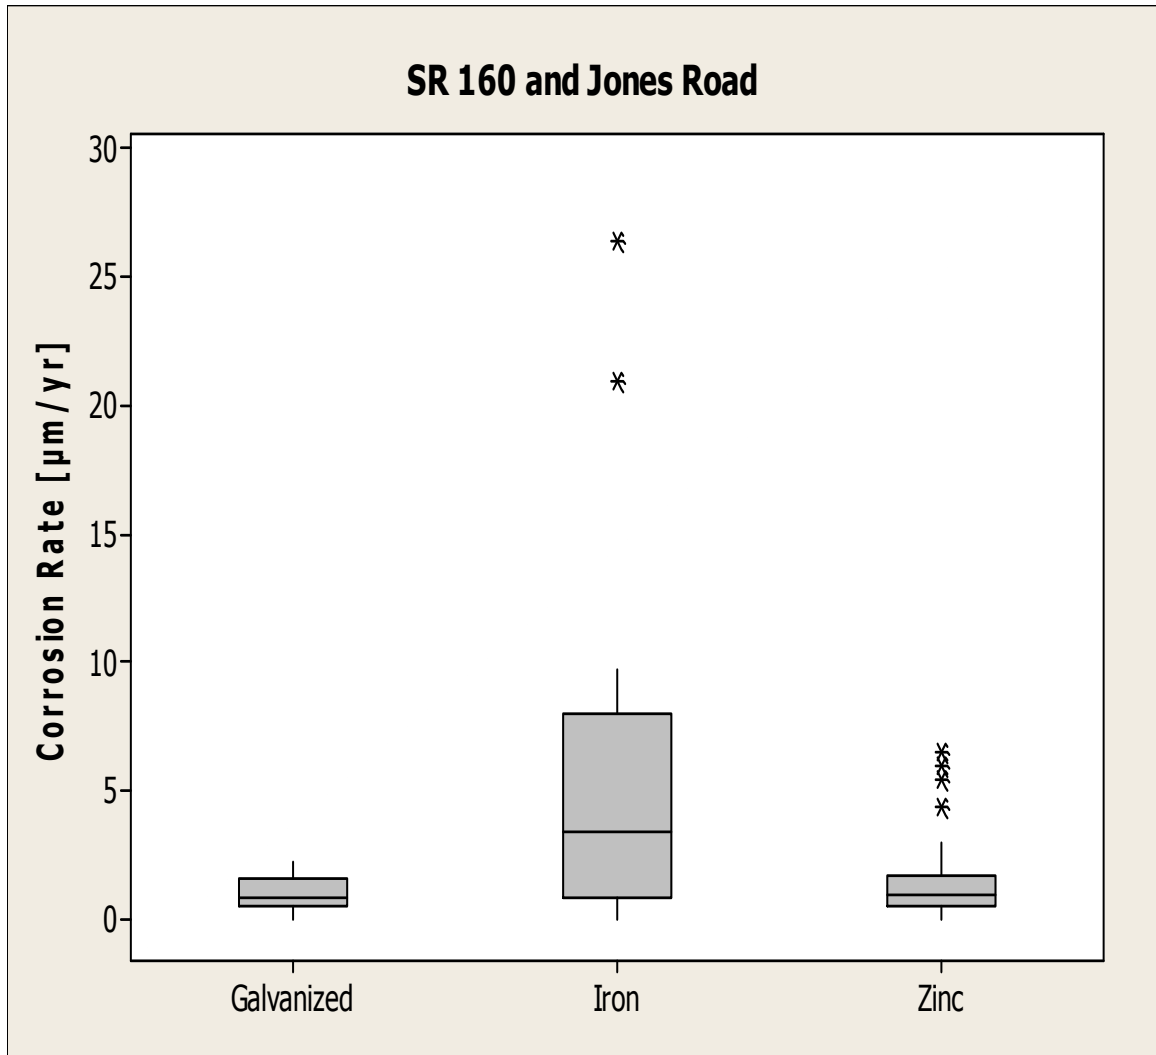
**Figure 3-23:** Phase II LPR corrosion rate box-plots by element type for SR 160 and Jones
