# Restoring a Fractured Endodontically Treated Incisor using Fiber Post: A Case Report

This present case report depicts a 23 year old male patient with fracture of tooth number 21 which had undergone an RCT 8-10 months ago and was restored using fiber post.

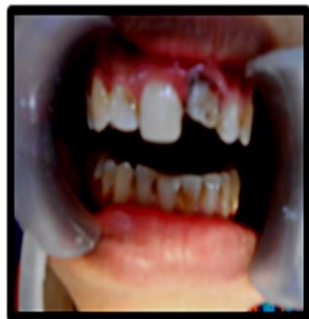
**Figure 1.** Pre-operative Photograph

A 23 year-old male patient reported to the our satellite clinic due to accidental trauma of the left central incisor. On examination, it was found that tooth 21 had undergone root canal treatment 8-10 months ago. However, tooth 21 was asymptomatic and the clinical crown was <2 mm. (Figure. 1)
