Desk study and walk-over survey of Rhiw Landslip, Lleyn Peninsula

Programme Research Report CR/03/199N

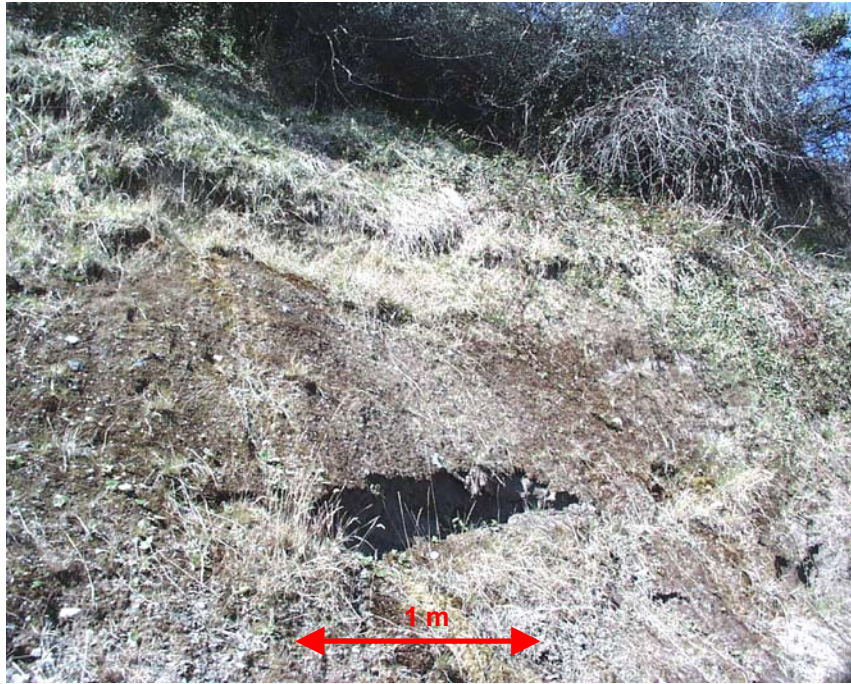
Figure 7. A shallow failure within the exposure of poorly laminated gravelly silt 10 m NW of the exposure in Figure 6., (looking NNE at approximate grid reference [223774, 328156, z34].

At the same elevation and 10 m further to the West, recent movements had exposed a section that appeared to consist of a soft, dark grey to dark brown poorly laminated silts. (Figure 7). Further upslope from here, in the cliffs immediately to the East of Bryn Foulk were exposed light brown, irregularly bedded sandy, gravelly diamictons (observed from a distance) which were thought to be of a fluvial/ fluvio-glacial origin. Although it is difficult to make an interpretation based upon so few exposures and it seems reasonable to suggest that these exposures represent the depositional margin of Porth Neigwl where a sloping bedrock surface is overlain by at least one till which in turn is overlain by glacio-fluvial derived deposits.

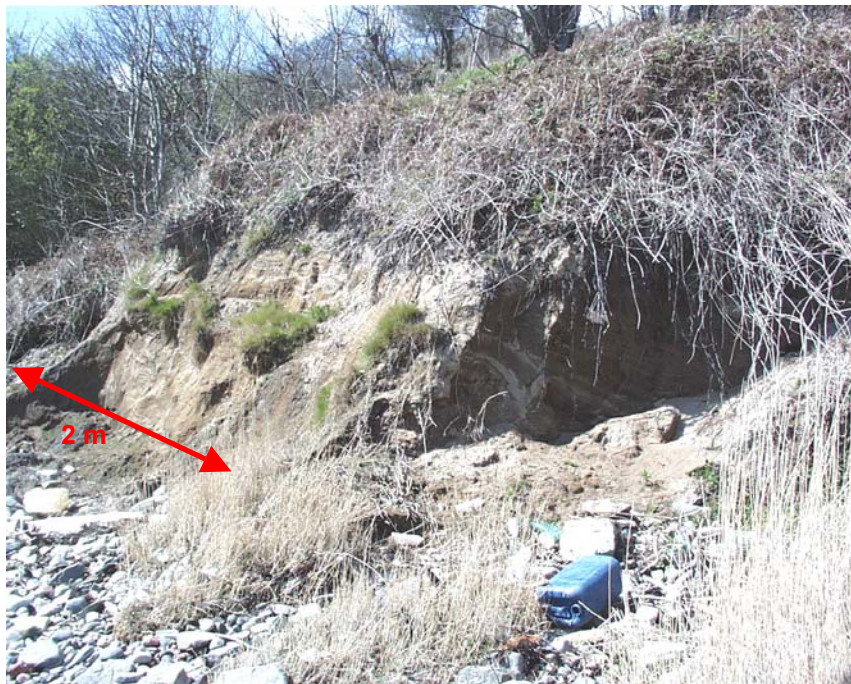
Figure 8. Exposure of soft, light brown to dark grey laminated, fine grained sands looking NW at [223973 328254, z1.5]. Although intact laminations could be seen in the exposure it is thought that the material had been emplaced as part of a slope movement.

Cliff top and coastal exposures of material elsewhere in the survey to the east of this location showed the variability of the glacially derived deposits in this part of Porth Neigwl. These included units of soft, light brown, laminated fine sands (Figure 8), soft to stiff sandy clays (Figure 9) and light brown gravelly sandy units (Figure 10).

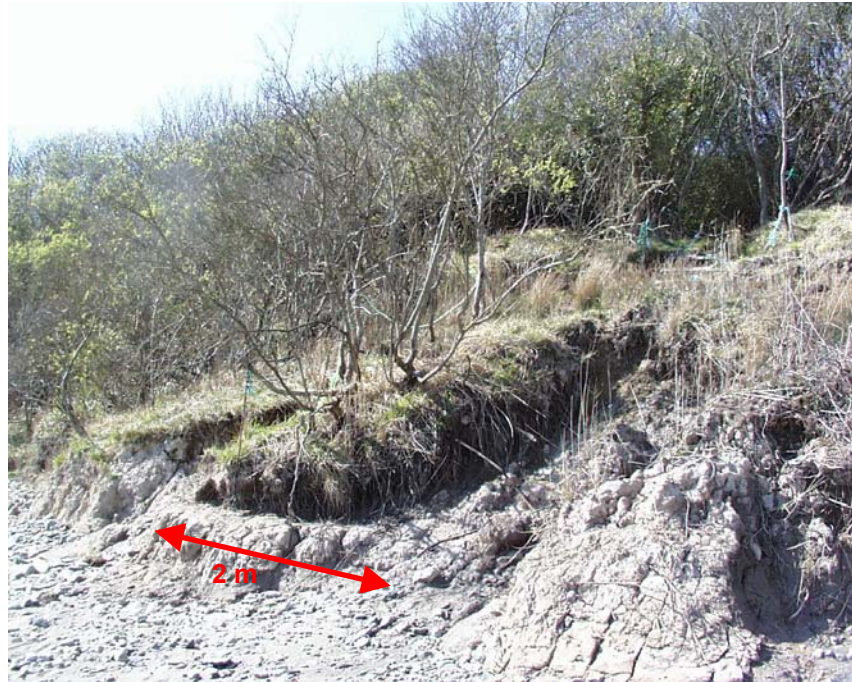
Figure 9. Exposure of disturbed soft to firm, light grey to light brown sandy clays at [224031 328306].

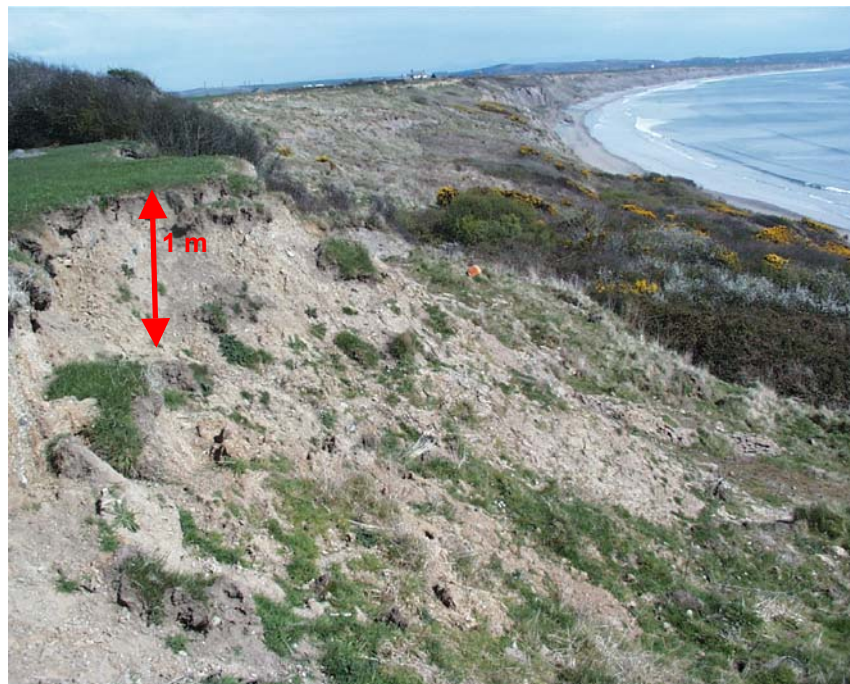
Figure 10. Exposures in the landslide rear-scarp of light brown, gravelly sandy clay diamicton interpreted as fluvio-glacial outwash deposits at the cliff top immediately in front of Treheli at [224131 328518, z35.8].

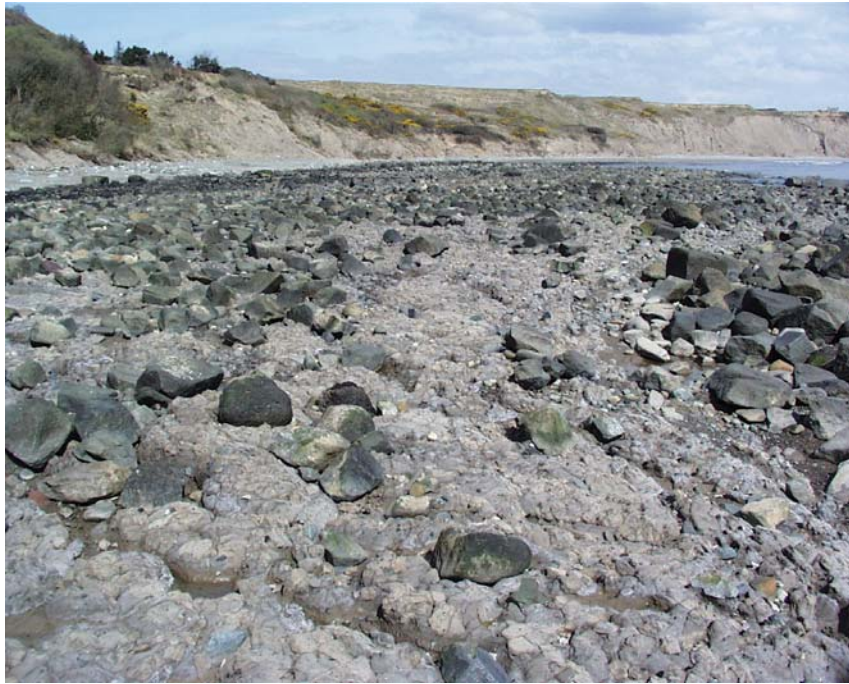
Figure 11. Remnants of light brown to purple stiff fissured clay on the foreshore in front of Treheli at which is probably the remnants of toe heave resulting from a deep-seated rotational landslide.

An isolated exposure of fissured, purplish light brown, clay with silt (interpreted by its colour as Irish Ice Till) was observed on the foreshore around 36 m seaward of the foreshore (Figure 11). This unit, with apparent fissuring running parallel to the coastline was thought (in agreement with the Arup report) to represent the toe of a rotational landslide. No purple clay was exposed in the coastal slope section, indicating either that the material must be in-situ below the current beach level and was heaved into its current position by a deep-seated rotational movement or that the clay is present but unexposed in the cliff and had been involved in a fairly shallow rotation. Whichever of these processes is correct the fact remains that there is evidence of an active shear surface beneath beach level.

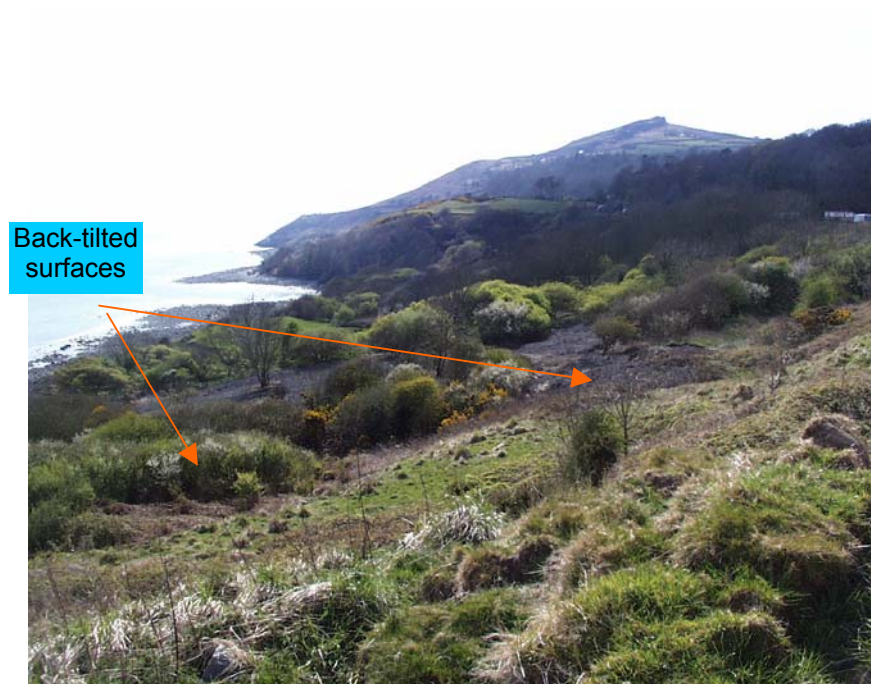
Figure 12. A typical profile of the landslide area immediately downslope from Treheli. The photograph was taken from the top of the arcuate back-scarp. Visible are the back-tilted ground surfaces indicating the upper surface of rotated blocks.

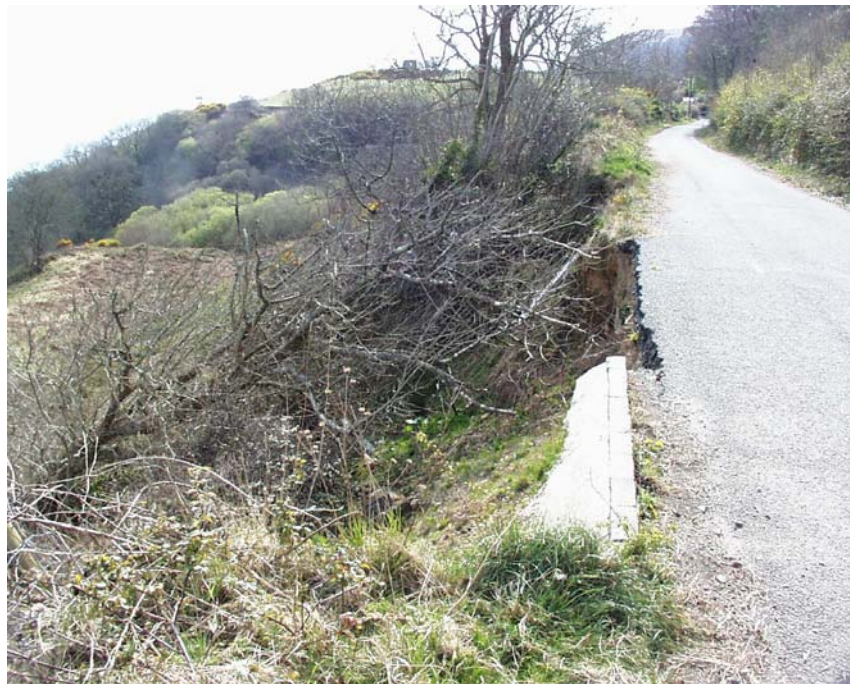
Figure 20. Loss of kerbing and road surface due to undermining southwest of Sarn y Plas.

Observations of damage to built structures were made during the walkover survey. None of the habitable buildings within the survey area appeared to be suffering structural distress as a result of slope instability. The northern wall of Sarn y Plas appeared to be in some distress and was not in exact alignment with the rest of the building but this could not be attributed to landsliding directly and could have been a result of processes other than landsliding. All of these buildings are of some antiquity, all appear to be over 100 years old and buildings in their locations appear on the 1888 map of the area. Although this indicates a lack of historic landslide activity in the area it could equally suggest that the rear scarp of the landslide has not yet regressed sufficiently inland to cause disturbance. Cracking was evident in the road immediately in front of Sarn y Plas (Figure 19) with a deep fissure over 10 m in length spanning between [223853 328325] and [223848 328317]. This fissure occurs upslope of a gabion wall constructed in 1988. To the southwest and parallel to that fissure, a recent failure in the rear scarp had resulted in the removal of kerbing and disturbance to the road surface (Figure 20) and fence line (figure 21).

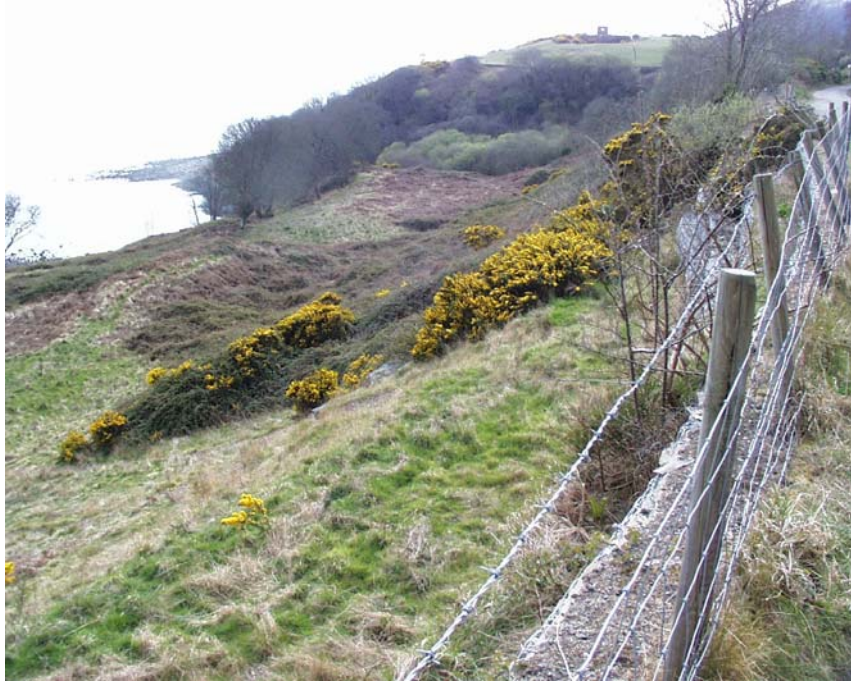
Figure 21. Distress to the fencing immediately southeast of Sarn y Plas. This photograph, facing towards the southeast is a further illustration of topography interpreted as the back-tilted blocks of rotational landslides.
