Early Detection of Near-Surface Void Defects in Concrete Pavement Using Drone Based Thermography and GPR Methods

**Final Report
January 2020**

Sponsored by
**Nebraska Department of Transportation
Project M082**

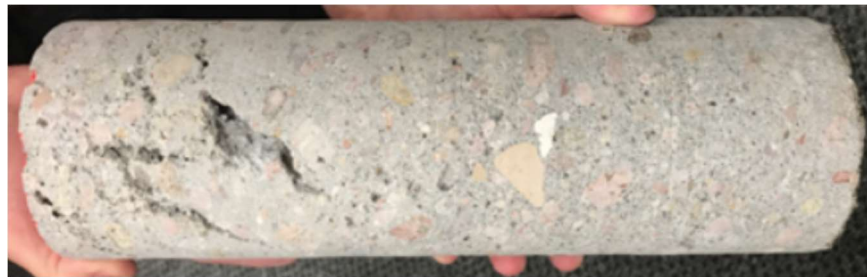
Figure 1 Air void in a cored concrete pavement sample

Sub-surface (i.e., less than 4 in deep) voids (**Figure 1**) that are 1/2" or larger in diameter (in both horizontal and vertical directions) is a common symptom of consolidation issues during the construction of concrete pavements. This issue was observed by NDOT in concrete pavements constructed by different contractors, on different roads (highways and local roads), and with different thicknesses (9-14 in).

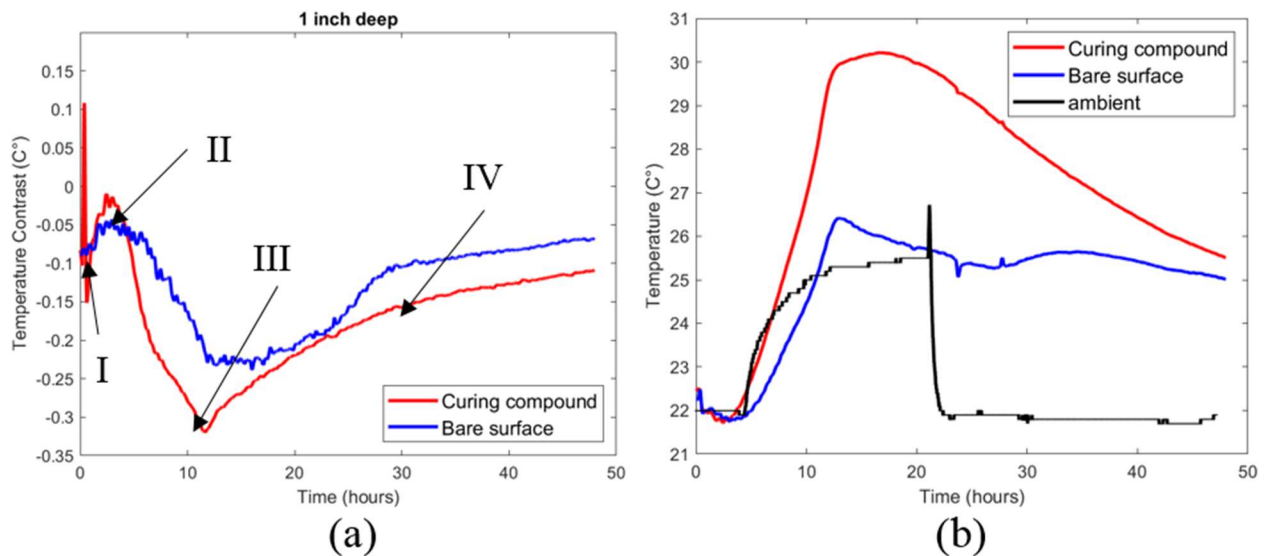
Figure 1.8 temperature evolution after pouring for EX1: (a) temperature contrast for void with 1" depth; (b) temperature for cure sprayed surface, bare surface and ambient temperature

Applying the curing compound has been found two-step influence on the temperature contrast of void defect. First, when the surface was wet (from time window I to II), the temperature contrast (Figure 1.9 I and II shows the contrast from -0.04 to -0.08°C) was low for both bare surface and surface with sprayed cure. It was found that applying the cure would decrease the temperature at the beginning where in Figure 1.8 from I to II, the contrast was decreased. This observation was also supported in EX2 (Figure 1.11) from I to II that a decrease of temperature contrast was found after applying the cure. Second, when the surface started to dry out, the surface temperature developed quickly. It was shown in Figure 1.8b that the surface with sprayed cure increased faster than the bare surface. It could be explained by the function of the curing compound that was designed for water retention. Water evaporation would remove heat from the concrete surface and thus the temperature would be lower at the bare surface than the surface with sprayed cure. As a result, the faster temperature raising at the cure surface developed higher temperature contrast of the void. In Figure 1.8a III and Figure 1.9 III, the temperature contrast of 1" deep void was around -0.28°C compared to -0.18°C of the void at the same depth on the bare surface. At this time stamp, the maximum temperature contrast was reached and started to decrease (Figure 1.8a IV and Figure 1.9 IV). In summary, applying the cure would decrease the temperature contrast of the void at the beginning while help to develop the contrast later.

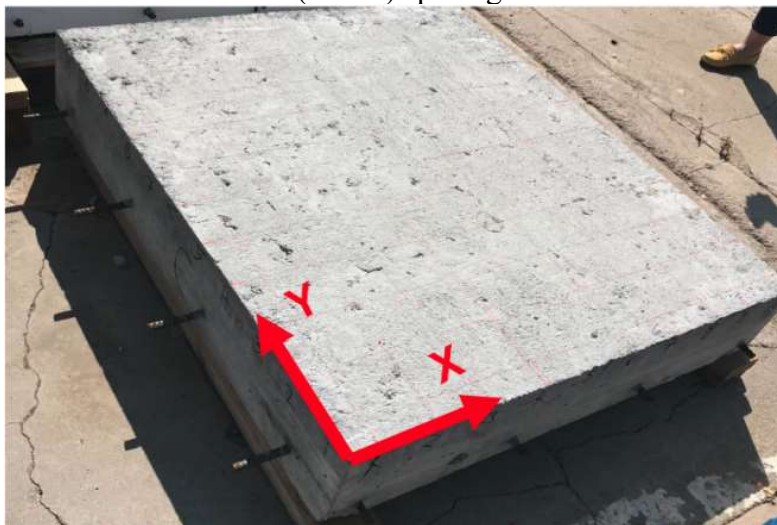
Figure 2.1 Slab 1- Specimen Photo and Scanning Axes

Three slabs were tested in the structures laboratories of University of Nebraska-Lincoln (UNL). The first slab tested was a 48" x 48" x 7.5" (1.22m x 1.22m x 19 cm) and reinforced with four #4 bars spaced at 12" as shown in **Figure 2.1**. The bars in the x-direction had a depth of 5.5" (13.9 cm), and the bars in the y-direction were at a depth of 6" (15.2 cm). It included small artificial air voids varying in dimensions from 0.5" – 1.5" (1.27cm – 3.81cm) and they were embedded at depths of 0.5", 1", 1.25", 2", and 3" (1.27 cm, 2.54 cm, 3.16 cm, 5.08 cm, 7.62 cm) as shown in **Figure 2.2**. GPR detection tests were conducted one week after the specimen was poured in this first trial, and line scans were done at 4" (10 cm) spacing.

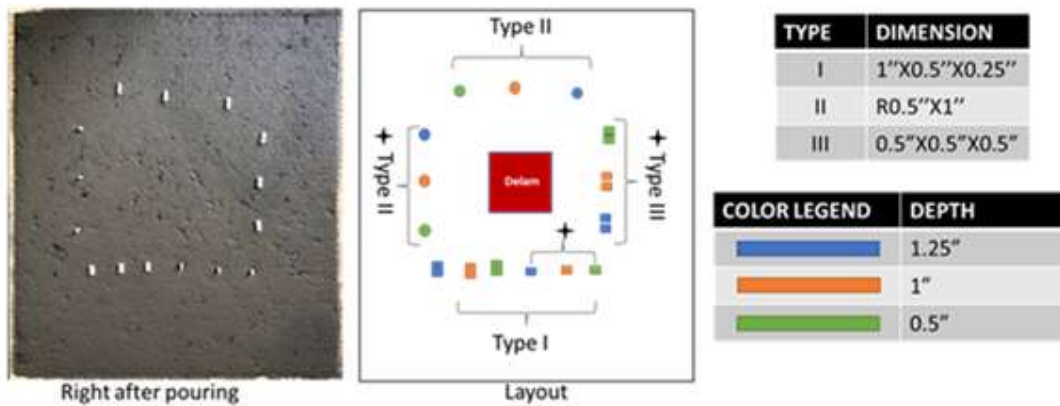
Figure 2.2 Slab 1 - Void Plan View

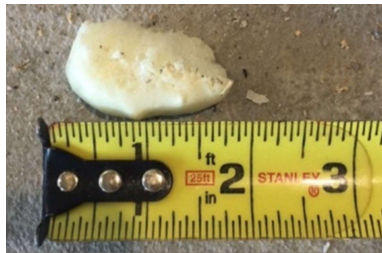
Figure 2.5 Slab 2 – Small Artificial Air Void

A second slab measuring 44" x 40" x 8" (1.12m x 1.02m x 0.20m) was cast. This specimen was reinforced with two #4 bars placed 1.5" (0.04m) from the slab end in both directions at an average depth of 6.25" (0.16m) in order to give the slab enough strength to move it around in the lab if needed, without major damage. This slab used two cubic yards (1.53 m³) of NDOT 47B Concrete Pavement Mix with 2" (0.05m) slump. Insulation spray foam was used to create the voids (**Figure 2.5**), which were implanted after the slab was divided into four quadrants in order to group the different void sizes and depths (**Table 2.3**) in each quadrant (**Figure 2.5**, **Figure 2.6**).

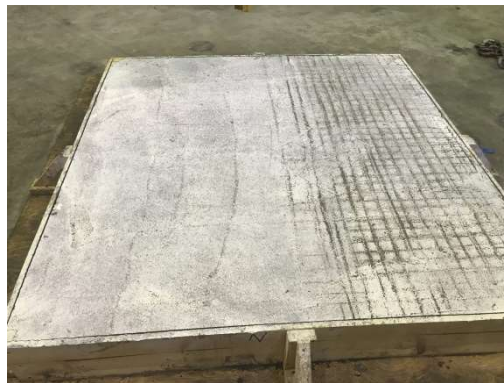
Figure 2.11 Slab 3 – Image after Scanning the Slab with GPR at 3 and 4 Hours on Curing Compound

NDOT’s Right Pointe White Water Wax concrete curing compound was sprayed on the top surface to follow typical field processes. NDOT routinely sprays this particular curing compound right after concrete placement. When GPR is used on wet curing compound, the wheels of the handheld GPR removes lines of compound, likely reducing its effectiveness (**Figure 2.11**). GPR scanning was conducted on a 2” x 2” o.c. grid (0.05m x 0.05m) on the western half of the slab, 3 hours and 4 hours after pouring, and on the entire slab 24 hours after pouring. **Figure 2.12** illustrates the slab with cardinal directions and void locations, as well as the location of the linear scan, results of which are presented in **Figure 2.13-15**.

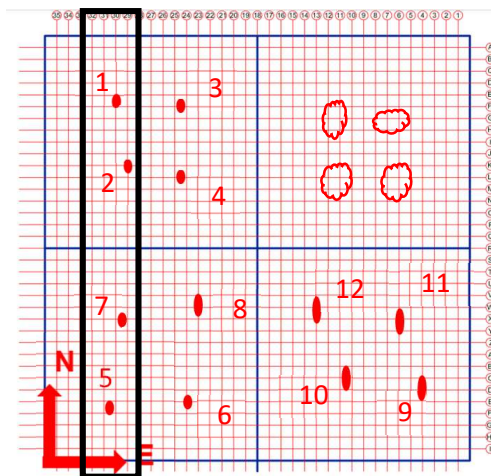
Figure 2.12 Slab 3 – North-South Linear Scan Location (denoted by rectangle) at 3, 4, and 24 Hours. Corresponding scans are presented in Figures 2.13, 2.14, and 2.15, respectively.

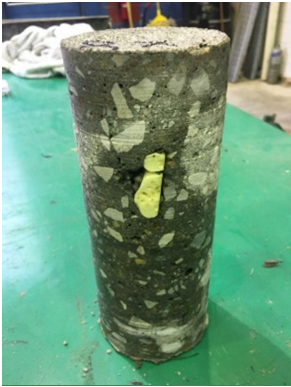
Figure 2.17 Slab 3 - Core 8 (Large Void)

testing. Core 8's GPR scans showed one of the weaker signals, whereas Core 12's GPR scan was one of the strongest signals. This can be explained by the surface area perpendicular to the direction of the magnetic waves. It is naturally easier to detect the oblong void parallel to the surface (Figure 2.18) compared to detecting a smaller are (Figure 2.17). The signals for the compressed air area were vague but a core was taken anyway to see the effects of the inserted compressed air. It appeared that the compressed air was dispersed into fine bubbles as the concrete consolidated, which explains the vague signals (Figure 2.19).

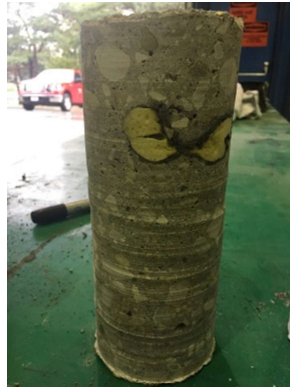
Figure 2.18 Slab 3 - Core 12 (Oblong Void)

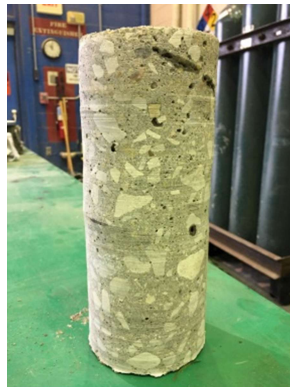
Figure 2.19 Slab 3 - Core 13 (Compressed Air)

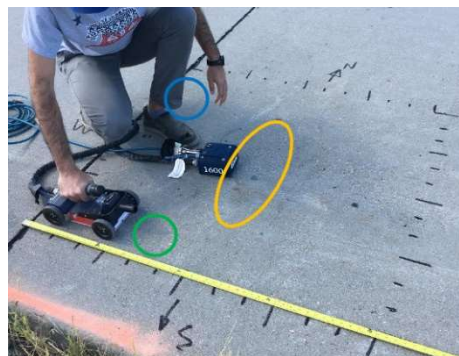
Figure 2.21 Field Experiment 1 - Scanning Grid with Suspected/Detected Voids

Figure 2.20 and **Figure 2.21** show an illustration and a photo of the scanning grid, respectively. **Figure 2.22** shows the resulting scans and detected voids, with the circles corresponding by color to those on 21.

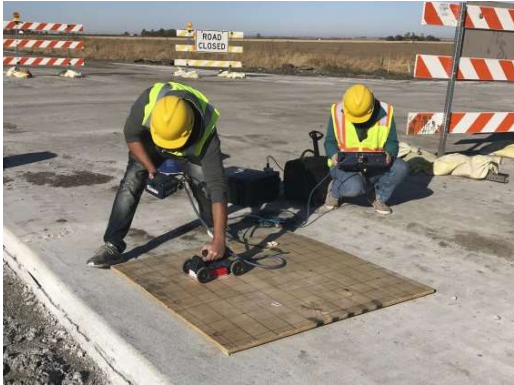
Figure 2.23 Field Experiment 2 - GPR Scanning

The second field experiment was conducted in late October 2019 where the high temperature was 57°F on a section of pavement on Highway 30, west of North Bend, NE. This pavement was cast 6 weeks prior to scanning. A 4' x 4' x 3/4" (1.22m x 1.22m x 1.9 cm) sheet of plywood with screws on the four corners (to elevate it 1/2" above the concrete) was laid on the pavement, and the GPR scans were conducted on a 4" x 4" (0.10m x 0.10m) o.c. grid (Figure 2.23). The 4" x 4" (0.10m x 0.10m) grid was marked on the plywood sheet for ease of use. Scans were not done on a 2" x 2" grid, as the team wanted to scan as many different spots as possible and it was faster to scan at 4" x 4" o.c. GPR scans did not pick up any voids in the top four inches of the pavement, which is the depth NDOT was most interested in; and coring at each scanning location yielded no voids (of a size of concern) in that region as well (Figures 2.24-2.26). The researchers concluded that there was proper consolidation at this location and the experiment was successful.

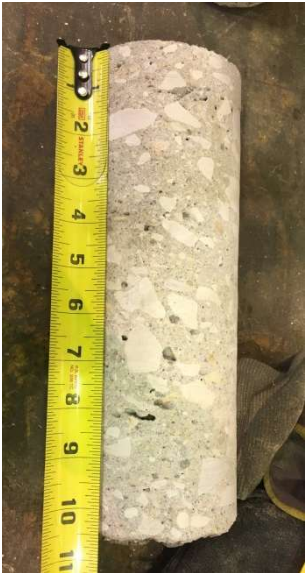
Figure 2.24 Field Experiment 2 - Core 1

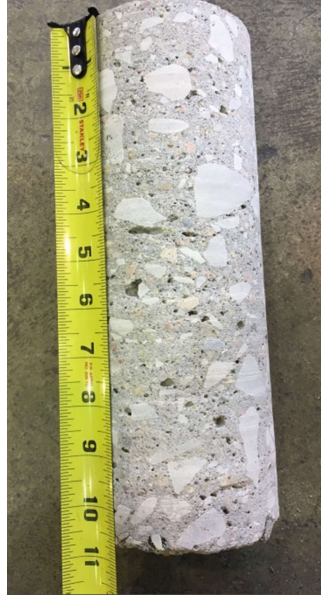
Figure 2.25 Field Experiment 2 - Core 2

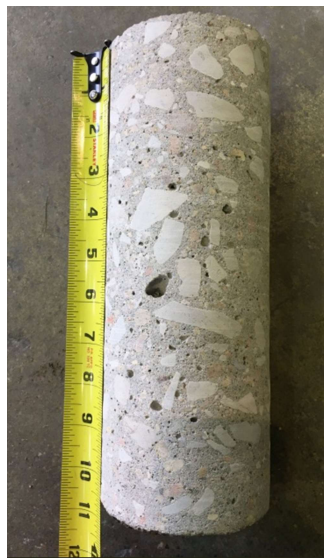
Figure 2.26 Field Experiment 2 - Core 3
