Charactering taper junction wear helps understand the mechanism of failure of metal on metal hip replacements.

Panagiotopoulos, Andreas, Hothi, Harry, Whittaker, Robert, Matthies, Ashley K, Bills, Paul J., Racasan, Radu, Blunt, Liam, Skinner, John and Hart, A. J. (2015) Charactering taper junction wear helps understand the mechanism of failure of metal on metal hip replacements. In: American Academy of Orthopaedic Surgeons Annual Meeting, March 24-28 2015, Las Vegas, NV, USA. (Submitted)

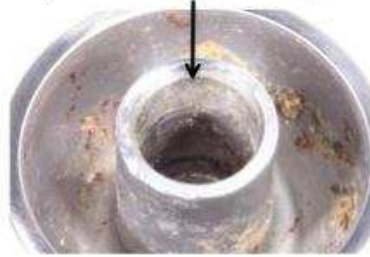
Low wear

| <b>Taper wear pattern</b> | <b>Definition</b> | <b>Number</b> | <b>Clinical Significance</b> |
|---|---|---|--|
| <b>Low wear</b> | Volume of material loss less 1 mm <sup>3</sup> | 62 | Well sealed or not yet worn taper |

Open-end of head taper
