Wheelset: Less Cost, Less Risk – The Challenge

# Inspecting the Depth of Wheel Tread Surface Damage Using Magnetic Flux Leakage

Stephanie Klecha – MRX Technologies

Dr Adam Bevan – Institute of Railway Research

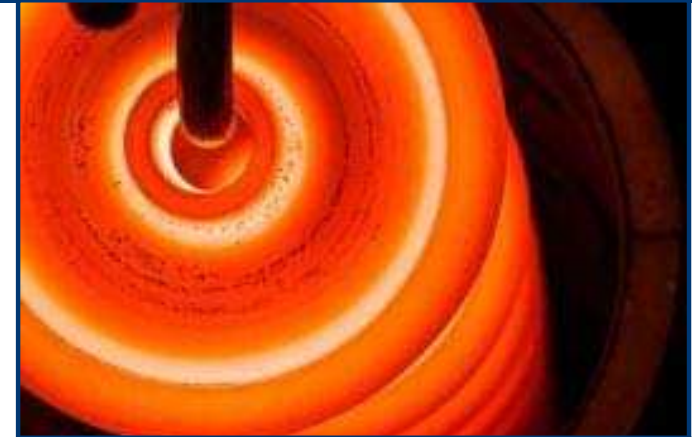
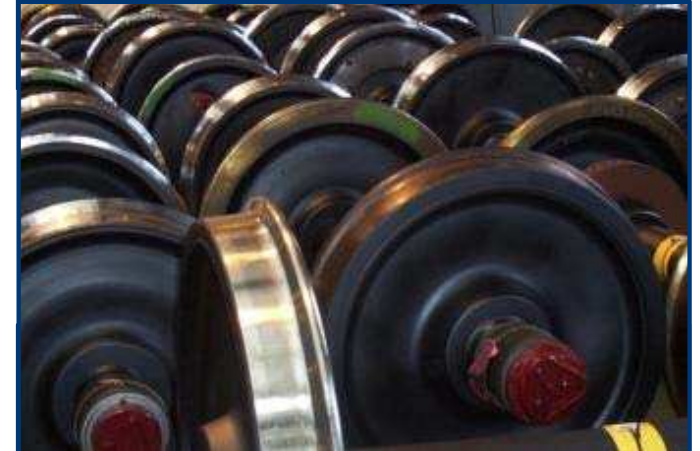
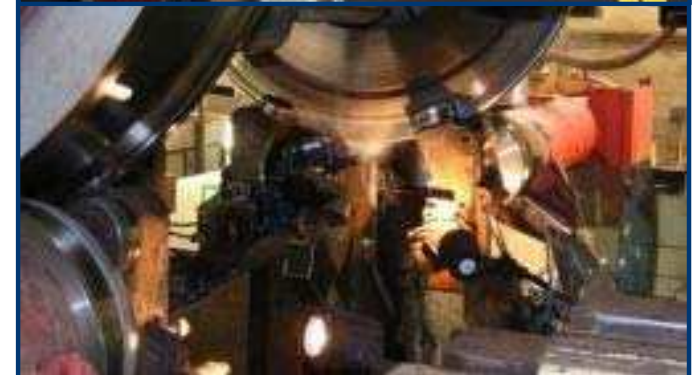
- Inspecting and quantifying surface condition:
  - Surface damage is difficult to classify visually
  - Highly subjective and poor repeatability
  - Not possible to establish depth of defects
  - Makes data assessment and trending difficult
- Wheel lathe best practice:
  - Reducing the time the vehicle is on the wheel lathe
  - Preventing excessive material removal to maximise wheelset life
  - Consistency between wheel lathe operators
- *Ability to reliably and accurately measure the depth of damage on the wheel tread would significantly assist in the decision making and optimisation of the management of wheel surface damage*

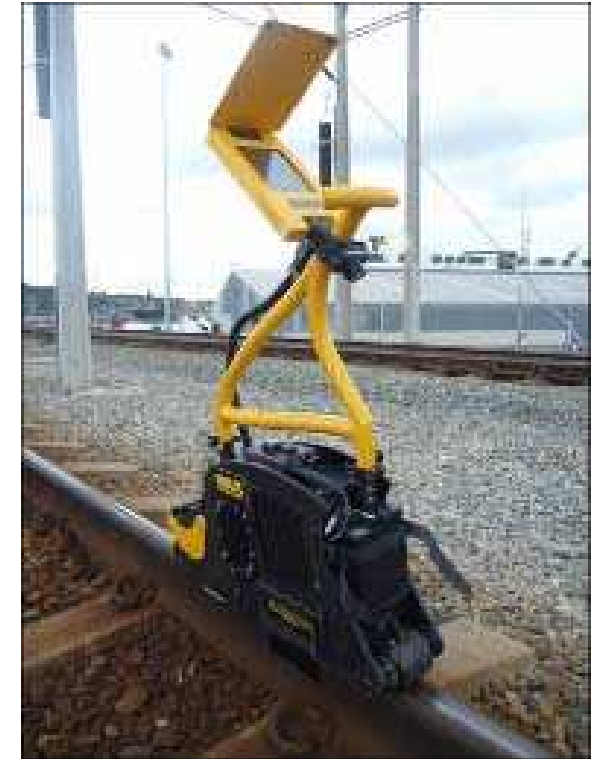
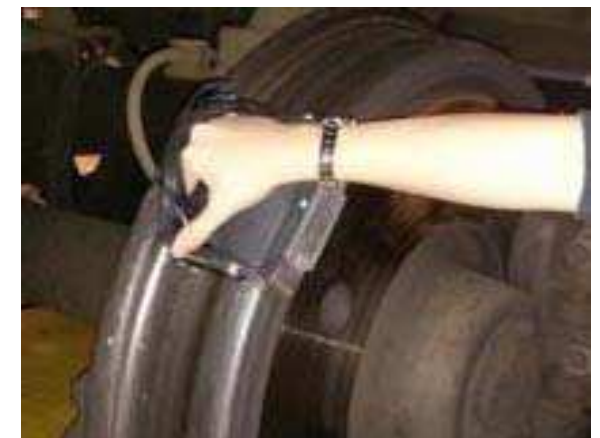
- MRX's Surface Crack Measurement (SCM) technology has been in use on rails for 8 years+
- 2014: MRX adapted the technology to measure surface cracking on wheels
- 2015: MRX awarded funding through the RSSB to validate the hand held product
  - collaboration with Bombardier Transportation and University of Huddersfield

- MRX's SCM technology currently quantifies defects in the top 7mm of the rail surface and the top 10mm of a wheel surface

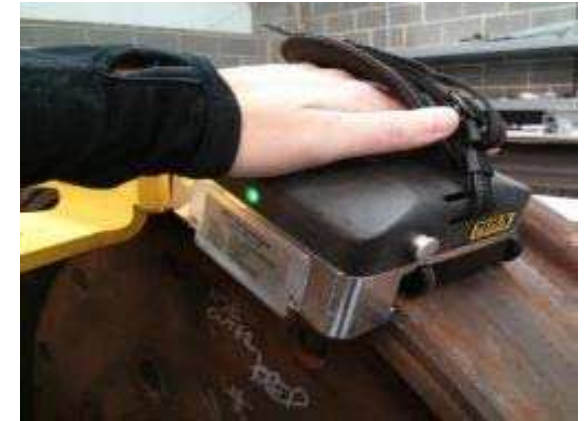
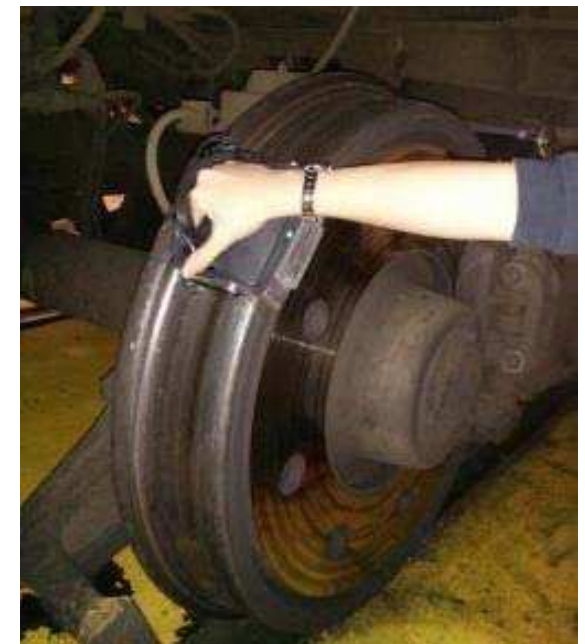
# SCM Technology Summary

- Wheel HHU reports the depth of the deepest artifact in the entire wheel scan
- Reported depth is the amount of material to remove from the wheel profile to eliminate the deepest artifact in the scanned segment
  - **1mm = Lower detection limit (shallowest)**
  - **10mm = Upper detection limit (deepest)**
  - **+/-0.5mm = System accuracy**

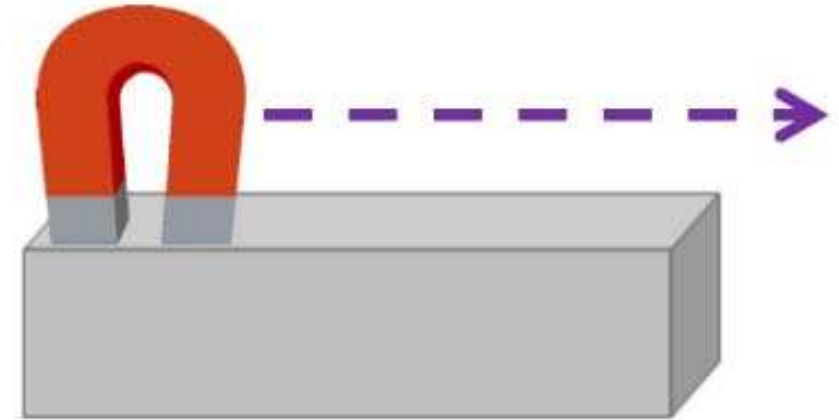
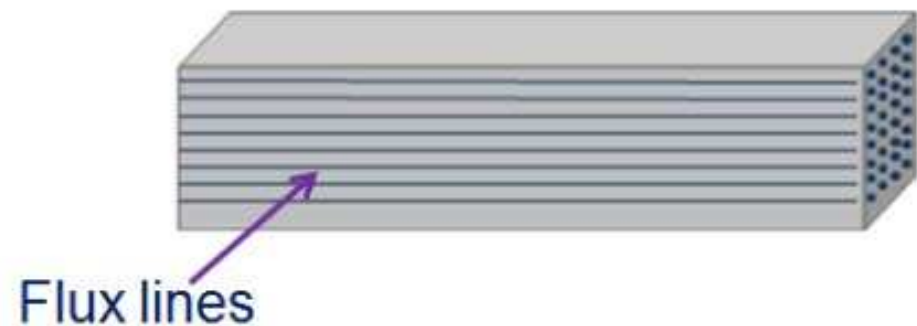
# Theory of SCM

- SCM involves magnetizing the specimen surface
- This introduces lines of magnetic flux into the specimen

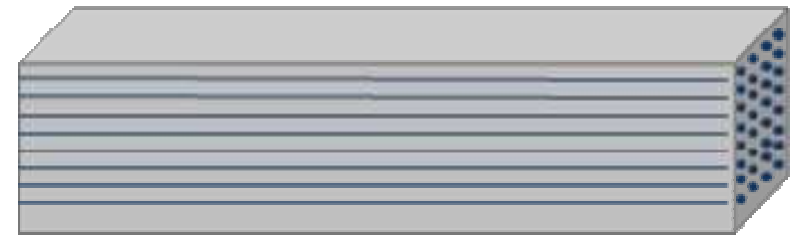
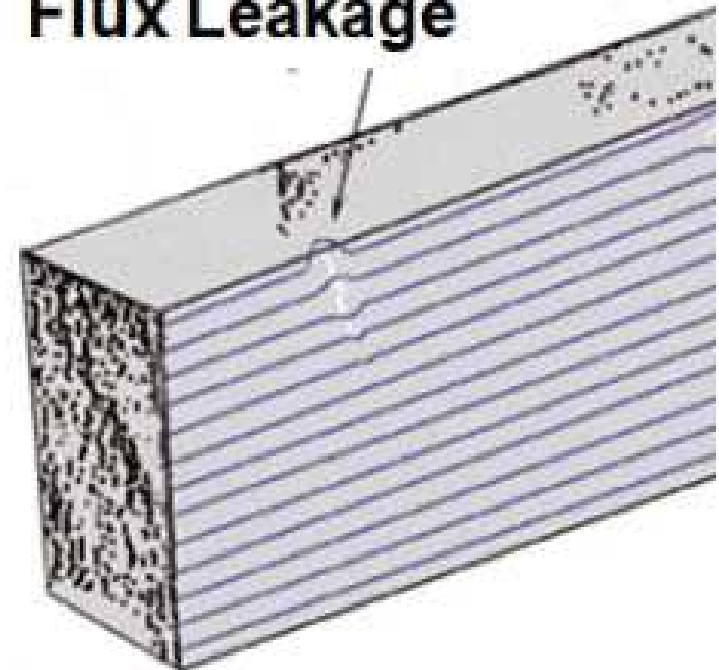
## Flux Leakage

- In a defect free specimen, these lines travel undisturbed through the specimen
- If a defect is present, the flux cannot travel as easily through it
- This causes some flux to leak at the position of the defect
  - SCM uses sensors to measure and record the leaking flux
  - This data is analysed to quantify the artifacts

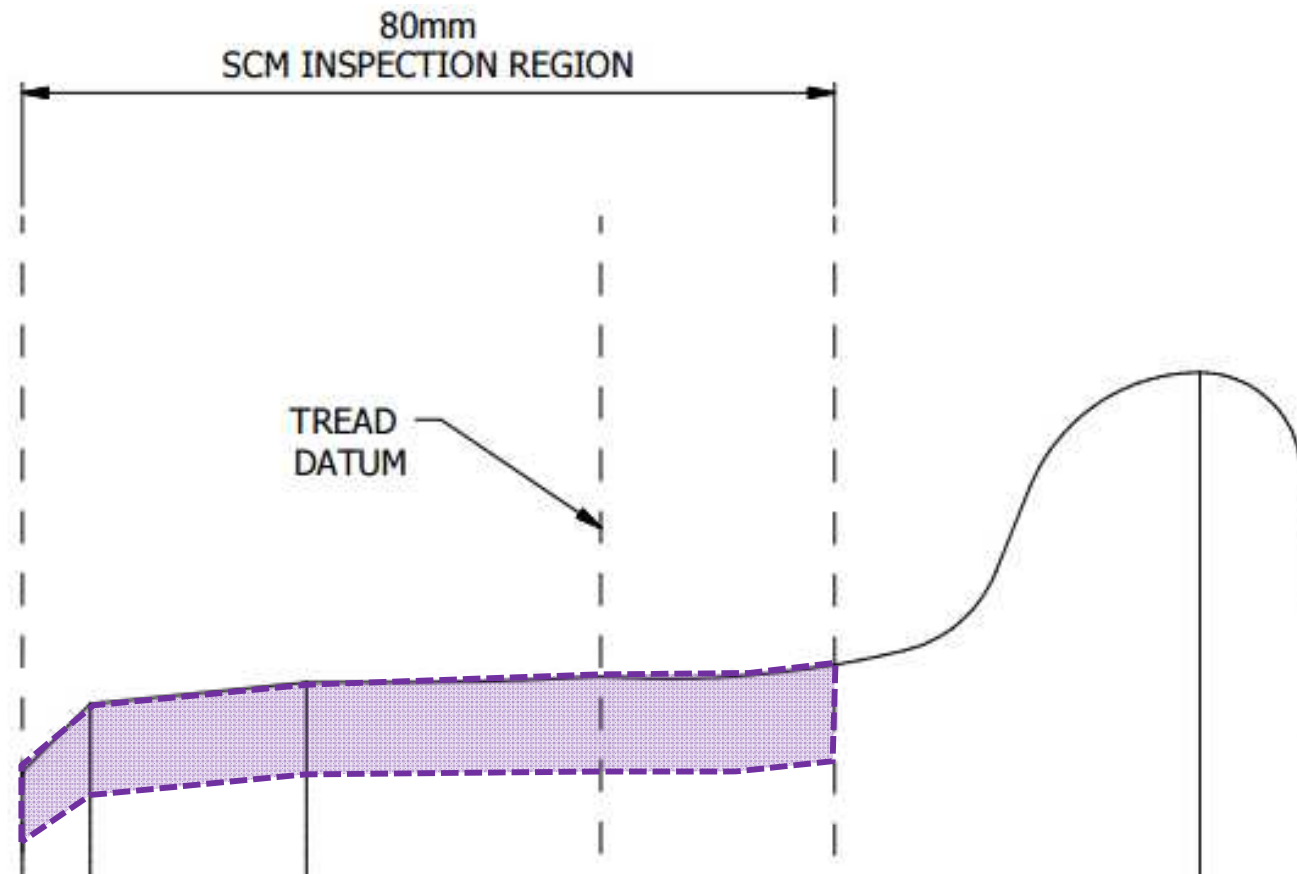
# Wheel Sensor Layout

- Wheel SCM contains 16 magnetic field sensors spaced at 5mm pitch across the wheel tread
- These cover a typical P8 profile as shown:

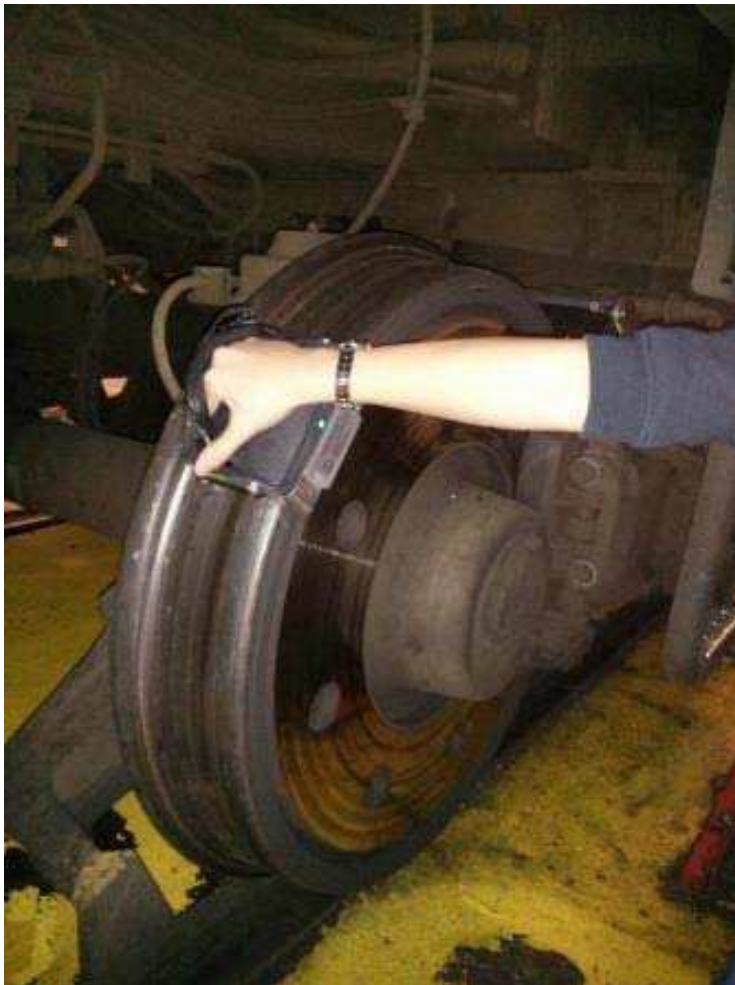
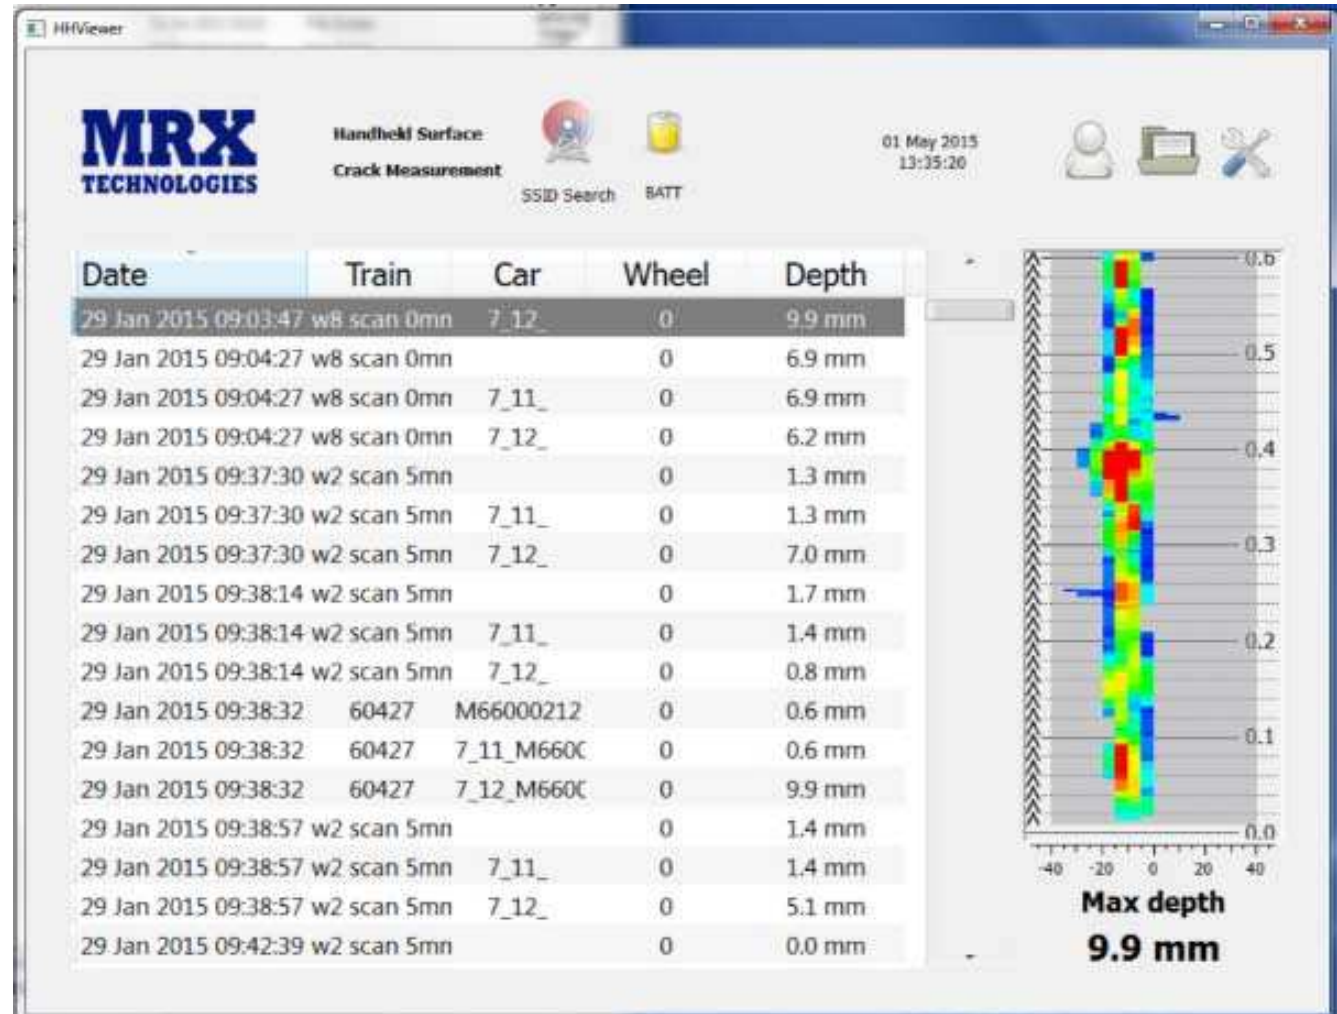
# Wheel SCM HHU

Data is available to the User immediately at the end of a scan

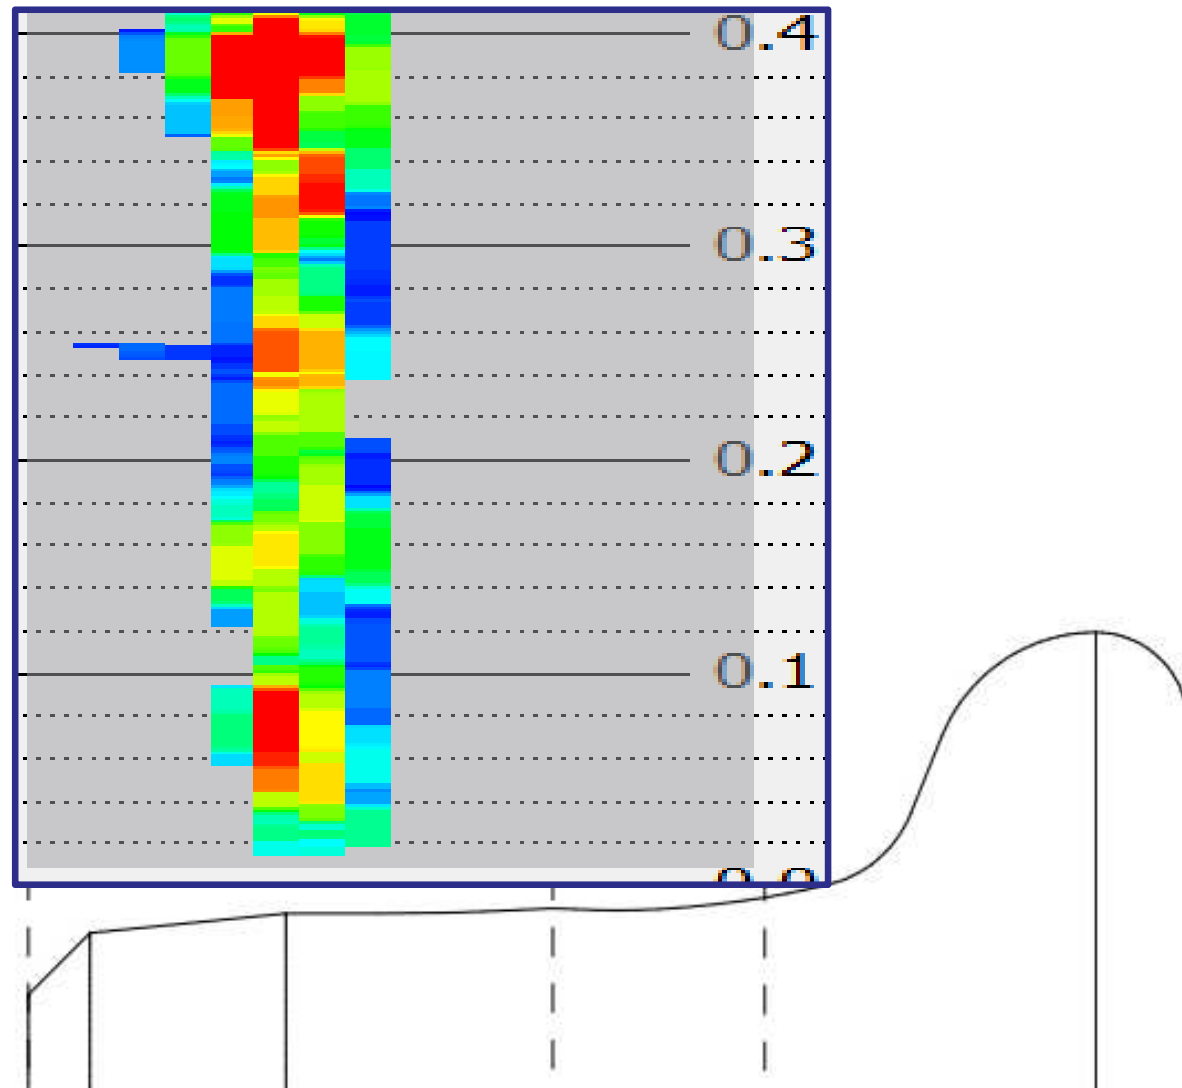
# Data Output

16 SCM sensors produce a damage map of the wheel surface:

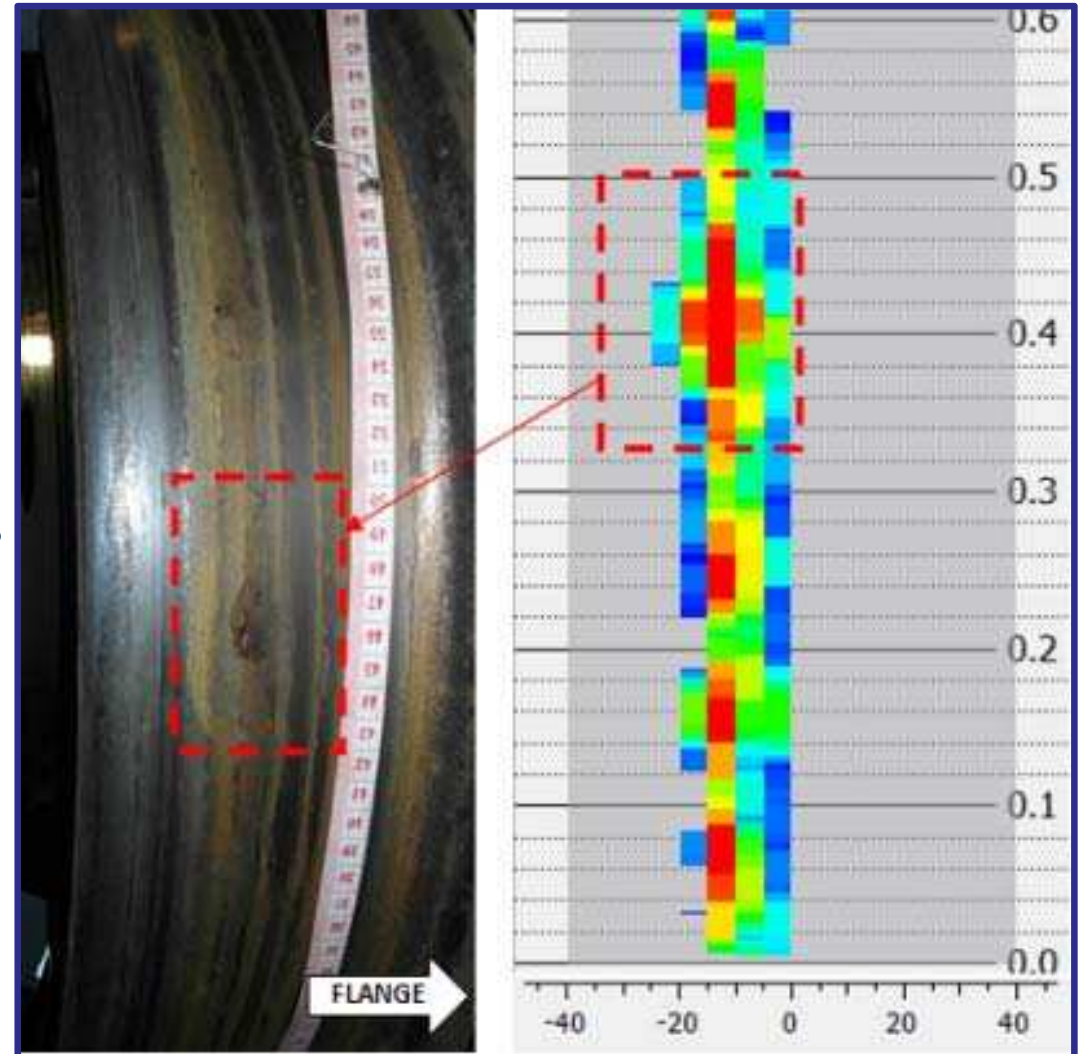
# Damage Types

- Surface breaking and near-surface damage
  - Rolling contact fatigue (RCF) cracking
  - Thermal cracking and cavities

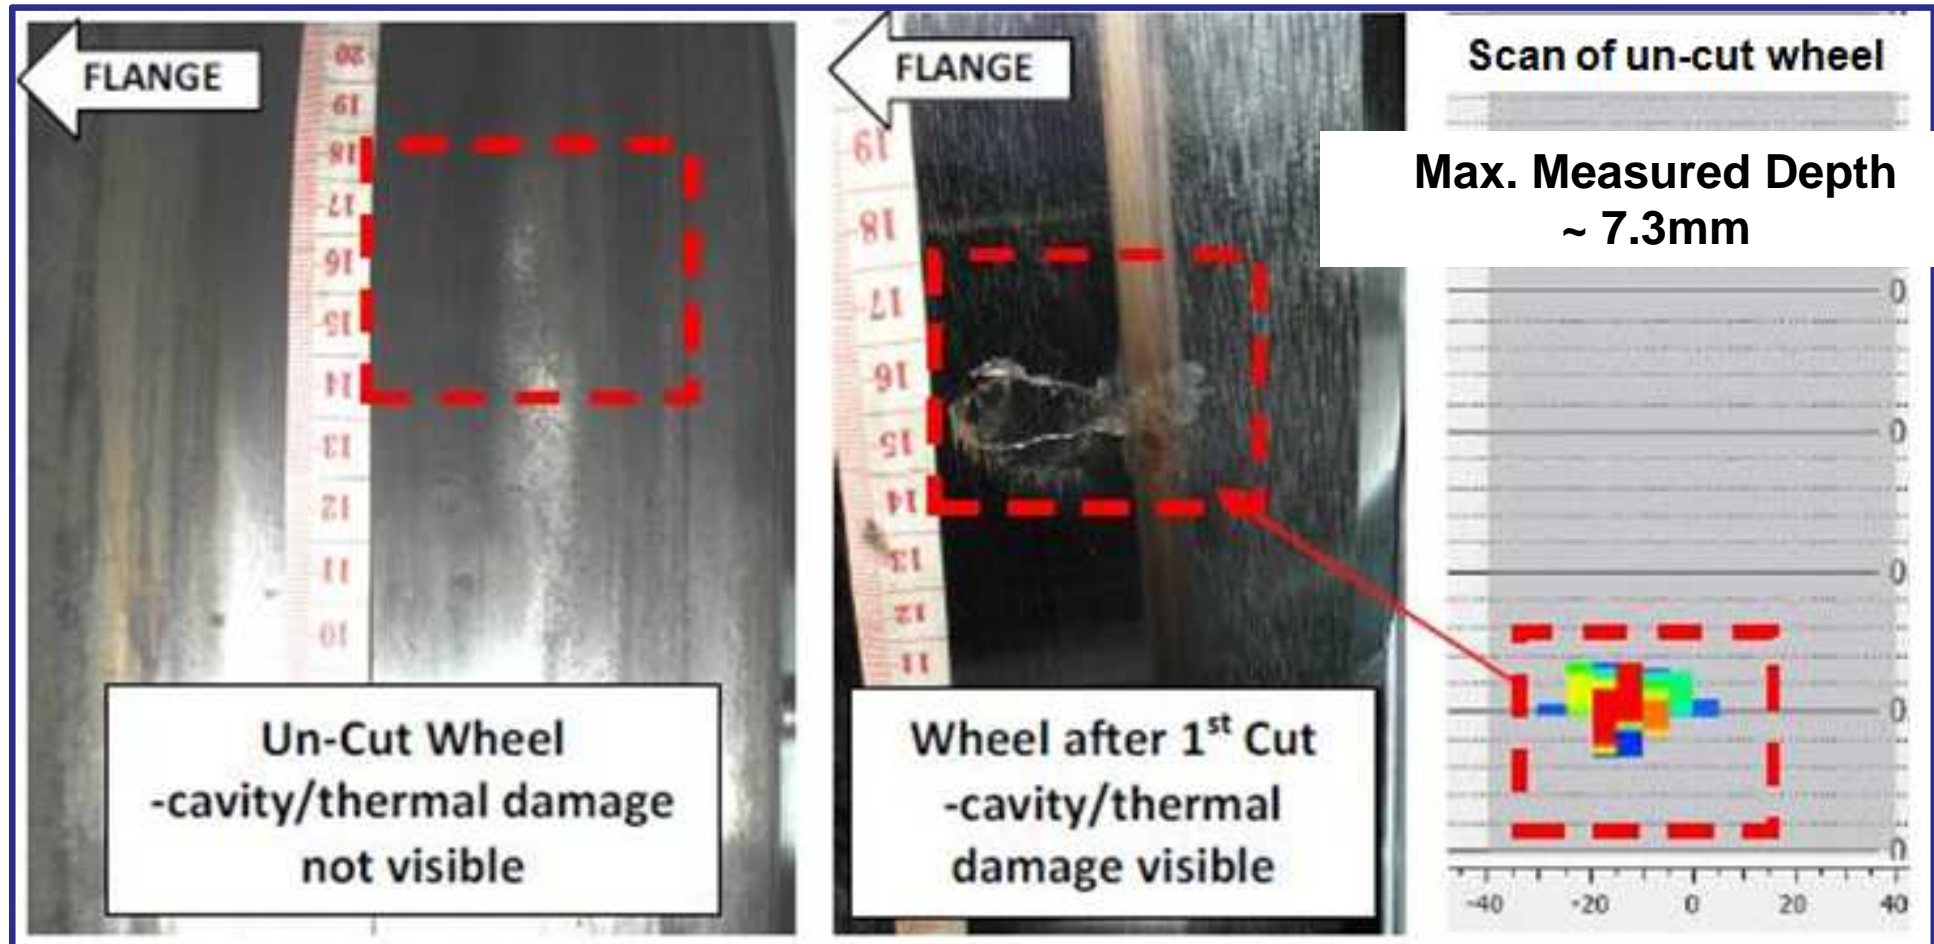
# Non-visible Damage

- HHU reveals damage not visible on uncut wheel

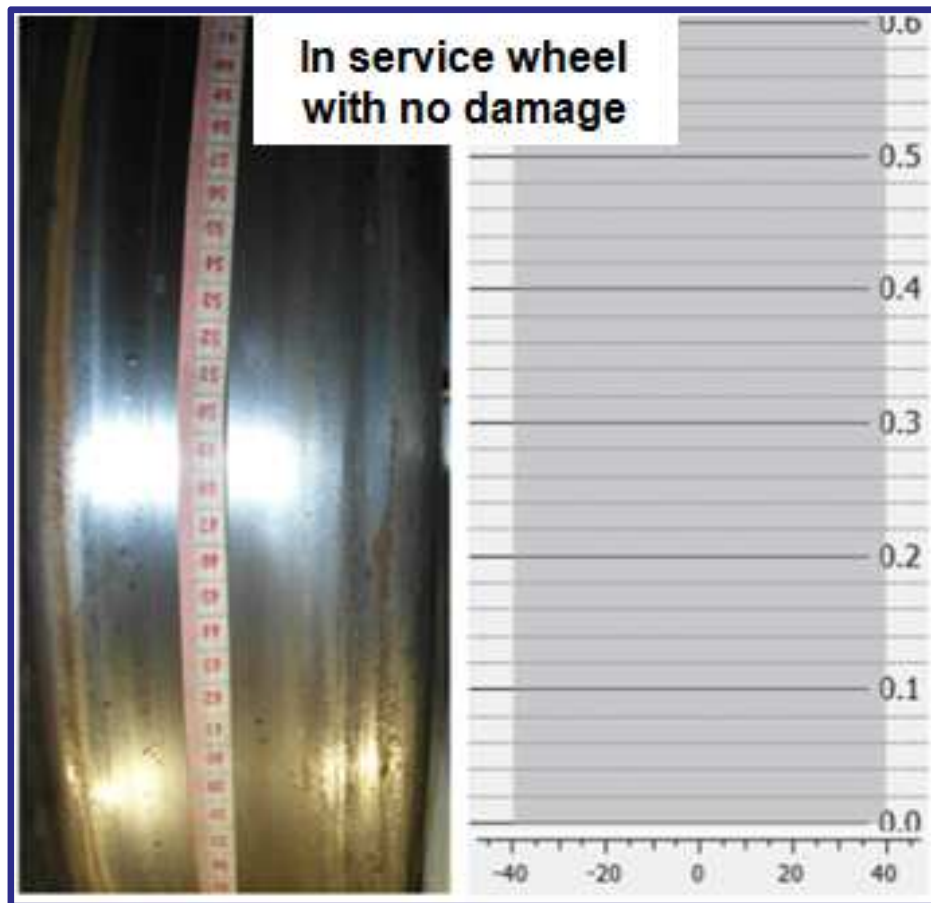
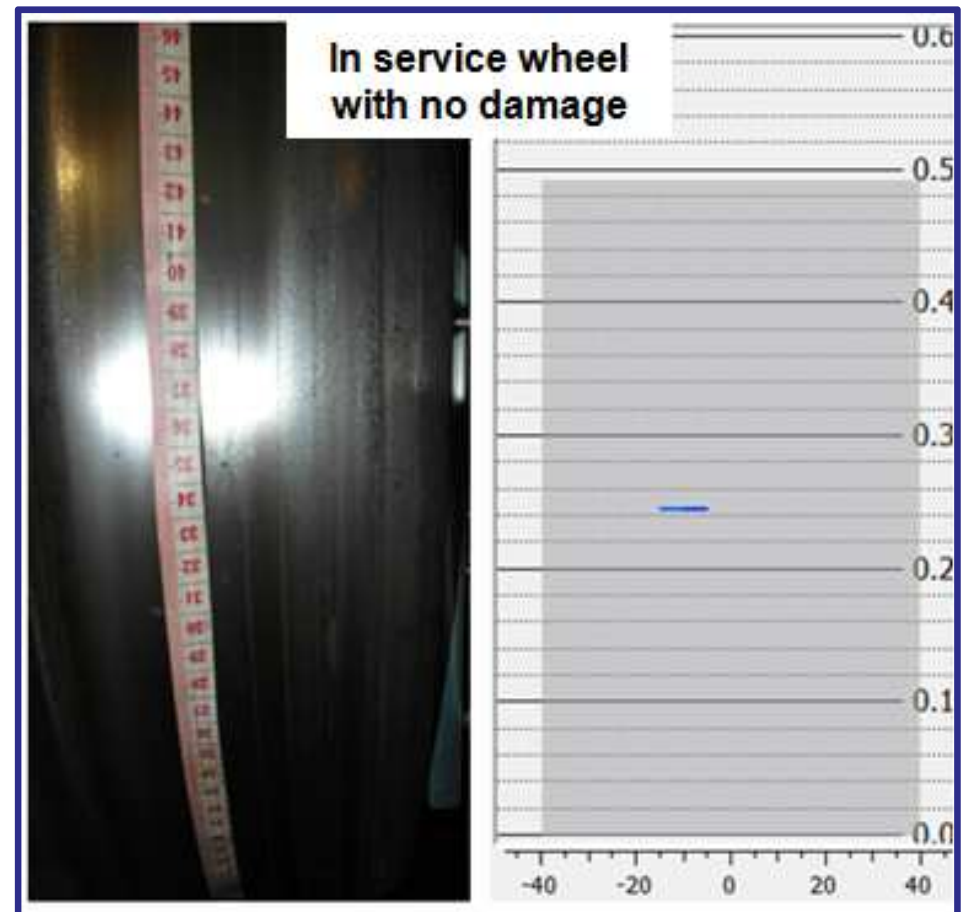
# Damage Free Wheel

- Confirms when wheel is damage free

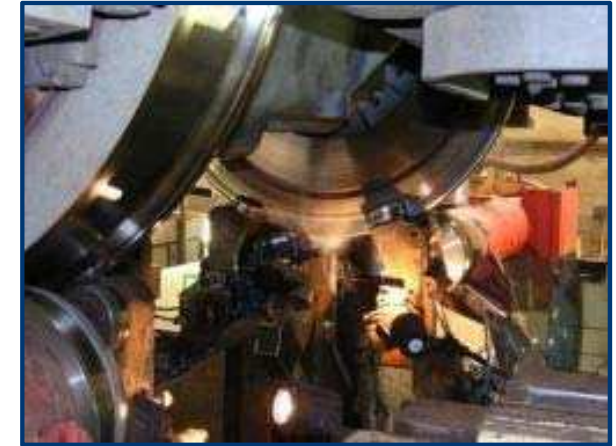
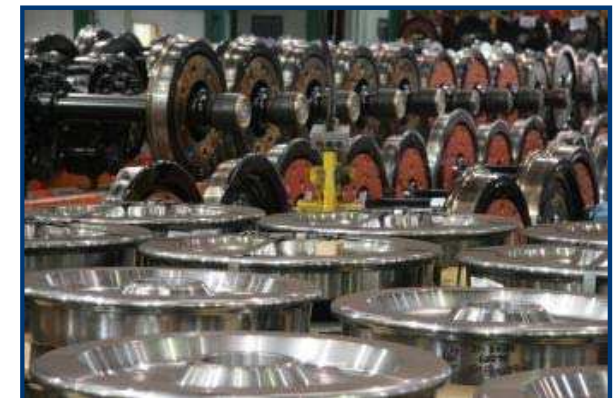
## Case Study 1:

Use of HHU during regular inspection (prior to wheel turning) to optimise cut depths at the wheel lathe

- Potential benefits:
  - Cut depths identified prior to reprofiling
  - Sub-surface damage not-visible during visual inspection identified
  - Confirm wheelsets requiring largest cuts and minimum cut depth required to maintain parity (prior to reprofiling)
  - Less time at wheel lathe
  - Extended wheel life (up to 2 reprofiling activities)

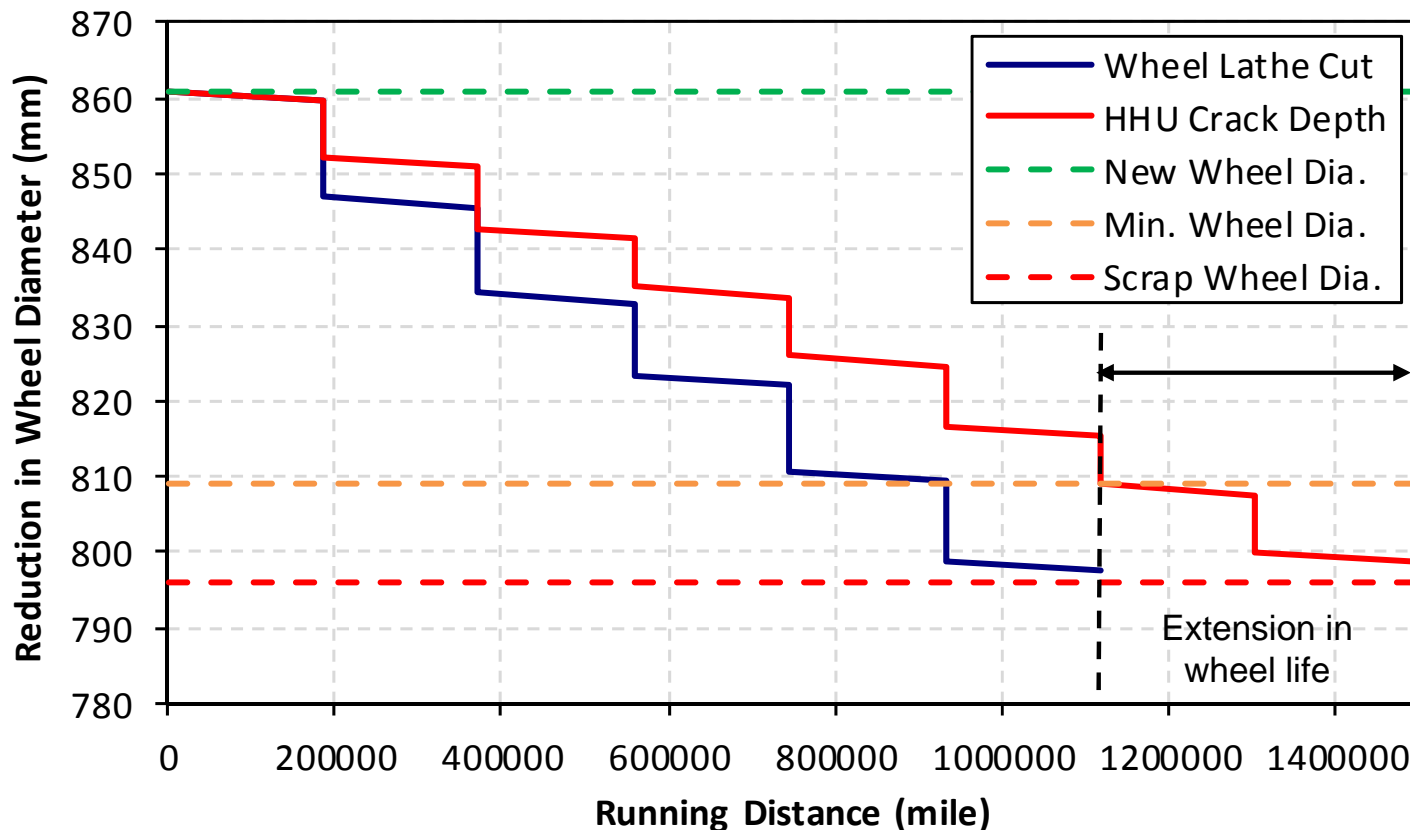
# Optimise Cut Depths

- Wheelset life tracked based on observed average wear rates and cut depths (with and without use of HHU). 40 wheels observed during the study
- Potential increase in wheel life by 2 additional turning activities (~370kmi) and potential saving in wheelset costs of ~25%

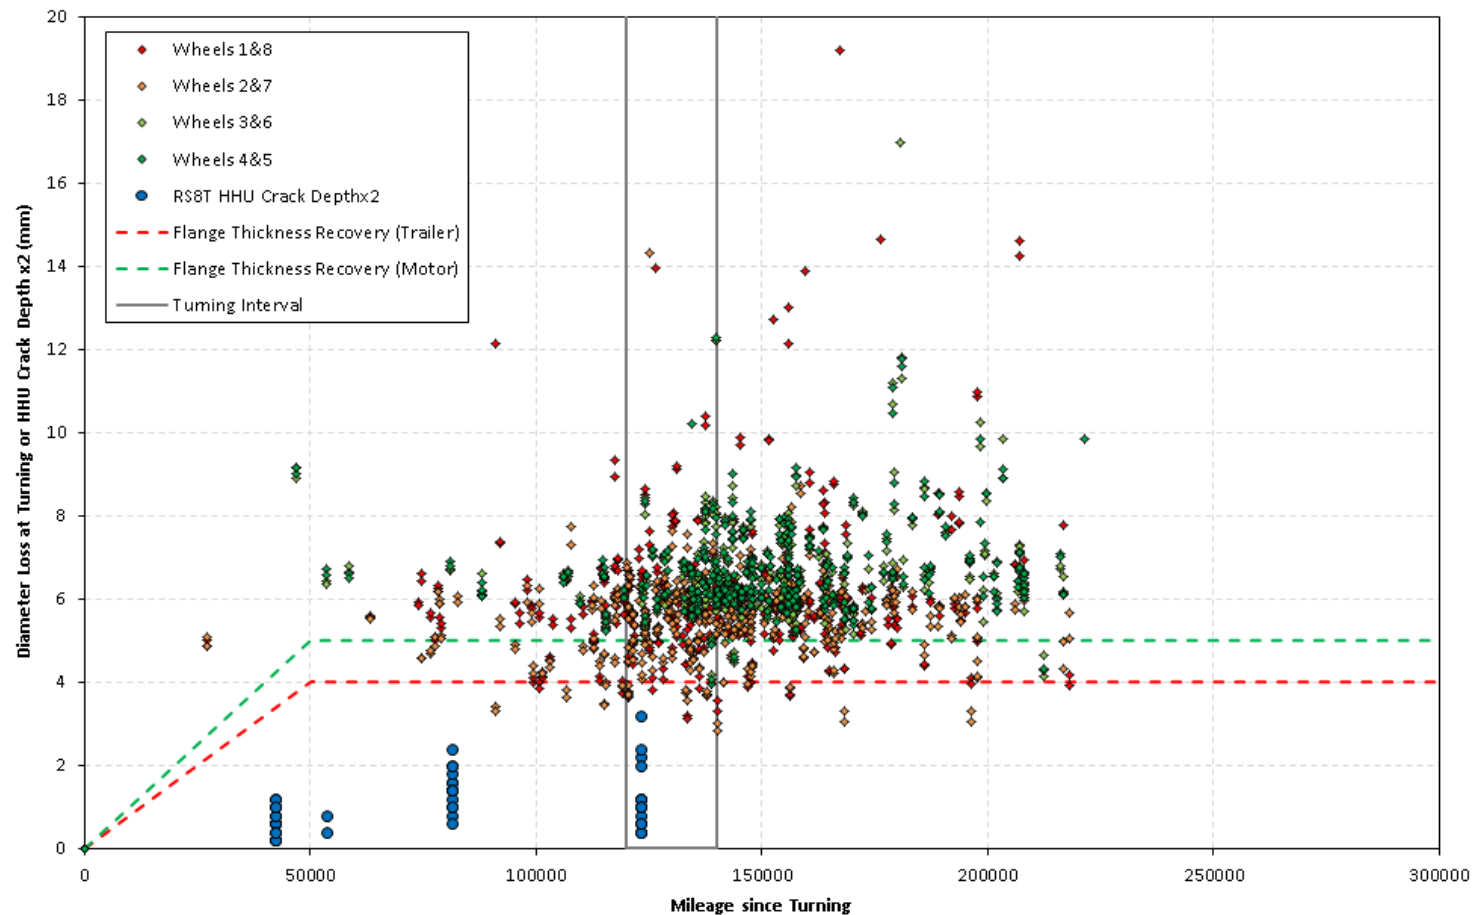
# Maintenance Decisions

- Benefits of alternative wheel steel (RS8T) quantified in short timeframe using more repeatable HHU data
- Decisions whether to apply to the entire fleet can be made sooner ~ greater savings in costs during franchise
