Master Thesis in Geosciences

On the dynamics of debris flows

Case study Fjærland, Western Norway - a debris flow triggered by a natural dam breach

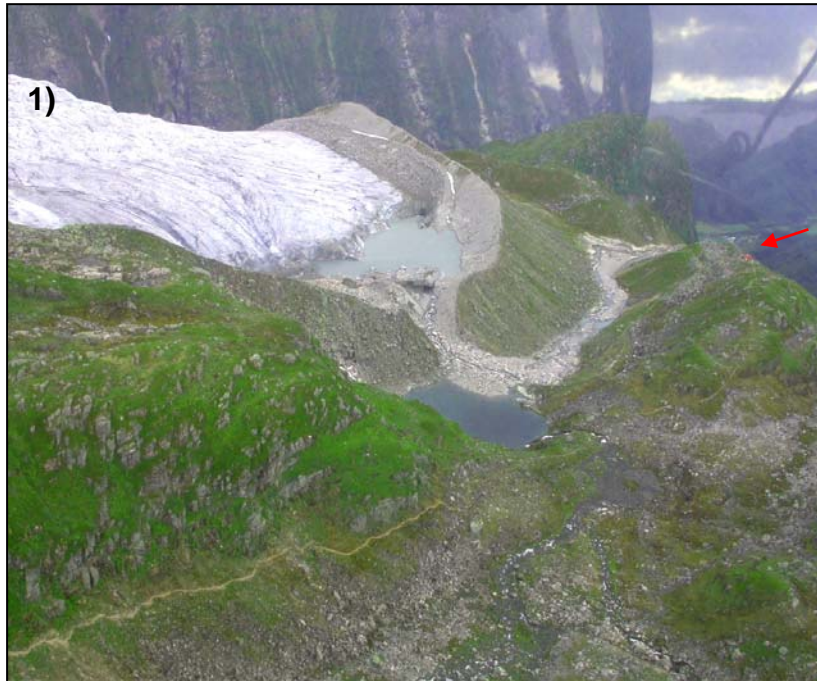
Figure 2.3

Overview of the dam failure area and the upper 350 meters of the track. The cabin Flatbrehytta is seen at the precipice on the right as a red dot. Photo taken from helicopter in summer 2004, by H. Elvehøy, NVE. See map and air photo in Figure 2.1 and Figure 2.2.

It is not likely that the flow has had a very high velocity in the beginning of the event, as it took a sharp turn (90°) and did not damage the small lake immediately downstream the moraine ridge (see Figure 2.3). Most of the masses from the scar (25 000 m³, see Chapter 8) were deposited immediately downstream the ridge. This is not consistent with a high flow velocity. Especially large boulders are found just downstream the scar.

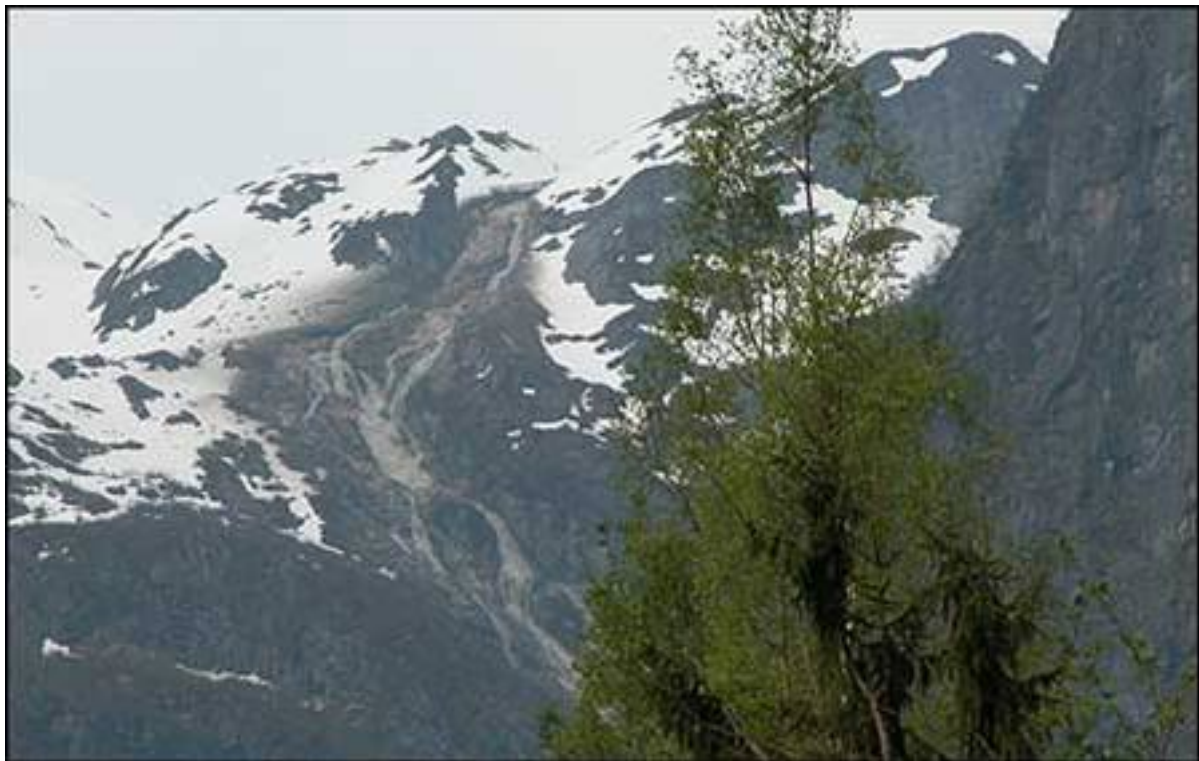
Figure 2.5 The debris flow track at the precipice a few hours after the peak flow shows that the masses spread over a wide area in this section. Water is still flowing. Photo: G. Eithun.

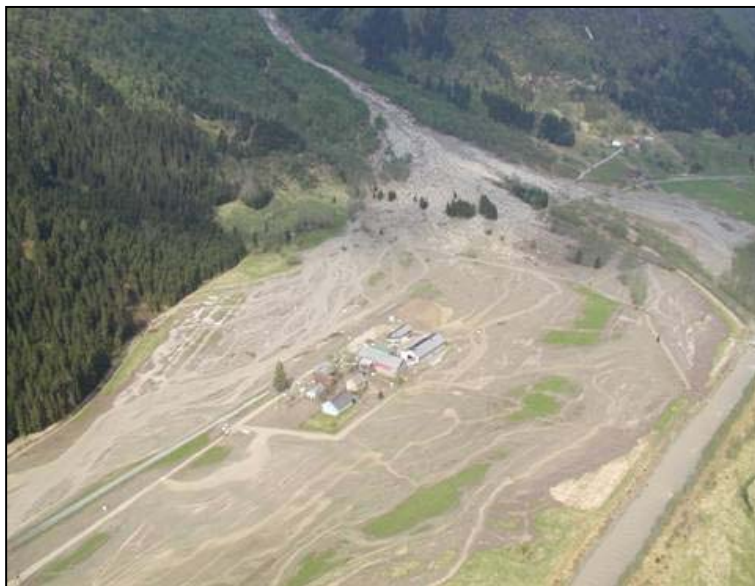
Figure 2.6 Fan and inundated fields at the farm Øygaard. The nearest houses of Supphella are seen in the background. Øygardsneset could be found some hundred meters from the lower left corner. Photo: E. Øygaard.

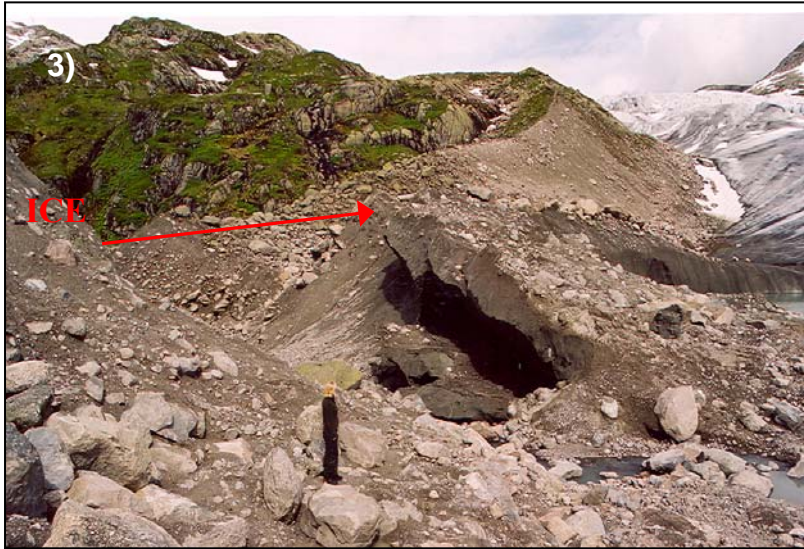
Figure 2.8 Failure seen from upstream side of dam. The ice structure in the middle of the picture may be ice transported from the glacier and covered by sediments, or an inner part of the moraine. Part of the lake is visible in the right corner.

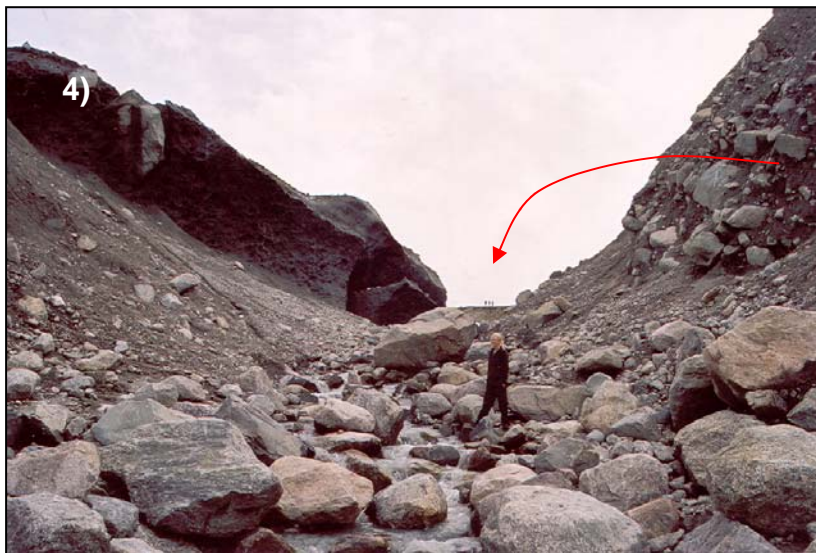
Figure 2.9 The moraine failure scar seen from downstream toe. Three persons are visible at the crest on the opposite side of the lake, and one person is in the middle of the breach.

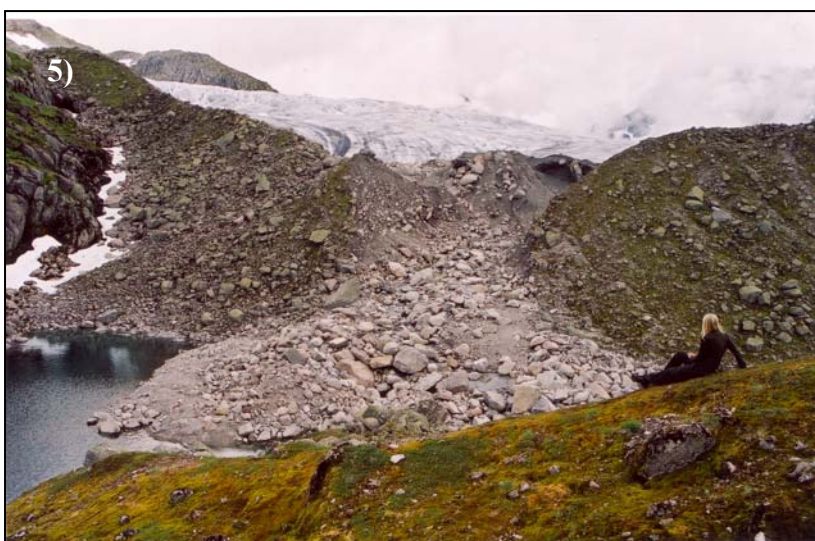
Figure 2.10 Most material from the dam breach is deposited immediately downstream the scar.

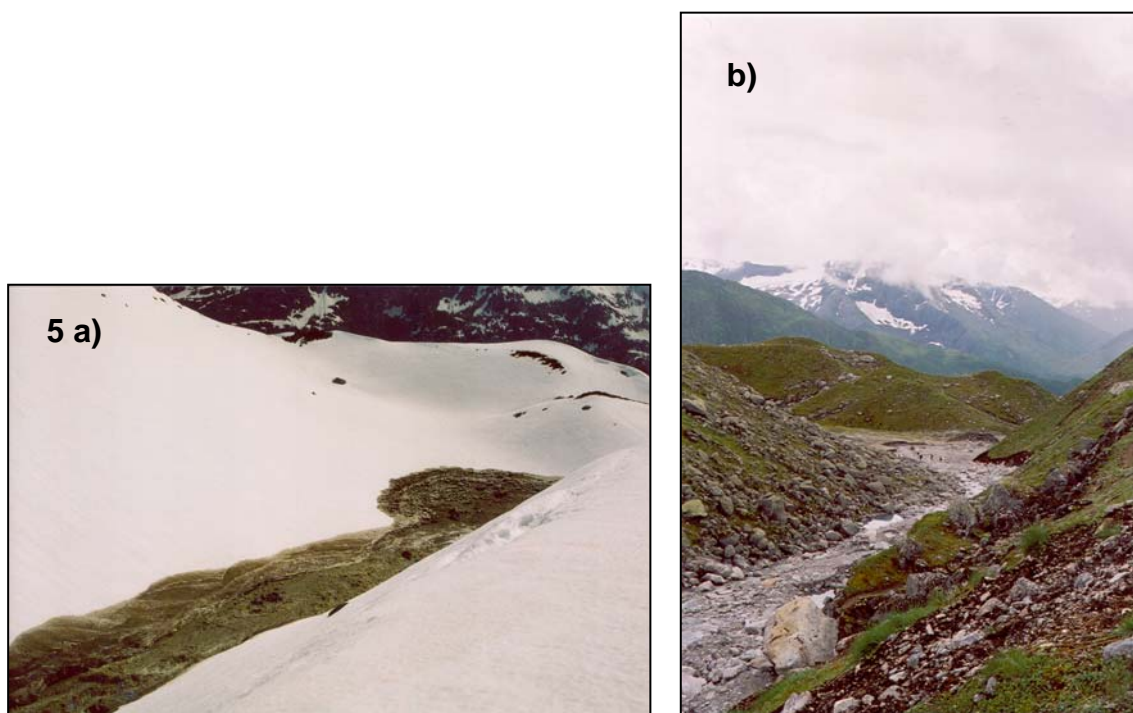
Figure 2.11 a) Along the first 300 m of the path the masses ran on snow. Photo: E. Øygaard. b) The same area shows little evidence of the debris flow three months after the event. Lower part of moraine ridge is seen to the left.

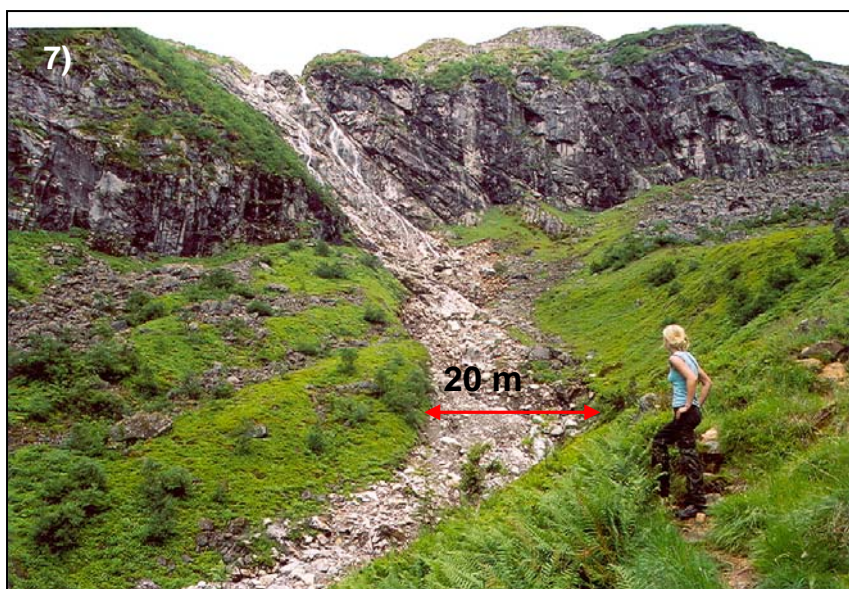
Figure 2.13 Lower part of the precipice and depression where the water hit the ground.

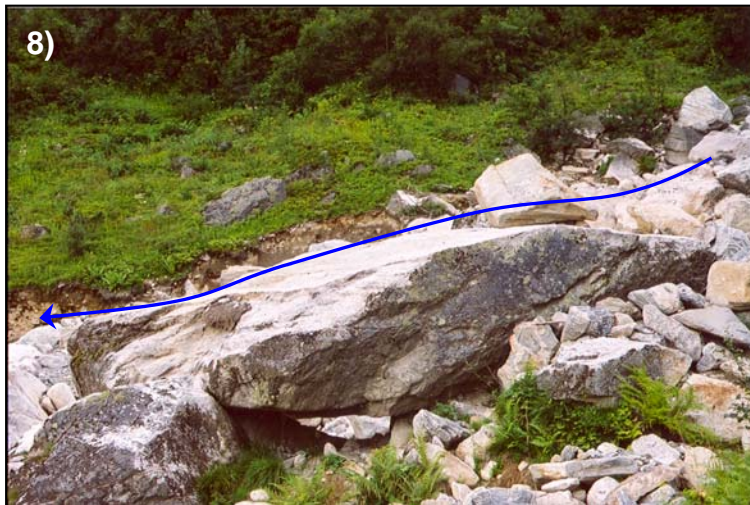
Figure 2.14 The debris flow has run on top of the stone as this part is bare, whilst its side against the camera is unaffected and covered by lichen.

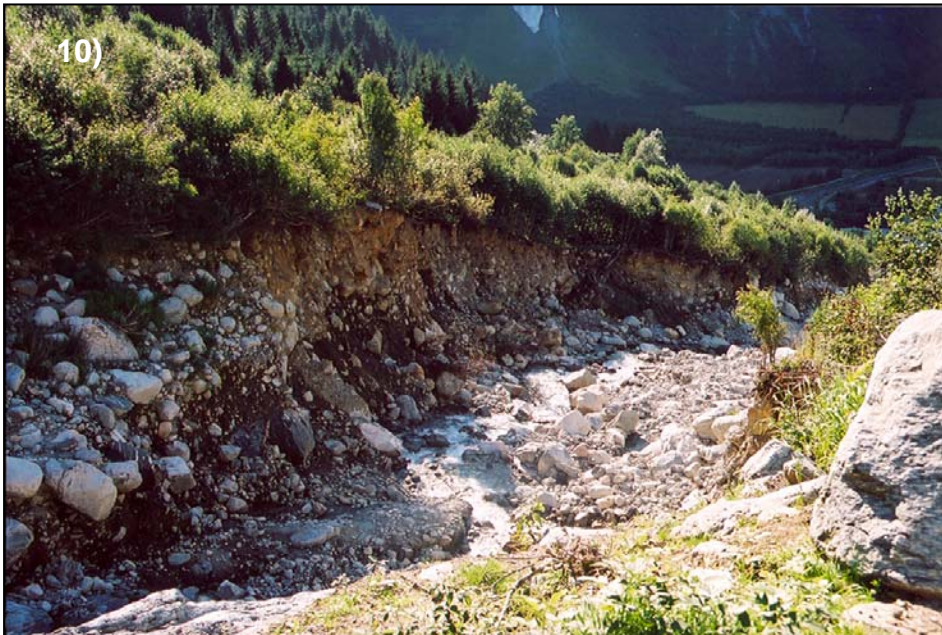
Figure 2.16 The vertical sides of the erosion track are up to 8 m high. The upper red part of the material is the weathered soil.

The soil material as far down the valley as shown in Figure 2.16 seems to be finer grained till than at higher altitudes, but a high content of large boulders is evident. The deposit is characterised by a weathered, upper layer up to a few meters thick, and a more coarse-grained lower layer. Blocks are found throughout the whole profile but seem to be more concentrated in some areas. The weathered part is seen as the reddish upper few meters of the profile shown in Figure 2.16. The almost vertical sides of the gully were still standing when the field investigation was done, three months after the event.

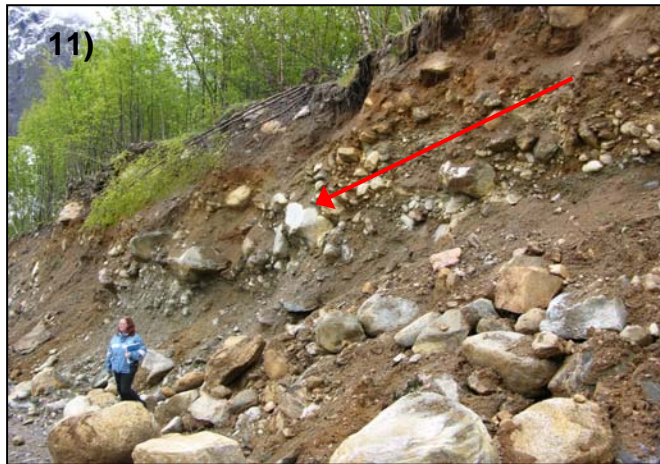
Figure 2.17 Old slide deposit in eroded gully sides, elevation 150 m.a.s.l., most probably being the 1947-event. The erosion depth is here more than 5 meters.

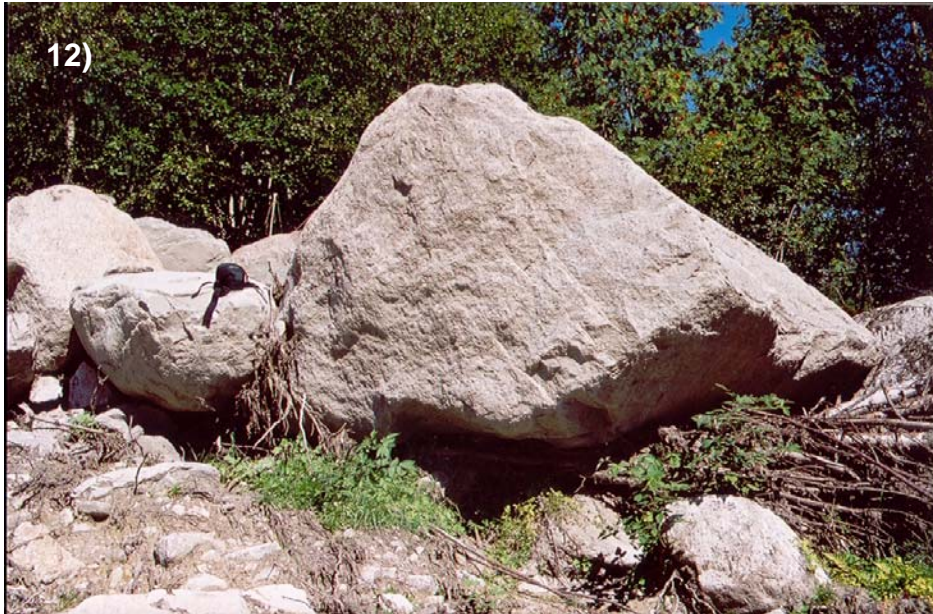
Figure 2.18 A large boulder has crushed a tree just outside the torrent track. For scale, a camera bag can be seen on the left of the large boulder. Debris flow has passed in the left part of the picture.

Some of the boulders fractured during collisions with other boulders (“exploded”) are found up to 25 m outside the main track near the fan area (Figure 2.19). The position of the rocks as well as its fractures, are very young, pointing towards recent cracking. Other boulders considerably larger (diameter up to 3 m) have been shown to be moved, if not in such a dramatic way, as they are lying over trees just outside the torrent track (see Figure 2.18).

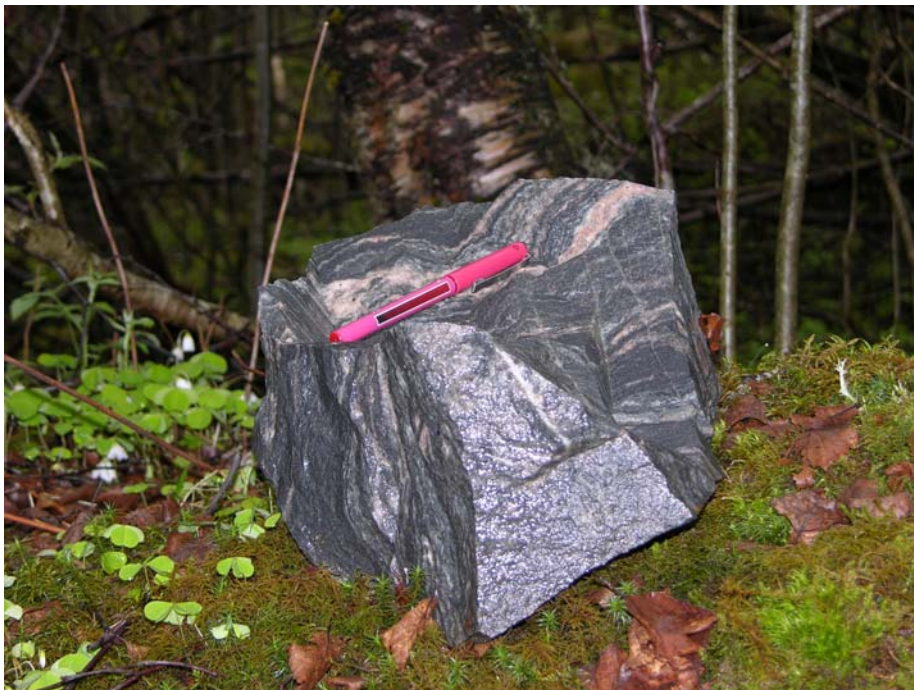
Figure 2.19 Recently fractured stone found 20-25 m from main track at elevation 100 m.

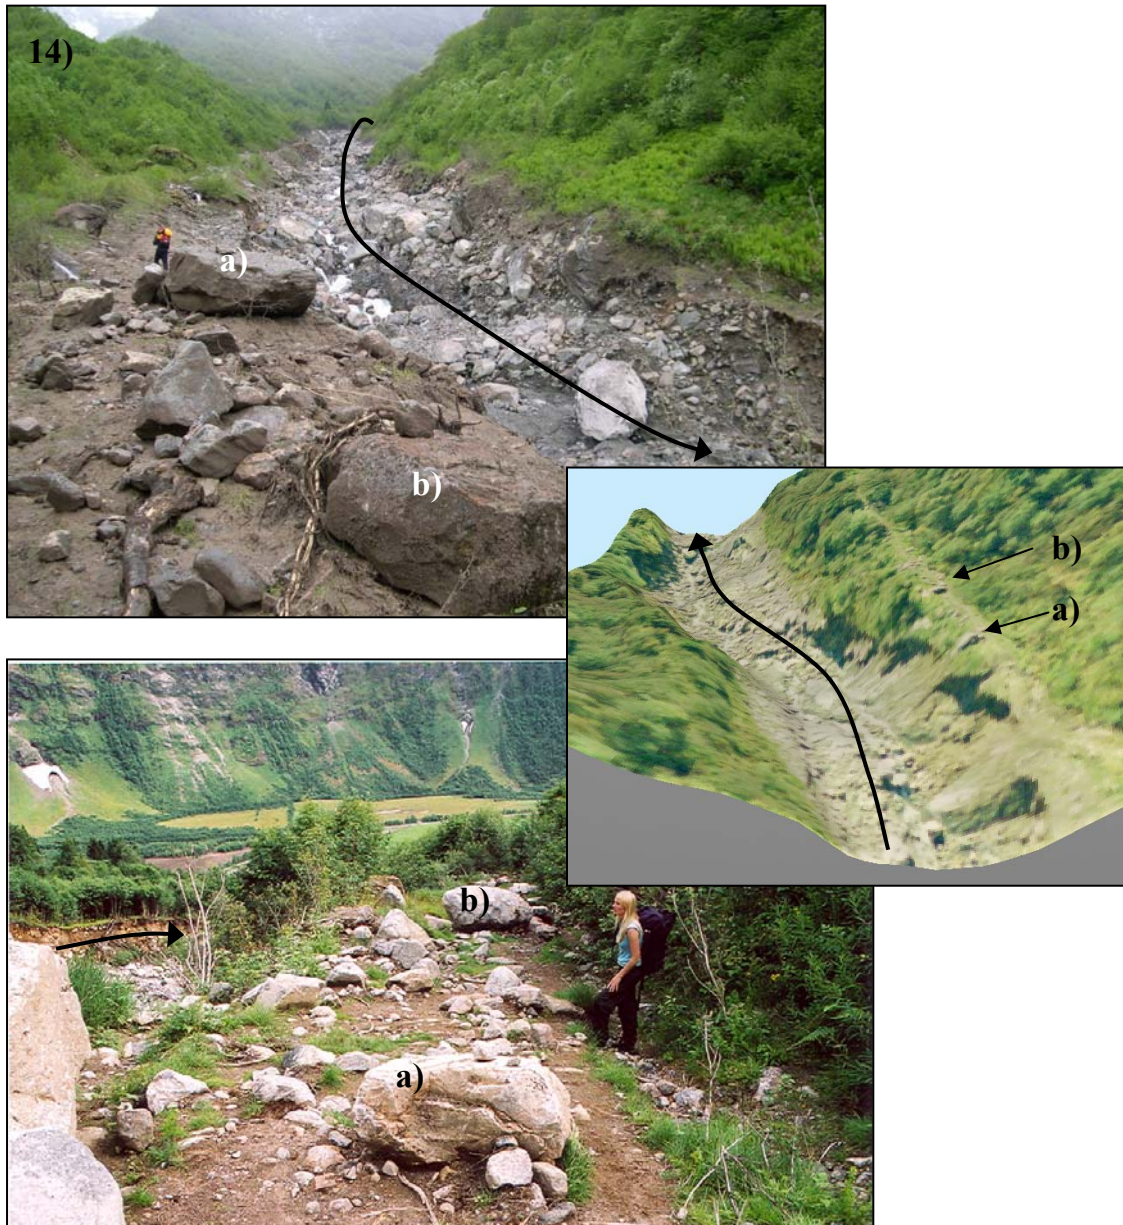
Figure 2.20 Boulders have been thrown up on the shoulder of the gully from the debris flow. The upper photo is taken a few days after event (photo: E. Loe), the lower three months later. The middle right 3D-figure is made by draping an orthophoto over a terrain model. The letters mark the corresponding boulders in the three pictures.

As the flow propagated and entrained material, the density of the flow is considered high (around 1.8 g/cm^3) in the lower parts of the track due to the boulders found on the nearby tourist path at around 200 m.a.s.l. (Figure 2.20). Sediment and water volumes are further discussed in Chapters 6 and 8. The split stones found 20 m from the track indicate that blocks of this size and larger were in turbulent suspension or thrown up from the torrent passing by due to grain collisions, and settling on the flank.

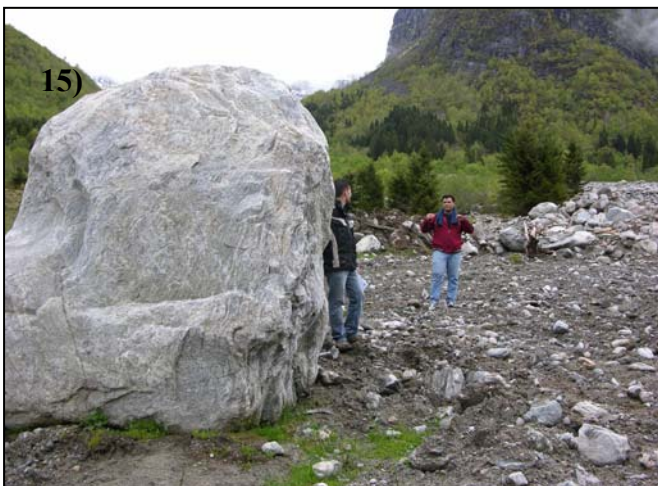
Figure 2.21 Dimensions of largest boulder found. Deposited outside the main fan area.

The area was covered by 5-10 m high trees before the event. After entraining the trees, the debris flow filled the lower lying road and parking lot with large boulders of the size of small cars. The outermost boulder has stopped at the flat farmland almost 450 m from the beginning of the fan, at 20 m.a.s.l.. One of the largest boulders found ran almost 90 degrees off the main flow direction and stopped 50 meters from the main fan (see Figure 2.21).

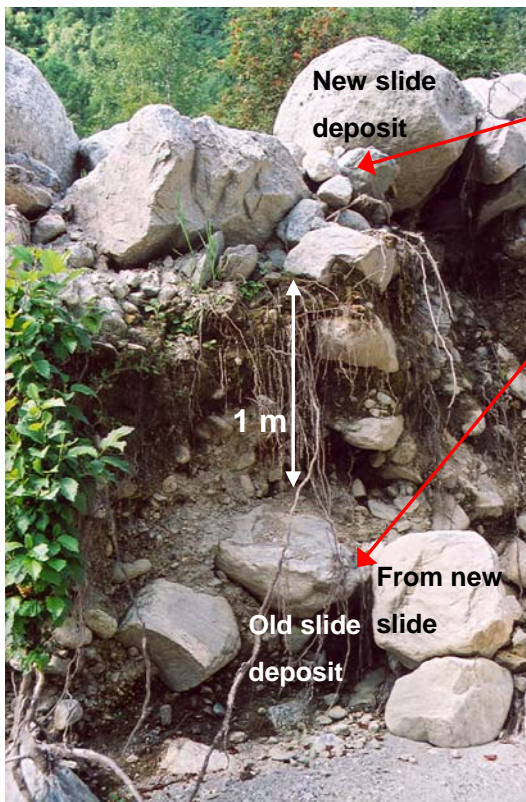
Figure 3.1

On the flanks of the fan cuts exposing old slide material are found. The boulders on top of the soil are fresh and originate from the 2004 debris flow, whilst the boulders seen beneath one m of mould were deposited here in the past.

When examining the fan deposit, scoured areas on the flanks have revealed sediments that probably are old landslide or debris flow deposits (Figure 3.1). Under a layer of soil, stones and boulders can be found, resembling the deposit of the new fan. According to Eirik Øygard all the hills in the opening of Tverrdalen (100-150 m.a.s.l.) towards Supphelledalen are landslide deposits. Also the presence of alders, which are the fastest to recover after a landslide, indicates unstable times. It should however be noted that snow avalanches are common in the area.

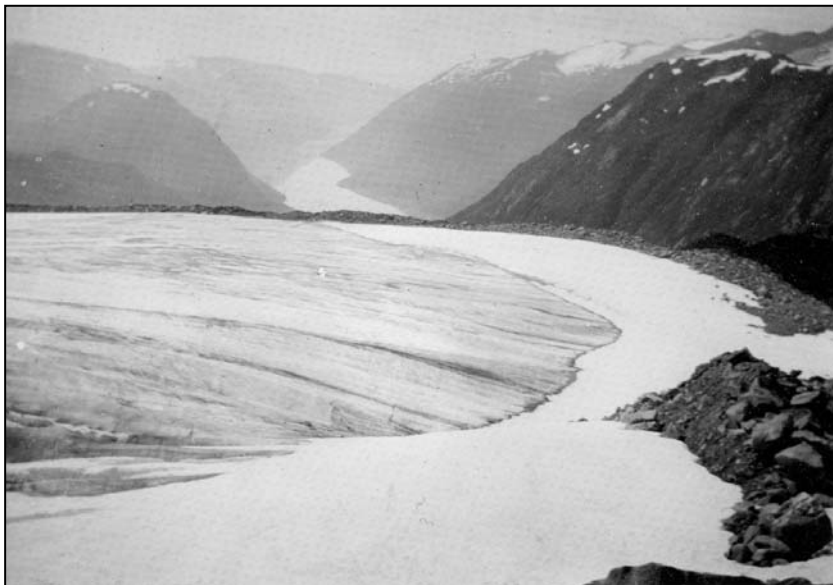
Figure 5.2

Supphellebreen anno 1906. Photo taken towards the moraine and the Fjærland fjord. No lake is evident. Photo: Monchton, NGU photo archive.

There has been a brook due to overtopping at the place of the scar also before the event, as this has been the lowest point of the moraine ridge since at least 1906 (see Figure 5.2). The pre-flow 3D-model (Figure 2.7) also shows a scar in the moraine ridge.

Supphellebreen reached its maximum around 1750 (Orheim, 1968), during the Little Ice Age. The moraine ridge damming the present lake probably dates back to this period. When studying the photos from 1906 and 2004 shown above (Figure 5.2 and Figure 5.3), the withdrawal of the glacier is evident, although periods of growth have been experienced. It is also clear that the shape of the moraine ridge has not changed much in the last 100 years. Only the smaller, inner moraine shown in the picture from 2004 could be of newer origin, probably from around 1930 when the ice had been advancing for some years and started retreating. The pictures show that already in 1906 the moraine had a lowest point where the breach is today (lower right corner in the photo).

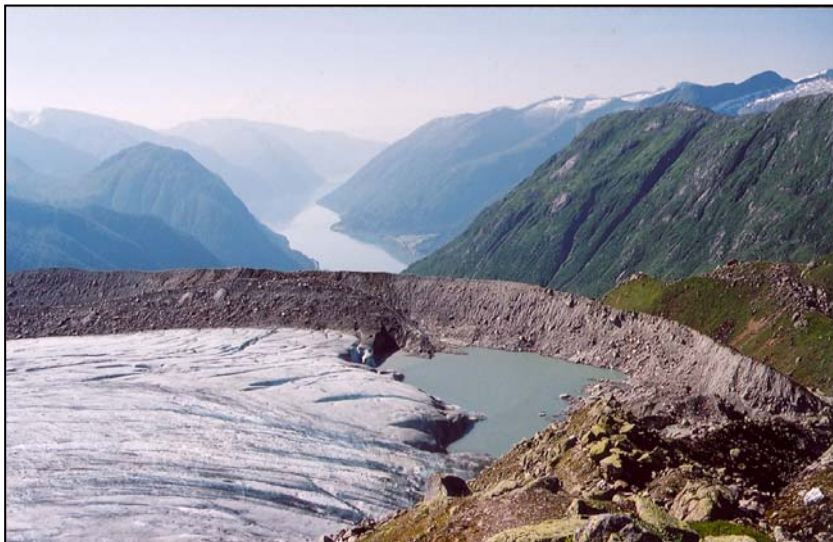
Figure 5.3

Supphellebreen anno 2004. A lake has formed between the glacier and the moraine. Failure of moraine in right end of the ridge. Normal drainage route is towards the left.

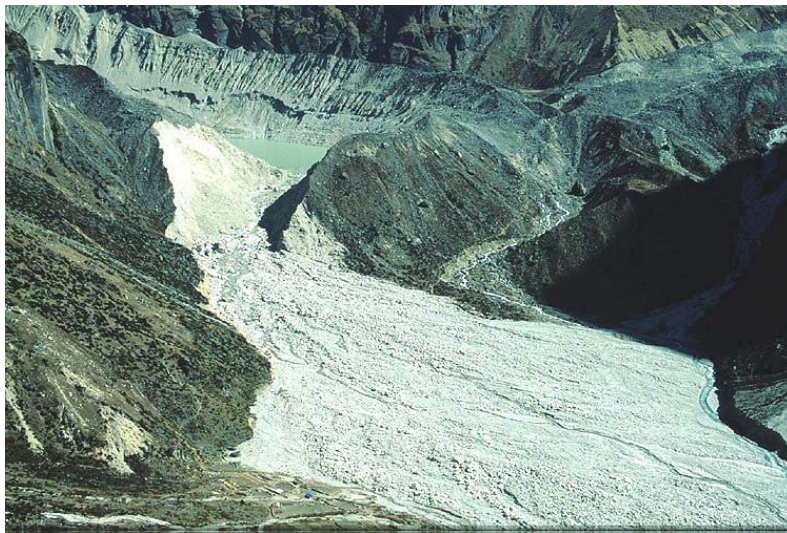
Figure 7.2

Breach of moraine causing glacial lake outburst flood and debris flow in high altitude Nepal. Photo: Øystein Lund.

It seems that the widening process in Fjærland has been stopped before the breach has reached a full trapezoidal form. Very similar breaches have been observed in enormous GLOFs from Himalaya (Figure 7.2). This could mean that moraine material dams may exhibit a larger resistance to breach widening than many other dam types, due to existence of cohesive clay material and/or ice.

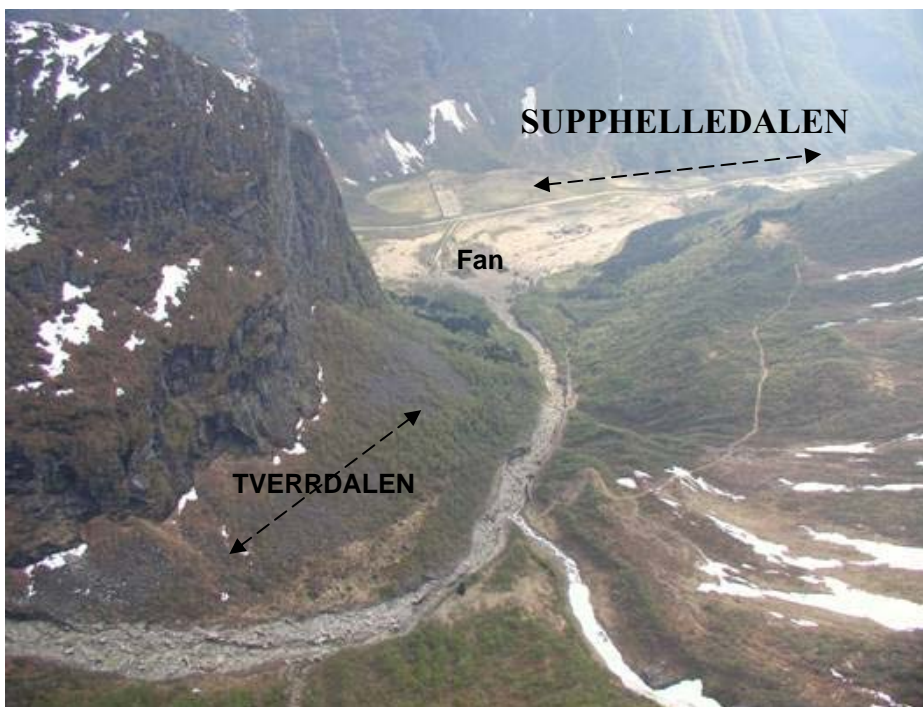
Figure 9.2 The debris flow track in Tverrdalen seen from the air in the direction of the flow a few days after the event. The fan is located where the two valleys meet. Mud is seen to inundate the fields in the flat lowland. Photo H. Elvehøy.

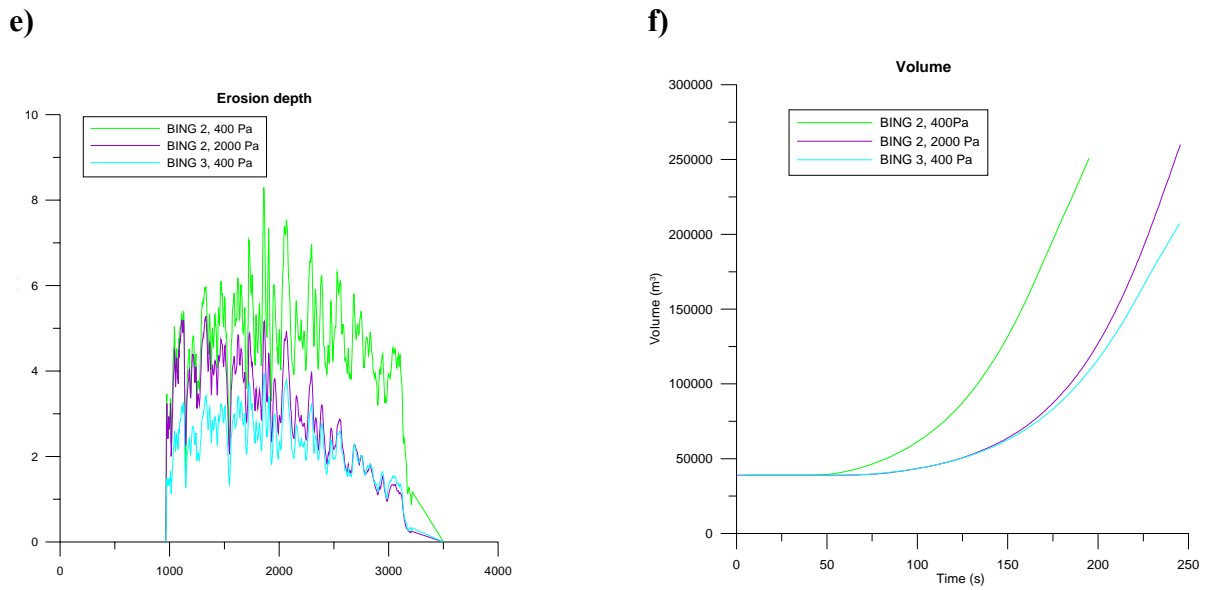
Figure 11.4 BING 2 and BING 3: Results from running the modified BING-model. Comparison of BING 2 (pure Bingham material with entrainment) and BING 3 (Bingham material with Coulomb friction and entrainment). Not to scale. a) Run-out. b) Run-out and profile of deposit. c) Velocity as a function of time. d) Velocity as a function of distance. e) Erosion depth along debris flow path. f) Accumulated volume.

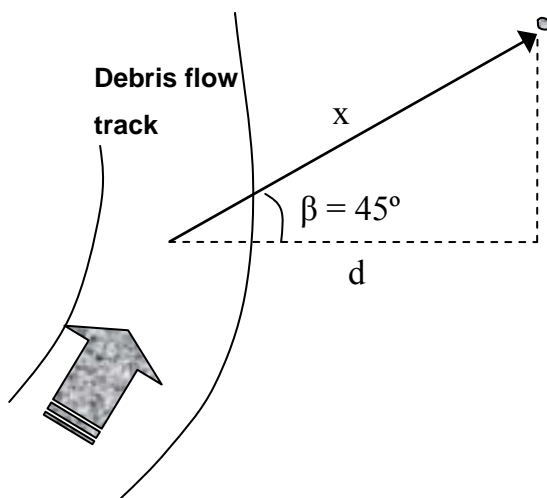
Figure 11.8 Illustration of angle at which stones are thrown from the main flow.

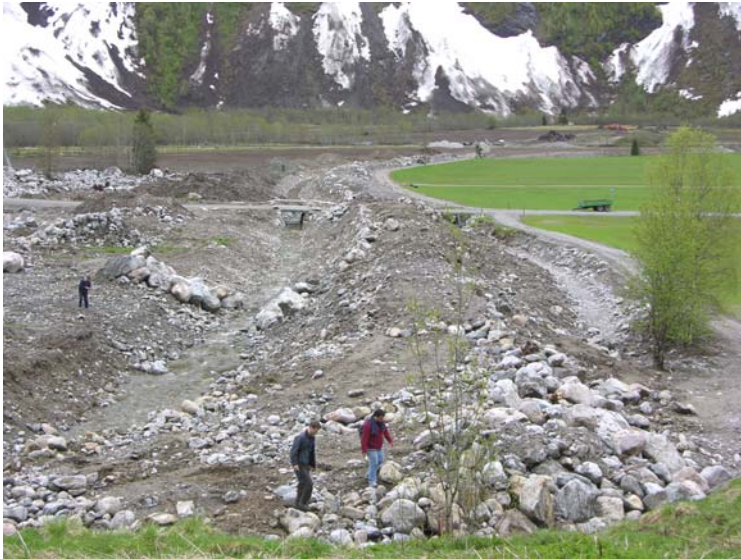
Figure 12.1 Retention and deflecting dam being built between the fan and the farm Øygaard. Photo taken May 2005.

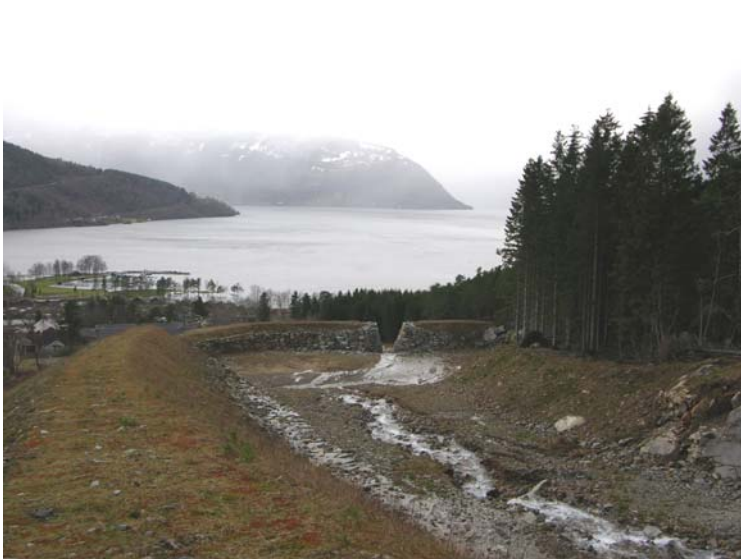
Figure 12.2 Deflecting dam for a debris flow built in Hardanger, Norway. Notice basin and drainage opening.
