# Lightweight filling materials for road construction

**Norwegian public Roads  
Administration**

Publication no. 100

# Long term performance and durability of EPS as a lightweight filling material

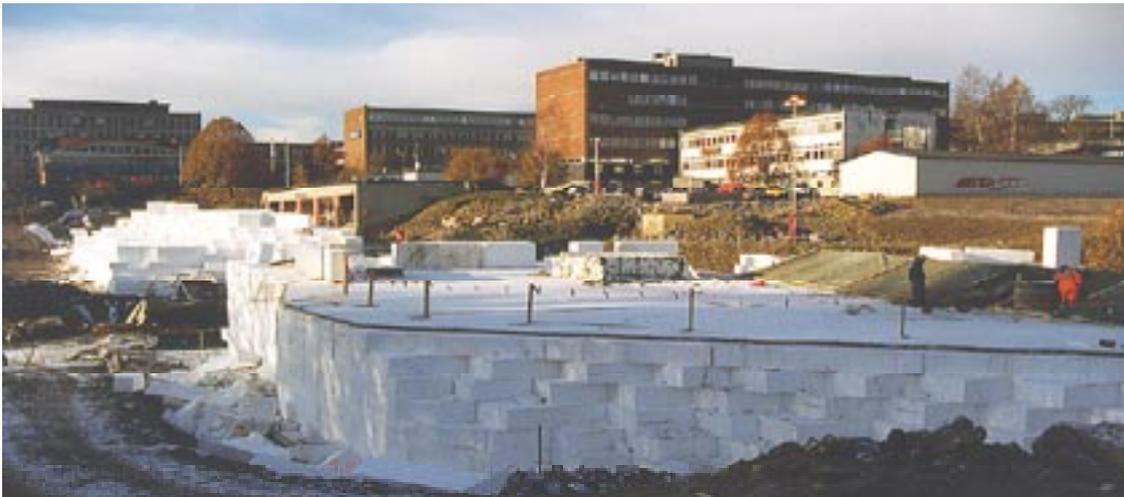
Figure 1: An EPS embankment with vertical walls for a city tramline in Oslo as an alternative to a bridge.

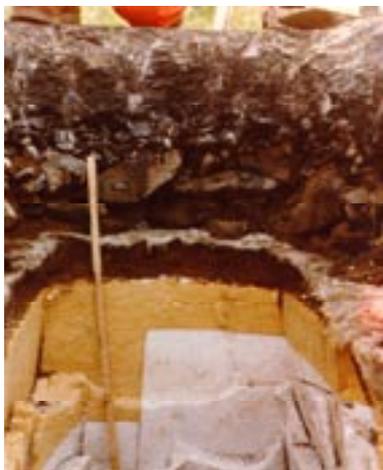
Figure 2: Excavation of the first EPS embankment at Flom bridge.

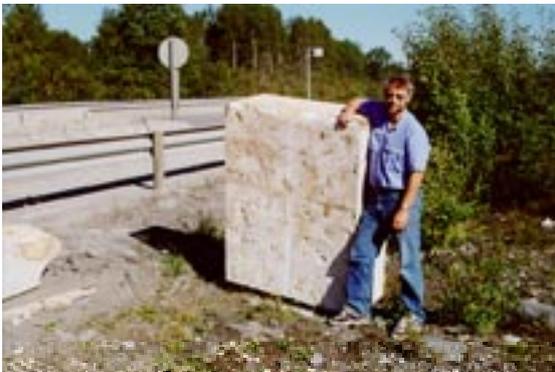
Figure 3: Excavation of a 24 years old EPS block from the first EPS embankment at Flom bridge.

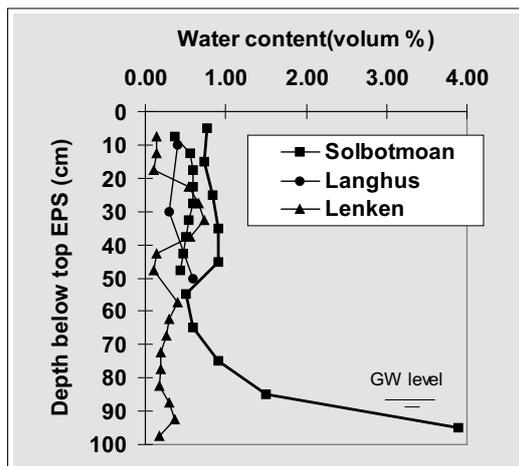
Figure 5: Typical drained situation from 3 EPS fills.

Tests performed on samples retrieved from three EPS fills placed in a drained position, i.e. blocks are located above the highest groundwater or flood level, all show water contents below 1 % by volume after more than 20 years in the ground (Figure 5).

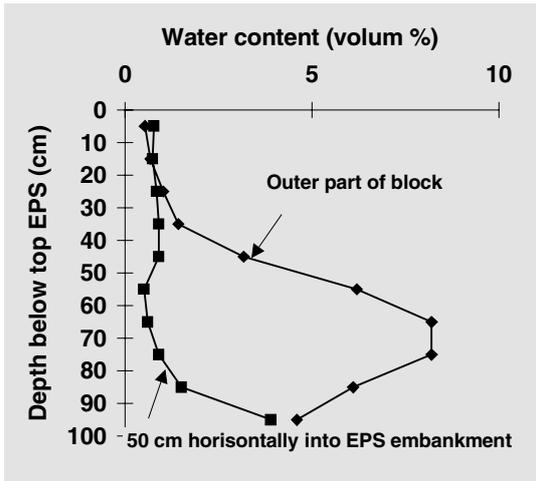
Figure 6: Horizontal gradient of water in EPS.

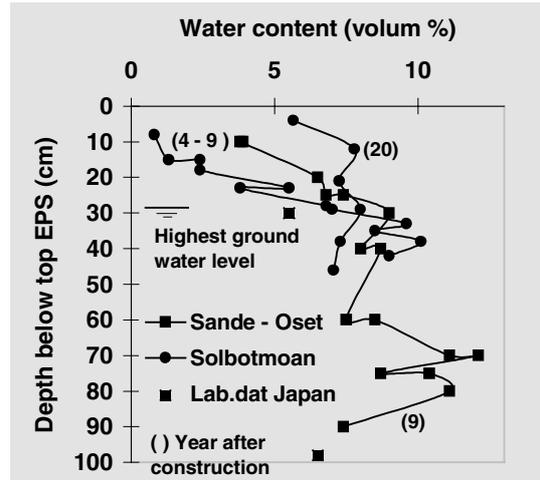
Figure 7: Typical water content in submerged EPS blocks.

In blocks, which are periodically submerged, water contents of up to 4 % by volume have been measured. In permanently submerged blocks measured water contents have reached values close to 10 % by volume with some increase over the years, Figure 7. Further increases above 10 % by volume are, however, not to be expected. For submerged fills the average density is therefore of the order of  $\rho = 90\text{-}95 \text{ kg/m}^3$  after some 20 years in the ground. The water content decreases rapidly above the water table and show values for drained conditions only some 200 mm above the highest water level.

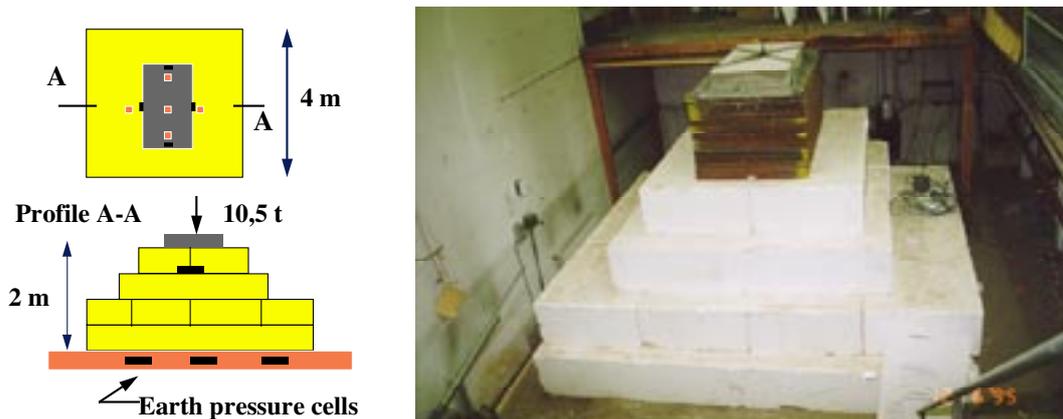
Figure 8: EPS test fill at the Norwegian Road Research Laboratory (now the Road Technology Department)

In a laboratory test at the Norwegian Road Research Laboratory (now the Road Technology Department) a test fill of height 2 m with normal size blocks and a compressive strength  $\sigma = 100$  kPa has been loaded to a value of  $q_{dw} = 52.5$  kPa and the resulting deformations observed over a period of 3 years (Figure 8). The results are shown in Figure 9 together with calculated deformations to be expected according to the theories introduced by Magnan & Serratrice.

Figure 18. Stress distribution measured in the test hall (see Figure 8).

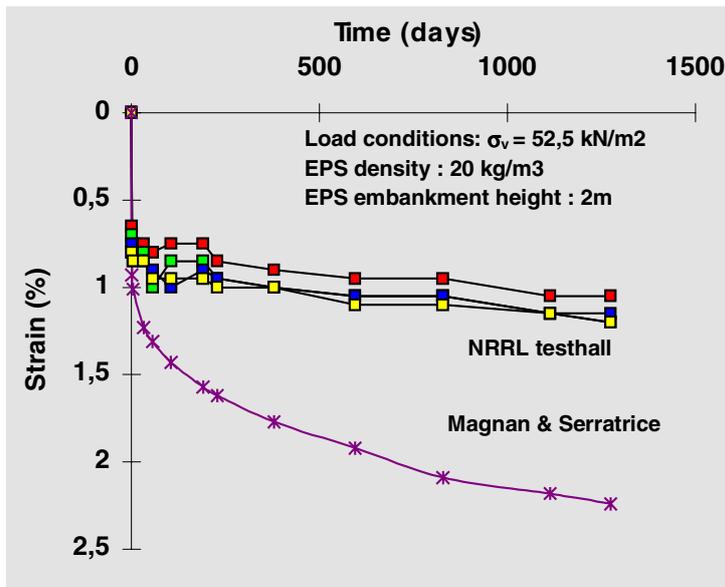
Figure 9: Deformation / creep in the test fill.

As may be seen the observed deformations are only about half of the calculated values and creep deformations with time are also much smaller.

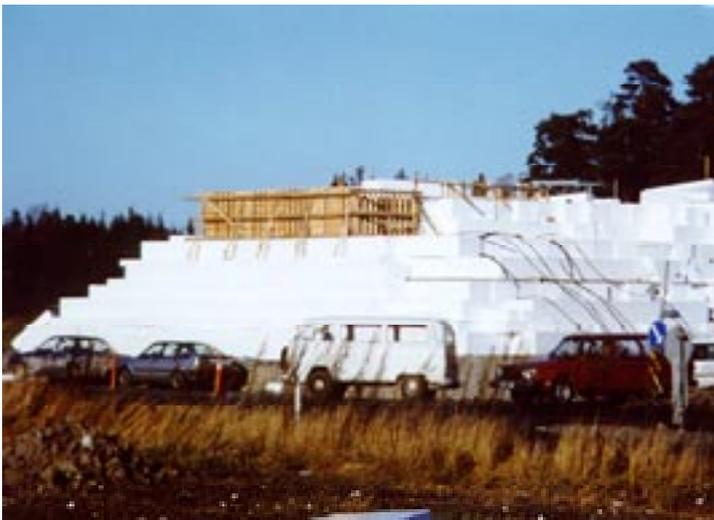
Figure 10: Construction of one abutment on the EPS embankments at Løkkeberg bridge.

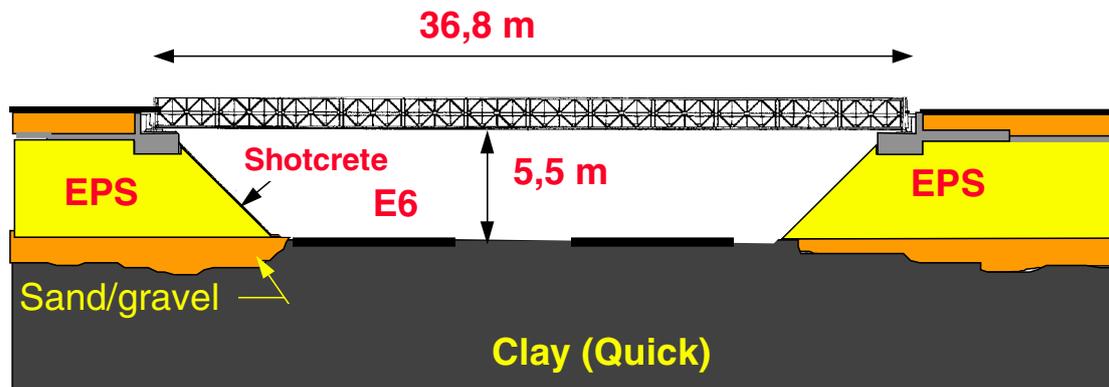
Figure 11: Longitudinal profile of Løkkeberg bridge.

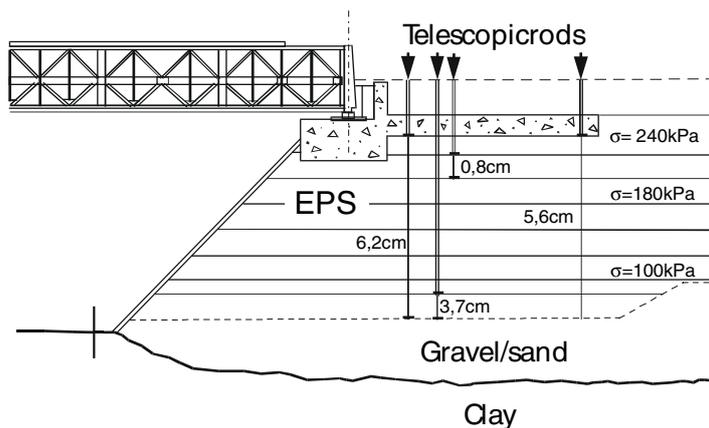
Figure 12: Deformation in EPS embankment at Løkkeberg.

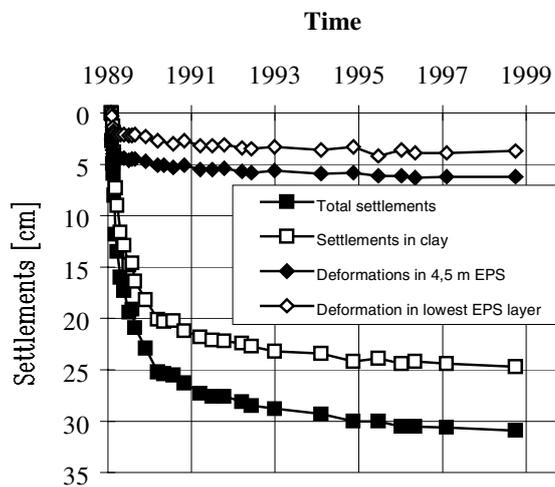
Figure 13: Creep deformation at Løkkeberg.

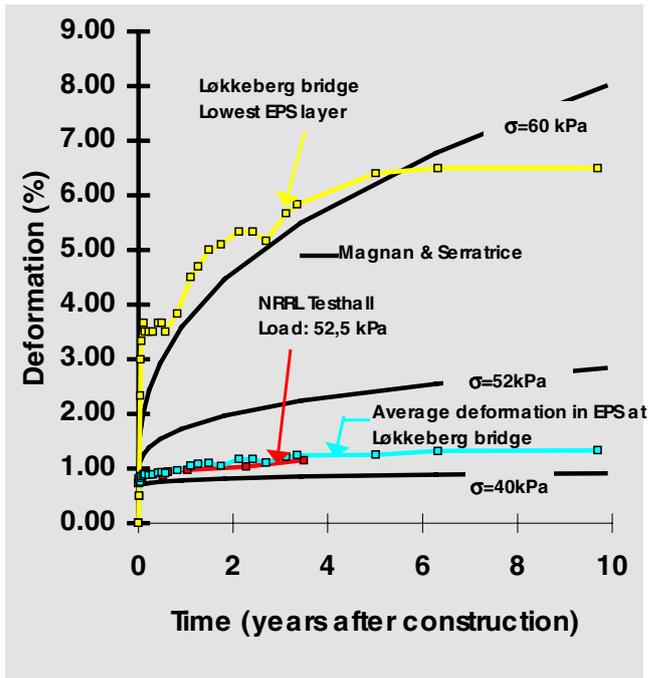
Figure 14: Creep deformations in EPS.

Observed deformations after 10 years in operation are plotted in Figure 14 together with data from the laboratory test and theoretical values according to Magnan & Serratrice calculated for various stress levels

The figure clearly shows that the average deformation at the Løkkeberg bridge is small and slightly over 1 % of the total fill height. Also observed creep effects are almost negligible for the total fill although deformations in the bottom block layer was 4 % initially and later creep effects amount to further 2.5 %. Creep deformations in the bottom layer correspond with the theoretical values the first 5 years but has later slowed down to almost zero.

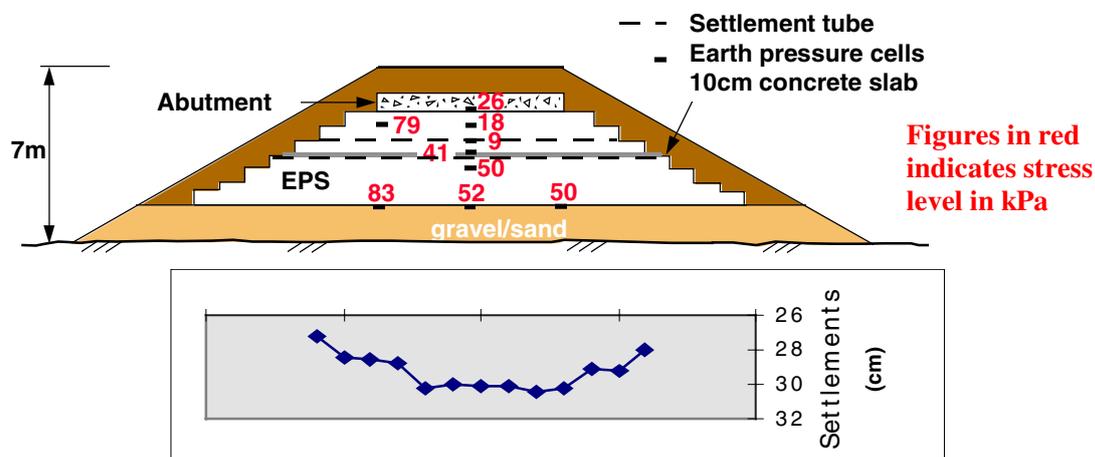
Figure 15: Løkkeberg bridge. Observed stress distribution and settlements in the cross section after 10 years in operation.

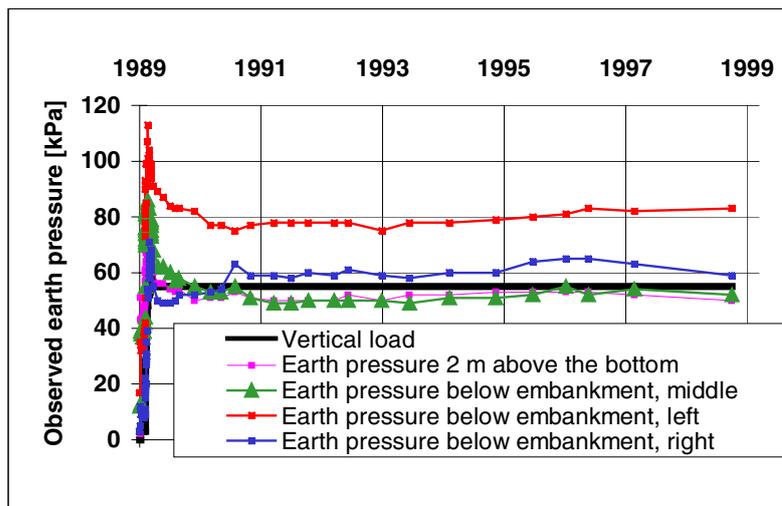
Figure 16: Long term measurements of earth pressure at Løkkeberg bridge.

Long term measurements from 3 earth pressure cells below the fill and one situated 2 m higher up have been plotted in Figure 16. During the first year of operation a stress decrease of 15 - 30 % was observed. Later only small variations with time have been observed. Measured stresses corresponds well with the theoretical vertical load in the lower part of the EPS fill.

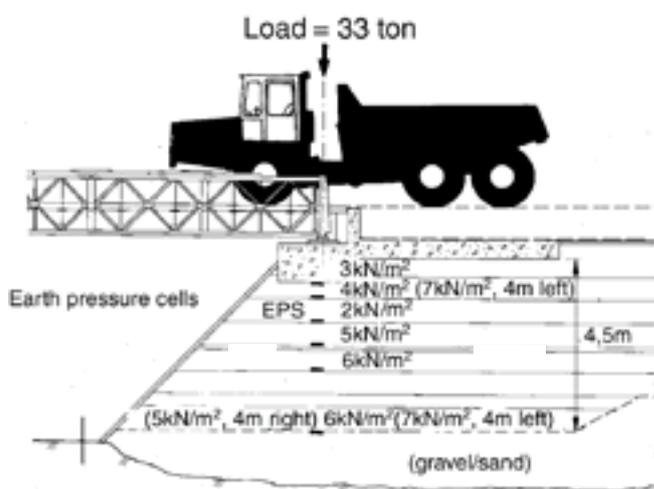
Figure 17: Stress distribution from additional load.

Another test was performed to check the stress result. A dumper with a weight of 33 tons was placed at different distances from the abutment. In the case when it was placed directly upon the abutment an increase of 6 kPa was expected. The measured stress increases in the various fill levels with the additional load from the dumper correspond well with the stress distribution without the dumper. The increase in stress levels from the dumper is shown in Figure 17. The same tendency to reduced vertical pressure in a zone beneath the abutment was also observed here. After unloading the abutment, the pressure cells immediately returned to the initial stress levels.

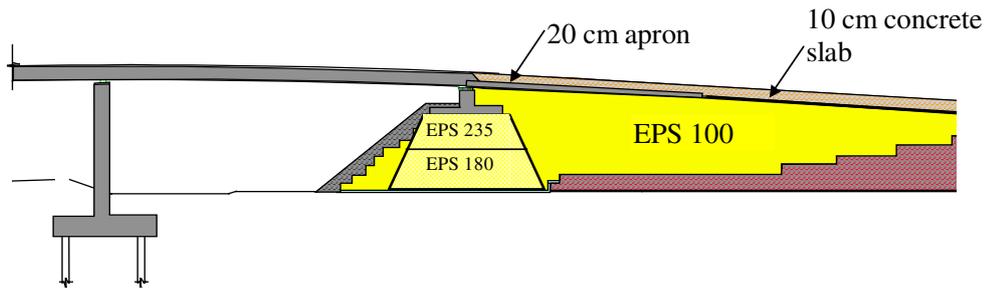
Figure 19. Supporting bridge abutments directly on EPS, Hjelmungen bridge, Norway.

Some 2 years after completion it became evident that the bearing capacity of the soil beneath the abutments had been exceeded as excessive settlements occurred and the abutments inflicted damage to the bridge deck. Deformation monitoring was initiated and it soon became clear that immediate repair measures had to be initiated. Since settlement caused by the approach fills was the main problem, it was decided to reduce the load on the subsoil by some 30-40 kN/m<sup>2</sup> in order to re-establish the initial subsoil stress conditions. This involved replacing parts of the fills with EPS blocks and supporting new bridge abutments directly on the EPS. The repair design is indicated in Figure 19.

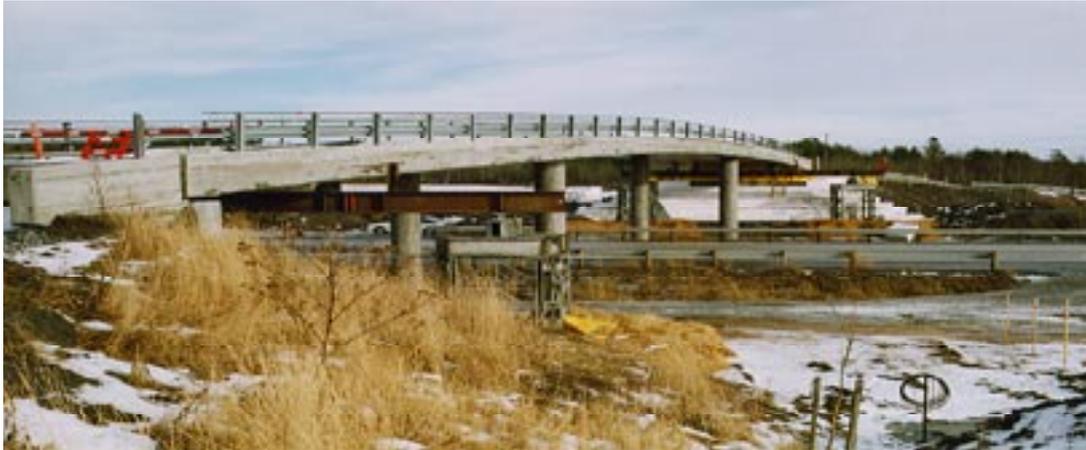
Figure 20: Temporary support of abutments at Hjelmungen.

Repair works were initiated in December 1995 and completed in the spring of 1996. One abutment was treated at a time while the bridge deck was provided with a temporary support as shown in Figure 20. Thickness and densities of the original filling materials were recorded as they were removed in order to have accurate data for control of load and settlement calculations. After removing the old abutments, the concrete piles were inspected regarding possible damage before being cut at ground level. No pile damage was observed. Construction of the EPS fills could then start. In this case three different qualities of EPS were utilized. In the zone directly beneath the bridge abutment, as indicated by the trapezoidal shaped lines in Figure 19, a material quality of  $\sigma = 235$  kPa was specified for the first three block layers beneath the bottom slab of the abutment. Further down a material quality of  $\sigma = 180$  kPa was specified within the indicated zone. For the rest of the EPS fill a material quality of  $\sigma = 100$  kPa was used. These quality requirements have been decided based on evaluation of stress distribution in the material in order to keep the stress level for dead loads within 30 % of the material strength. Stricter geometric requirements than normal were also enforced related to block dimensions in order to obtain an even fill and reduce initial deformations when the load from the bridge deck was transferred to the new abutment.

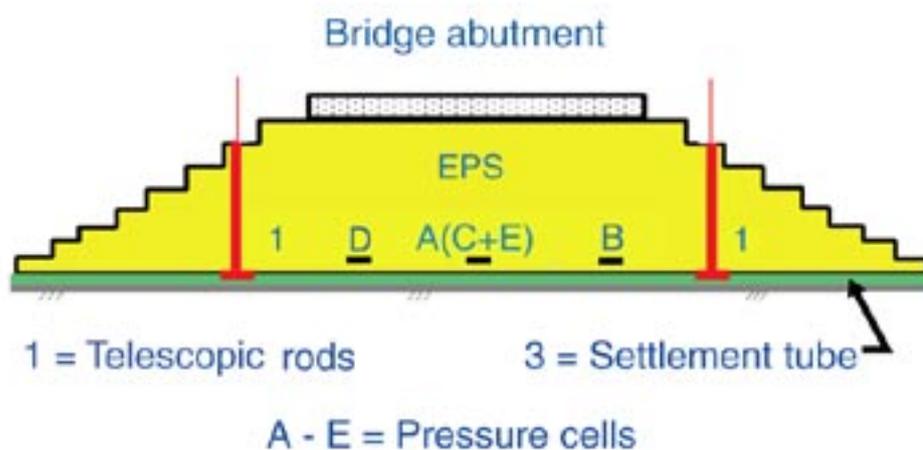
Figure 21: Cross section indicating location of monitoring equipment.

In order to monitor the behaviour of the reconstructed bridge both settlement and stress gauges have been installed. The different types of gauges and their locations in relation to the bridge abutment are indicated on the cross section in Figure 21. Prior to reconstruction the settlement rates of the adjoining fills were observed to be 100 mm/year and constant. After reconstruction the settlements have nearly been halted as shown on Figure 22.

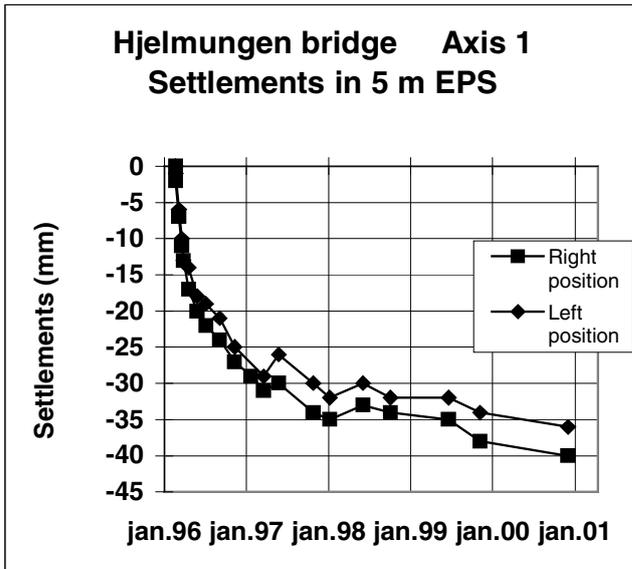
Figure 22: Measured settlements at Hjelmungen.

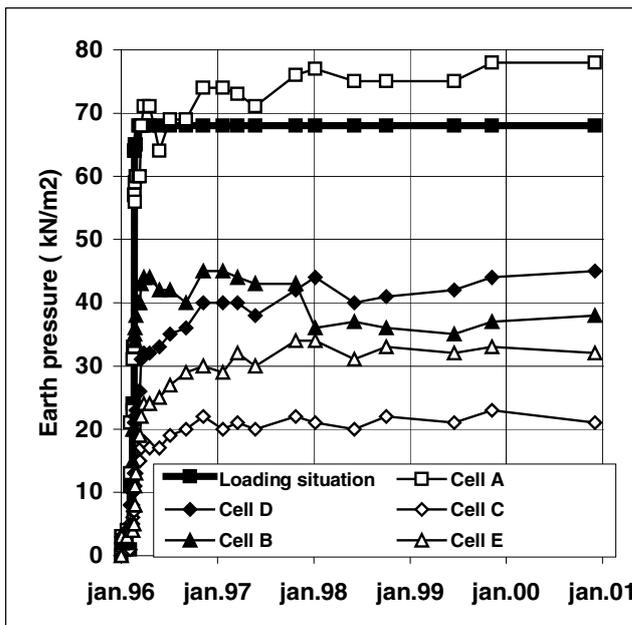
Figure 23: Earth pressure below EPS layer at Hjelmungen.

Observed stresses beneath the EPS fill indicate a higher stress under the central part of the abutment than under the edges as shown in Figure 23. Calculated loads on the abutment are indicated by the heavy line drawn in the diagram. Problems associated with providing enough lifting force when jacking up the bridge deck may, however, indicate that reaction forces from the bridge deck are somewhat higher than calculated.

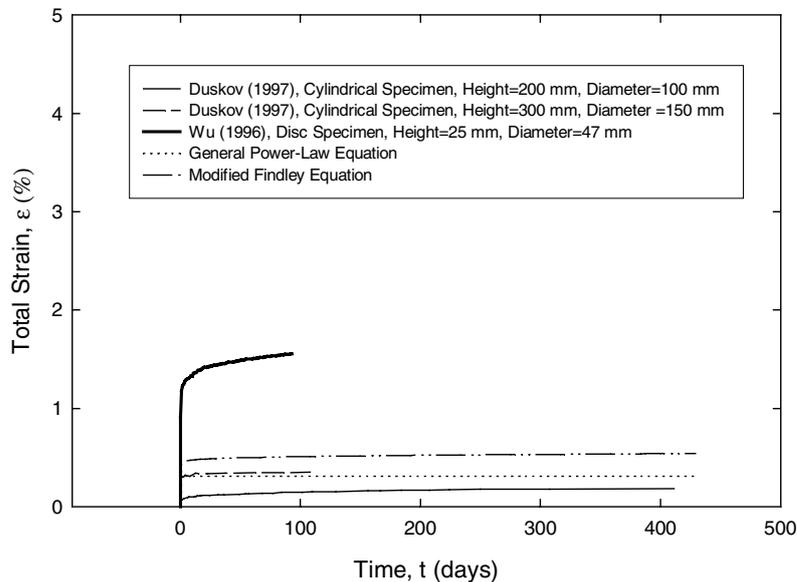
Figure 1: Comparison of Laboratory Compression Creep Test Data for an EPS Density of 20 kg/m<sup>3</sup> and Applied Stress of 20 kPa and Calculated Values.

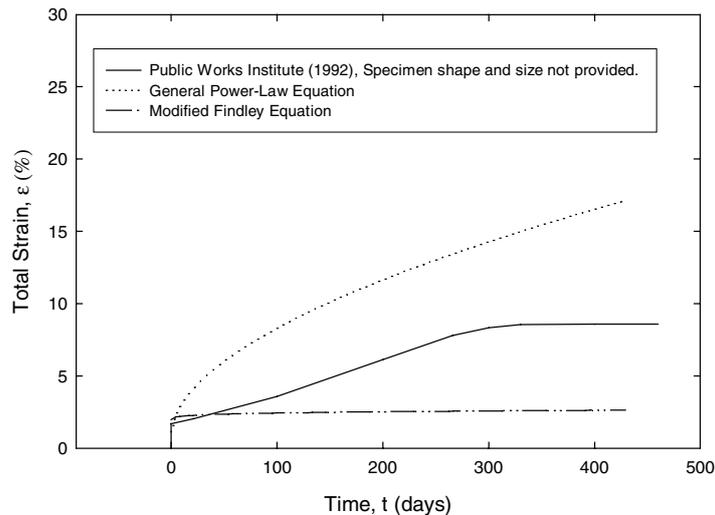
Figure 2: Comparison of laboratory compression creep test data for an EPS density of  $20 \text{ kg/m}^3$  and applied stress of  $70 \text{ kPa}$  and calculated values.

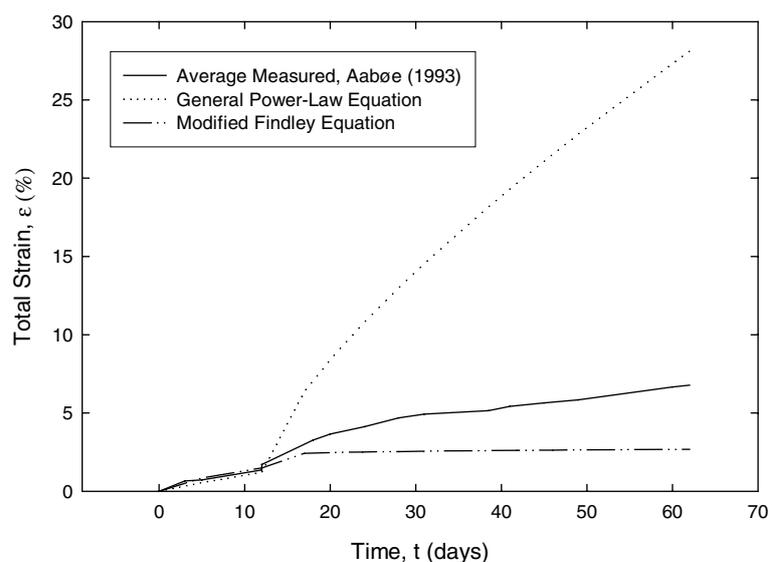
Figure 3: Comparison of full-size EPS block creep test data and the creep equations for an EPS density of  $20 \text{ kg/m}^3$  and an applied stress of 34 kPa for days 1-5, 55 kPa for days 5-12, and 79 kPa for days 12-62.

Figure 3 shows a comparison between the calculated and measured total strains for compressive stresses of 34, 55 and 79 kPa. At the initial stress levels of 34 and 55 kPa, both the general power-law and modified Findley equations predict total strains that are in agreement with the measured strains. At the largest stress of 79 kPa, the power-law equation significantly overestimates the measured strains and the modified Findley equation underestimates the measured strains. However, the modified Findley equation provides the best agreement with the measured values especially as the time,  $t$ , increases.

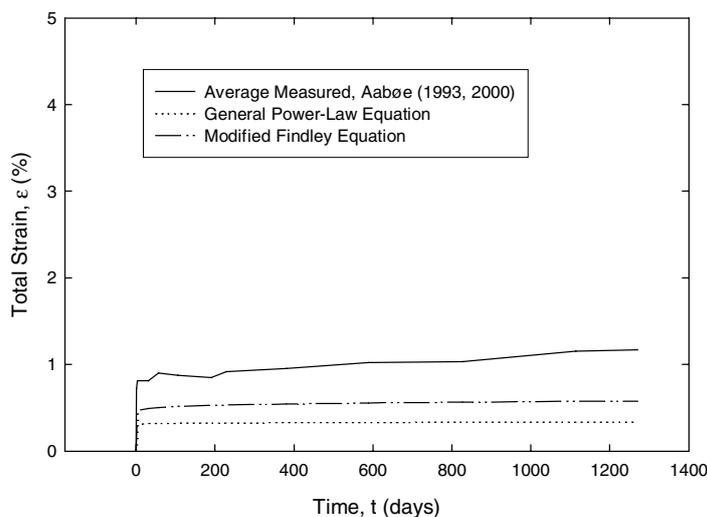
Figure 4: Comparison of full-scale model creep test data and the creep equations for an EPS density of 20 kg/m<sup>3</sup>.

Figure 4 shows a comparison of the total strain measured in the EPS blocks of the full-scale test fill and the calculated total strains based on the power-law and modified Findley equations. In calculating the total strains, the fill was divided into the same number of horizontal layers as EPS block layers used, four. The total strain of each layer was determined based on the average stress calculated at the middle of each block using the measured 1 (horizontal) to 1.8 (vertical) stress distribution. Thus, the stress used for each layer from top to bottom was 36.2, 20.4, 13.1, and 9.1 kPa. As indicated in Figure 4, both the general power-law and modified Findley equations underestimate the strains measured in the full-scale test fill. The power-law predictions are lower than the modified Findley predictions and thus the Findley equation provides the best agreement.

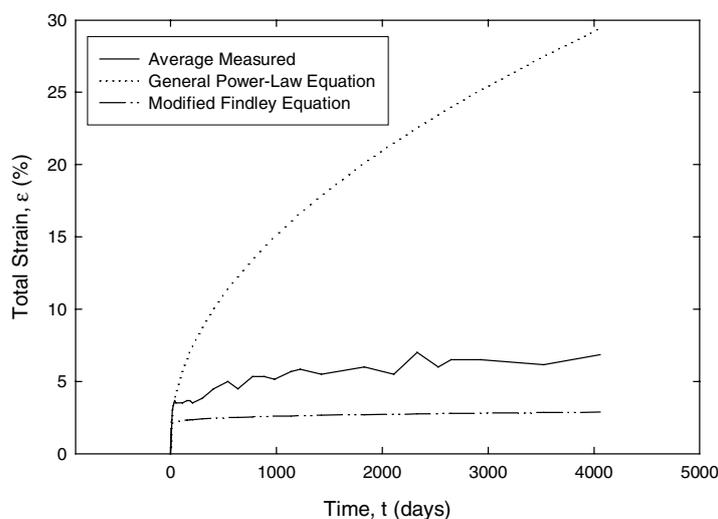
Figure 5: Comparison of total vertical strain measured in the lowest EPS block layer of the field test fill and the general power-law and modified Findley equations.

Figure 5 shows the total vertical strain measured in the lowest block layer. The density of the bottom row of EPS blocks is  $20 \text{ kg/m}^3$  and the original thickness of the EPS blocks is 0.6 m. Three pressure cells were installed below the first row of blocks. An average pressure of 67 kPa was recorded in the three pressure cells during the period that the vertical strain was being obtained from the settlement rods. As shown in Figure 5, the power-law and modified Findley equations significantly overestimate and underestimate the measured total strains, respectively. However, the total strains predicted by the modified Findley equation are again in better agreement with the measured values than the power-law equation.

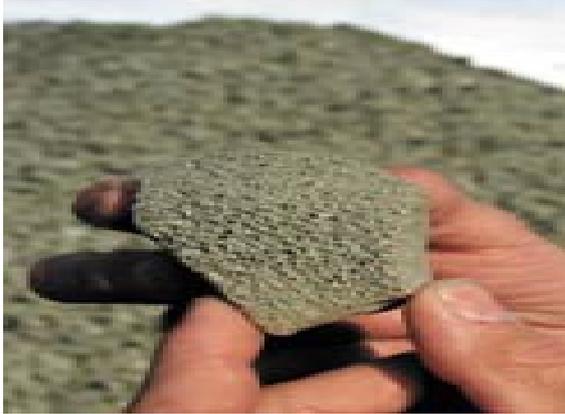
Figure1: Typical foamglass particle.

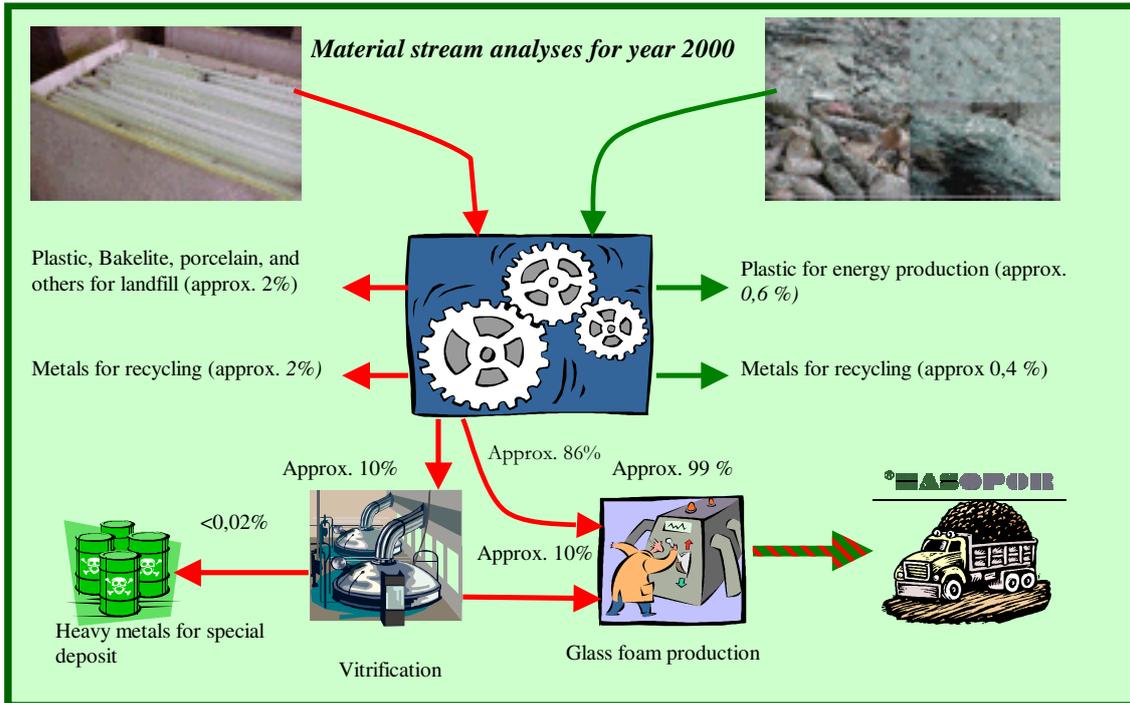
Figure 2: Recycling process.

The production process may be visualised as indicated in Figure 2.

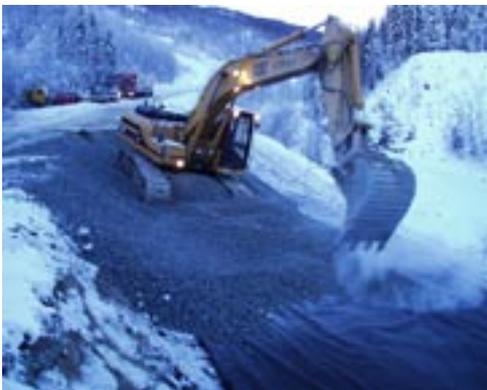
Figure 3: Placing of foamglass with excavator.

Due to erosion along the riverbed a 10 m high road slope failed over a distance of some 30 m. At the river level and in the slope the subsoil consisted of quick clay of medium strength. In order to re-open the road and prevent further erosion along the riverbank and more slides, it was necessary to quickly implement repair measures. Erosion protection was established using blasted rock before filling the slide area with foamglass of the Hasopor type. The material was delivered on site by large trucks and side tipped into slide area. Volumes of up to 100 m<sup>3</sup> could be transported in one haul. The foamglass was then distributed and placed in layers of 0.5 m thickness by a 30 tonnes crawler mounted excavator and compacted by 3-4 passes by the crawler belts giving a compaction ratio of 1.4. In this way a total volume of 300 m<sup>3</sup> was placed within the time span of 4 hours, see Figure 3.

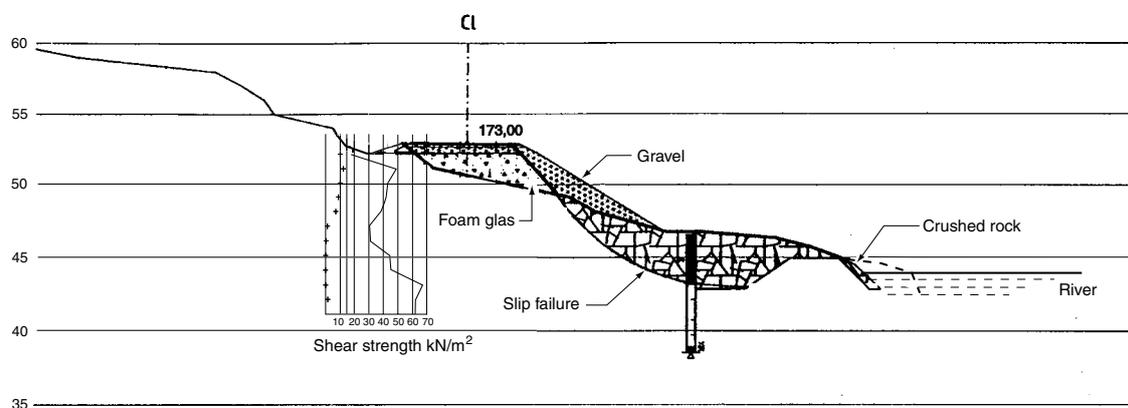
Figure 4: Cross section showing repair measures in the slide area.

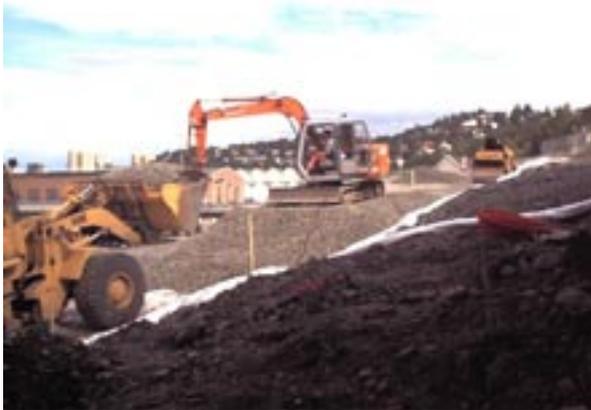
Figure 5: Distributing foamglass material using a crawler mounted excavator (Hitachi EX60, 8 tonnes). For internal transport on site a shovel dozer (CAT 923E) was used.

The foamglass was placed in layer thickness up to 2 m. The top surface was levelled off by the excavator. Compaction was performed by the crawler belts of the excavator, see Figure 5. On the slopes light compaction was performed with the excavator bucket. The natural slope angle for uncompacted foamglass seems to be 45°.

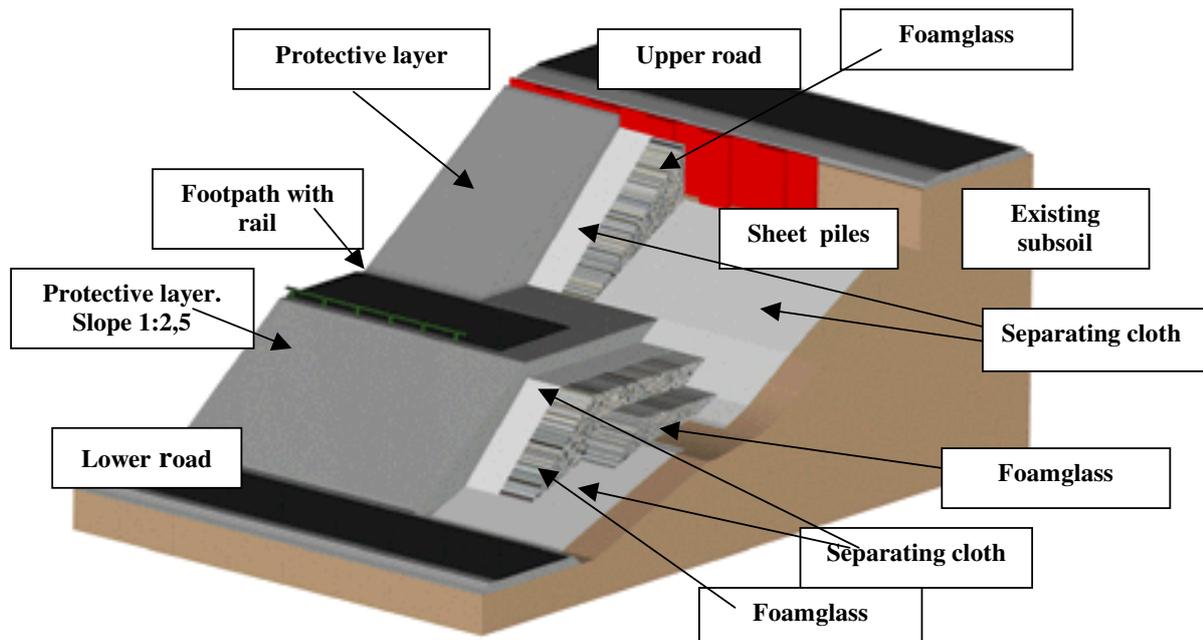
Figure 6: Isometric view of foamglass fill at Lodalen.

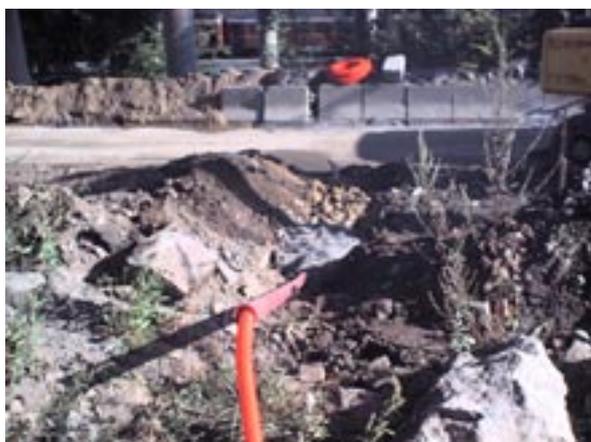
Figure 7: Monitoring long term deformations with tube settlement gauges.

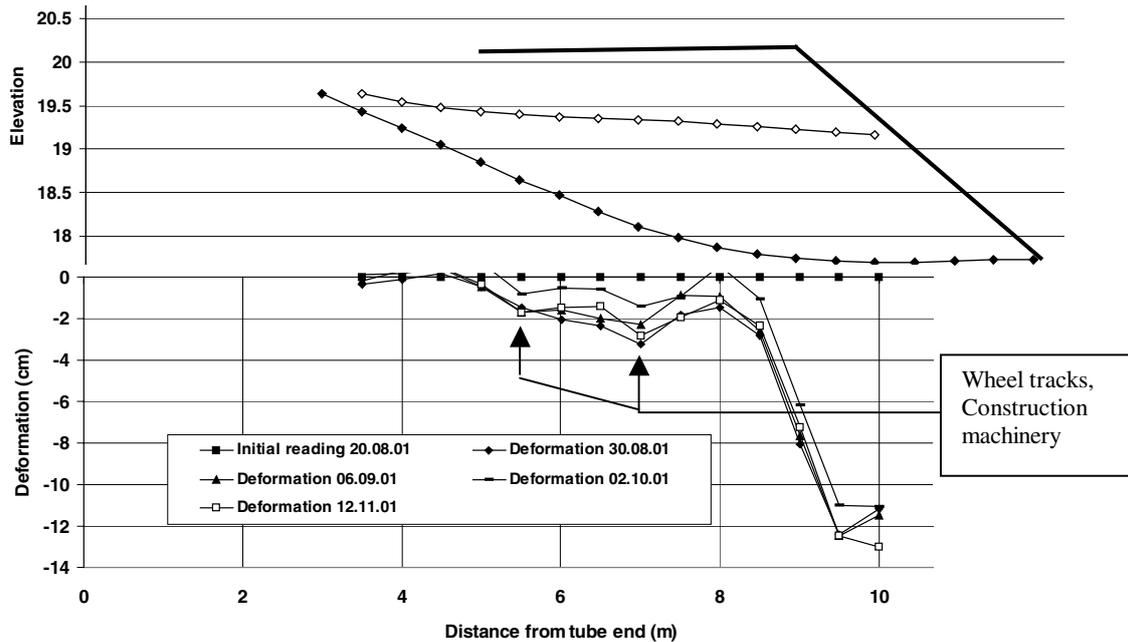
Figure 8: Deformations measured in foamglass fill at Lodalen.

According to the measurements shown in Figure 8 the foamglass layer deformed about 12 cm after the roadbase materials were placed. It is important to note that the deformations in the outer area occurred immediately after the foamglass layer was loaded.

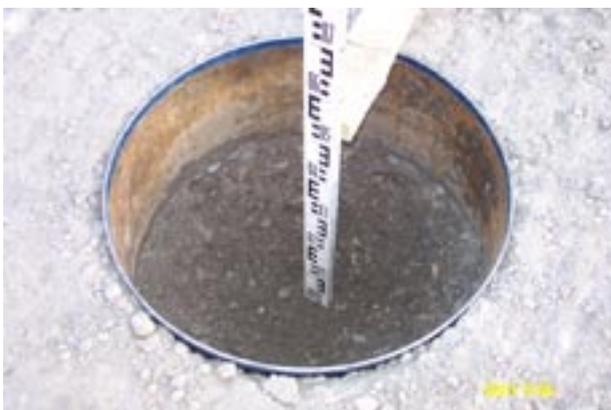
Figure 9: Steel tube with material removed.

At two locations a thin walled steel tube with diameter 570 mm was pressed 270 mm into the foamglass fill until the top was level with the top of the foamglass layer, see Figure 9. One test site was located in the open and the other underneath a bridge crossing over the foot/cycle-path. The particles contained within the steel tube was removed and the excavated material weighed wet and dry. Also the void left in the tube was lined with a thin plastic sheet and filled with water from a measuring glass in order to determine the excavated volume, see Figure 10. Just before the samples were taken, heavy rain occurred.

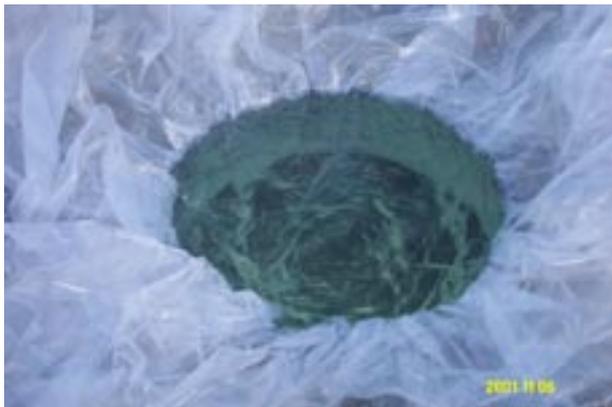
Figure 10: Water used to measure excavated volume.

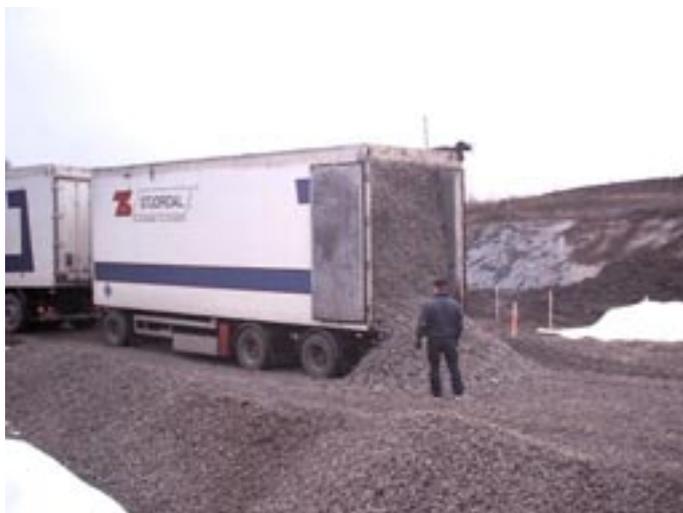
Figure 11: Transport to site in large trucks.

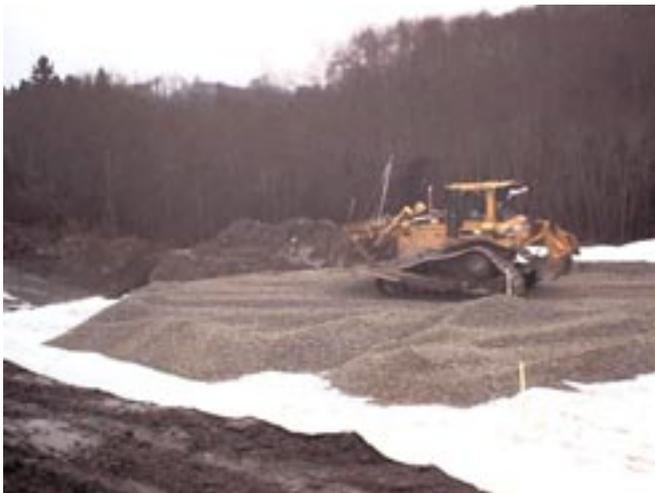
Figure 12: Distribution and compaction with dozer.

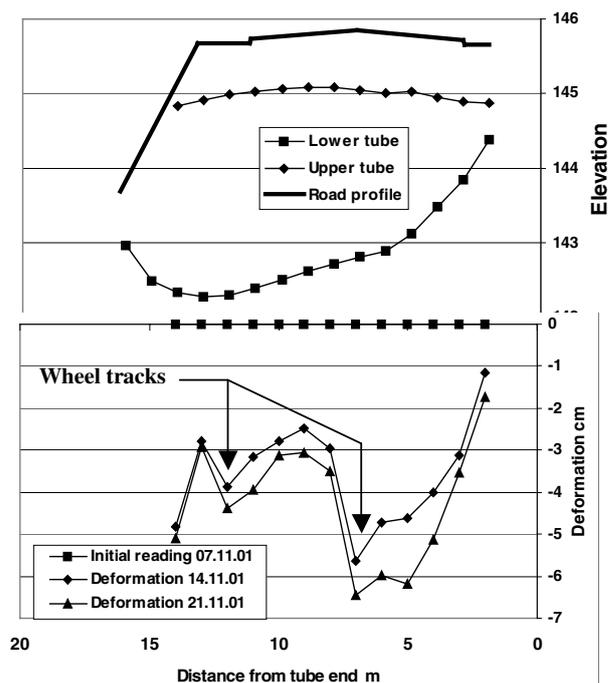
Figure 13: Deformations measured in foamglass fill on National road No. 120.

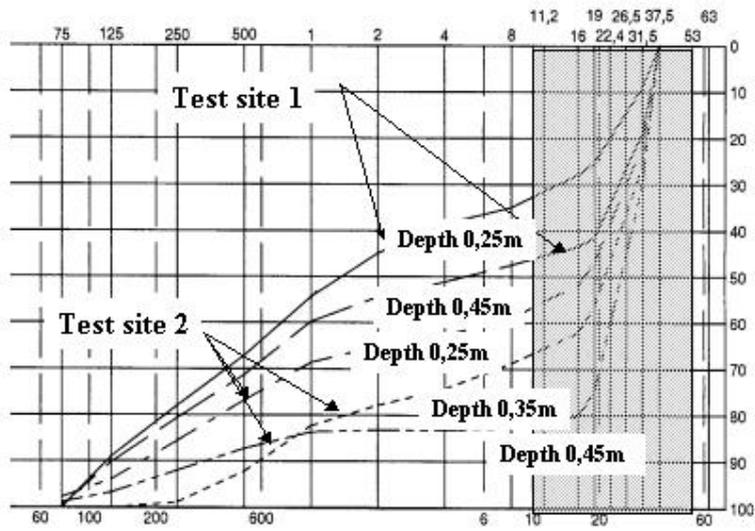
Figure 14: Grains size distribution of excavated material.
