2.1 IMPROVED THUNDERSTORM WEATHER INFORMATION FOR PILOTS THROUGH GROUND AND SATELLITE BASED OBSERVING SYSTEMS

Abstract

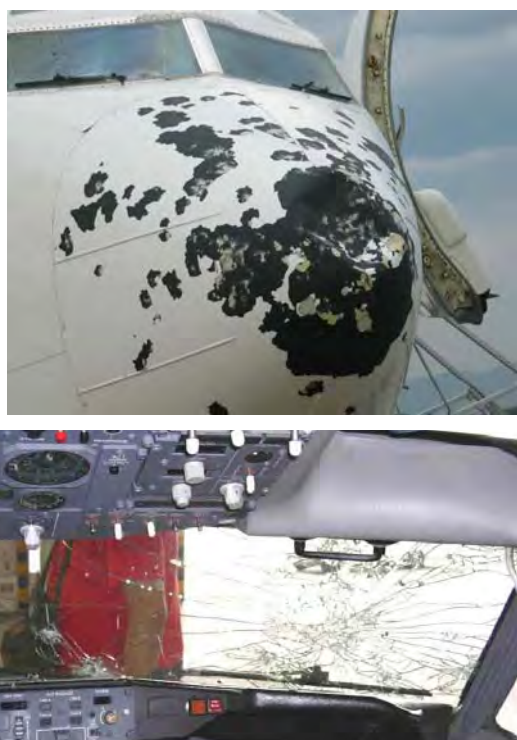
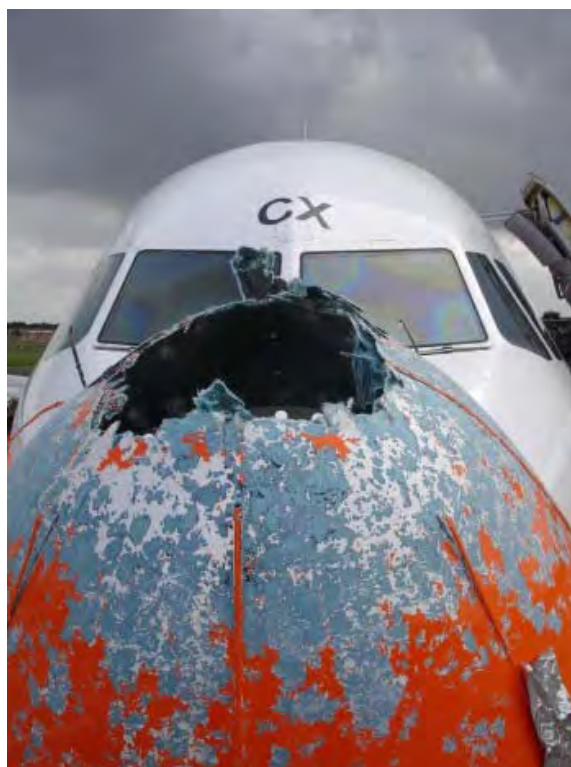
Figure 1: Nose and wind shield damage of two aircraft hit by hail stones during passage of thunderstorms. Left: Easy Jet Boeing 737 after take-off from Geneva, 15 August 2003. Right: WindJet A319 near Catania on Oct 1st 2009 (The Aviation Herald, Photo: ATRDRIVER)

aircraft is passing through it, the duration of exposure, the type of aircraft and the flight phase. Figure 1 shows two examples where aircraft have been hit by hail when passing through a thunderstorm. In both cases the aircraft's nose has been heavily damaged, and in one case also the wind shield has been cracked.

A photograph taken after landing (figure 1, right) shows a hole in the aircraft's radome due to hail encounter. Also it is noted in the Aviation Herald page by referring to a report from a mechanics after landing that *"the airplane experienced wind shear of +50/-50 knots on final approach to Palermo prompting the crew to initiate a go-around. The airplane did not climb until after passing the runway at very low height despite the engines at full thrust"*.

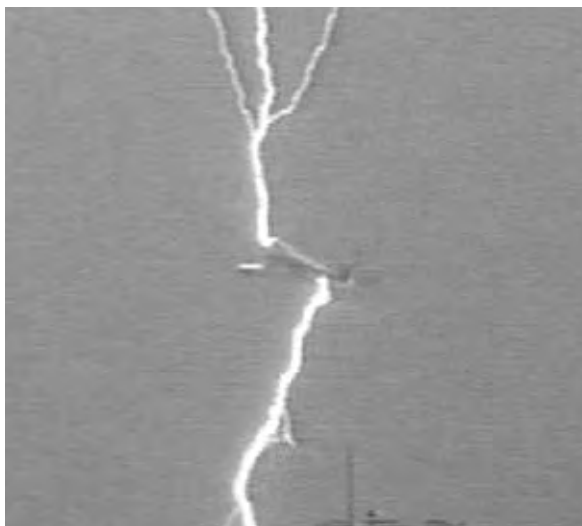
However, lightning strikes cause electronic equipment to malfunction which might affect safety. Figure 2 shows a lightning stroke which was probably triggered by the aircraft itself after take off from a Japanese Air Force Base as described in Uman and Rakov (2003).

Figure 2: Aircraft hit by lightning. Photograph found on the internet. Reprinted and discussed by Uman and Rakov (2003).

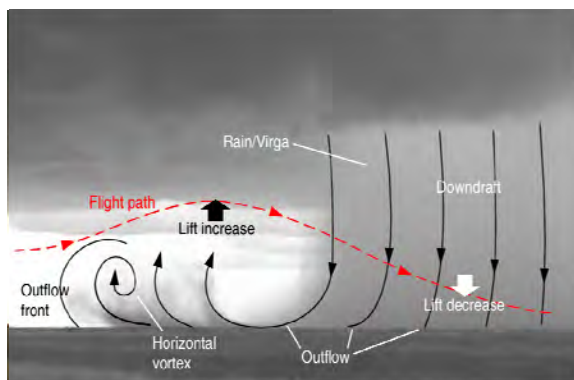
Wind shear can be a great hazard for an aircraft especially on approach to land when passing through the up- and downdraft regions of a thunderstorm. Figure 3 illustrates the situation. First the aircraft experiences a lift increase when it encounters the outflow boundary of the thunderstorm; thereafter it enters the downdraft region where it encounters a downward force which is of course dangerous on approach to landing.

Figure 3: Lift increase and decrease for an aircraft which passes through a thunderstorm at low levels (FLYSAFE)

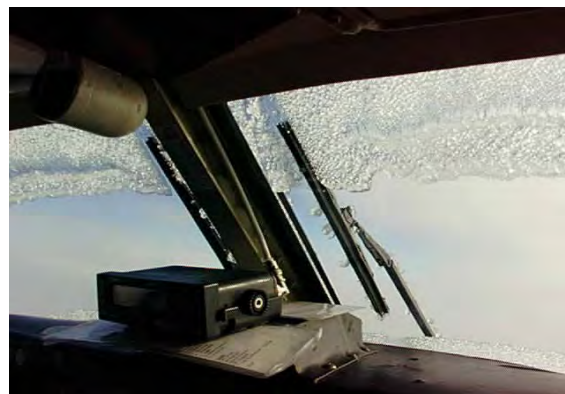
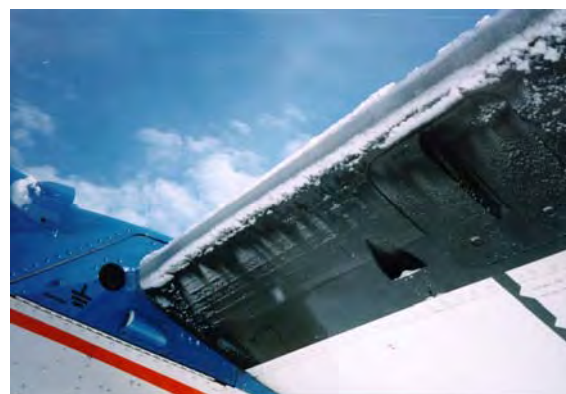
Figure 4: wind shield and wing icing after a flight of the DLR Dornier 228 aircraft in severe icing conditions.

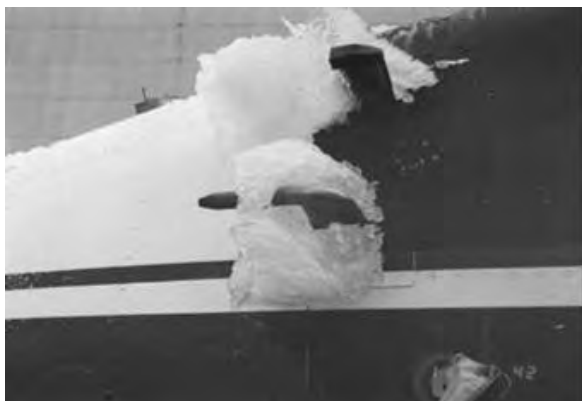
There have been numerous incidents and also a few accidents due to aircraft icing, e.g the ATR-72 crash near Chicago 1994 (Sand and Biter, 2000). Icing of the Pitot tubes can result in wrong speed indications for the pilots or the onboard computer. In two cases of unintended descent within the upper parts of two independent thunderstorms a complete freezing of the Pitot tubes was observed even though the anti-ice (heating) systems were activated (Hauf et al., 1999). Figure 5 shows icing accretion on the Pitot tubes of the DLR Dornier 228 after landing.

Figure 5: Icing of Pitot tubes, picture taken after landing of a flight of the DLR Dornier 228 aircraft in severe icing conditions.

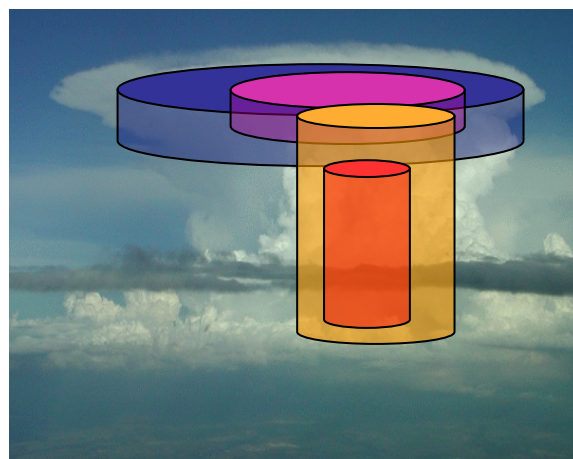
A set of requirements of pilots were obtained from a questionnaire and from discussions held at meetings, Pilots had expressed clearly that they do not wish to be confronted with a picture of the full complexity of a particular thunderstorm, which they would have to interpret themselves with regard to their flight, rather they would have the weather experts to define hazardous regions and tell the pilots where they can or where they cannot go. To fulfil this requirement the thunderstorm forecasts output from CB-WIMS are reexpressed as weather object, which define hazard volumes representing thunderstorm threats for aircraft. The aim of the weather object is to reduce then complexity of the weather feature. Figure 6 illustrates the concept.

In Figure 6, hazard volumes are depicted as cylinders for simplicity, however, in practice polygons are used. A thunderstorm object is composed of a “top volume” and a “bottom volume.” The nested bottom objects define volumes where the thunderstorm hazards of wind shear, turbulence, heavy rain, hail, icing and lightning can occur within the lower tropospheric part of a thunderstorm cell which present a hazard to aircraft flying at low levels, especially during landing and take-off.

Figure 6: Bottom and top volumes representing hazard volumes for aircraft in two severity levels.

The bottom volumes are constructed by use of 3D-radar and lightning data using Météo-France’ CONO algorithm (Hering et al., 2005) with severity defined by radar reflectivity thresholds 33 and 41 dBZ. The volume of each cylinder, in this case, represent the severity levels “moderate” and “severe” respectively.

The top volumes represent the hazards: turbulence, icing, and lightning and are detected from satellite data using DLR’s Cb-TRAM algorithm (Zinner et al., 2008). Here the “severe” threshold is selected based on lightning density, an additional data source from the LINET network (Betz et al., 2004). A detailed description of the thunderstorms objects and their attributes is found in Tafferner et al. (2008).

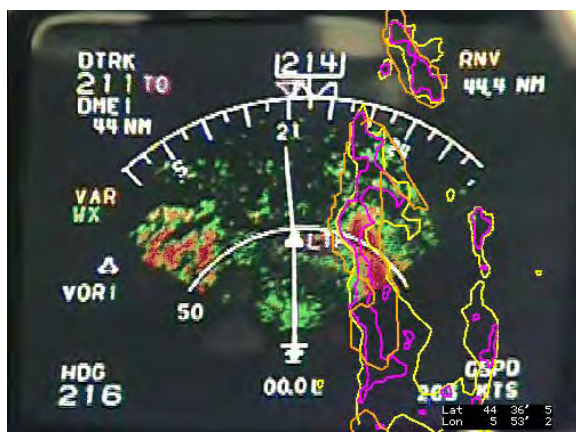
As an example, we reprint here, figure 7, a snapshot of the radar display recorded during an experimental flight (figure 14 of Sényesi et al., 2009). The CB Weather objects from the WIMS are shown as outlines in figure 7. CB bottom objects are pink and yellow representing severe and moderate hazards. CB Tops are orange and represent a moderate hazard. The spatial distribution of the CB weather objects agree well with the close range radar depiction to the forward right of the aircraft position (near the 50 nm range circle). However, beyond the close range, Cb weather objects indicate additional thunderstorm activity and also another cell further away (beyond the 100 nm range circle). Both these Cb cells are later confirmed after 10 and 20 minutes respectively by the onboard radar as the flight continues. Note that the radar returns on the left side beyond 50 nm are due to ground clutter and therefore not confirmed by CB WIMS as thunderstorm activity.

Figure 7: On board radar image for 14h05 UT on 19th August 2008. WIMS CB objects for 14h05 shown in yellow and pink for bottom objects moderate and severe plus orange contours showing CB top objects.

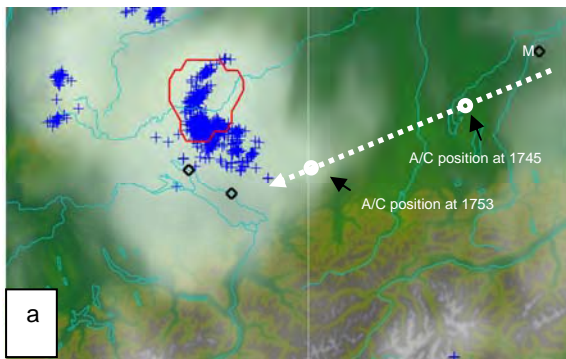
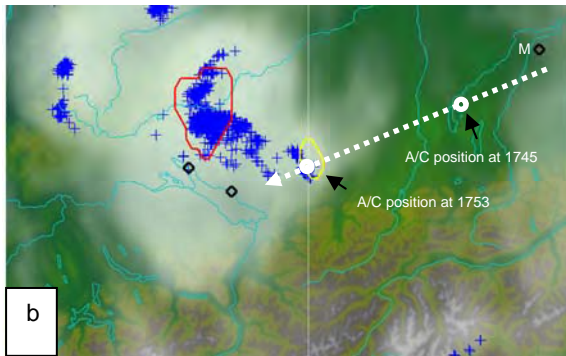
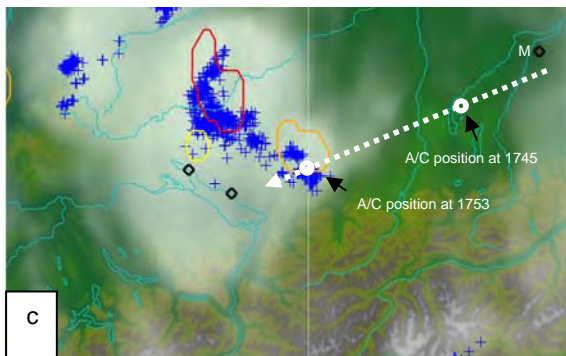
Figure 8: Thunderstorm cell development from 1755 (a) over 1800 (b) to 1805 UT (c). Marked in red: Cb top, yellow: convection initiation, orange: rapid development; blue: lightning observations during past 5 minutes (from LINET, Betz et al., 2004). Infrared satellite image in grey transparent shading. Flight track starting from Munich marked by dotted line, also a/c position at 1753 UT.

On 9 May 2009 a thunderstorm system originated in northern Switzerland and moved north-eastward over Lake Constance. At 1755 UT it is located north of the lake and partly over the river Danube (Fig. 8a). The red contour marks the upper level thunderstorm "top object" as determined from Meteosat satellite data by the DLR cloud tracker Cb-TAM (Zinner et al., 2009). The top object encircles the strongest updraft region. The figure sequence exhibits the rapid development of a new thunderstorm cell on the right flank of the mature cell, detected as convective initiation on 1800 UT (yellow contour in Fig. 8b) and rapid development at 1805 UT (orange contour in Fig. 8c). During the initiation phase an Airbus A321 enroute from Munich to Lisbon hit the related convective updraft. Severe turbulence was reported by the pilots, as a result two flight attendants and thirteen passengers were injured. The flight data recorder shows at 1753 UT a vertical acceleration of +1,85 g immediately followed by -0.5 g (BFU, 2009). The ground based radar observation from the European composite (Hafner, DWD) shows reflectivity values below 37 dBZ in the region of the yellow contour at 1800 UT and outside the thunderstorm bottom objects (figure 9). The latter are determined by DLR's radar tracker Rad-TRAM (Kober and Tafferner, 2009). The radar image is composed of measurements from different radars such that at any point in space the reflectivity value is that of the lowest value within the set of scans and therefore is not representative of the convective precipitation processes in the whole vertical column. Indeed, inspecting the cross section along the flight track constructed from the full 3-dimensional radar scan from the Türkheim radar (48.06° N, 10.64° E), we find a small but intense reflectivity cell between about 5 and 7 km height reaching 30 dBZ just underneath the flight track at around 1750 UTC (Fig. 10). The flight track in the figure is marked by pink line segments. Note that the time stamp of the radar image in figure 10, 1746 UT, is the start time of the radar scan and it takes a few minutes to scan the full volume. It is probable that these observations correspond to the convective cell which produced the turbulence at the height of the flight track, at about 9 km, when the aircraft passed over it. As reported by the pilots there were indications of precipitation but without echoes on the radar display. This can be explained in the following way.

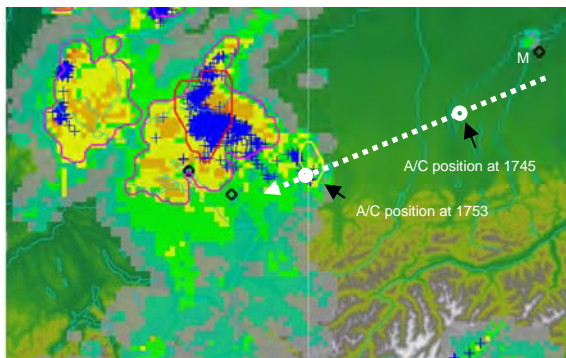
Figure 9: Same situation as in Fig. 8 at 1800 UT, but with radar reflectivity instead of satellite image and with violet contour marking the Cb bottom objects (by use of a 37 dBZ reflectivity threshold) in addition to the top object.

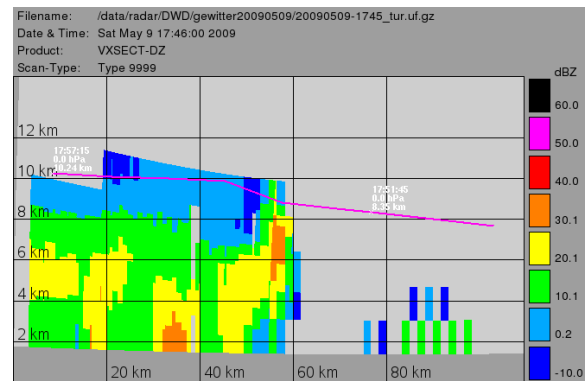
Figure 10: Vertical section through the radar reflectivity field as gained from the Türkheim radar at about 1748 UT along the flight path (pink line). Aircraft positions marked for 1751 and 1757 UTC.

During that particular flight phase when the aircraft approached the thunderstorm region from the east, the aircraft was ascending (refer to the pink line in Fig. 10). Provided the radar only performed a horizontal scan without tilting, it probably did not detect the small cell because it was

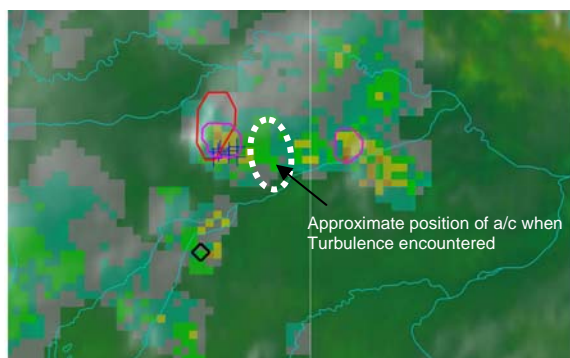
On 5 June 2008, an Airbus A319 aircraft during the descent to Munich experienced turbulence about 3 nm north of the way point LANDU at flight level 110 at 1637 UTC (BFU 2008). The approximate position is indicated in figure 11 by the dotted white oval.

Figure 11: Radar reflectivity and Cb bottom volumes (pink contours) over southern Germany at time 1645; MSG rapid scan HRV image (transparent grey) and Cb top volume (red) at time 1640; approximate aircraft position indicated when turbulence encountered at 1637 UT. The black diamond marks the position of Munich airport.

According to the BFU report, the pilots saw two cumulus clouds left and right of the flight path which were also apparent on the navigation display. In the figure, these are obviously the two cells marked by coloured contours on both sides of the aircraft position.

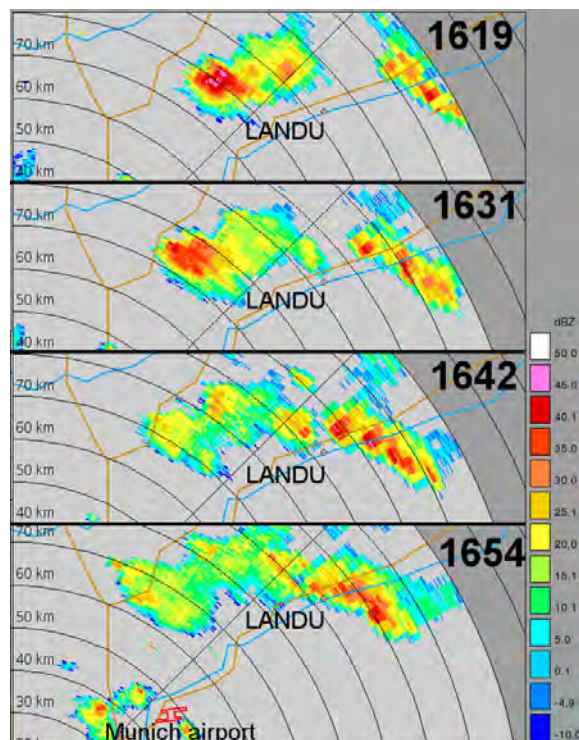
Figure 12: Radar reflectivity at four different times on 5 June 2008 from DLR polarimetric radar at a height of 3100m AMSL. The little dot at the crossing of the river Isar and the 80 km range circle marks the way point LANDU.

Like in the previous case, the intensity values in the radar composite are below 37 dBZ in the region of the aircraft. However, a detailed inspection of radar data from the DLR operated polarimetric radar POLDIRAD in the form of a constant altitude plan position indicator (CAPPI) at 3.1 km, somewhat below the height where the descending aircraft was at that time, shows the growth of small cells of high reflectivity up to 40 dBZ just north of waypoint LANDU between 1631 and 1642 UTC (figure 12). It is plausible that the aircraft approaching from north hit one of these cells with the turbulence encounter.

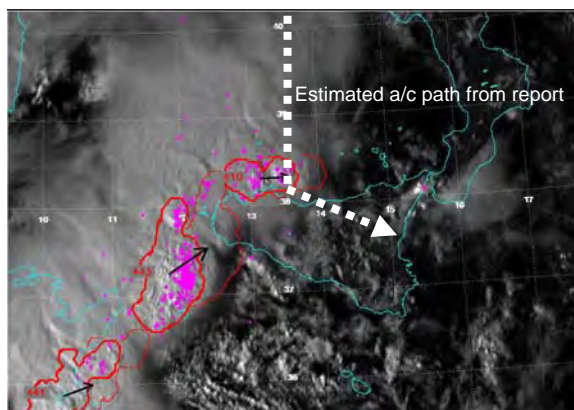
The METAR from Palermo, available around the time of the incident, reports at 1450 UT a 20° Wind with 26 knots with lowest visibility of 4000m, thunderstorm as present weather. The Cb-TRAM analysis for about this time is shown in figure 13.

Figure 13: High resolution visible satellite image in grey transparent shading and mature thunderstorm cells at 1455 UT marked by thick red contours, thin red contours indicate one hour nowcasts of the cells. Lightning observations recorded during past 5 minutes before 1455 UT marked by pink dots (from LINET observation system). Dotted line segments mark direction from Forli to Palermo and from Palermo to Catania.

The satellite image from Meteosat in the high resolution visible channel shows an approaching thunderstorm front towards the island of Sicily. The heavy convection cells, marked in red, and the lightning activity in the frontal line, observations from the LINET network, can be traced back for more than three hours before this time. Most probably the aircraft flew into the foremost convective cell (labelled with 410) just off the coast of Palermo, where the black arrow indicates its progression. Note also that the one hour nowcast of that cell indicates propagation to the east. There are also lightning observations in that cell.

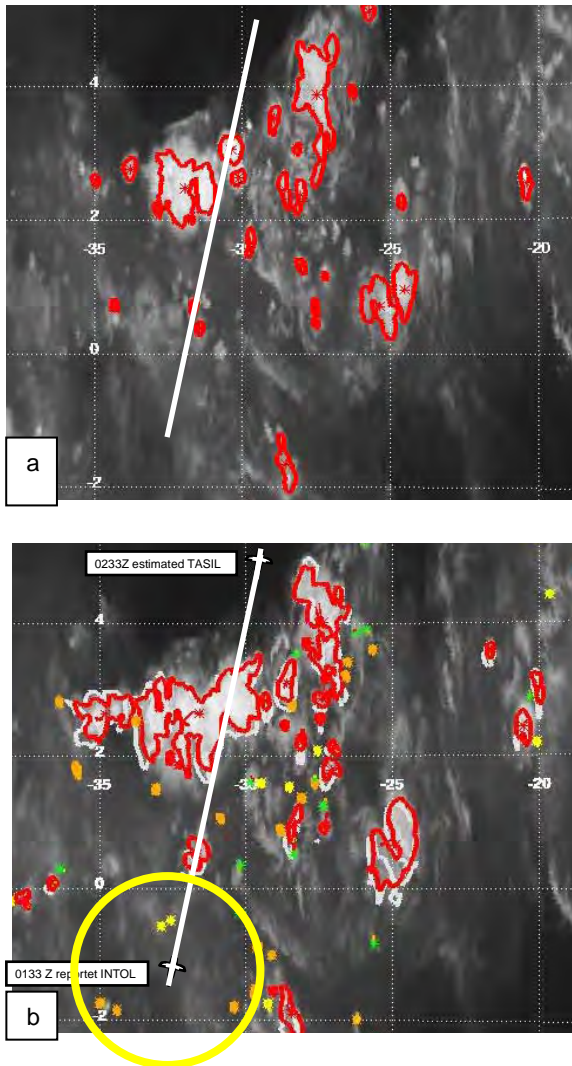
Figure 14 shows the convective situation over the Atlantic at two different times, i.e. 0000 and 0130 UTC, from the satellite cloud analysis. Red contours mark again the convective updrafts as detected by Cb-TRAM. The flight track is indicated by a white line combining the way points INTOL and TASIL. The convective cloud feature which is traversed by the flight route is seen to grow remarkably during this time span of ninety minutes. For the time 0130 UTC when the aircraft reported waypoint INTOL to ATC an approximate radar range of 80 nm is drawn as a yellow circle around the aircraft. This is to demonstrate that at this time the pilots could not foresee the strong convective activity on their future track from the on-board radar detection (also a longer range would not change the situation). Also, just from looking out of the window it was probably impossible for them to recognize the thunderstorm complexes in the far distance due to the midnight darkness. Furthermore there are no lightning discharges observed from the networks for this region at this time (noted by Vasquez' report) which could have warned the pilots. Half an hour later, at 0200 UTC, when the aircraft was close to the major convective complex (figure 15a), the onboard radar should have detected the cells, but now indicating convective activity almost everywhere in front of the aircraft which makes it

Figure 14: Meteorat infrared image over the Atlantic east of Brasil together with convective clusters (red contours) as identified from the Cb-TRAM cloud analysis on 1 June 2009 for time 000 UTC (a) and 0130 UTC (b). Also marked is the flight route between the way points INTOL and TASIL. The yellow circle indicates a radar range of about 80nm. Yellow, orange and green little patches mark initial developments not relevant for this analysis and not discussed.

sequence of figures 14 and 15 makes clear that the ground based information is able to represent the real situation about the convective activity and that this information, when brought to the cockpit, would help pilots in making decisions, especially when the planned route is impacted by thunderstorms. Ideally an alternative route in a given situation would be proposed by the ground based systems, e.g. as indicated by the dotted line in figure 16. This is not to say that the indicated route would have been possible for flight AF447. There might be restrictions due to ATC, prescribed air routes or fuel uptake which would not allow such a detour. Furthermore, it is known that often aircraft fly through these storms without any problems. Obviously, it is not only the mere presence and location of these storms that is relevant but also their evolution; whether they are growing in size or depth, their movement and possibly more elaborate attitudes like height, precipitation rate and type, lightning activity and turbulence level. Some of which have been addressed in the FLYSAFE Cb WIMS.

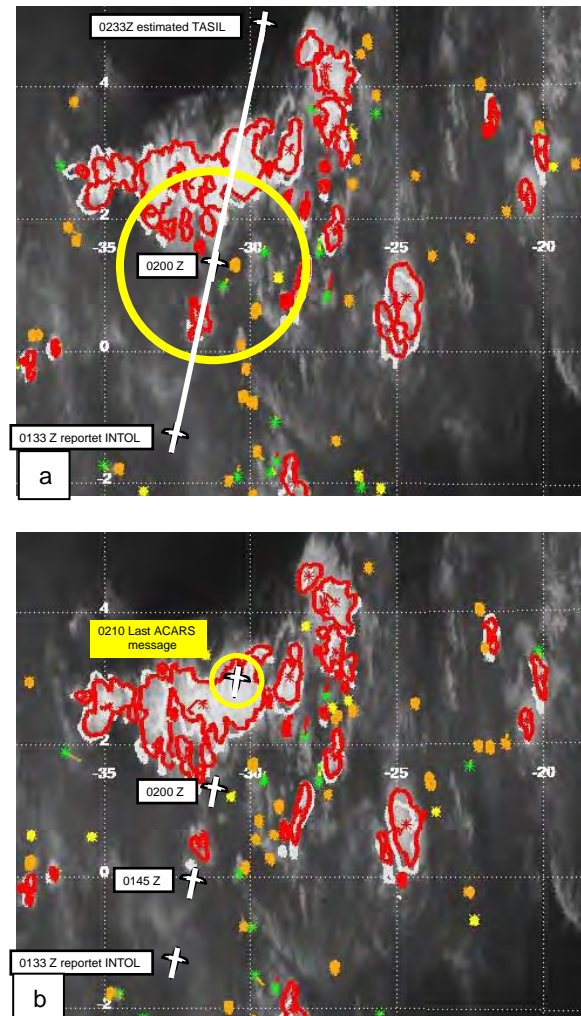
Figure 15: as in figure 14, but for 0200 UTC (a) and 0210 UTC (b)

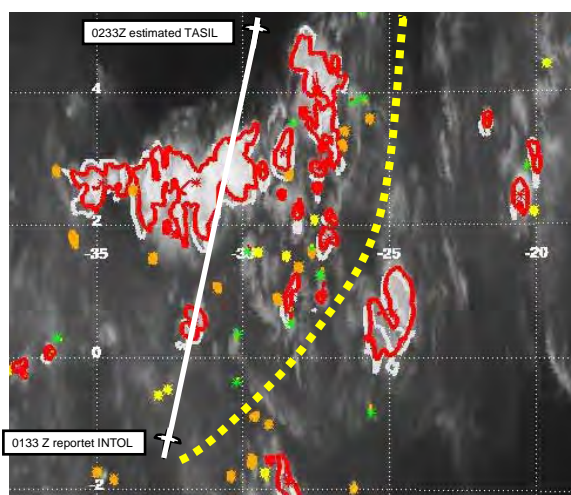
Figure 16: As in fig. 14b, with indication of alternative route marked by dotted line.

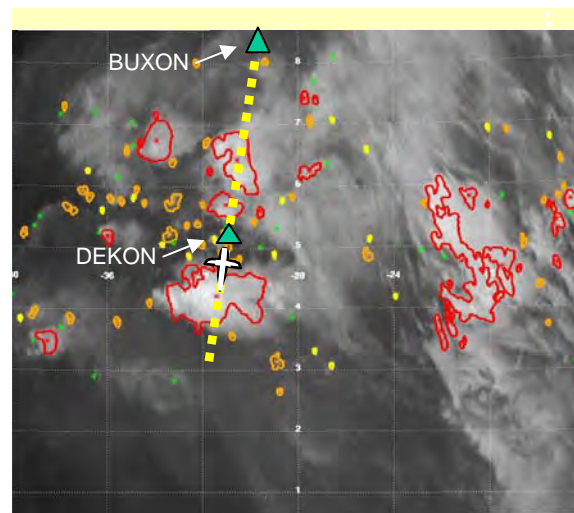
Later in the report it is noted that the airplane was at FL380 about 60nm ahead of DEKON on airway UN866 at time 0350 UTC. The Cb-TRAM analysis for this date and time is shown in figure 17

together with the airway and the approximate position when Mayday was called. Apparently the aircraft flew right through a major thunderstorm as seen clearly in the satellite image and marked by the red contour. From inspection of the development before and after this time (not shown) it is apparent that the convective cluster in this location originated around 0100 UTC and was still growing at the time of encounter. Also one can notice that additional convective clouds are on the

Figure 17: IR Meteosat 9 image on 30 November 2009 at 0350 UTC with mature convective cells (red contours) from Cb-TRAM analysis. Airway UN866 marked by yellow dotted line together with position of aircraft.

flight path further to the north between DEKON and BUXON way points (fig. 17). According to the report the turbulence lasted for about 30 minutes. It is not clear whether it would have been possible for the pilot to choose another route. The French Bureau d'Enquêtes et d'Analyses (BEA) reports that according to the air safety report weather forced the crew to divert from the airway and descend to FL360 employing oceanic contingency procedures after being unable to obtain clearance from ATC.
