Solar Energy Materials & Solar Cells

Durability of solar reflector materials for secondary concentrators used in CSP systems

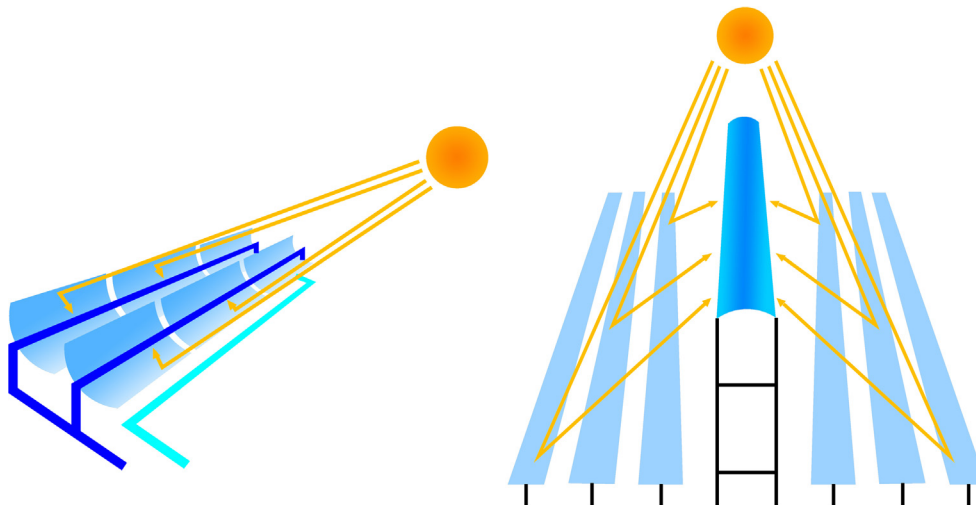
Fig. 1. Diagrams of single axis tracking systems: PTC (left) and Fresnel collector (right).

examples are parabolic-trough collectors (PTC) (see Fig. 1 left) and Fresnel collectors (see Fig. 1 right).

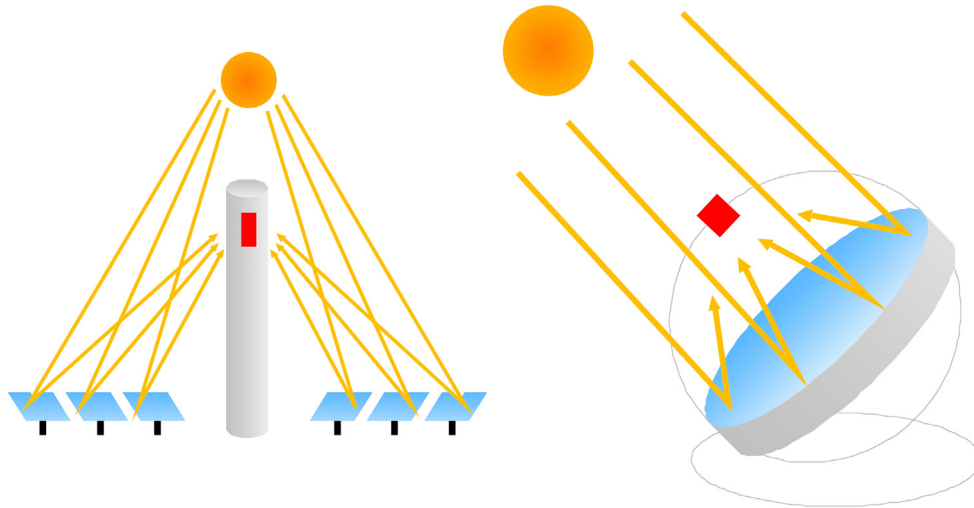
Fig. 2. Diagram of two axis tracking systems: CRS (left) and parabolic dish (right).

- (2) Two axis tracking technologies (3D-concentration). Here the process is similar to the single axis one. The peculiarity is that, the focus is a point instead of a line. Representative examples are central receiver systems (CRS), also called central towers, using heliostats reflectors (see Fig. 2 left) or parabolic dishes, typically used with a Stirling engine (see Fig. 2 right).

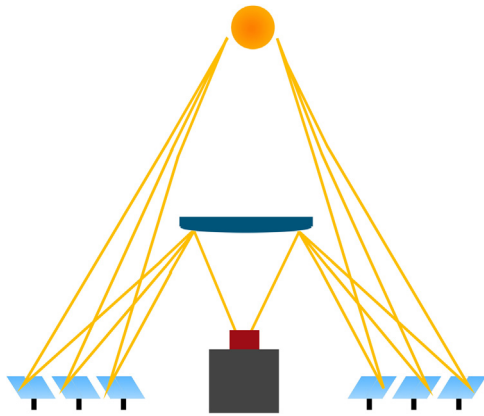
Fig. 3. Diagram of a beam-down system.

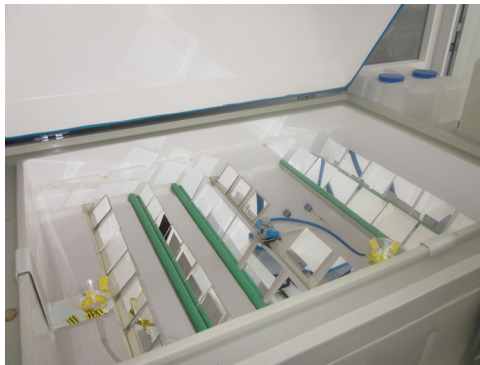
Fig. 5. Salt Spray chamber samples holder at PSA.

- Salt spray test chamber, CSF-500 by *Control Técnica* (Fig. 5). This chamber has been manufactured to perform tests according to ISO 9227 standard [17]. Combined cycles can be programmed (salt spray, condensation and ambient conditions). Different temperatures can also be applied during tests, from 10 to 50 °C.

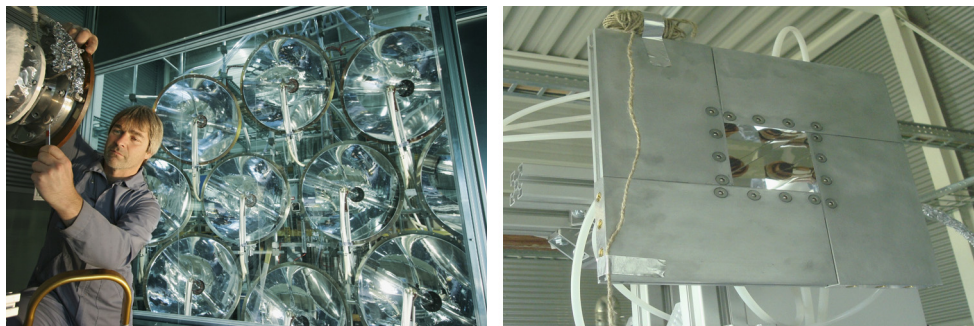
Fig. 6. High flux simulator (left) and frontal view of the OMX (right) at PSI.

and characterized (Fig. 6 right). The OMX is a rectangular tube consisting of mirrored inner walls, leading to an approximate homogenization of the flux at its exit where the samples were placed.

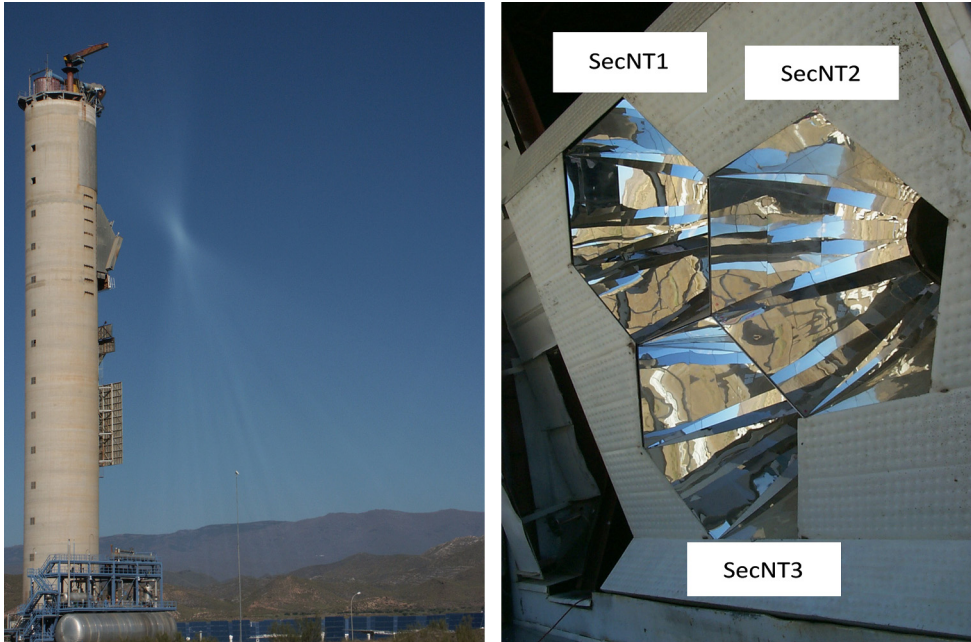
Fig. 7. CESA-1 tower (left) and REFOSS secondary concentrator unit composed of three secondary concentrators (right) at PSA.

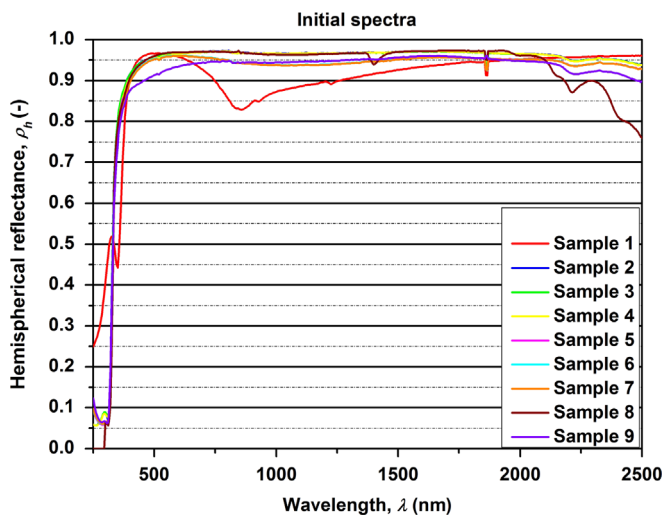
Fig. 8. Initial hemispherical reflectance spectra of all material types.

Average $\rho_s(\text{SW}, 15^\circ, 12.5 \text{ mrad})$ of all samples before testing was obtained by taking measurements with the spectrophotometer and reflectometer, and applying eq. (1) afterwards. Results are presented in Table 6. As can be seen in Table 6, all silvered-glass manufacturers presented $\rho_s(\text{SW}, 15^\circ, 12.5 \text{ mrad})$ values between 0.910 and 0.950. Only reflectance of laminated reflector (sample 9) is lower than for the rest of the silvered-glass reflectors (samples from 2 to 8). It is also predictable to have slightly reduced reflectance in thick glass reflector (sample 8) than in thin glass reflector (samples 2 to 7) because of absorption inside the glass. The aluminum reflector (sample 1) shows lower initial reflectance than silver reflectors, as expected.

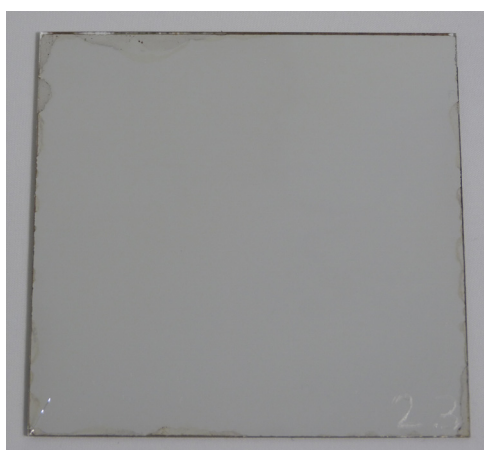
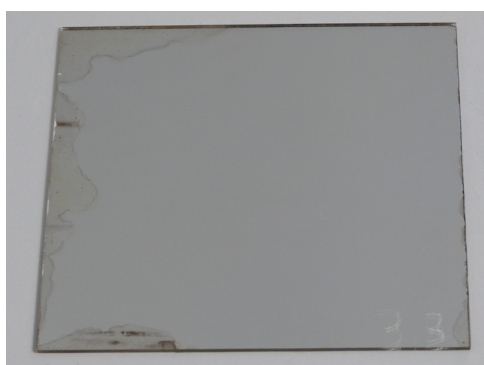
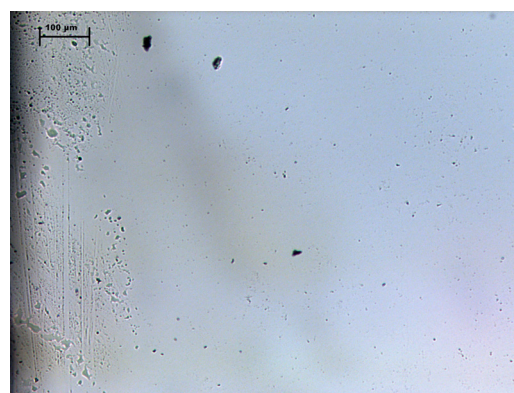
**Fig. 9.** Picture of sample 2, after the humidity test.

**Fig. 10.** Picture of sample 3, after the humidity test.

**Fig. 11.** Microscopic view of sample 3 edge, after the humidity test.

Samples 2 and 3 showed the second best response, presenting both a similar behavior, with an average $\Delta\rho$ of -0.010 after constant temperature test, and $\Delta\rho$ around -0.016 after the whole consecutive weathering test campaign. Damp heat test did not affect these samples. According to these results, back paints type 1 and 2 (corresponding to the samples 2 and 3, respectively) appear to be good enough for this type of systems. The only problem in these two samples was degradation in the back paints close to the edges, involving silver corrosion (see Figs. 9–11). This problem should be avoided with a proper edge protection.

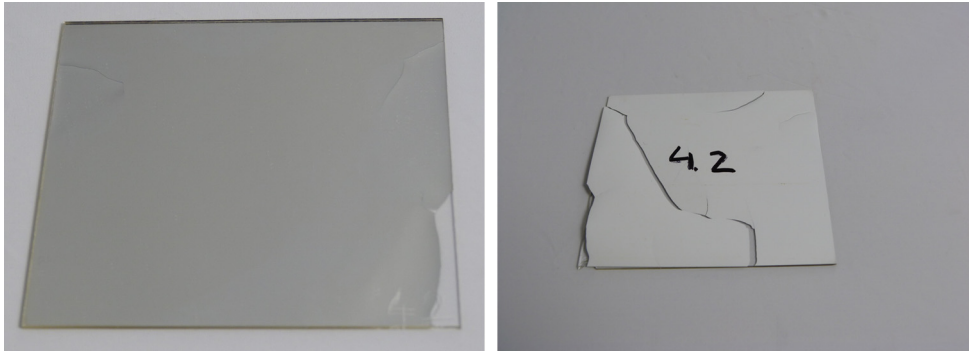
Fig. 12. Picture of front side (left) and back side (right) of sample 4, after the damp heat test.

Durability of sample 4 was excellent in the first three tests, with a $\Delta\rho$ negligible. Nevertheless, this material suffered a considerable degradation of the back paint and the silver after the damp heat test ($\Delta\rho = -0.110$), as can be seen in Fig. 12. As a consequence, back paint type 3 can be considered really adequate for all operating conditions, except for the combination of high temperature and humidity (that is, the damp heat test), which represents the most aggressive operating conditions.

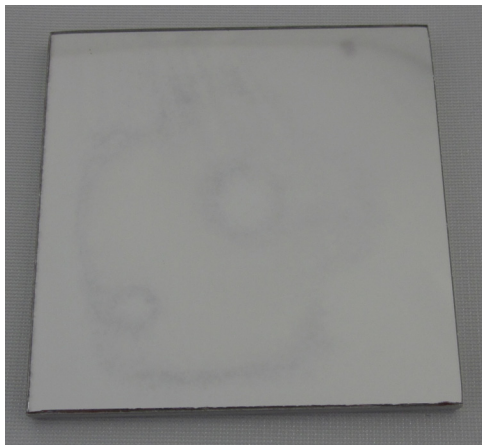
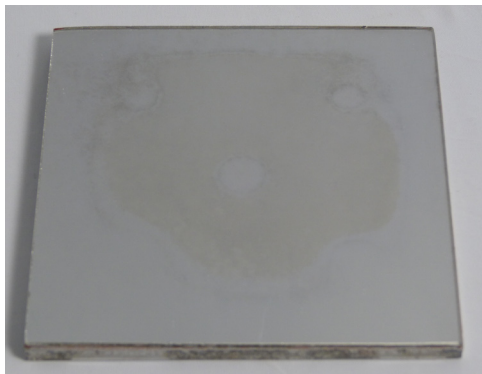
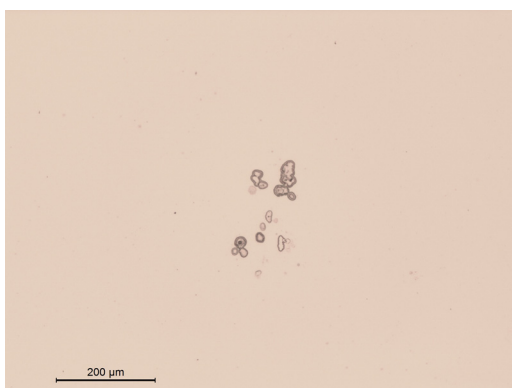
Fig. 13. Picture of sample 5, after the humidity test.

Fig. 14. Picture of sample 5, after the damp heat test.

Fig. 15. Microscopic view of sample 5 degradation stain, after the damp heat test.

Medium to high reflectance losses (between -0.029 and -0.068) were noticed in thin-glass samples glued to an aluminum support structure (samples 5, 6 and 7). The increasing degradation throughout the combined weathering tests could be due to a chemical reaction of the glue used between the reflector surface and the aluminum structure. This conclusion was obtained because the corrosion signs appeared exactly in the same places where the glue was applied (as shown in Fig. 13 for sample 5). This degradation was less aggressive in sample 6, where protection type 1 was applied on the edges, which indicates that the chemical reaction happened in the glue is aggravated by the penetration of oxygen through the unprotected or insufficiently protected edges. Therefore, this type of protection has demonstrated to be more effective than the other two options tested. The sample without protection in the edges (number 5) presented the worst behavior (as expected). As a result, the conditions applied in the damp heat test seem to be the most aggressive ones. This effect may be noticed in Figs. 13 and 14, where degradation stains are observed

due to a chemical reaction with the glue applied between the sample and the back aluminum support, effect that is also aggravated by the fact that the edges are insufficiently protected. If Figs. 13 and 14 are compared, a more aggressive degradation is noticed after the damp heat test. Fig. 15 provides a microscopic observation on the middle of the sample of these degradation patterns. Sample 7, with protection type 2 applied, showed an intermediate response between samples 5 and 6. Therefore, protection type 1 behaves better than protection type 2. These

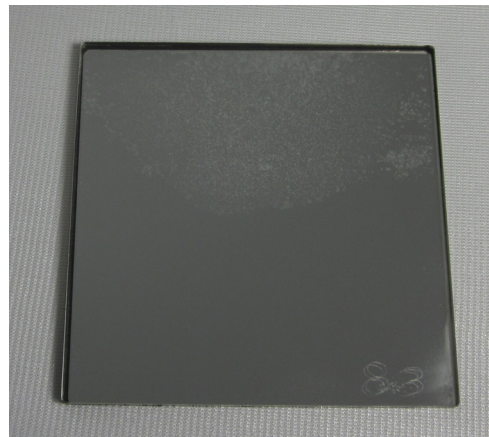
Fig. 16. Picture of sample 8, after the humidity test.

Finally, high reflectance loss ($\Delta\rho = -0.095$) was observed in the thick silvered-glass reflector for uncooled systems (sample 8), due to corrosion of the silver layer (Fig. 16). This degradation started to appear after the constant temperature test and significantly increased after the thermal cycling test. The reason why the sample 8 appears more degraded might be due to an insufficient protective back layer or due to absence of protection on the edges for such high temperatures reached by the uncooled systems (although the protective back paint does not appeared visually degraded).

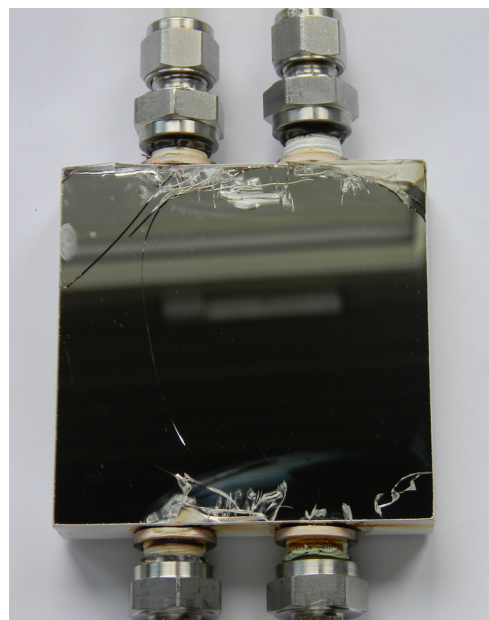
Fig. 17. Picture of sample 7, after high radiation flux test with 1470 kW/m^2 .

While after concentrated solar irradiation, almost no degradation of the reflectance value was observed, a few structural defects occurred. Sample 7 showed multiple cracks after the irradiation (see Fig. 17). These cracks were apparently originating from stress induced by screwing in the piping connectors far enough to make them water tight. This shows the importance of correct handling and gluing procedures of the mirrors on their support to avoid critical stresses during testing. In addition, radiation flux (or

mechanical stress induced by temperature gradients) probably helped the cracks to form or enlarge in the future. These temperature gradients are produced because samples are exposed to cooling from the internal side and a high radiation flux from the external side (something that does not occur in the temperature test, where temperature is homogeneously applied in the whole sample surface). In order to perform a deeper investigation of the

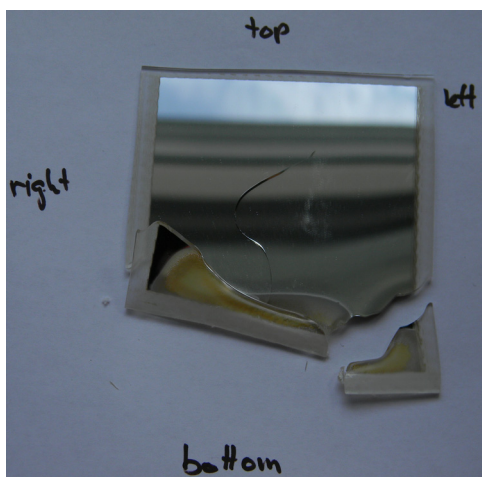
Fig. 18. Picture of sample 9, after high radiation flux test with 291 kW/m^2 .

Sample 9 was seriously damaged during the 2nd irradiation test at the highest planned flux of 291 kW/m^2 (see Fig. 18), which is a flux level far above the typical level in a 2D-CPC. Therefore, this failure shows a limit, but is not relevant for nowadays operating conditions.

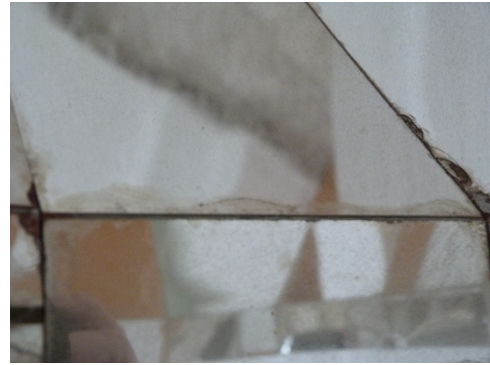
Fig. 19. Edge silver corrosion, after natural aging.

- (a) *Edge silver corrosion.* The most frequent degradation pattern is silver corrosion in the edges of the reflector segments. The area affected in this case is typically a line in the segment border with a width of up to 1 cm. The number of segment edges affected by this kind of defect was counted. Considering the total number of segment edges that forms the concentrators, it was determined that the 35% of them was affected. In the inspection, it was observed that the edges suffered some adhesive material (glue or sealing) losses. It is reasonable to believe that the silver deterioration started in the same area where the adhesive material is lost. Therefore, the way to avoid this defect is to use a more resistant material to attach the different reflector segments among them. This deterioration seemed more aggressive in the down facing reflectors, located on the ceiling of the concentrator cavity and in the ones facing up according the horizontal concentrator axis, as shown in Fig. 19.

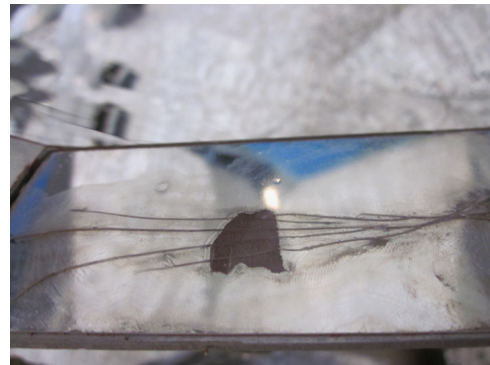
Fig. 20. Glass-cover breakage with inner silver corrosion, after natural aging.

- (b) *Glass-cover breakage with inner silver corrosion.* Some spots were detected with the corrosion starting at the center of the reflector segment and not at the edges. In this case, the size of the area affected by the silver corrosion is typically a circle of

up to around 1.5-cm diameter. The length of the glass-cover crack is variable, from some millimeters to 4 cm. All the zones with this type of silver corrosion also present a glass-cover breakage. Therefore, the corrosion is probably caused by the previous top glass breakage and the later humidity penetration, as Fig. 20 shows. The most probable reason for the glass breakage is that the cooling system is insufficient and temperatures reached are too high. Another reason may be found in fissures made during system manipulation (manufacturing, installation or maintenance). Consequently, to avoid these defects, cooling systems must be carefully designed and mounted.

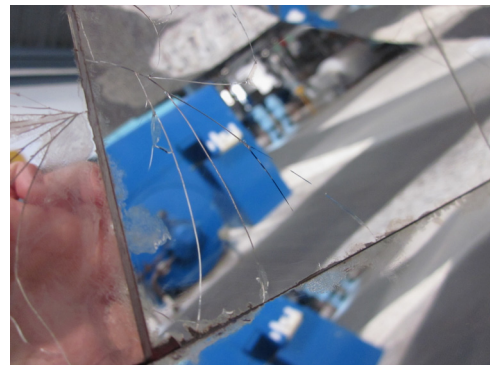
Fig. 21. Glass-cover breakage, after natural aging.

- (c) *Glass-cover breakage.* As can be observed in Fig. 21, in this case the glass-cover breakage did not involve deterioration of the silver around it. One reason for not having silver corrosion could be that the glass breakage is not deep enough and has not reached the silver layer yet.

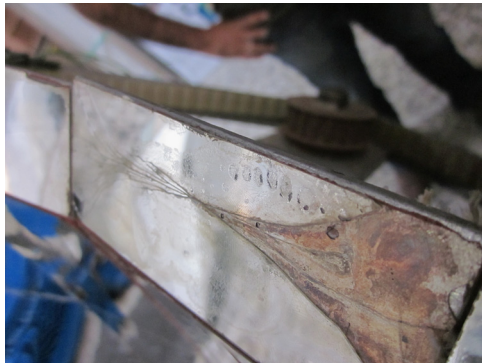
Fig. 22. Glass-cover breakage with glass-cover losses and silver corrosion, after natural aging.

- (d) *Glass-cover breakage with glass-cover losses and silver corrosion.* This defect is the most extreme and the combination of the previous ones (Fig. 22). In this case, the glass-cover breakage evolved to a loss of glass and, as a consequence, the corrosion of the silver layer was complete.
- (e) *Back paint degradation.* Deterioration of the back paint was observed in unprotected areas where the back painting is completely exposed or not assembled to any cooling system structure (see Fig. 23).

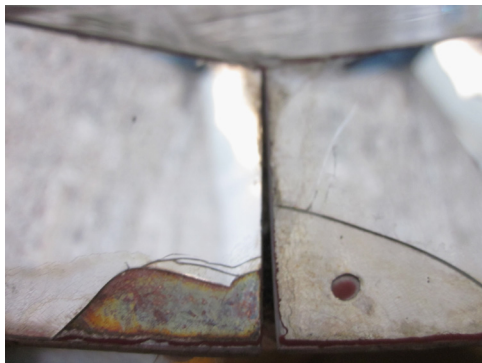
Fig. 23. Back paint degradation, after natural aging.
