Effectiveness and Limitations of Vegetation Bioshield in Coast for Tsunami Disaster Mitigation

Norio Tanaka

*Graduate School of Science and Engineering, Saitama University
Japan*

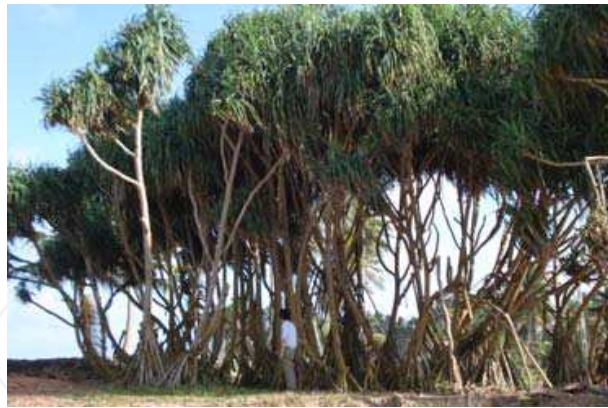
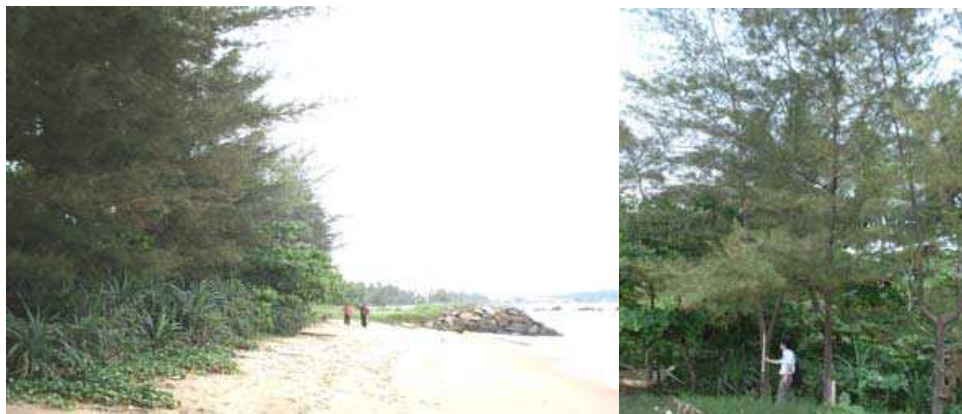
Fig. 2. Effective coastal vegetation, (a) *Pandanus odoratissimus*, and (b) *Casuarina equisetifolia* in tropical countries (undergrowth bushes is young *P. odoratissimus*)

A combination of different tree species is recommended in a buffer forest (Tanaka et al., 2007, 2008b, 2009). *Pandanus odoratissimus* (Fig.2a) was observed to grow under the shade of the taller *Cocos nucifera* and *Casuarina equisetifolia* (Fig.2b). In field observations, two layers of vegetation, *P. odoratissimus* and *C. equisetifolia*, in the vertical direction exhibited a strong potential to decrease the damage behind the vegetation cover (Tanaka et al., 2007), but a combination of *P. odoratissimus* and *C. nucifera* had little effect because they leave wide gaps vertically. *C. equisetifolia* is recommended as an appropriate tree species for a mixed forest. If it does not break, it traps debris. Considering the other roles, i.e. trapping debris and providing something to climb to escape or a soft-landing place for people, that coastal vegetation plays (Shuto, 1987; Tanaka et al. 2006b, 2007), a two-layer forest of *P. odoratissimus* and dense *C. equisetifolia* should be planted and preserved near the coast, and other broad-leaved trees should be grown behind this buffer forest (towards inland), as shown in Fig. 3 (Tanaka et al., 2007).

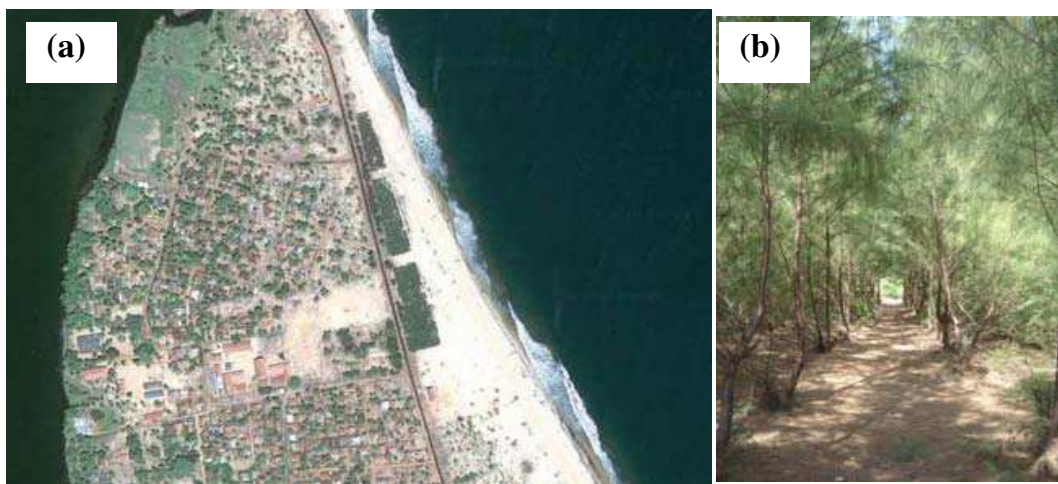
Fig. 7. Planting situation in eastern coast in Sri Lanka, (a) aerial photo (from Google Earth), (b) straight gap inside forest (photo by Methsiri Samarakoon)

Although the danger at the gap has been pointed out, large number of coastal vegetation belt were still constructed with the gap after the Indian Ocean tsunami. Fig.7 shows the planting situation in eastern coast in Sri Lanka. A lot of *Casuarina* forests are planted there but some forests has supposed to make dangerous zone behind or around the forest although the tsunami damage in most of the area are supposed to be mitigated. As it is not realistic to consider a coastal forest without any gap in the barrier, careful planning is required in the design of an actual coastal forest to incline the gap direction away from the tsunami current direction or to stagger it to reduce the water velocity through the gap (Thuy et al., 2009).

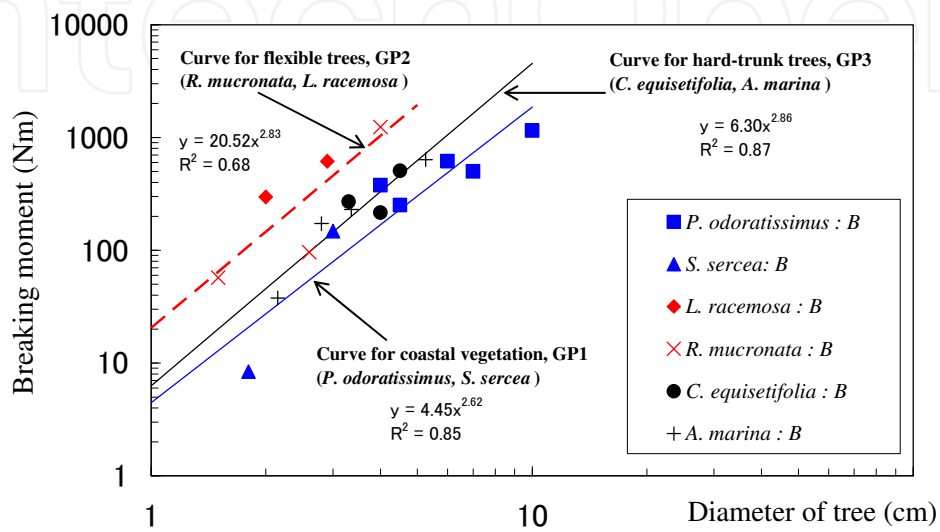
Fig. 9. Breaking moment curve of representative coastal tree species in tropics (modified from Tanaka et al.(2009))

Tanaka et al. (2006b, 2008b) conducted tree breaking tests in situ using small diameter trunks or branches and showed that the breaking moment curve of representative tree species (Fig.9) can be classified into three parts by elasticity and habitat as

1. the curve for coastal vegetation (ex. *P. odoratissimus*),
2. the curve for elastic trees
3. the curve for trees with hard trunks (ex. *C. equisetifolia*).

Although the breaking test was conducted in Sri Lanka before the 2006 Java tsunami (Tanaka & Sasaki, 2007), the breaking condition coincided well with the actual damage observed at the sites of the Java tsunami, except for *C. equisetifolia* (Tanaka et al., 2009). *C. equisetifolia* does not have aerial roots, but its diameter becomes greater at ground level than at breast height as the tree grows. Thus, its trunk was rarely broken. Most of the damage to *C. equisetifolia* was due to uprooting. This indicates that the breaking condition is not well expressed by the breaking test using *C. equisetifolia* with small trunk diameters. Further study of the breaking or uprooting conditions for *C. equisetifolia* is recommended with real-scale breaking or uprooting tests like those of Peltola et al. (2000) because *C. equisetifolia* is expected to be an effective species for dissipating tsunami energy in Sri Lanka, Thailand (Tanaka et al., 2006a, 2006b, 2007; FAO, 2007), and India (Mascarenhas & Jayakumar, 2008). Tanaka & Sasaki (2007) examined the height at which *P. odoratissimus* and *C. nucifera* trees were broken in two tsunamis (the 2004 Indian Ocean and 2006 Java tsunamis) and found that the threshold of tsunami water depth at which a tree trunk broke was about 80% of the tree height for *P. odoratissimus* (Fig.10). *C. nucifera* was seldom damaged except for small trees, but when it was toppled, the critical tsunami height was about 80%, the same as *P. odoratissimus*. Because the breaking point of *P. odoratissimus* is 1-2 m high, the moment by drag at that point is smaller than that of a tree without aerial roots. Although the threshold tsunami water depth for breaking *P. odoratissimus* is similar to that for *C. nucifera*, the trunk

strength of *P. odoratissimus* is not as great and it receives a large drag force from the tsunami current when the tsunami water depth is greater than the height of its aerial roots. The studies by Tanaka & Sasaki (2007) and Tanaka et al. (2008b) elucidated the breaking condition for a single tree when the scouring around the tree is not severe. However, the breaking condition is not applicable for critical tree damage in the fringe area of a forest, especially the frontal vegetation on sand dunes where the substrate is not hard and severe scouring occurs.

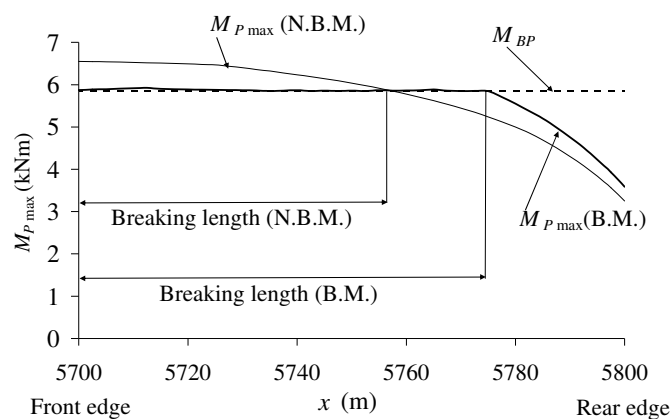
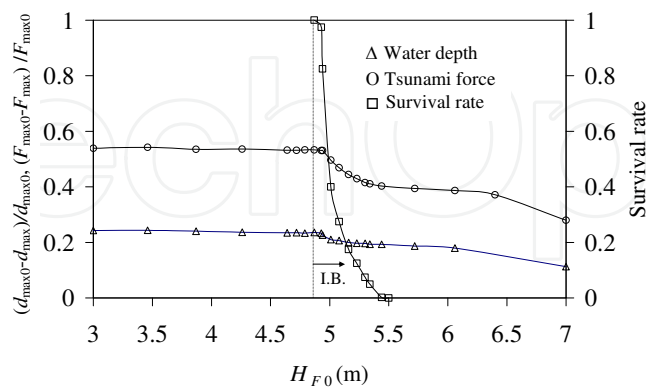
The tsunami force is directly related to the damage of trees, however, the effects of breaking on numerical simulation results were not directly discussed in previous studies except for Thuy et al.(2010a). Thuy et al.(2010a) developed the numerical model for estimating tsunami bending moment on a tree and including tree breakage, and then the damage length of

vegetation, reduction of water depth and tsunami force behind the forest are discussed. The study elucidated that: (1) tsunami moment is decreased from the front to the behind due to the decrease in water depth inside the vegetation, and (2) the reduction rate in water depth and tsunami force increases when the incident tsunami water depth exceeds the initial breaking. Fig. 11(a) shows spatial distribution of the maximum tsunami moments (M_{Pmax}) along the forest for two models. According to the result, the damage length of forest by the model including tree breakage (B.M.) is about 77.5m (77.5%) and increased in comparison with the model that does not include tree breaking (N.B.M.) due to the decrease in vegetation resistance in the front area where vegetation is broken. Fig. 11(b) shows the relationship between the tsunami water depth in front of vegetation in the case of no forest and the reduction of water depth ($(d_{max0} - d_{max})/d_{max0}$), tsunami force ($(F_{max0}^* - F_{max}^*)/F_{max0}^*$) behind the forest and survival rate of *P. odoratissimus* (number of remained trees/total tree), where subscript 0 indicates the case of no forest. The results show that trees start breaking at water depth of 4.8m (Fig. 11(b), I.B.). When tsunami water depth reaches to 5.5 m all the trees are broken. The reduction rate in water depth and tsunami force decrease when the tsunami water depth exceeds the initial breaking of water depth.

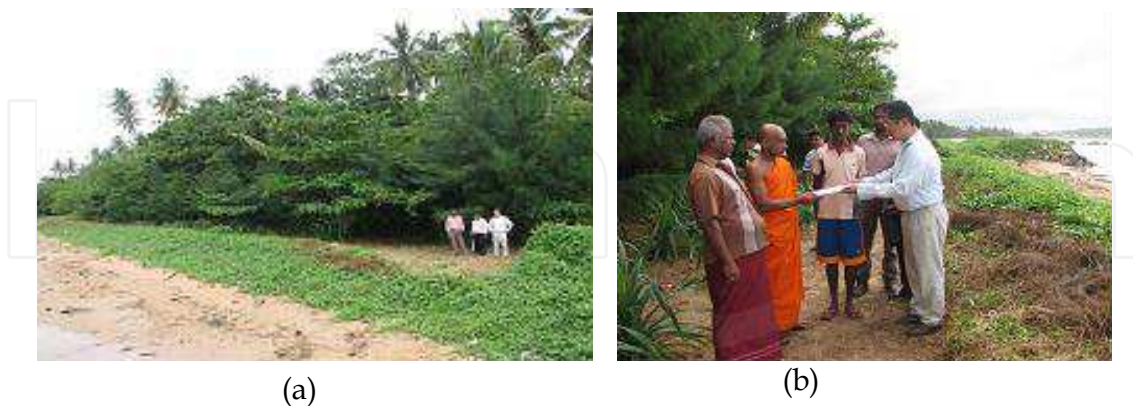
Fig. 12. Pilot project in Matara city. (a) growth situation after 18 months, (b) long term maintenance by local temple

A survey was conducted by a team comprising researchers from Saitama University, Japan, and the University of Peradeniya, Sri Lanka (the SU-UoP team) to examine the present situation of coastal vegetation for tsunami mitigation in Sri Lanka. Many government institutions and NGOs have also undertaken such projects along the southern and western coasts in Sri Lanka. An evaluation was carried out to assess whether the coastal vegetation fulfilled the functions of dissipation of wave energy and trapping debris, and offering opportunities to escape and make a soft landing (Tanaka et al., 2007). Currently, 50% of the vegetation barriers are planted in one or two rows due to land availability constraints in areas along main roads or railway tracks. Dissemination of knowledge and coordination with government institutions and research institutions are very important for establishment and management of effective coastal vegetation for tsunami mitigation with community participation, especially at the initial development stage.

The findings of Tanaka et al. (2007) suggested several options for coastal vegetation management that could effectively reduce the impact of tsunamis and other natural disasters in the future. Accordingly, the SU-UoP team proposed a pilot-scale coastal plantation in the Matara Thotamuna area in the southern coastal belt near the mouth of the Nilwala River, Matara City, Sri Lanka (Fig.12(a)), which was severely affected by the 2004 tsunami. *C. equisetifolia* and *P. odoratissimus* were planted in a mixed culture, and their growth was monitored continuously. The average height and girth of *P. odoratissimus* were around 92 cm and 117 cm, respectively, and the average height and trunk diameter of *C. equisetifolia* were 627 cm and 4 cm, respectively, 18 months after planting (Perera et al., 2008). The project was very successful and effective compared to similar projects that suffered from poor maintenance and operation. The project indicated that support from local authorities and communities are vital to make such programs successful, especially in initial development stage. For long-term maintenance of the pilot project, management of the site was handed over to the local temple (Fig.12(b)). This is one of the ideas for sustainable maintenance.

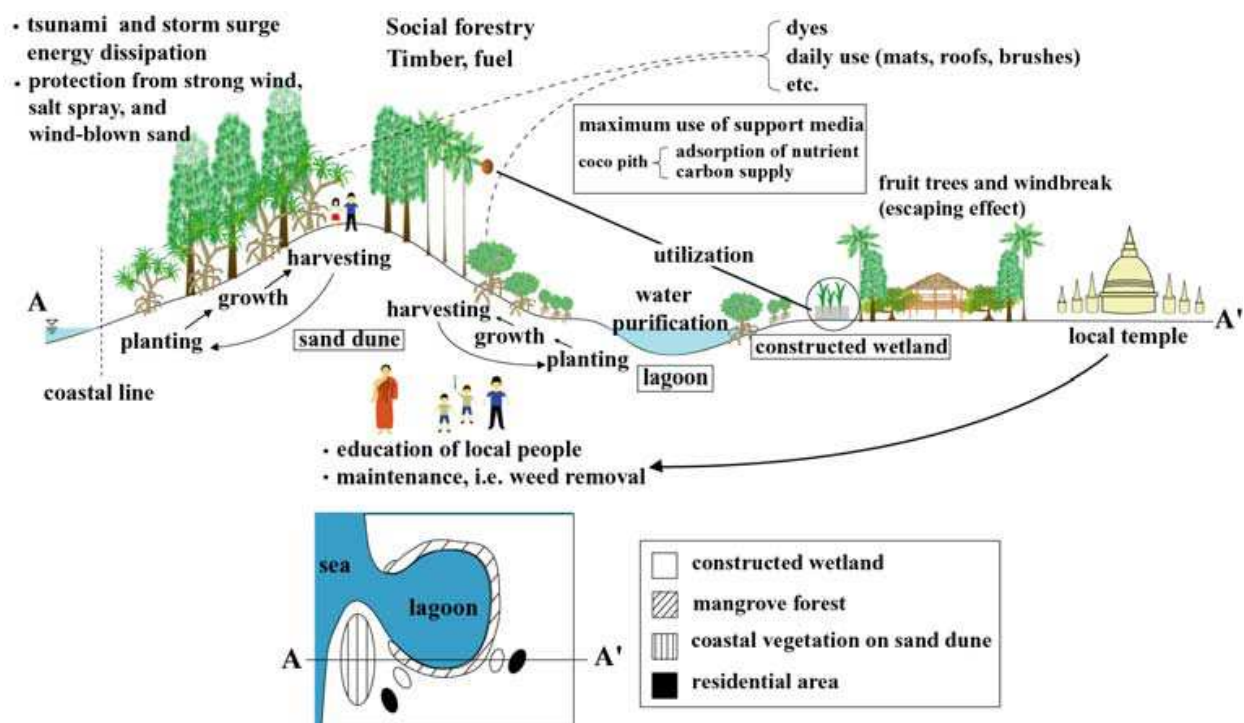
Fig. 13. Integrated coastal vegetation management system (modified from Tanaka et al., 2009)

Considering the Matara project by the SU-UoP team and the research by De Zoysa (2008), the author recommends an integrated coastal vegetation management system (Fig. 13) that maintains the vegetation bioshield effect for a long time. With the growth of trees, the tsunami energy mitigation effect of the vegetation may be reduced, because the tree spacing becomes larger and effective cumulative tree diameter in the stream-wise direction dN_{all} is reduced (Tanaka et al., 2007), and the trees themselves limit the light needed for the undergrowth that prevents soil erosion. To keep the forest dense, proper management is needed by using the forest as a source of firewood or for timber production to thin it, and maintaining various-aged stands of trees by replanting (FAO, 2007). In particular, the front line of the forest close to the sea should be dense vegetation (i.e., a *Pandanus-Casuarina* belt) as Tanaka et al. (2007) proposed. Although *C. nucifera* cannot provide a large drag on the tsunami current, this species is important for economic use. *C. nucifera* has many uses, i.e. fruit production, fuel, timber, and coconut fiber is used as water storage and water purification materials in the substrate of manmade wetlands (Tanaka et al., 2008a). Thus, it is not necessary to remove *C. nucifera* from the coastal region if it is kept at the backside of coastal sand dunes or combined with dense *Pandanus* forest, even though the contribution of *C. nucifera* to increase the overall drag coefficient by itself is not large.
