# Contribution to the Evaluation of Silicon Carbide Surge Arresters

Arnaldo Gakiya Kanashiro and Milton Zanotti Jr.  
*University of São Paulo  
Brazil*

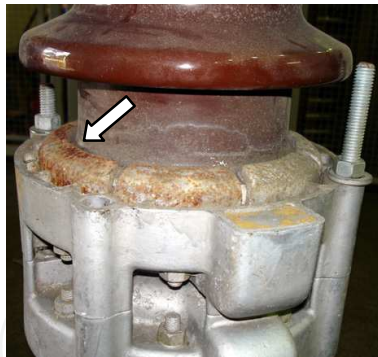
Fig. 2. Corrosion in the metallic parts of the surge arrester.

In some of the 88 kV arresters, surface erosion was observed which is a typical sign of electric arc damage on the porcelain, as shown in Fig. 1. Also, most of them had some degree of corrosion in their metallic parts, as shown in Fig. 2. Finally, in order to check the viability of measuring the leakage current in the field, some SiC surge arresters installed at Paraibuna substation were chosen. After this, due to the explosion of one 88 kV SiC surge arrester at Mairiporã substation, leakage current measurements were also performed in this substation.

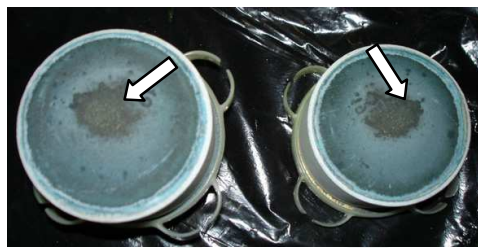
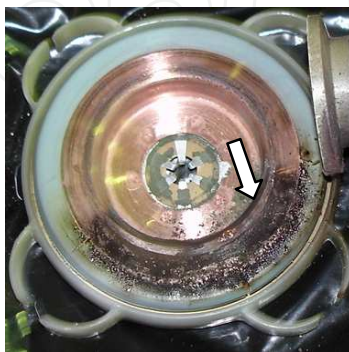
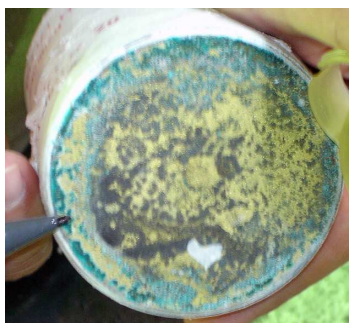
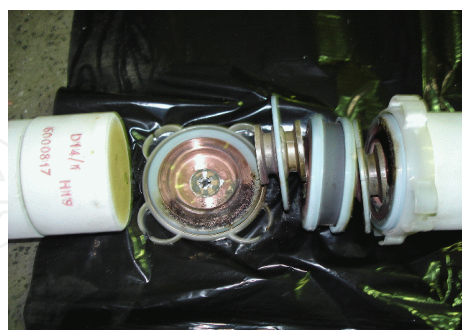
Fig. 7. Surge arresters of manufacturer A, (a) blocks: signs of discharge, (b) gap electrodes: signs of discharge, (c) block: presence of moisture and (d) gap electrode: signs of discharge.

In general, it was noticed that moisture was presented in the internal components of the arresters. Some traces of discharges on the surface of the blocks were also observed. Some of the surge arresters presented signs of discharges in the gap electrodes. During the visual inspection, it was also observed that some nonlinear resistors were damaged.

The surge arrester A6 (manufacturer A) was more degraded in comparison with A2 and A4. The arrester C5 (manufacturer C) was the worst in comparison to the surge arresters C1 and C3.

The surge arrester C5 presented some damaged nonlinear resistors and, probably, this was the reason for the high level of RIV ( $4,518 \mu\text{V}$ ), shown in Table 4. This surge arrester also failed the power frequency spark-over voltage test. In Fig. 7 and Fig. 8 it is possible to visualize the condition of the components of the surge arresters, considering manufacturers A and C, respectively.

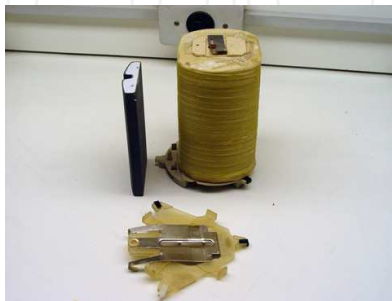
Fig. 8. Surge arresters of manufacturer C, (a) block surface: presence of moisture, (b) group of gap electrodes: damaged, (c) nonlinear resistor: broken and (d) nonlinear resistor: broken.
