Modular Femoral Neck Fracture After Total Hip Arthroplasty

Igor Vučajnk and Samo K. Fokter
*Celje General and Teaching Hospital
Slovenia*

6. Case report

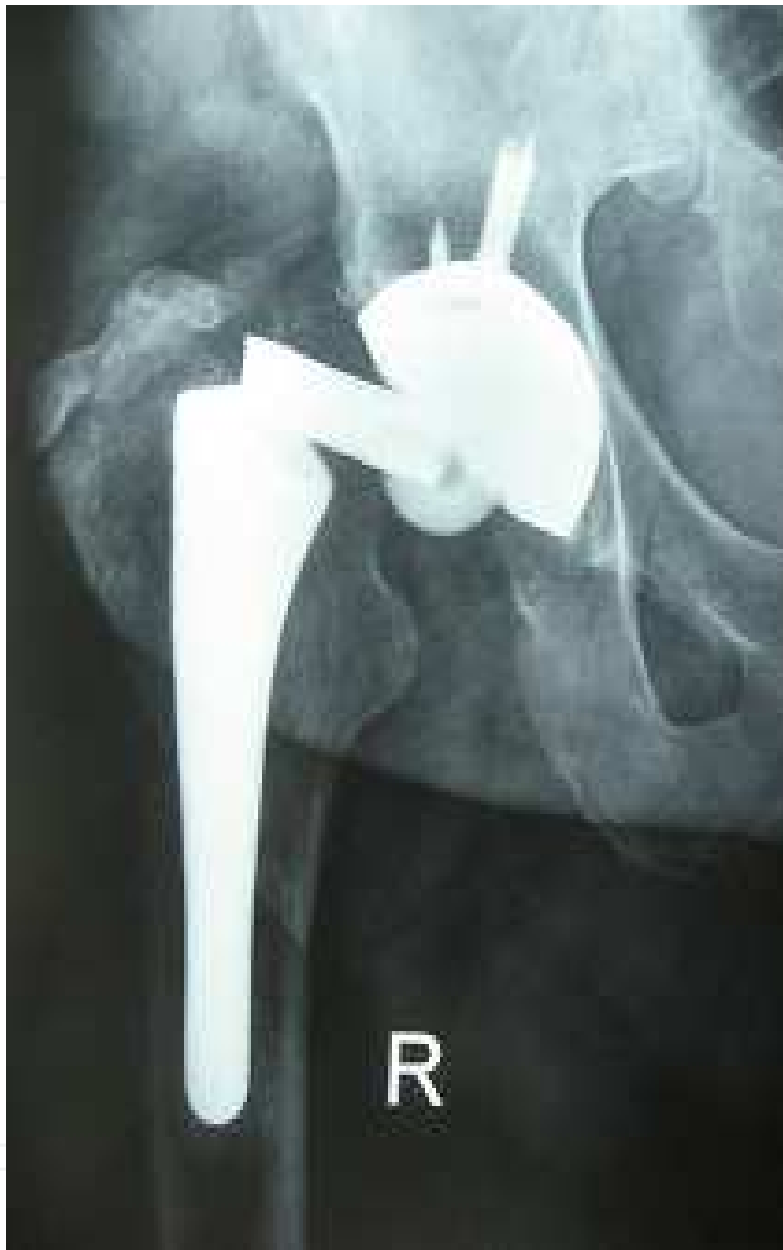
In December 2010, a 69-year old male was admitted to our hospital's emergency department with acute pain in his right hip. The pain appeared after a fall on his right side from standing height. The examination revealed right inguinal tenderness and shortening of his right lower extremity with external rotation. The review of standard radiographic exams showed modular prosthesis neck fracture. This was the first such complication seen at our department (Fig. 1). The patient's height was 178 cm and he weighed 110 kg (BMI 34.7). He was treated at our institution in 1998 when he was 56 years old. At that time his BMI was 31.6 (weight 100 kg). The operation was performed because the patient suffered from rheumatoid arthritis with the involvement of his right hip. A fully modular cementless total hip endoprosthesis was implanted (fully hydroxy-apatite coated femoral stem (GSP) with modular cobalt-chromium long straight neck, 28 mm diameter ceramic head, and acetabulum of the press-fit type (ANCA-Fit) with ceramic acetabular insert, (Cremascoli Orthopaedics, Sorem Ortho, Toulon, France). None of the postoperative visits or radiographic exams showed any signs of wear or other complications. The patient was pain free before the event.

Fig. 1. Standard antero-posterior radiograph of the patient's right hip at admission. (Courtesy M. Kotnik, M. D.)

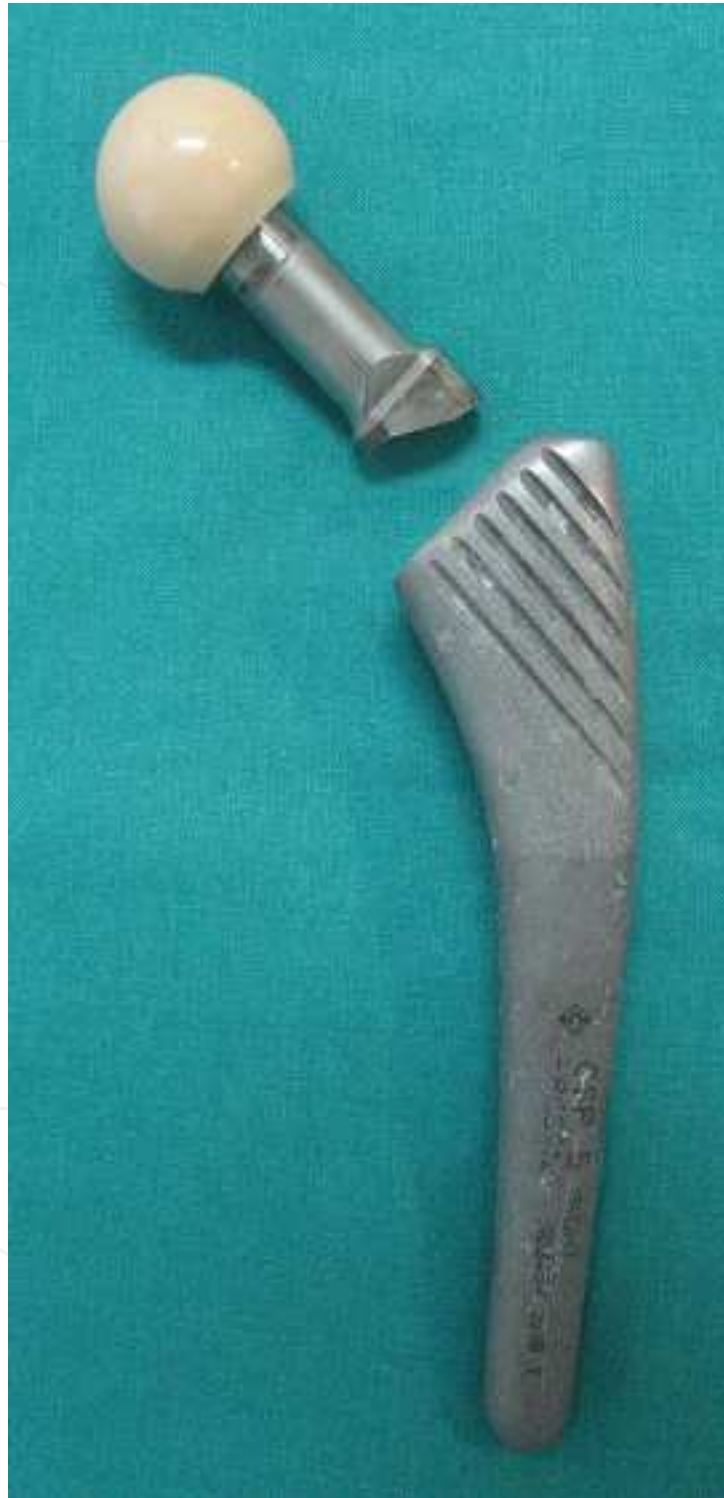
Revision surgery was scheduled as soon as we received the custom made acetabular cup inlay (ANCA-Fit, Wright Medical Technology Inc., Arlington, TN, USA). The operation was performed by the same surgeon and the previous lateral approach was used. Revision surgery confirmed the fracture of the modular prosthesis neck. It was impossible to remove only the remaining neck from the taper, so that the entire femoral stem had to be removed. The femoral stem was well integrated in the femur and femoral osteotomy was necessary in order to remove the implant. Macroscopically, the tissue showed no metal debris or granuloma. The remaining part of the fractured neck module was approximately 2 mm below the top of the taper (Fig. 2-4).

Fig. 2. Photograph of the retrieved fully-modular prosthesis showing the modular neck fracture.

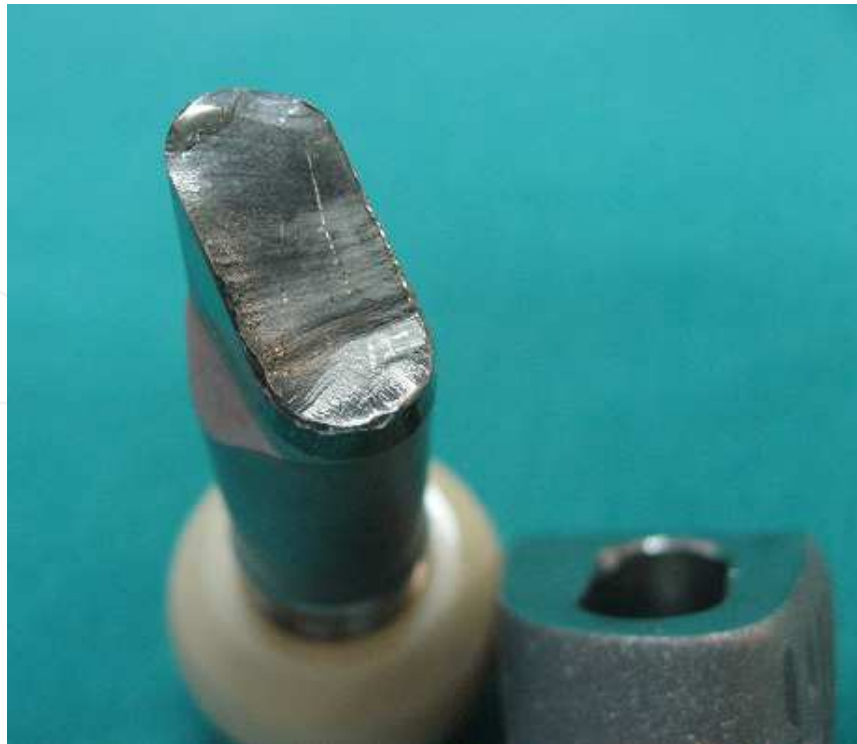
Fig. 3. A close-up photograph showing the fractured modular femoral neck.

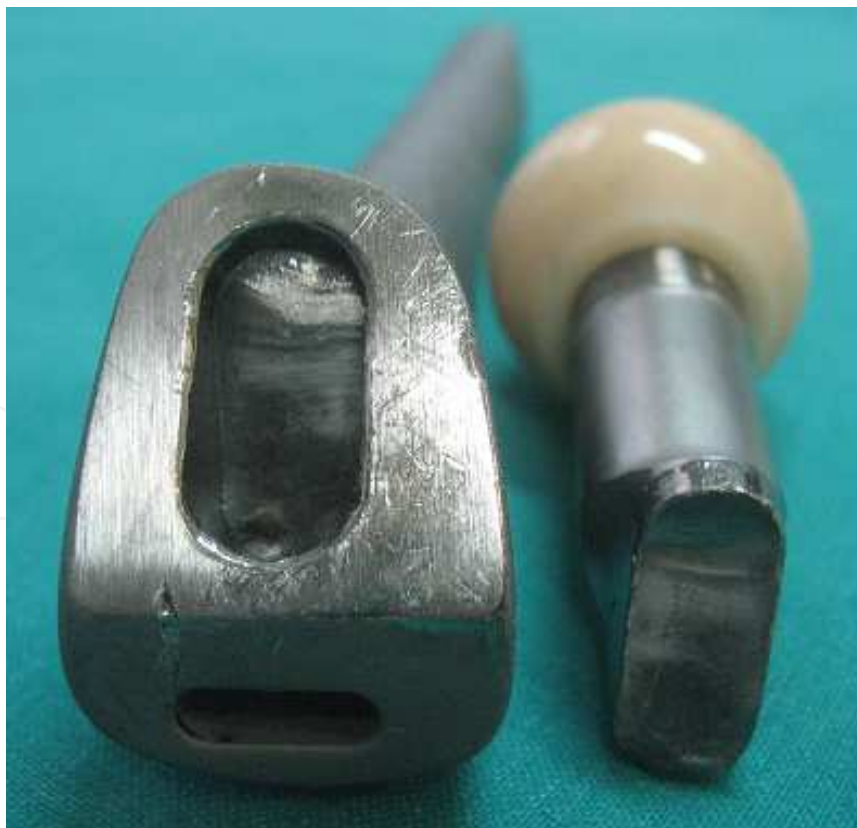
Fig. 4. Photograph showing the removed prosthesis with fractured neck and the remaining of the modular neck in the femoral stem taper.

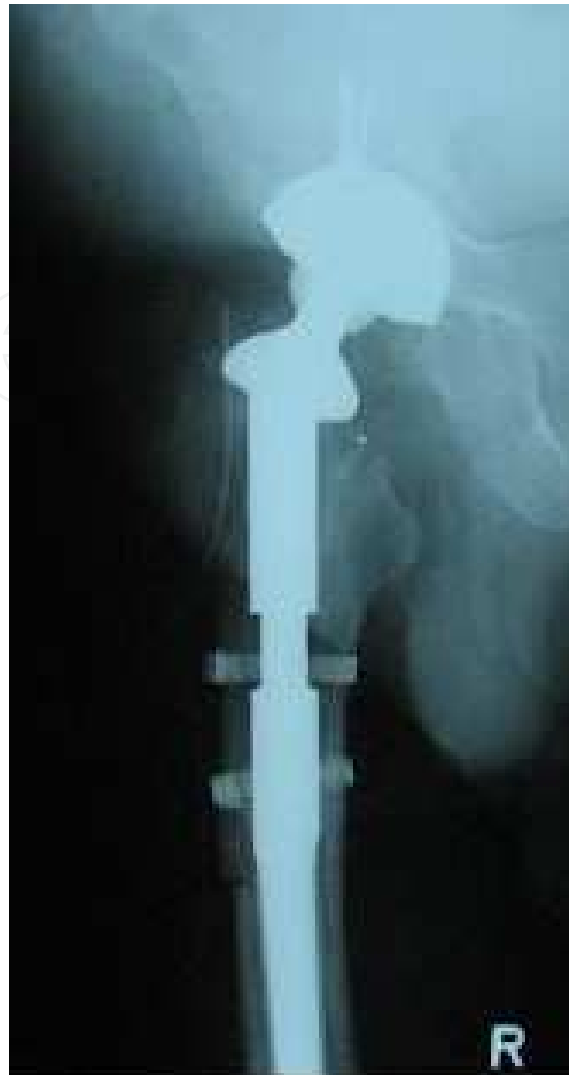
Fig. 5. Radiograph of the revised right hip with the cementless revision modular prosthesis in place. (Courtesy M. Kotnik, M. D.)

In order to properly reconstruct the biomechanics of the hip, cementless revision modular stem with ceramic head (Waldemar Link GmbH & Co, Hamburg, Germany) was used. The acetabular lining was exchanged as well and a custom made ANCA-Fit (Wright Medical Technology, Inc., Arlington, TN, USA) component implanted (Fig. 5). Standard tissue specimens were collected during the revision procedure for microbiologic cultures which showed no bacterial growth.
