# Application of Remote Sensing for Tsunami Disaster

Anawat Suppasri<sup>1</sup>, Shunichi Koshimura<sup>1</sup>, Masashi Matsuoka<sup>2</sup>,  
Hideomi Gokon<sup>1</sup> and Daroonwan Kamthonkiat<sup>3</sup>

<sup>1</sup>*Tsunami Engineering Laboratory, Disaster Control Research Centre,  
Graduate School of Engineering, Tohoku University*

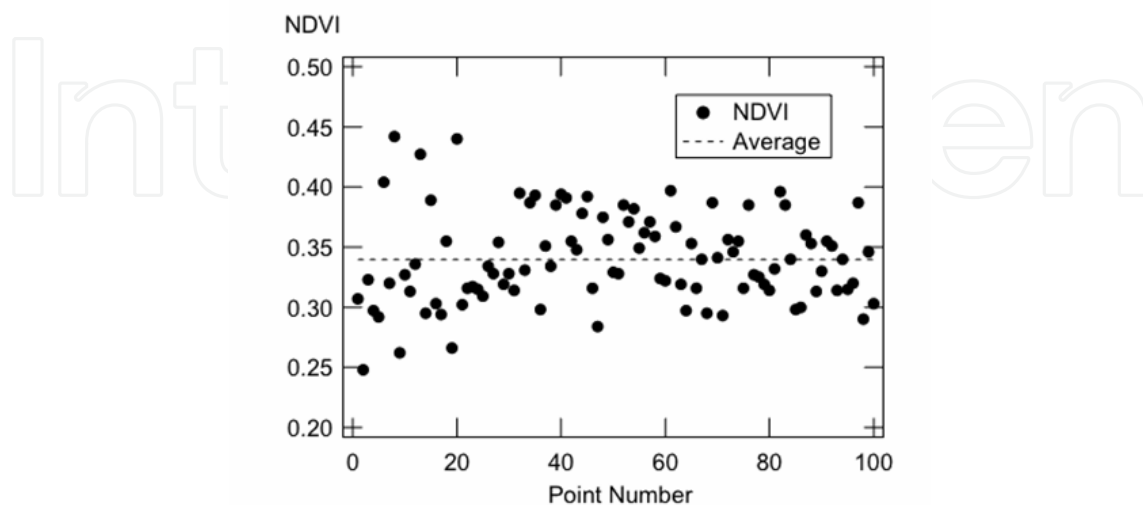
Fig. 1. Threshold value of NDVI within the tsunami inundation zone obtained from the analysis of the post-tsunami satellite imagery.

where  $R$  and  $NIR$  stand for the spectral reflectance or radiance in the visible (red) and near-infrared bands, respectively. Focusing on the existence of tsunami debris, 100 points were sampled to identify the NDVI threshold to classify the tsunami inundation zone. As shown in Fig. 1, the NDVI values are calculated within a range  $0.34 \pm 0.05$ . As a result, the extent of the tsunami inundation zone is determined by the supervised classification based on the NDVI threshold. As shown in Figure 2 (a), the QuickBird imagery clearly detects the vegetation change between pre- and post-tsunami. Tsunami debris can be seen along the edge of the tsunami inundation zone. Figure 2 (b) shows the result of the detection of the tsunami inundation zone by applying the threshold value of NDVI, and the result is consistent with the field survey.

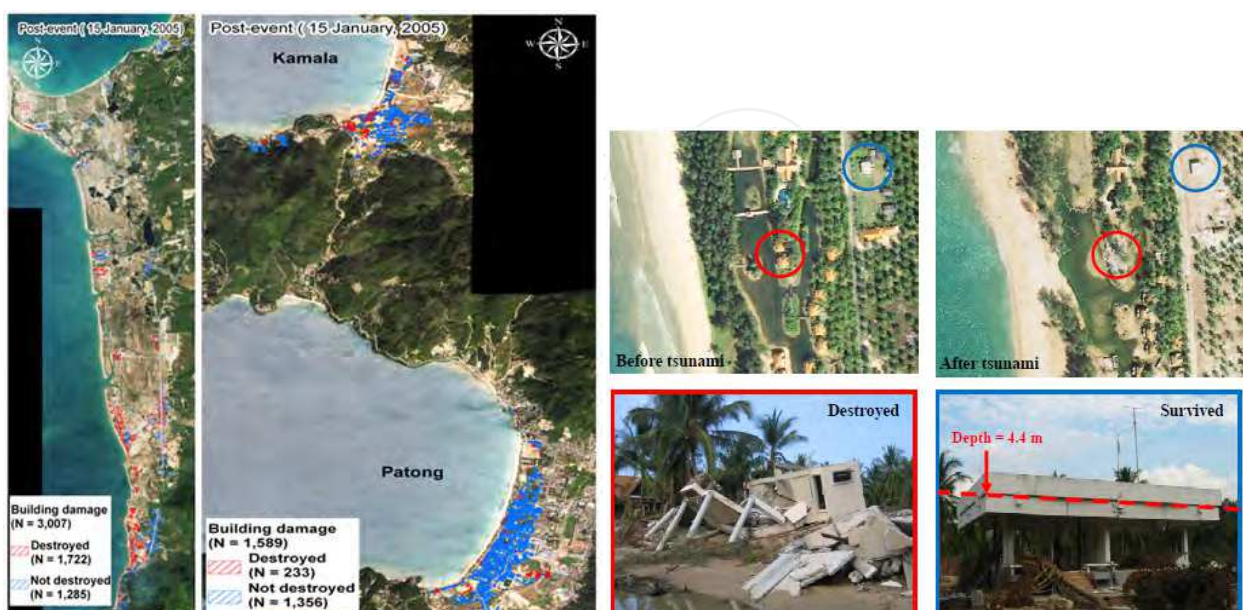
Fig. 10. Visual damage inspection results in Phang Nga and Phuket, Thailand

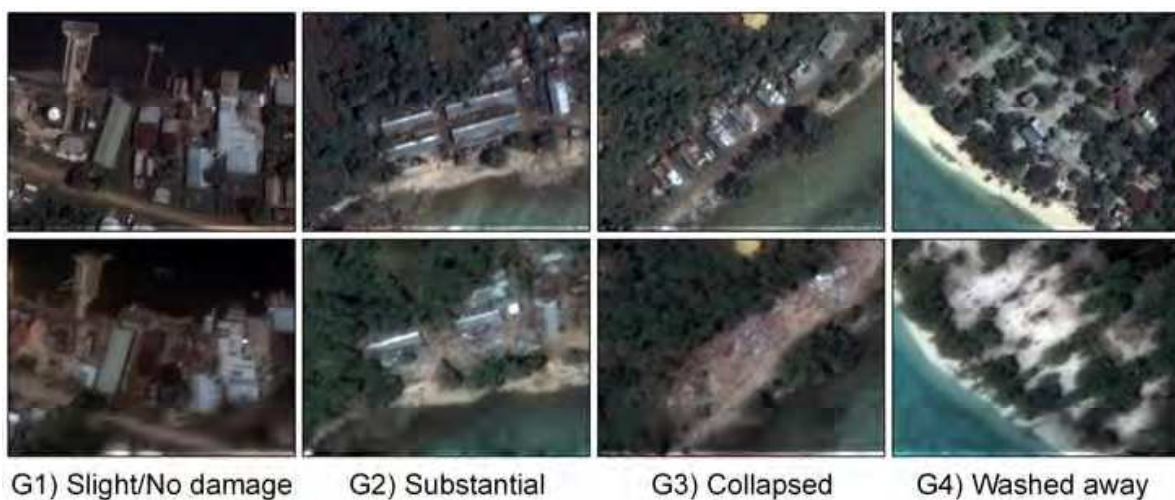
Fig. 11. The structural damage interpretation is divided into four classes: slight/no damage, substantial damage, collapsed and washed away

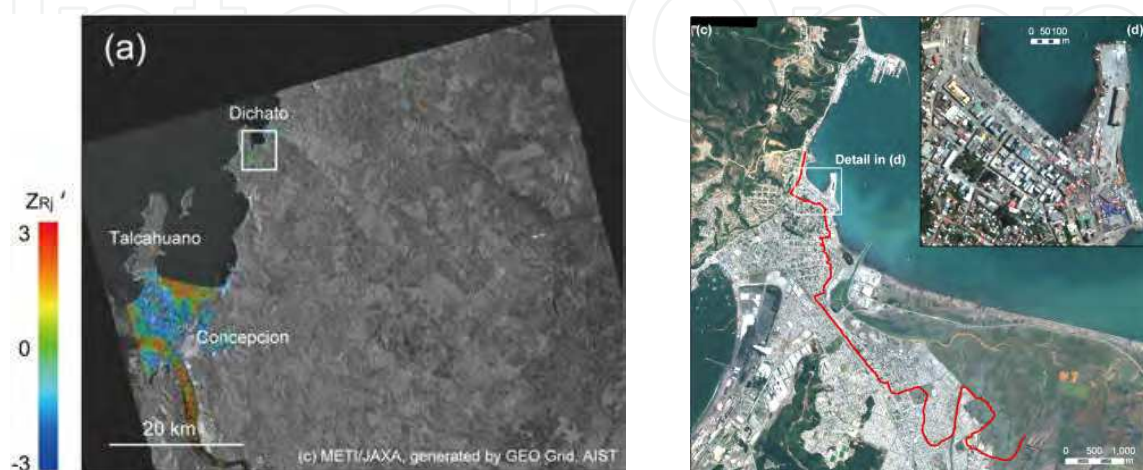
Fig. 14(a). Distribution of  $Z_{R2}$  obtained by ALSAR images in Talcahuano and optical images

The results are shown in Fig. 14 (a) and (b). The sections on the sea are masked, but the areas where the river could not be masked have large  $Z_{R2}$  values because of the surface changes caused by the flow of water. The wetlands near Talcahuano and Llico, where the  $Z_{R2}$  values are large, seem to be affected by the tsunami. Figure 14(b) shows a close-up  $Z_{R2}$  image of the Dichato area, with a comparison pre- and post-tsunami from an optical image (Koshimura et al., 2011).

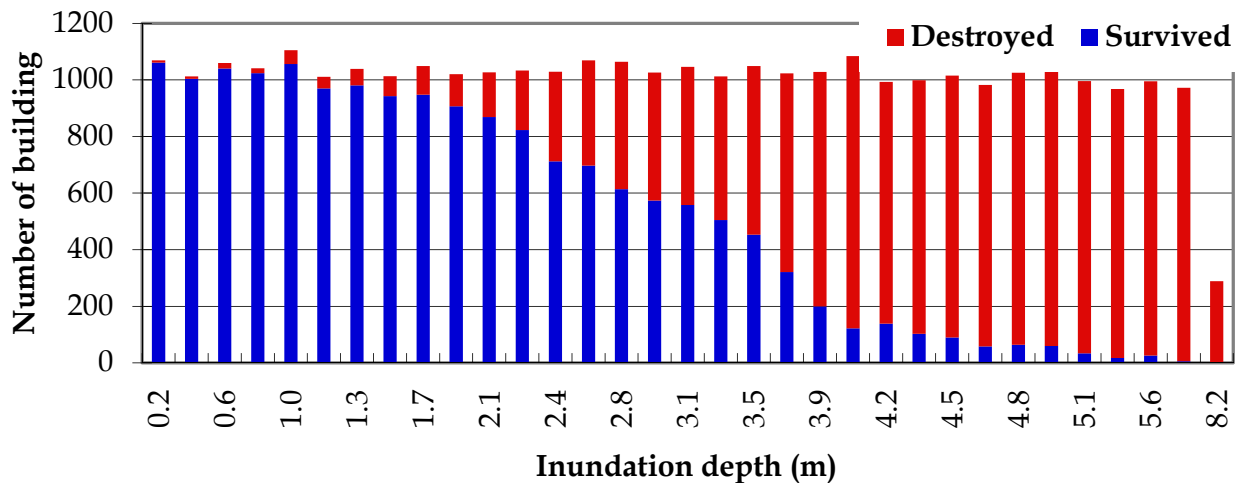
Fig. 18. Histogram of damaged and not-damaged houses to calculate the damage probability

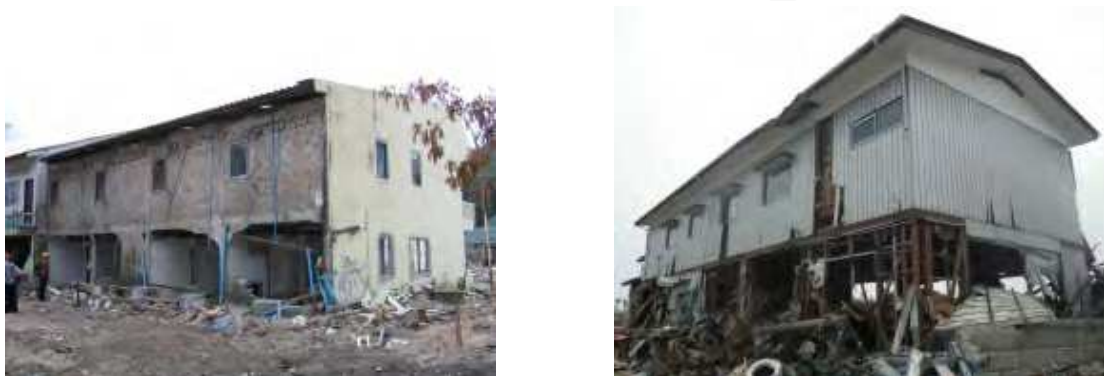
Fig. 25. Examples of building damage in the case of the 2004 Indian Ocean tsunami in Thailand and the 2011 Tohoku tsunami in Japan
