# Resolving the Difficulties Encountered by JPL Interplanetary Robotic Spacecraft in Flight

Paula S. Morgan

*Jet Propulsion Laboratory, California Institute of Technology,  
USA*

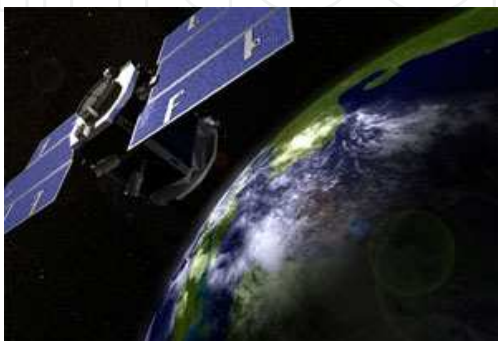
**CloudSat:** Earth Orbiting Satellite

**Standard FP:** 3 Safe-Mode Responses

5 Under-voltage Responses

Memory Scrubber & Bus FP

**Unique FP:** Significant computer & thermal FP

Fig. (4a). CloudSat Spacecraft FP Allocation. Fig. (4b). Stardust Spacecraft FP Allocation.

Figures (4a) through (4d) depict four JPL spacecraft designs with quite different mission objectives, which employ typical and mission unique FP (Ball Corp., 2001; JPL, 1997, 2005).

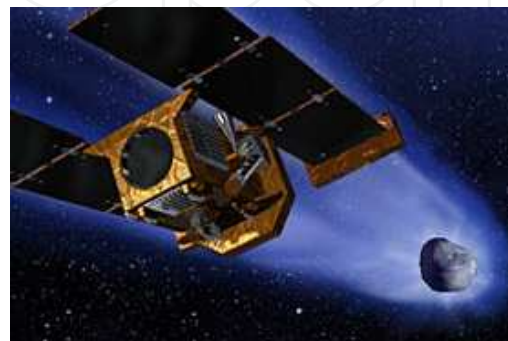
**Stardust Spacecraft:** Inner Solar System; Comet Explorer

**Standard FP:** 1 Safe-Mode Response

1 Under-voltage Response

1 Command Loss Response

Memory Scrubber & Bus FP

**Unique FP:** Some computer & thermal FP

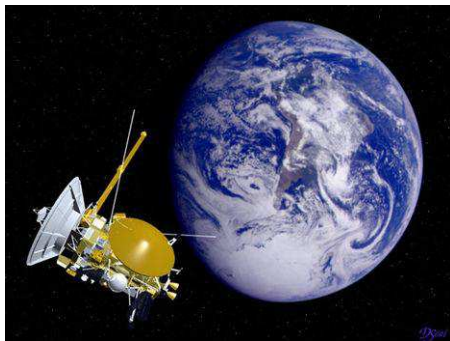
**Cassini Spacecraft:** Outer Solar System Explorer

**Standard FP:** 1 Safe-Mode Response  
 1 Post-Safe Mode Response  
 1 Under-voltage Response  
 1 Command Loss Response  
 Memory Scrubber & Bus FP

**Unique FP:** Significant command & data processing computer FP, radio unit FP, thermal FP, fuel tank pressure FP, attitude articulation and control computer FP

Fig. (4c). Cassini Spacecraft FP Allocation.

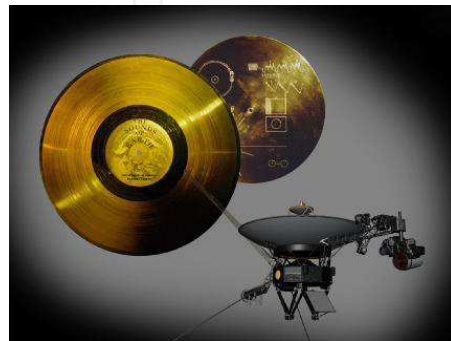
**Voyager Spacecraft:** *Interstellar Explorer*

**Standard FP:** 1 Under-voltage Response  
 1 Command Loss Response

**Unique FP:** Computer FP, attitude articulation and control computer FP, and radio unit FP

Fig. (4d). Voyager Spacecraft FP Allocation.

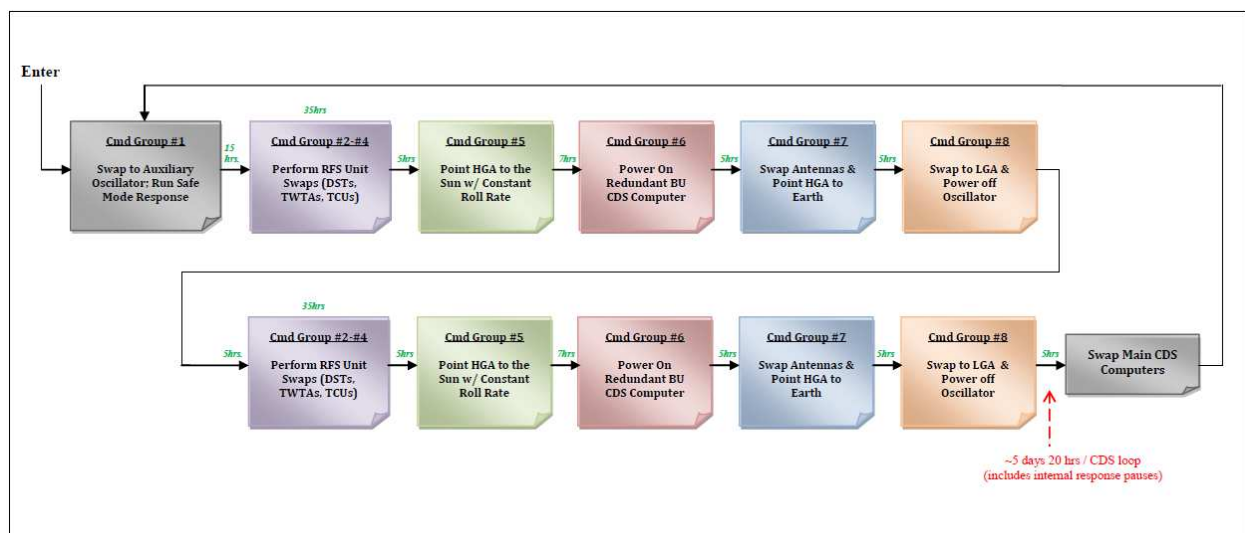
Figure 7 illustrates how the Cassini Spacecraft's Command Loss FP Algorithm addresses faults that can cause ground-spacecraft communications loss; this condition is referred to as "loss of spacecraft commandability." A special "countdown timer" has been implemented into the onboard CDS FSW to keep track of the last time an uplink command was received from the ground operators. This timer decrements continuously (at one second intervals) and is reset back to its "default value" (several days for Cassini) each time an uplink command is received by the spacecraft. The extended absence of uplink commands will eventually lead to the monitor's request for the response, since the timer will eventually decrement to "0". Under these conditions, the assumption is that the spacecraft has experienced a failure where it can no longer receive commands.

Fig. 7. Cassini's Command Loss Response Chain for One CDS Cycle (Endless Loop Response).

Cassini contains redundant units for the Command & Data Computer (CDS), Radio Frequency (RFS) devices, (Deep Space Transponders, TWTAs, Telemetry Control Units (TCU)), as well as three antennas (one High Gain Antenna (HGA) and two Low Gain Antennas (LGA)). The Command Loss Response is divided up into "Command Groups" with "Command Pauses" installed after each group of commands has been executed. These pauses allow several hours (the equivalent of at least two RTLT periods) for the SOFS team to attempt re-acquisition of the spacecraft using the newly response-commanded spacecraft configuration. As shown in the figure, the first Command Group will select the auxiliary oscillator and execute the Safe-Mode response which turns off non-essential loads, commands the spacecraft's High Gain Antenna to the Sun, and places the spacecraft in a known uplink & downlink state. A 15 hour wait period has been installed after this first Command Group to allow sufficient time for the SOFS team to re-establish the uplink, if possible, before hardware swaps begin. If this attempt is unsuccessful, the response will proceed with the next course of actions in Command Group #2 which is to start the series of RFS hardware unit swaps. Five to seven hour wait periods are installed between each subsequent Command Group to allow the SOFS team adequate time to send commands to the spacecraft to re-establish the uplink on the new commanded configuration. At the end of the response chain (approx. 5 days 20 hrs), a swap to the redundant CDS is initiated and the

response will activate on the other computer's FSW (the response runs endlessly until an uplink command is received by the ground). The goal of Command Loss FP is to perform hardware swaps and/or re-command the S/C attitude until the ground acquisition is restored. Once the spacecraft successfully receives a command from the ground and the uplink has been re-established, the response will terminate and reset its countdown timer, thus leaving the spacecraft on the last successfully commanded configuration.

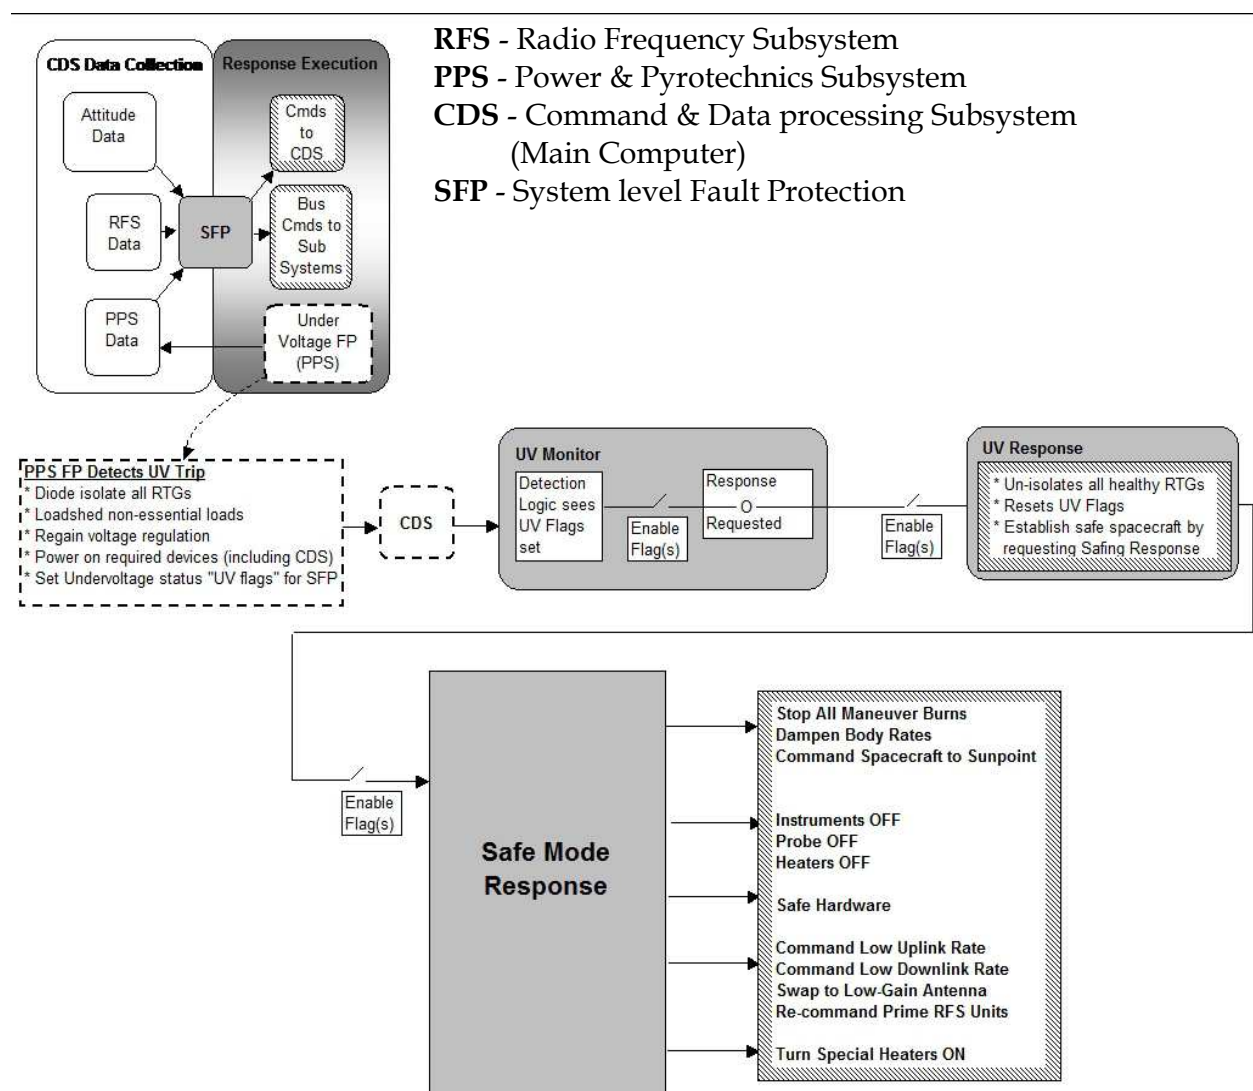
Cassini's "Under-voltage Trip" monitor and response are shown in Figure 8, "Cassini Spacecraft's Under Voltage FP Actions for Shorted RTG" in which a RTG power unit (one of three on this spacecraft), has shorted. In this example, the Power Subsystem FP senses a power drop below the predefined threshold for the duration of the persistence filter. The

Fig. 8. Cassini's Under Voltage Fault Protection Actions for a Shorted RTG.

first action taken by the Power Subsystem FP is to diode-isolate all three RTGs, turn off (loadshed) all spacecraft non-essential loads, regain the voltage regulation to 30 watts, and then turn on all essential hardware. It also sets three "UV Status Flags" (one for each RTG) to notify System-level FP (SFP) that an Under-Voltage trip event has occurred. Once the CDS becomes operational, it will deliver these UV Status Flags to SFP. SFP's Under Voltage monitor will examine the state of each RTG and if enabled, will request the Under Voltage response. The SFP response un-isolates any correctly operating RTG, unsets its corresponding UV Status Flag, and establishes a predictable, safe spacecraft state by executing the Safe-Mode response.

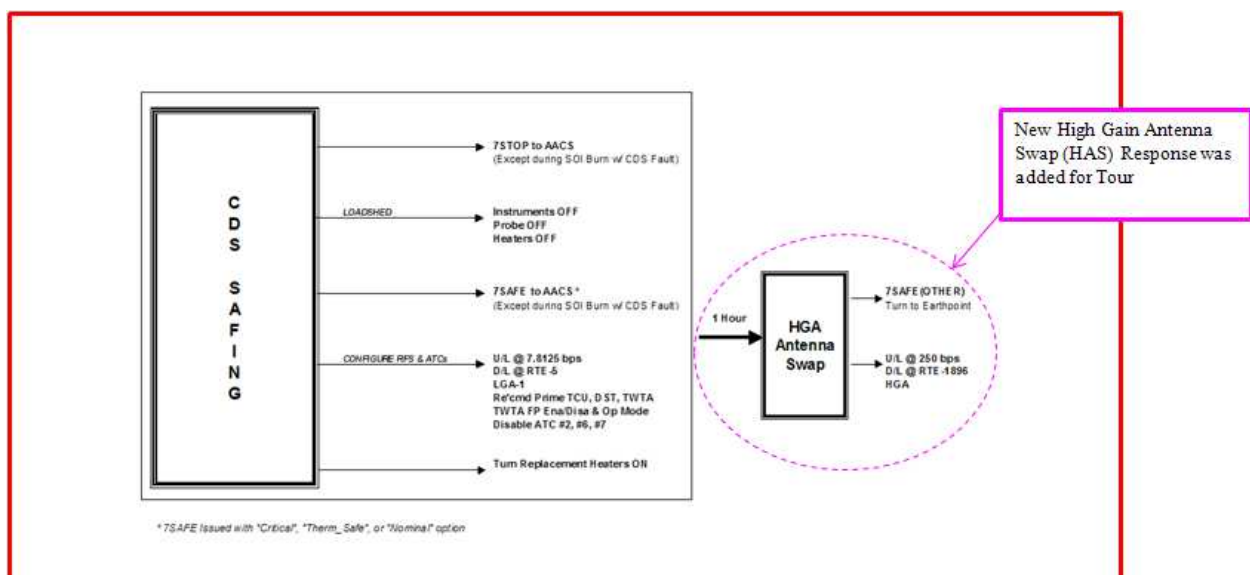
As stated previously, the Safing Response (and internal FP routines) provide a safe spacecraft state with low uplink & downlink rates for the SOFS team to diagnose the fault condition, recover the spacecraft systems, and reactive the onboard sequence. Two weeks was originally allocated for this recovery period. But once the Cassini spacecraft reached the Saturnian system and began its mission Tour phase in 2004, three Orbital Trim Maneuvers (OTMs) were now required for each loop around Saturn-Titan, making the two-week-turnaround period infeasible since a lengthy spacecraft recovery period could cause Cassini to fall off the Tour trajectory. A High Gain Antenna Swap (HAS) Response was therefore designed into the FSW to help the SOFS team improve recovery time. This HAS response executes one hour after the Safing Response activation to increase the downlink rate from 5bps (bits per second) => 1896bps, and the uplink rate from 7.8125bps => 250bps. Figure 9 shows the HAS Response following the Safing Response activation.

Fig. 9. New HGA Response was added in 2003; Configured to Run 1 hr. after Safing Response Executes.

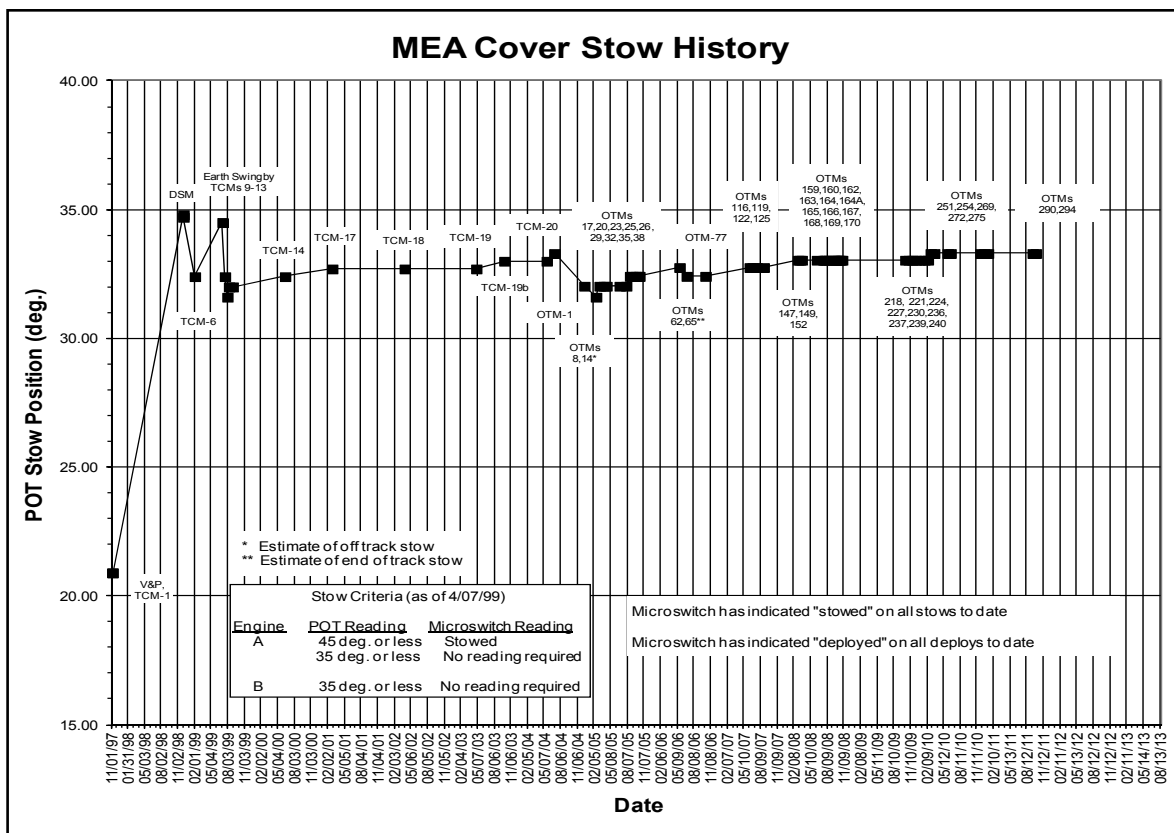
Cassini's ME assembly requires a cover which must be deployed (closed) when the engines require protection from micrometeoroid and on-orbit dust impacts which often surrounds Saturn and its moons. Shortly before the Deep Space Maneuver (DSM) burn when the MEA cover was stowed (opened), the cover assembly did not open as far as was observed in ground tests. The cover opened 14 degrees less than expected, but the SOFS team demonstrated that this opening angle was adequate to allow for successful main engine burns to commence (on either nozzle). The cause of this degradation in performance of the MEA cover was attributed to the increased stiffness in the cover material (kapton & beta cloth) due to exposure to the space environment which was experienced during flight within the inner solar system, although a period of disuse also contributed to this increased stiffness. These environmental effects cannot be adequately modeled in ground tests. The SOFS team's ongoing response to this unexpected behavior of the cover actuation was to monitor its behavior closely (along with device experts) with results to date demonstrating that the opening angle has remained acceptable through several dozen cycles, with no further signs of degradation observed as depicted above (Figure 10). As of the date of this writing, 66 in-flight cycles have now been performed (Millard & Somawardhana, 2009).

Fig. 10. Main Engine Assembly (MEA) Cover Stow (Open) History ~ Position vs. Mission Time.

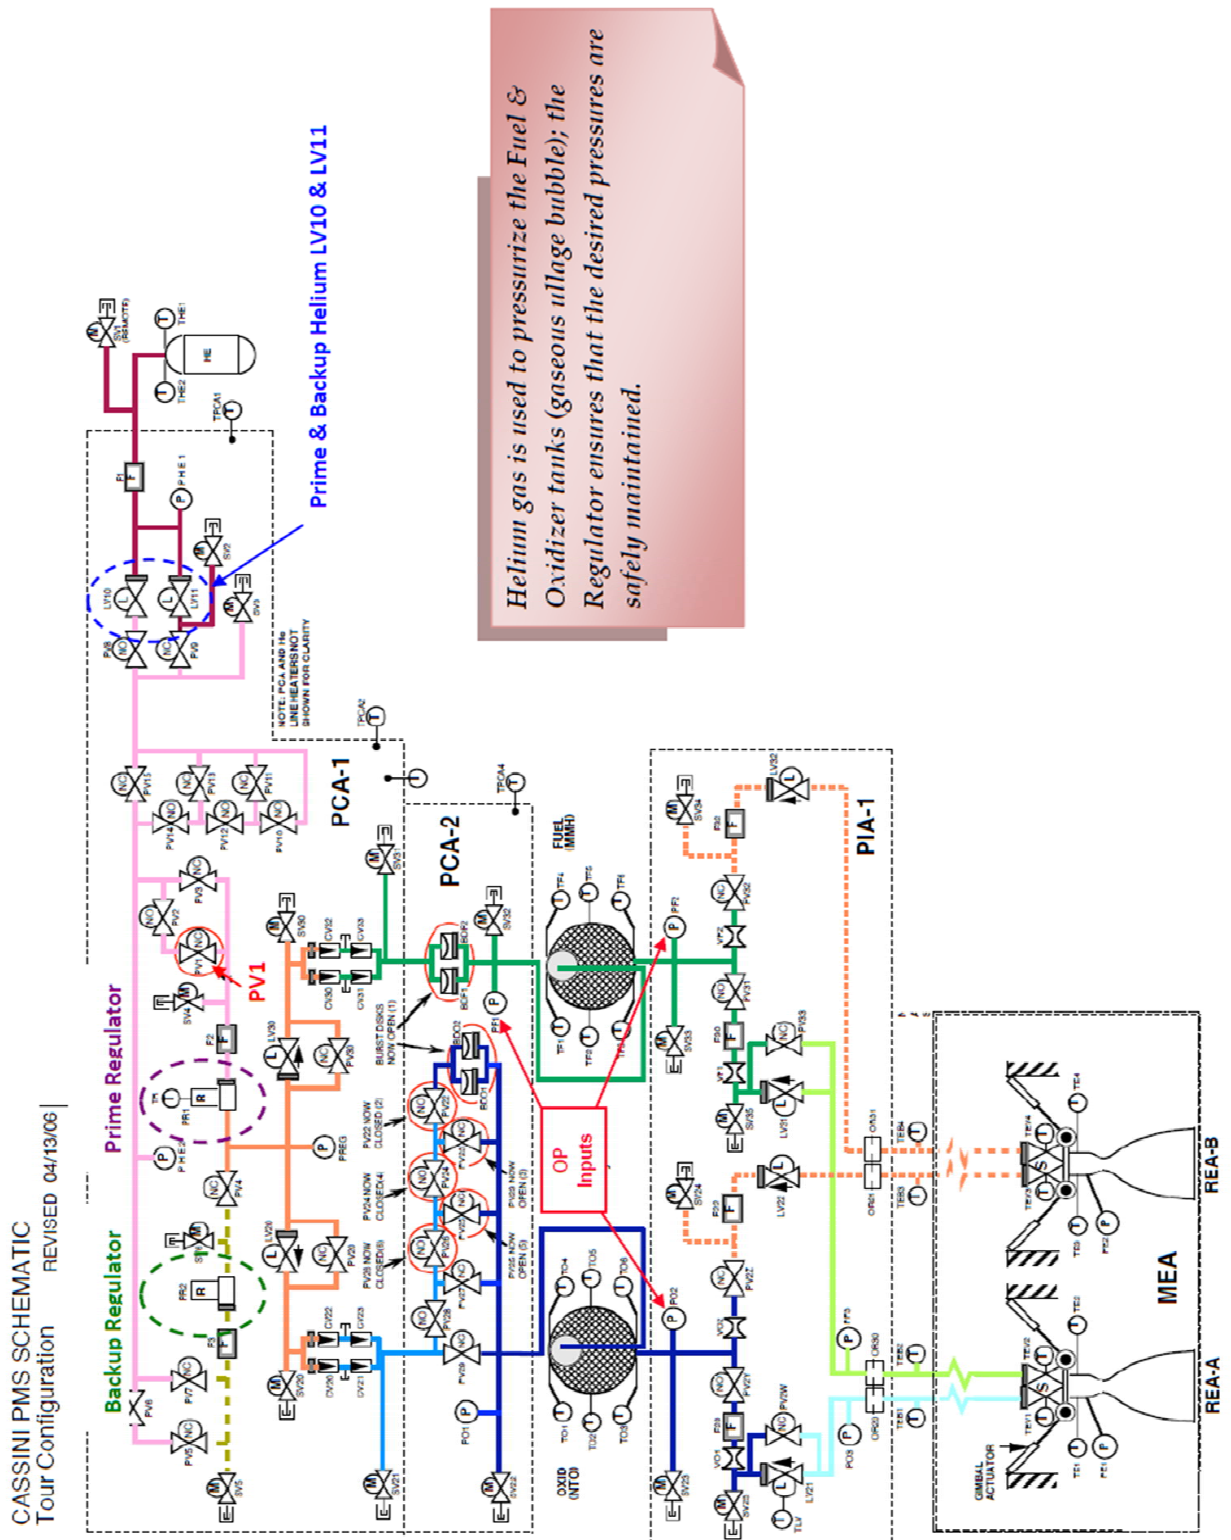
Enhancements were incorporated into Cassini's PMS design due to this increased risk in leak rate. A redundant, backup regulator was installed, as well as two new 'Over Pressure' (OP) FP algorithms, which were designed to detect any tank over-pressurization within the fuel and oxidizer tanks, which was to be use for all non-critical ME burns (non-critical mission phases; i.e. not used during the critical SOI Burn event). The pre-launch mission design called for the PMS system to be characterized 30 days prior to the SOI Burn maneuver, so that the OP FP could be disabled. Leak mitigation measures were also added to the PMS plumbing: Two high-pressure helium latch valves (LV10 & LV11), a pyro-isolation ladder upstream of the regulators (PV10-PV15), plus several filters as depicted in Figure 11 (Barber, 2002; Leeds et al., 1996):

Fig. 11. Cassini's Propulsion System Schematic (ME Only).

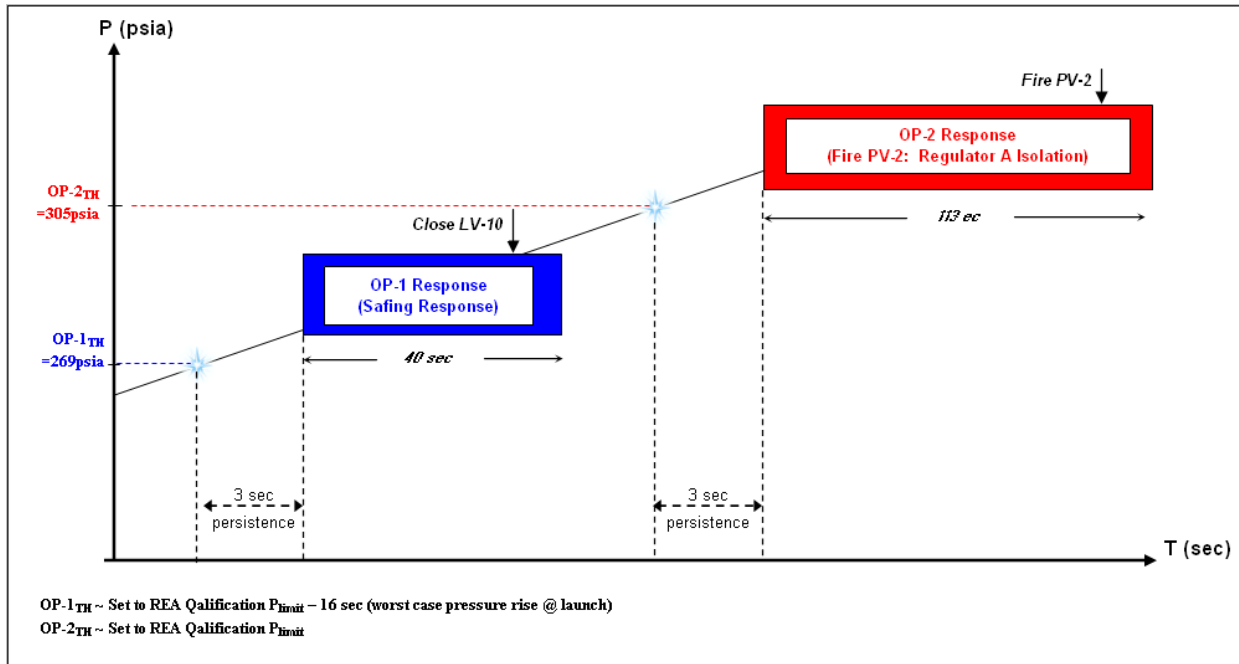
Fig. 12. OP-1 & OP-2 Monitor and Response Configuration.

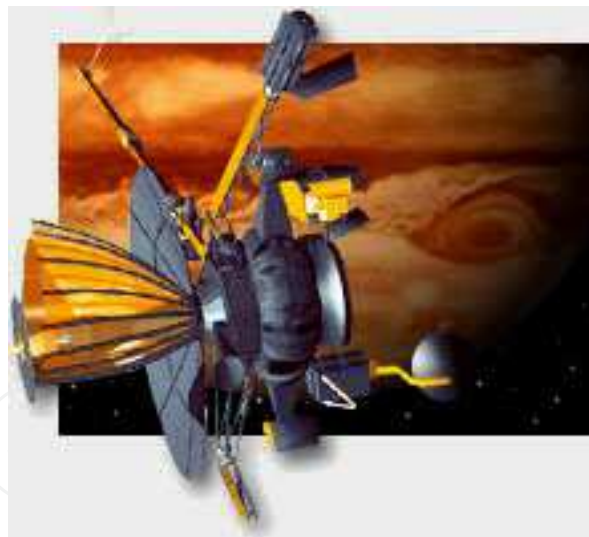
away (after the first Earth flyby). The SOFS Team communicated with Galileo through its two Low Gain Antennas (LGA). When commanded to deploy on April 11, 1991, the HGA only partially deployed, leaving the HGA mission in jeopardy. An investigation team was organized to rectify the problem where numerous attempts were made to fully deploy the antenna over the next two years, while investigating the alternative of using the LGA to support the Jovian operations segment of the mission. All attempts to fully deploy the HGA were unsuccessful, leaving the HGA antenna nearly useless.

Fig. 16. Galileo's Undeployed HGA.

In order to redesign the Galileo mission for LGA use only, the telecommunications link architecture was redesigned. The current architecture only supported 10 bps at Jupiter which was less than  $1/10,000^{\text{th}}$  of the 134 kilobits per second (Kbps) required. Since modifications to the spacecraft's hardware to boost the transmit power was not possible, receiving capability of Earth's ground stations and developing a more efficient data and telecommunications architecture was the primary focus of the needed upgrades. Arraying the DSN antennas increased the rate by a factor of 2.5, and modifications to the receivers and telecommunications link parameters, improving encoding and onboard data compression further increased the downlink from 10 bps to 4.5Kbps. Since these improvements were insufficient to bring down all science data objectives, the SOFS team negotiated with the science team to prioritize science goals, develop new science plans, and periodically update spacecraft FSW to increase data efficiency. Also, as a backup to the downlinked data, the onboard Data Memory Subsystem (DMS) tape recorder was utilized during selected high activity periods (Nilsen & Jansma, 2011).

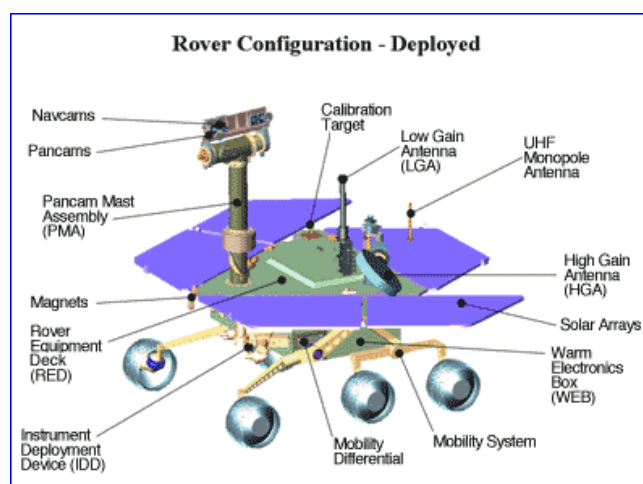
Fig. 18. Rover Configuration - Deployed.

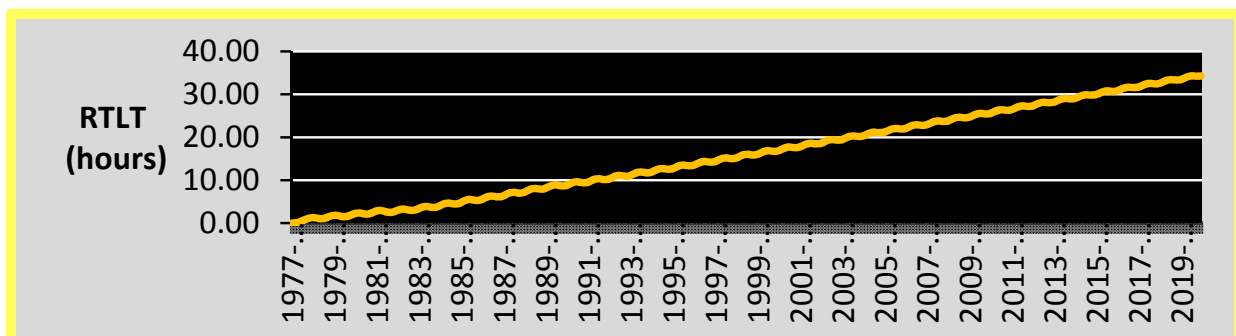
Fig. 21. Voyager 1 RTLT vs. Time.

A total time allotment of 32hrs, 23min, and 55sec plus sequence execution time, FSW processing time, and command execution time is required in order to verify each command sequence (i.e. more than one DSN antenna pass coverage is required to uplink and verify every command/command sequence; see Figure 23).

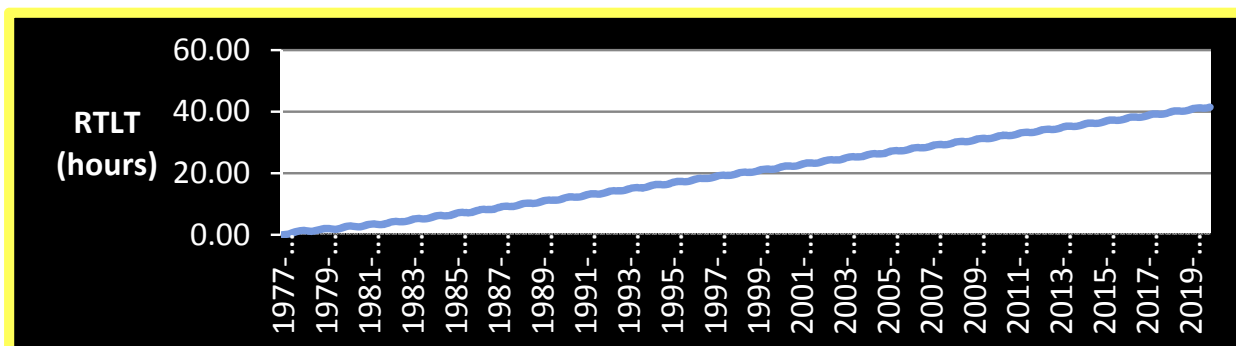
Fig. 22. Voyager 2 RTLT vs. Time.

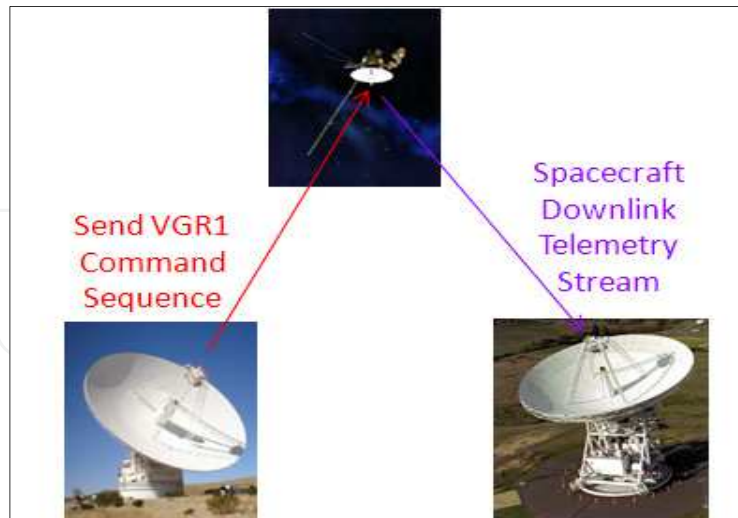
Fig. 23. Voyager DSN Strategy.

SOFS teams managing missions with long RTLs such as the Voyager spacecraft must minimize real-time commanding. When commands are sent, typically the team must verify these commands the following day (or two). To date, both Voyager spacecraft have adequate electrical power and propellant margin to maintain systems and attitude control until around 2025, at which time, science data return and spacecraft operations will cease.
