“Salt Weathering” Distress on Concrete by Sulfates?

Zanqun Liu^{1,2,3}, Geert De Schutter², Dehua Deng^{1,3} and Zhiwu Yu^{1,3}

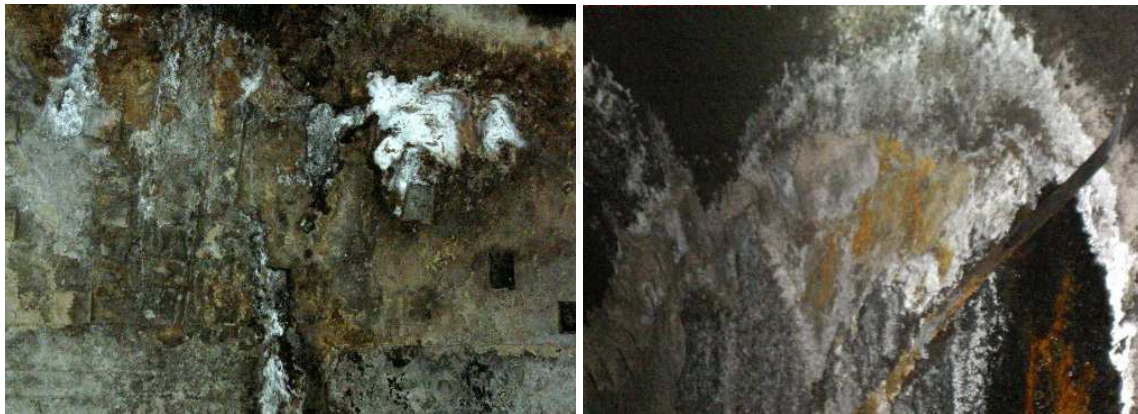
Fig. 1. Deterioration of railway tunnel (Southwestern Region, China)

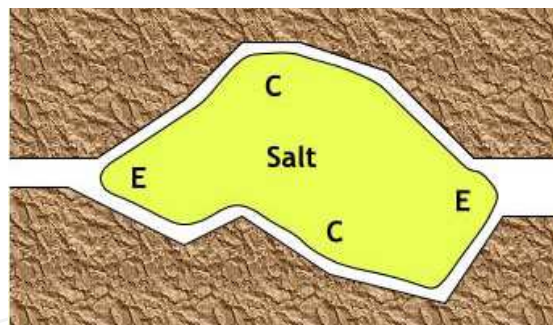
Fig. 2. Schematic of crystal of salt growing in a pore [14]

Where, κ_{cl}^E is the curvature of the pore entrance (labeled point E), and κ_{cl}^C is the curvature of other internal points (labeled point C) (Fig.2).

Because κ_{cl}^E is less convex (positive) than κ_{cl}^C , the compressive strength is negative, but it creates a tensile stress in the hoop direction around the pore. This tensile stress is the destructive “crystallization pressure” A high equilibrium crystallization pressure requires a confined crystal in a pore of any geometry with a very small pore entrance [16]. Therefore, the stones with a bimodal pore size distribution are extremely susceptible to salt attack [17-19].

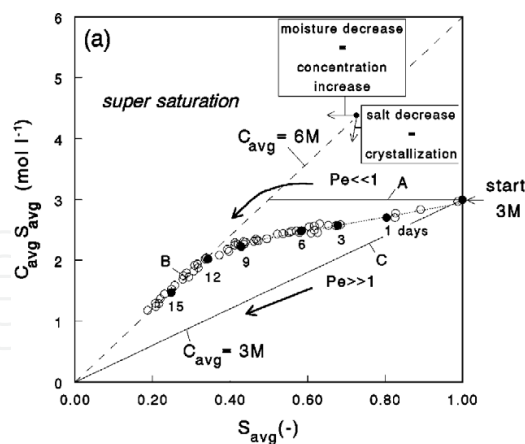
Fig. 3. Efflorescence pathway diagram [35]

Nuclear magnetic resonance (NMR) is used to study the crystallization of sodium chloride due to wick action. Measuring the moisture and ion profile in a fired-clay brick cylinder ($\varnothing 20 \times 45mm$), an efflorescence pathway diagram is plotted [35, 36] as shown in Fig. 3.

According to this diagram (Fig.3), when $Pe \ll 1$, i.e. very slow drying or high relative humidity, the ion profile remains homogeneous and for some time no crystallization will occur. The average NaCl concentration slowly increases until the complete sample has reached saturation, forming a high concentration pore solution zone. When $Pe \gg 1$, i.e. very fast drying or low relative humidity, ions are directly advected with the moisture to the top of the sample and a saturation peak will build up with a very small width. If the rate of

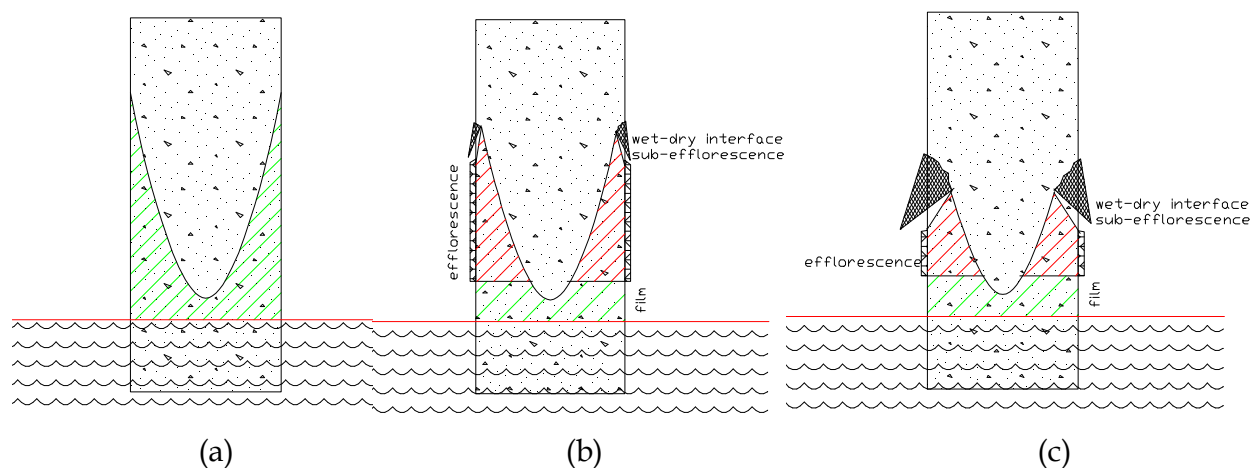
Fig. 4. Schematic of salt weathering distress on porous material.

(a) no evaporation condition, (b) low evaporation condition, (c) high evaporation condition

In summary, the efflorescence and sub-efflorescence of salt weathering distress on the porous material can be schematically shown in Fig. 4.

As we know, the capillary absorption just occurs in the interconnected pores between air and water. When a porous element is partially subjected to the sulfate solution under no evaporation condition, a pore solution zone will be formed as shown in Fig. 4(a). The solution cannot rise from the solution surface to the top of the element by capillary absorption due to few or no interconnected pores from the bottom to the top in a relatively long distance. The interconnected pores can form from the solution surface to the side surface of the element in a relatively short distance, resulting in the generation of capillary absorption.

Under a low evaporation condition, the wet-dry interface can occur in the tip of the pore solution zone, where the rate of evaporation is fast compared with the rate of solution rise, because solution rises into the bulk at a rate that decreases with height. At the same time the sulfate concentration of pore solution will slowly increase until the complete sample has reached saturation, forming a high concentration pore solution zone, where the efflorescence occurs. Near the solution a liquid film occurs on the surface of the element, where the rate of rise is fast compared with the evaporation and the sulfate concentration is close to the exposure solution [20]. In this case the deterioration due to salt crystallization is minor (as shown in Fig. 4 (b)).

Under a low relative humidity condition, due to the high evaporation rate, the position of the wet-dry interface will move to the inner part of the element and closer to the bottom of the element, where a saturation peak will build up with a very small width, forming supersaturation, and resulting in sub-efflorescence and more severe deterioration. The breadth of efflorescence zone decreases and the average concentration of the pore solution will remain constant at nearly the initial concentration of exposure solution (as shown in Fig. 4 (c)).

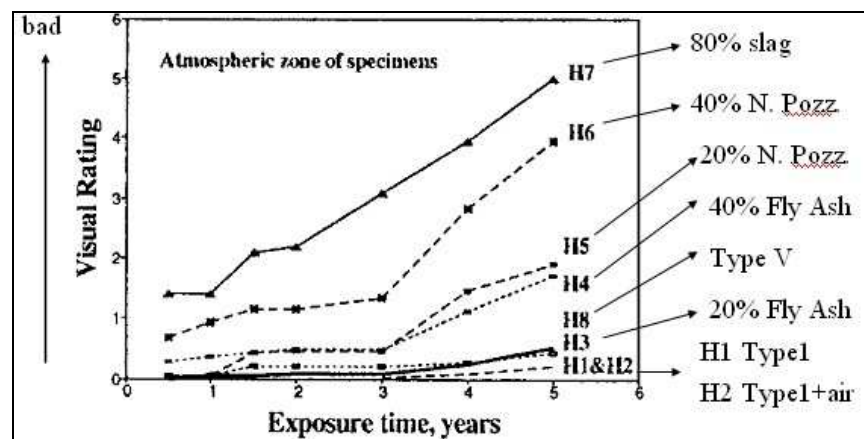
Fig. 5. Evolution of visual rating at the atmosphere part of concrete [46]

Concerning the deterioration mechanism, researchers attributed the failure of concrete to physical attack or salt crystallization. However, in effect the experimental results cannot be explained by salt weathering. Fig. 5 is the evolution of visual rating of the upper part of concrete in contact with air, obtained by Irassar and Di Maio [46].

1. Comparing concrete H1 and H2, the difference between them was the air content, namely 1.3% resp. 4.4%. Thus, if the damage mechanism of the upper part of concrete was caused due to salt weathering, there would be a big difference in visual rating of these two concretes due to the different pore structures. However, after 5 years exposure the visual ratings were almost the same.

2. As to the role of mineral additions, with the increase of dosage of fly ash and natural pozzolan, the concrete cylinders showed worse visual observation. This may be explained by the fact that salt crystallization in smaller pores can form higher crystallization stress due to the refinement of mineral additions. On the other hand, if we compare concrete H3 and H5, H4 and H6, we can find that with the same dosage the natural pozzolan (H5 and H6) played a more negative role in concrete damage than fly ash (H3 and H4). However the compressive strength of reference cylinders of H5 and H6 were higher than H3 and H4 respectively. The tests of PCA also showed similar results. This appearance cannot be explained by the salt weathering.

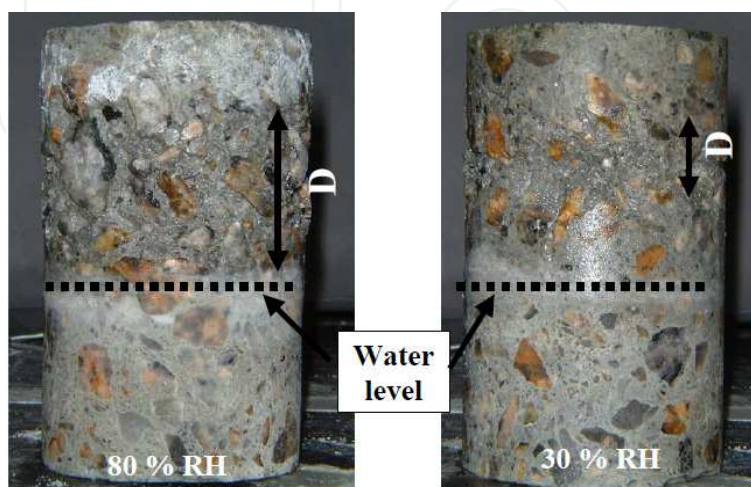
Fig. 6. Concrete cylinders exposed to sodium sulfate solution for 75 days [51]

However, contradictory observations can be found with respect to concrete exposed to sodium sulfate solution [51]. Two concrete specimens with the same mixture proportions were partially immersed in 10% Na₂SO₄ solution. One specimen was placed at 80%±5% RH and the other was placed at 30% ±5%. After 75 days of exposure to a constant temperature of 25 °C, the specimens at 80% RH showed signs of deterioration first over a very large area, starting from above the solution level. On the contrary, at 30% RH, the zone of deterioration was narrower and was situated at a certain distance above the solution level. In this case, the first sign of deterioration was a crack, not spalling (shown in Fig. 6).

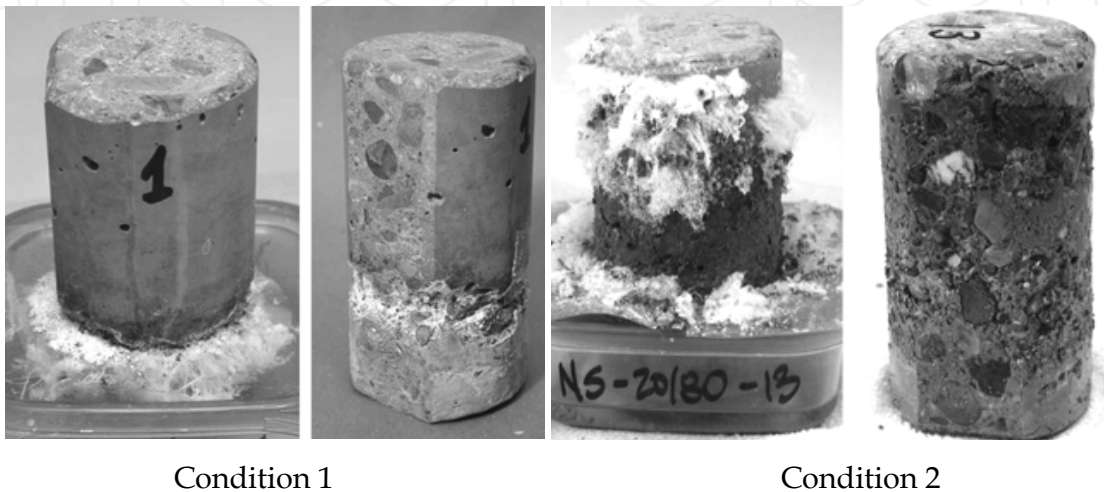
Fig. 7. Visual observation of concrete deterioration. Condition 1: steady at 20°C and 54% relative humidity from 28 to 530 days (Phase I), and then 20°C and 32% relative humidity from 530 to 1132 days; Condition 2: steady at 20°C and 82% relative humidity from 28 to 530 days (Phase I), and then from 530 to 1132 days [2]

1. When concrete cylinders were exposed to Na_2SO_4 solution, as abovementioned the concrete cylinders exposed to high relative humidity condition were deteriorated more severely than low relative humidity condition (as shown in Fig. 7).

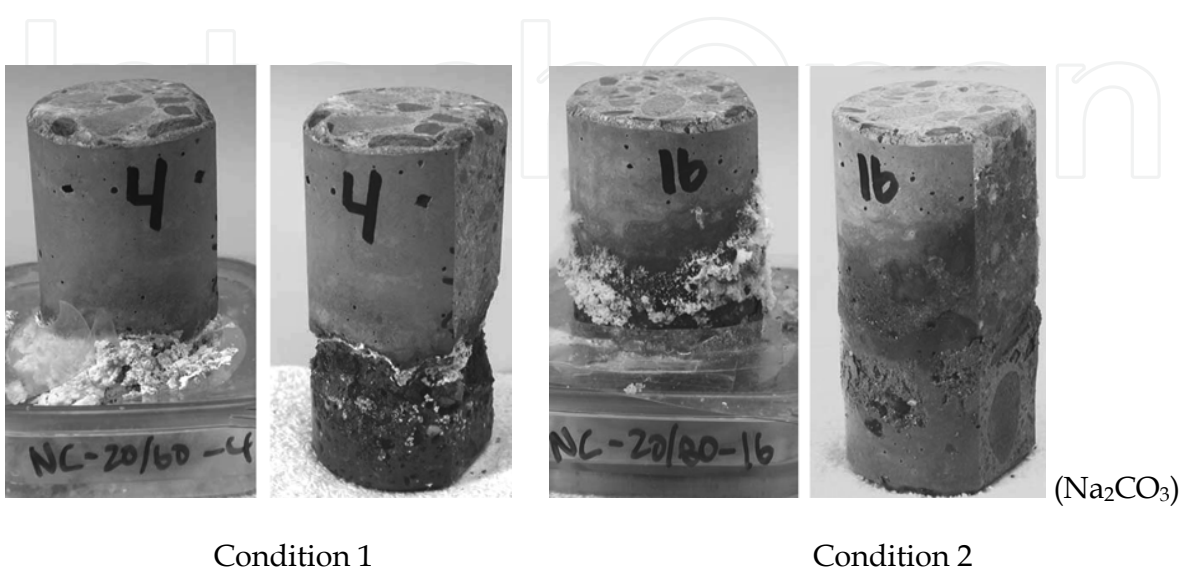
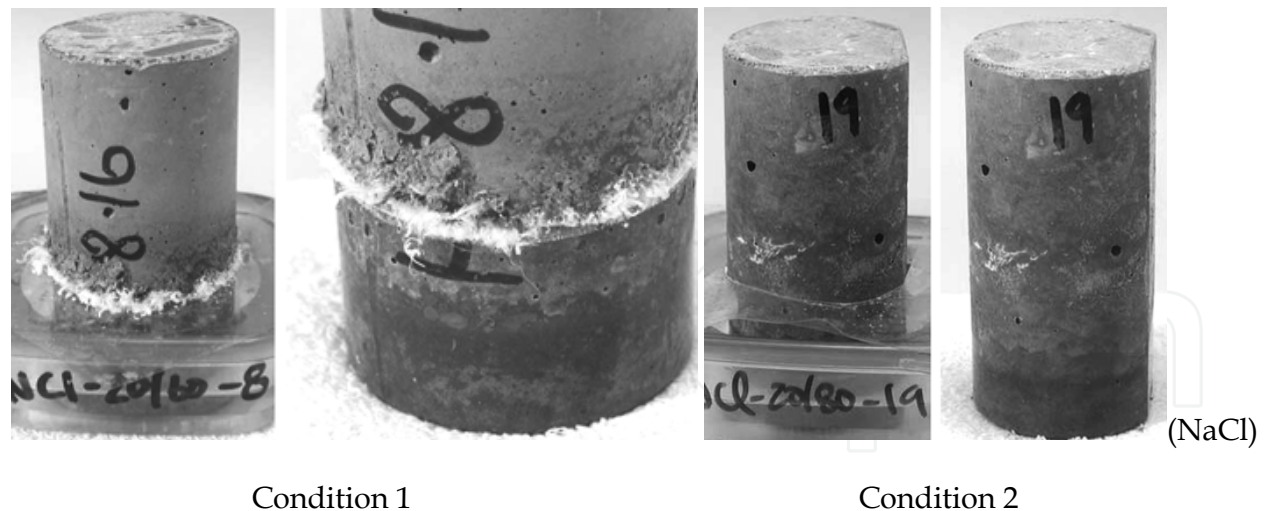
Fig. 8. Visual observation of concrete deterioration exposed to Na_2CO_3 and NaCl solutions [9]

Correspondingly, Fig. 8 shows the visual observation of concrete exposed to Na_2CO_3 and NaCl solutions under Condition 1 and Condition 2.

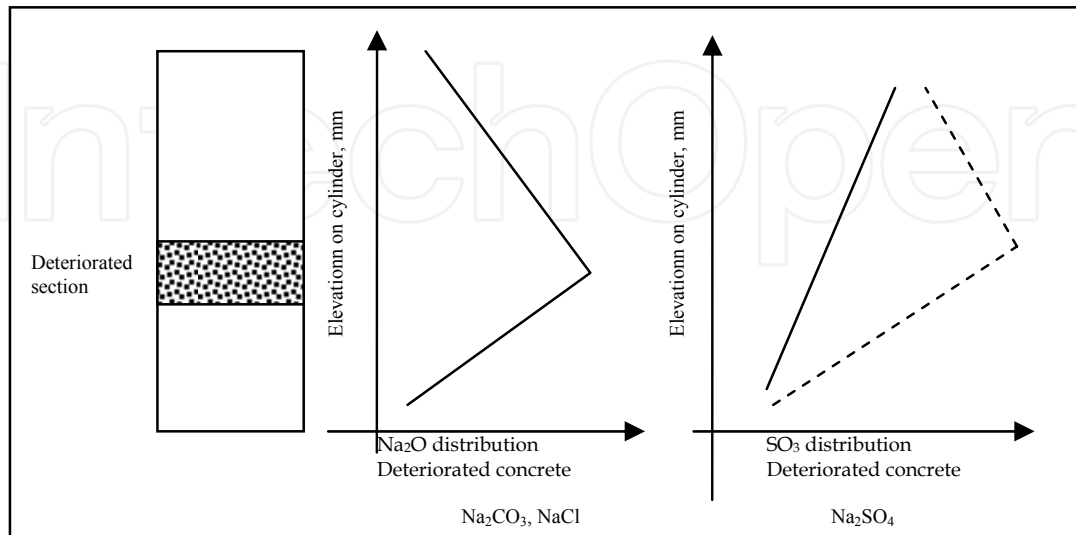
Fig. 9. Schematic of salt distribution in the concrete cylinders

the reason why the position where Na_2O content is highest corresponds with most severe deterioration of concrete exposed to Na_2CO_3 and NaCl solutions. However the situation is opposite in the case of Na_2SO_4 , the position, where SO_3 content is highest, locates on the top portion of cylinder that shows little or no deterioration (as shown the black line).

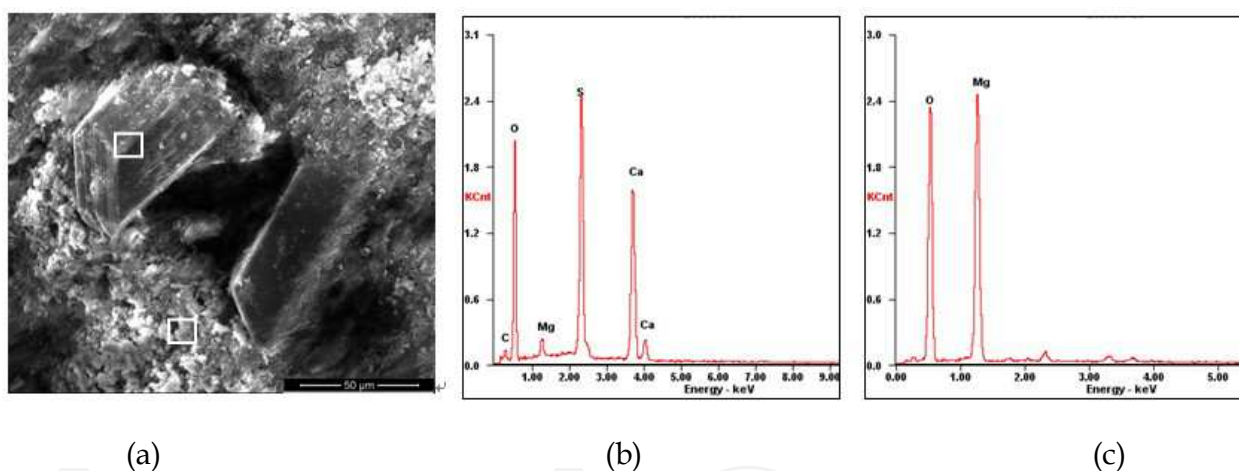
Fig. 10. ESEM and EDS analysis of white substance on the surface of shrinkage crack [54]
 (a) ESEM image of white substance (b) EDS analysis of prismatic crystal
 (c) EDS analysis of flocculent crystals

However, based on the micro-analysis results the sulfate crystals were not detected in the atmospheric part of the paste partially exposed to Na_2SO_4 solution. On the contrary large amounts of ettringite crystals, the main chemical sulfate attack product, were identified as the reason for paste spalling. Another important observation is that a layer of white substance was formed on the surface of shrinkage cracks in the atmospheric part of the paste partially exposed to MgSO_4 solution. Two distinct crystals can be distinguished: prismatic crystals surrounded by flocculent crystals. According to the EDS analysis, the prismatic crystal is gypsum and the flocculent crystal is brucite (shown in Fig.10). The products of this white substance in the shrinkage cracks are the same as the products in the interfacial zone of concrete fully immersed in magnesium sulfate solution [56].

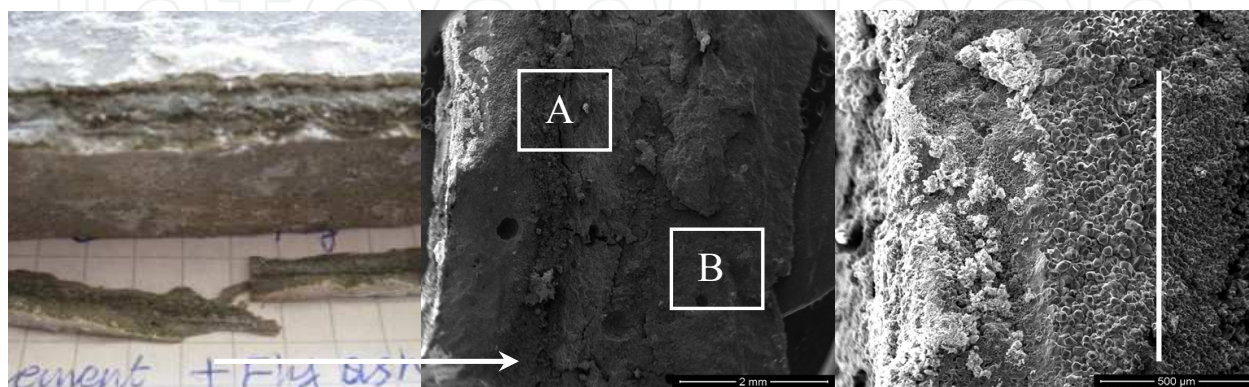
Fig. 11. Cracks in cement – fly ash paste [54]

Cement – fly ash paste specimens (20×20×150mm) were partially exposed to Na₂SO₄ solution. After 5 months exposure under the constant storage condition (20°C and 60%RH), some cracks were found near the upper edge above solution level of the cement-fly ash paste specimen. Along the crack, small pieces were carefully broken off using a thin blade. The ESEM image of a small piece is shown in Fig. 11.

The middle image is the zoomed surface of a small piece with magnification of 25 times. The left side is the outer surface of paste in contact with air, and zone A is the surface of a crack. Zone B is a small point in the bulk of paste.

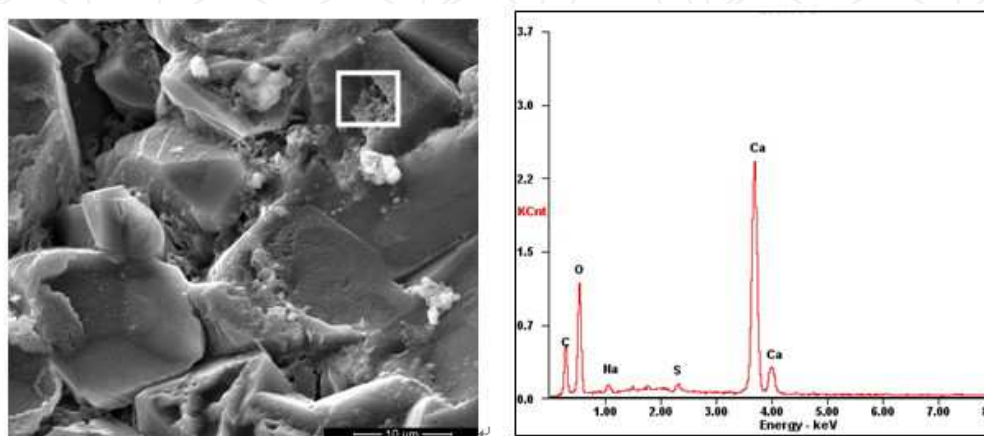
Fig. 12. ESEM image and EDS analysis of f the granular crystal at left side [54]

Two distinct parts can be observed at the right and left hand side of the white line in Zone A. At the right side a large amount of dense granular crystals cover the surface (Fig. 12), while at the left side porous crystals can be found accompanied with white substance (Fig. 13). It can be found that the crystals at left and right sides are both calcite. However, some calcite crystals at left side are peeled off and crystal caves are left. Some crystals are honeycombed with small pores. According to the EDS analysis, Na and S are also present. Obviously, the crystallization of sodium sulfate results in damage of the calcite crystals. At the right side, the calcite crystals show no damage.

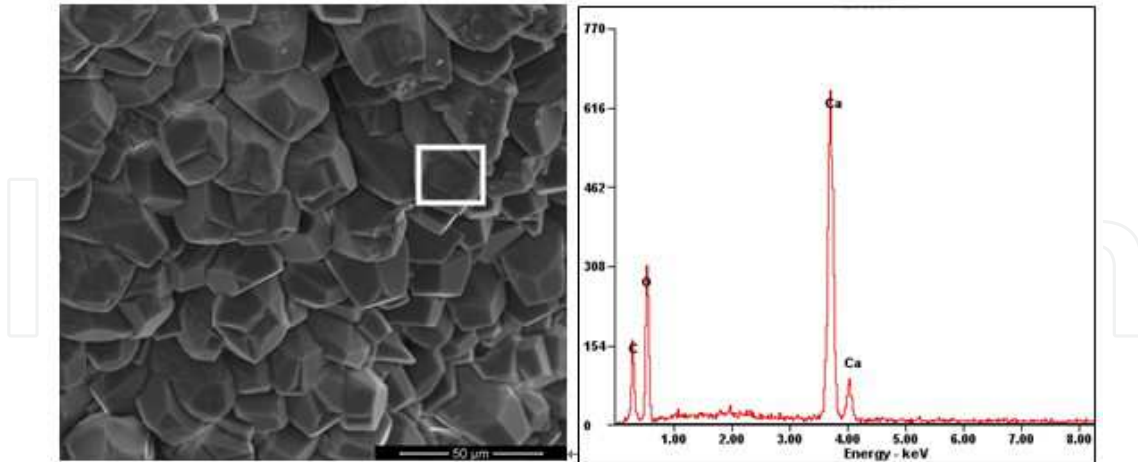
Fig. 13. ESEM image and EDS analysis off the granular crystal at right side [54]

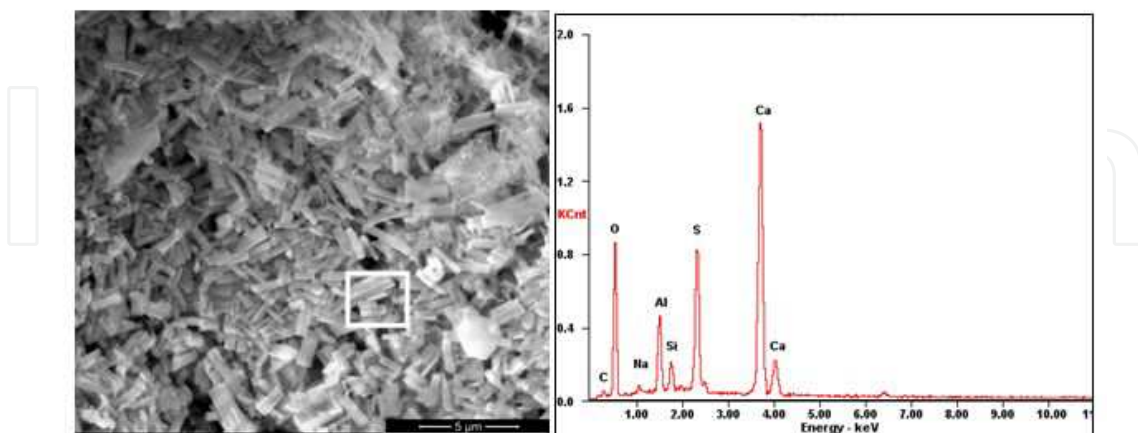
Fig. 14. ESEM and EDS analysis of white square [54]

As we know, the crack formation is attributed to some expansive products present in the paste. When a small piece was broken off along the crack, the inner zone B on the surface of piece was a weak part in the paste and the source of crack initiation. The analysis of the products in this zone can disclose the real reason for the crack formation. Fig. 14 shows the ESEM image of the surface of Zone B.

In Fig. 14, a large amount of short needle crystals are found in this zone. According to the EDS analysis, there are Ca, Al, Si, S, Na, and O elements. Combining the XRD analysis, thenardite was not identified and the crystals were ettringite.

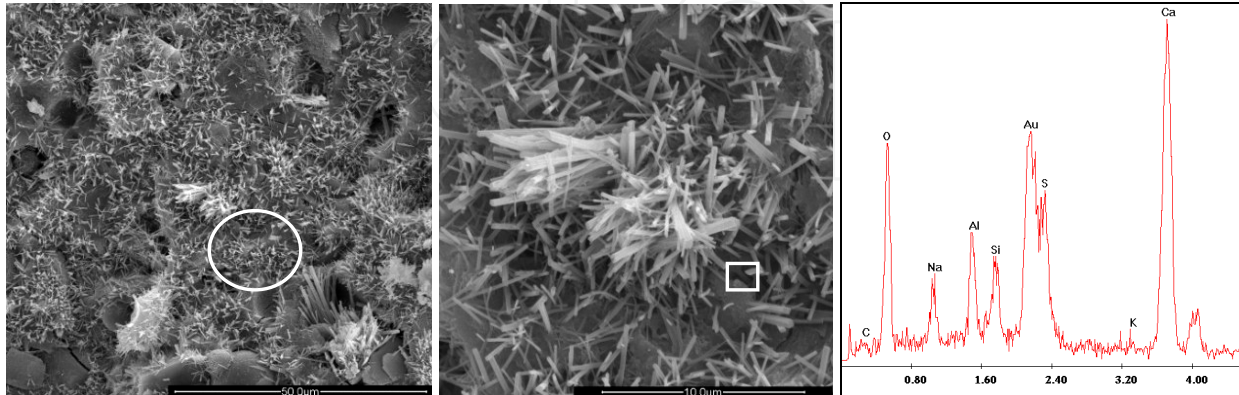
Fig. 15. SEM image and EDS analysis of the surface of a crack [54]

Specimens (10×40×150 mm) were placed in a fluctuating condition (40±2°C and 35±5% RH for 24 hours, 10±1°C and 85±5% RH for 24 hours). After 3 cycles they were broken into several small pieces along some cracks. We checked the products on the surface of a crack. Fig. 15 shows the SEM image and EDS analysis.

It can be found that a large amount of needle-like crystals grow on the surface like a hedgehog. Some pores are filled with a cluster of the needle-like crystals. Based on the EDS analysis and combining the XRD analysis, the needles are ettringite.

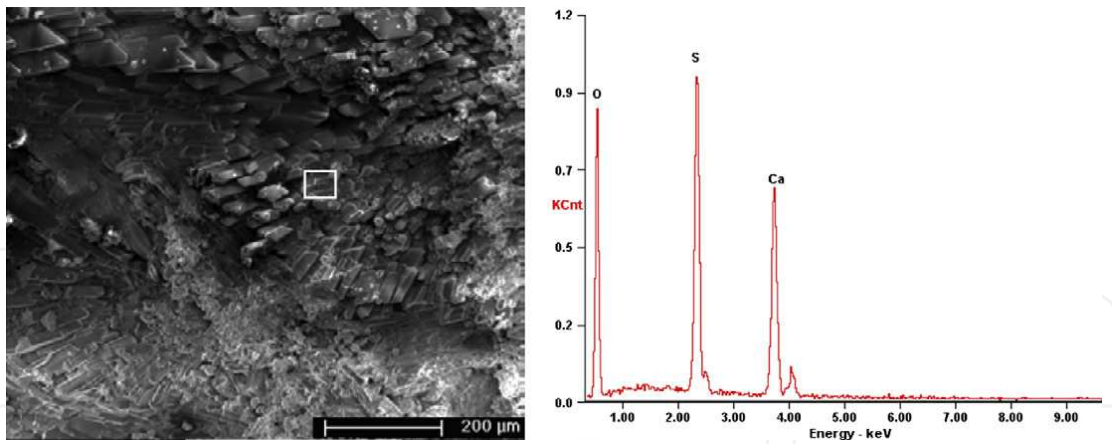
Fig. 16. ESEM image and EDS analysis of surface of cement paste [53]

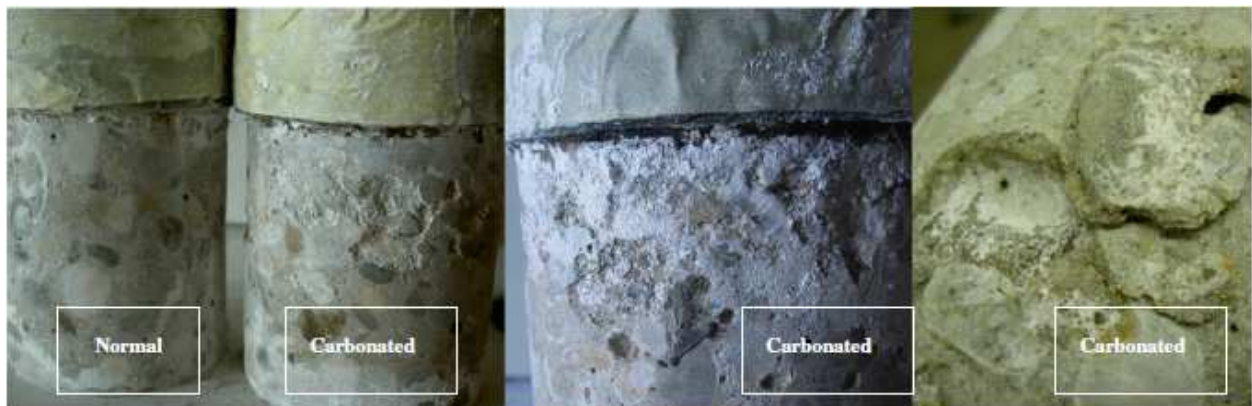
Fig. 17. Visual observation of normal and carbonated concrete specimens exposed to sodium sulfate solution [53]

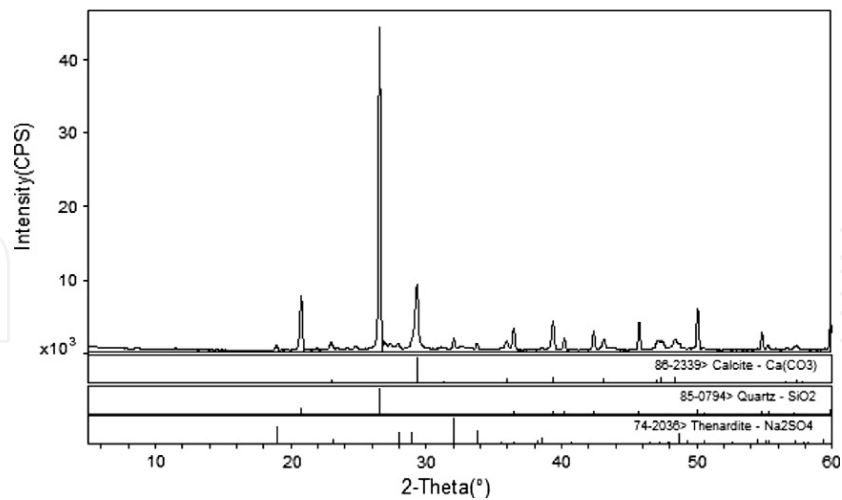
Fig. 18. XRD pattern of mortar [53]

During the process of cleaning the surface of cylinders, a lot of small mortar pieces could be easily brushed off. According to the XRD analysis (Fig.18) Na₂SO₄ crystals and CaCO₃ crystals were present in the mortar. This appearance also means that salt crystallization can occur in the CaCO₃ crystals.

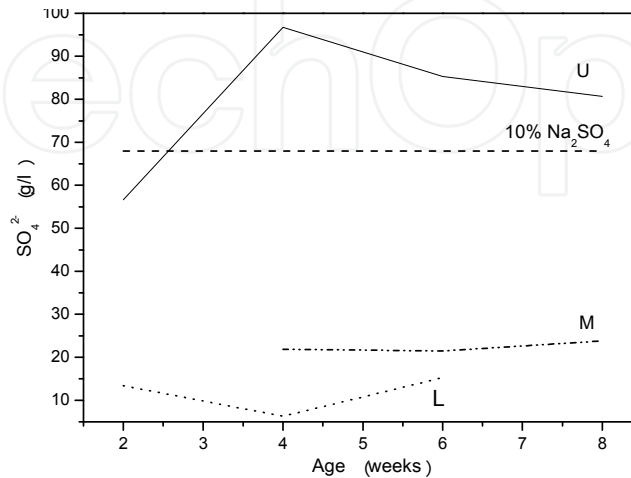
Fig. 19. SO₄²⁻ concentration of different parts of the cement paste partially exposed to the 10% Na₂SO₄ solution [61]

In our previous study [61], the pore solution expression test method was used to squeeze the pore solution in the cement paste. Cement paste samples were partially exposed to 10% Na₂SO₄ solution under the constant storage condition (20°C and 60% RH). The sulfate concentrations of pore solution in the lower part under solution (labeled L), film zone (labeled M) and efflorescence zone (labeled U) (shown in Fig. 4) were measured respectively. Fig. 19 gives the results.

The results confirm that a pore solution zone can be formed in the efflorescence zone in the concrete, and the sulfate concentration was much higher than the lower part under solution and even the exposure solution (10% by mass). The strong chemical reactions occurring in this high concentration pore solution cause severe concrete decay. This also confirms the wick action theory.

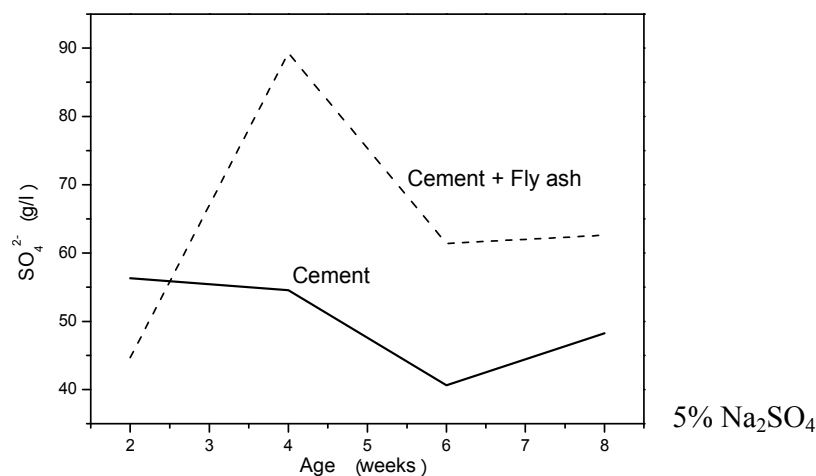
Fig. 20. SO_4^{2-} concentration of the pore solution in efflorescence and film zone of cement paste and cement-FA paste exposed to 5% Na_2SO_4 solution [61]

However, in the case of partial immersion the pore size refinement due to mineral additions will contribute to an increase in the capillary sorption height following Eq. 5. The pore solution expression tests showed that this process can draw more sulfates into fly ash concrete than into normal concrete, resulting in a pore solution with a higher sulfate concentration as shown in Fig. 20 [61].

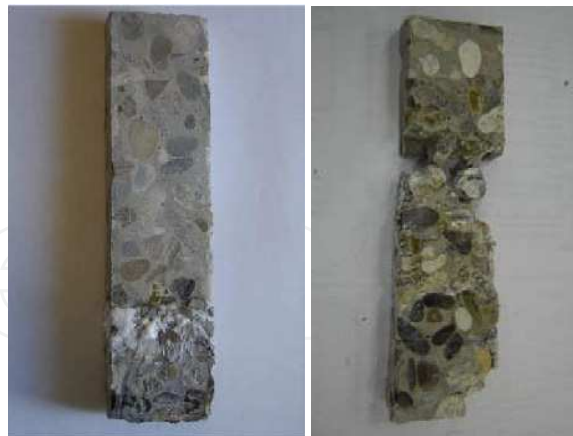
Fig. 22. Visual observation of concrete specimens partially exposed to Na_2SO_4 and MgSO_4 solutions [53]

However, during the process of “salt weathering” on concrete, the test results showed the opposite appearance. Nehdi and Hayek [47] observed the appearances of the cement mortar partially exposed to 10% sodium sulfate and magnesium sulfate solution in a RH cycling between $32\pm 3\%$ and $>95\%$ condition respectively. The results showed that a large amount of efflorescence covers the surface when mortar is exposed to sodium sulfate solution. On the contrary, the surface of mortar subjected to magnesium sulfate solution is clean. It seems that sodium sulfate performs more corrosive effect on mortar than magnesium sulfate. The tests [53] also showed the same results. The aggregates and cement paste were completely separated in the upper part of concrete after 8 months exposure. However, the samples exposed to magnesium sulfate solution showed little damage. As shown in Fig. 22.

This appearance may indicate that the concrete damage cannot be explained by salt weathering. First, MgSO_4 showed a harmful effect on stone due to salt weathering. As a porous material concrete should also show a similar scaling manner. Secondly, Fig. 23 shows the surface tensions of NaCl , Na_2SO_4 and MgSO_4 [92]. According to Eq. 5 the equilibrium heights of capillary rise of sodium sulfate and magnesium sulfate should be

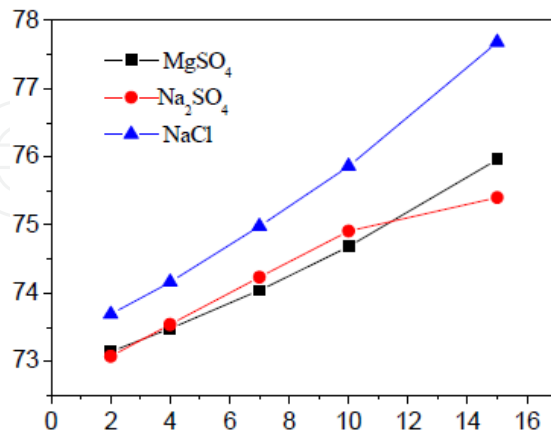
Fig. 23. Surface tensions of NaCl, Na₂SO₄ and MgSO₄ [92]

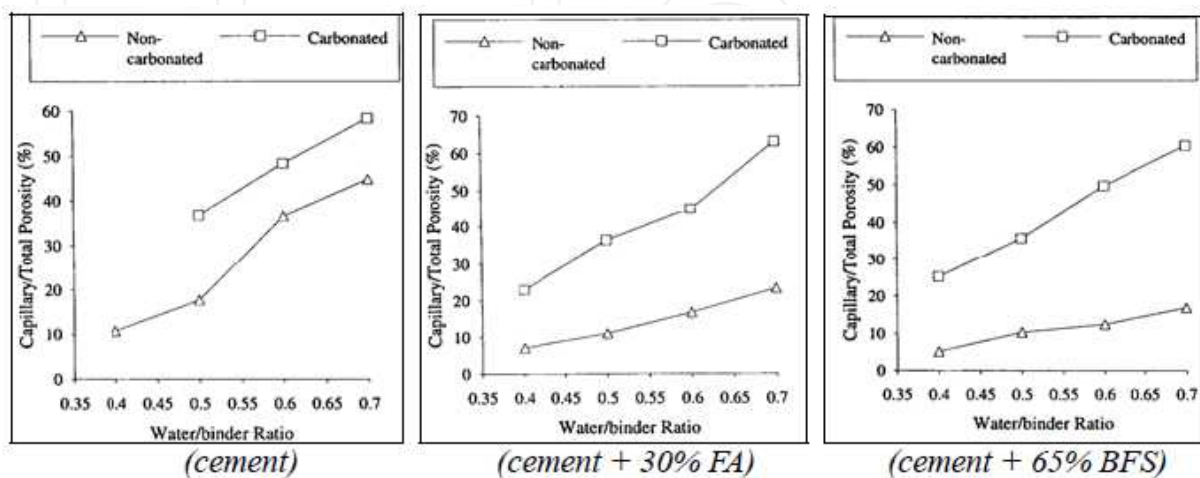
Fig. 24. Ratio of capillary to total porosity of non-carbonated and carbonated paste [94]

From Fig. 24, compared to cement paste, the ratios of capillary pores fraction of cement + 30% FA and cement + 65% BFS were higher than cement paste after carbonation. Some research showed that blended concrete has high carbonation rate [96], high degree of carbonation [97] or large carbonation depth [98] compared to the ordinary cement concrete. The carbonation susceptibility of blended concrete may be another reason for the negative effect of mineral addition on sulfate resistance of partially exposed concrete.
