The Use of Fiber Reinforced Plastic for The Repair and Strengthening of Existing Reinforced Concrete Structural Elements Damaged by Earthquakes

George C. Manos and Kostas V. Katakalos

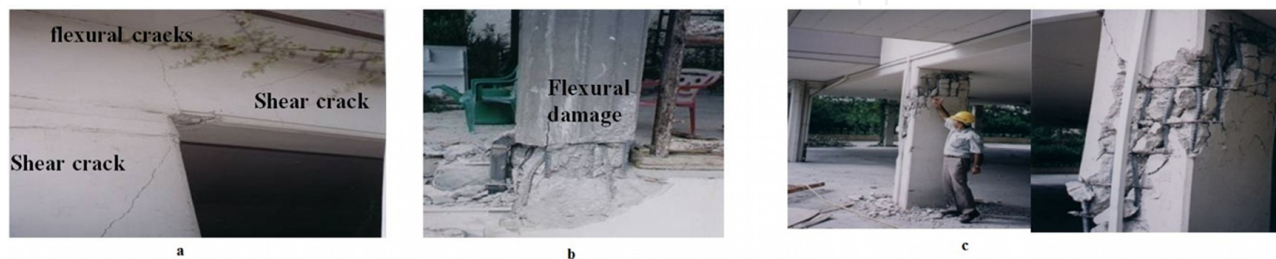
Figure 2. a Typical damage of beam at the joint with the nearby column (6th story building, Aharnes, Athens earthquake 1995), [2]. b Typical damage of the toe of a column at ground floor (two-story building, Nea Kifisia,, Athens earthquake 1995), [2]. c Typical shear damage at the columns of a “soft story” (4-story Metamorfofi building, Athens earthquake 1995), [2].

ance of shear damage in the form of diagonal cracks (figure 2a). The presence of large bending moments mainly from the seismic load together with large axial forces will cause the formation of flexural damage at the top and the toe of columns (see figure 2b) whereas the presence of shear forces from the seismic loads together with axial forces will lead to the formation of shear damage at the columns (see figure 2c). The presence of large shear forces from seismic loads together with relatively low level axial forces will lead to the development of shear damage in the shear walls (see figure 3a) whereas the presence of short columns will lead to the development of large shear forces from seismic loads and the development of shear damage as shown in figure 3b.

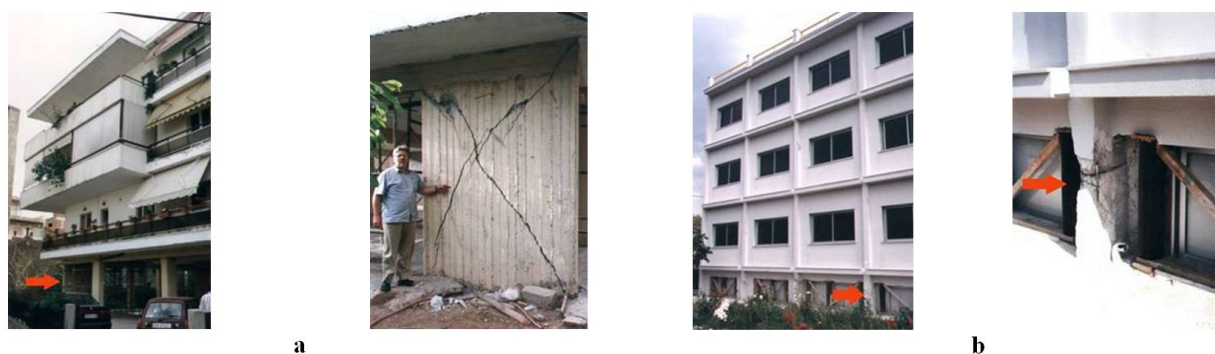
Figure 3. a Typical damage of shear walls at the “soft story” during The Kozani 1995 Earthquake in Greece. b. Typical damage of “short” columns during The Kozani 1995 Earthquake in Greece.

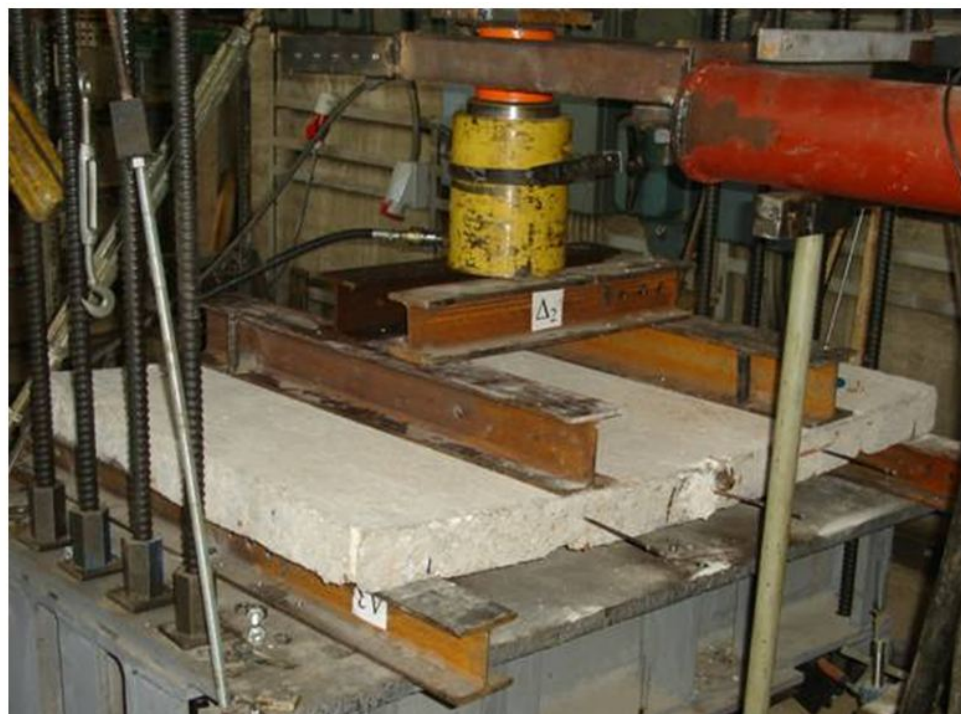
Figure 7. Loading arrangement of the slab specimens in flexure.

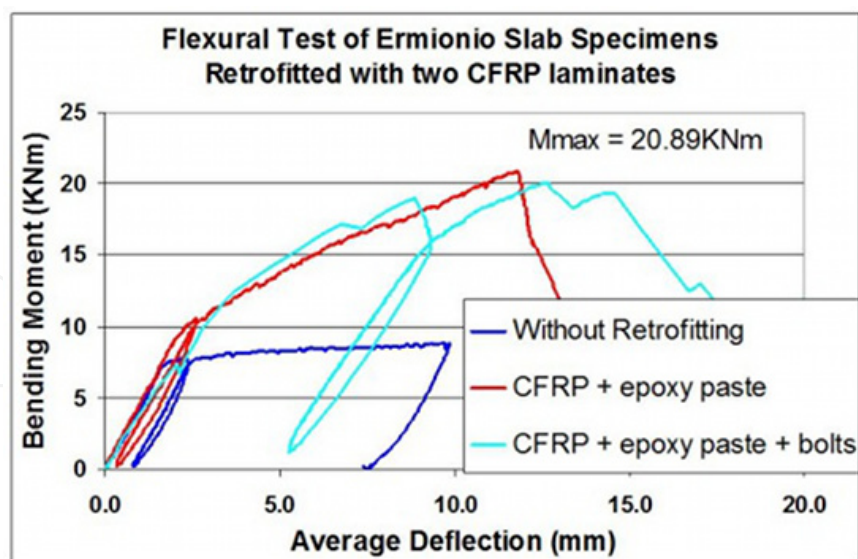
Figure 8. Flexural behavior of Ermionio slab specimen retrofitted with two CFRP laminates either bonded only with epoxy paste or with epoxy paste and bolts.

136% when compared to the maximum bending moment value of the un-retrofitted slab. This retrofitted slab failed in the form of the debonding of the CFRP laminates (figure 9). The debonding of the two CFRP laminates was followed by a sharp decrease in the flexural bearing capacity together with the formation of a plastic hinge at mid-span in the form of excessive plastic deformations of the old steel reinforcing bars at the bottom of the slab as well as crushing of the concrete at the top of the slab. Next, two new CFRP laminates were reattached to the same slab specimen; this time epoxy paste was used again together with bolts penetrating through the slab and securing the attachment of these CFRP laminates. The flexural bearing capacity of the slab this time reached the same maximum bending moment value as the one observed when only epoxy paste was used for the attachment of the laminates; they exhibited satisfactory performance without any signs of failure either in the form of debonding or fracture. This is shown by the bending moment versus mid-span deflection curve plotted for this test in figure 8. Despite the satisfactory performance of the CFRP laminates, no increase in the flexural bending capacity could be achieved due to the slab damage from its previous loading history; however, the performance of the anchors for the attachment of the CFRP laminates was satisfactory and the flexural behavior of the slab exhibited a much larger range of deformability (figure 8).

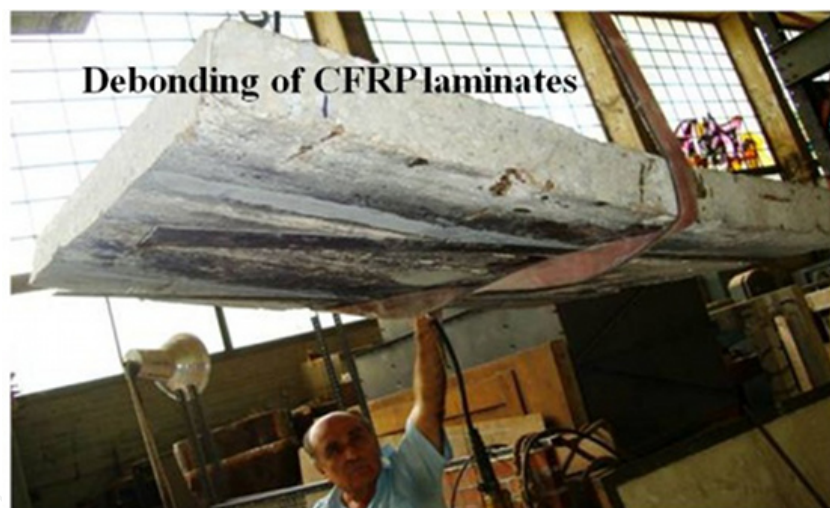
Figure 9. Flexural failure of the Ermionio slab specimen retrofitted with two CFRP laminates bonded only with epoxy paste. The CFRP laminates were debonded from the concrete slab in this case.

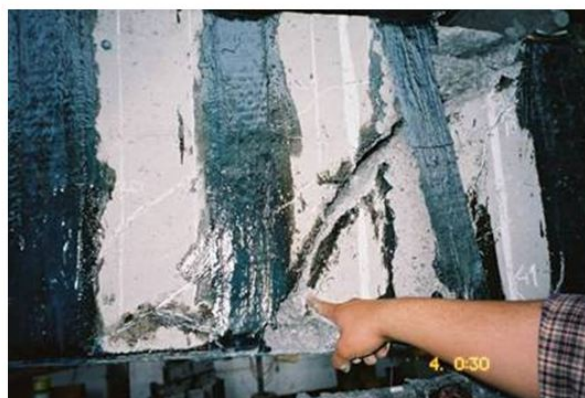
Figure 18. Shear failure accompanied by the rupture of the CFRP stirrups as well as of crushing of the concrete compressive zone at the shear transfer area neighboring the point of loading.

P [KN]	Description of the observed cracking
73.6	Partial activation of the shear cracks that were formed from past loading
166.8	Activation of the previously formed flexural cracks
235.4	Formation of main flexural crack next to the CFRP stirrup at loading point (left side)
343.4	Formation of main flexural crack next to the CFRP stirrup at loading point (right side)
421.8	Initiation of crushing of the concrete compressive zone at the shear transfer area neighboring the left loading point.
423.8	Rupture of a CFRP stirrup
431.6	Crushing of the concrete at the compressive shear transfer zone neighboring the left loading point. Rupture of the CFRP hoops that were crossed by the main shear crack (figure 18).

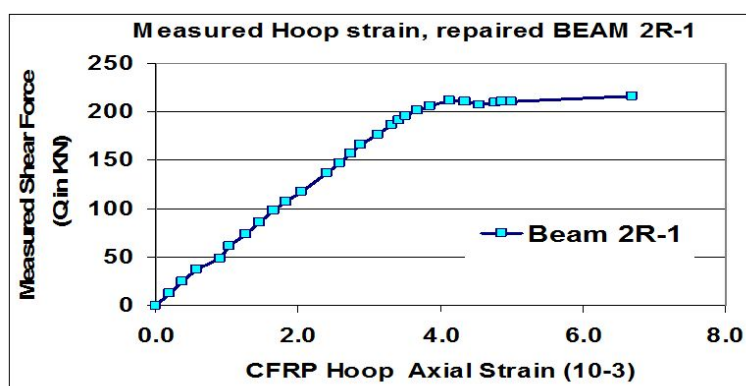
Figure 20. The variation of the CFRP-hoop strain with the measured shear force for BEAM 2R-1.

The maximum axial strain measurement equal to 0.67% was recorded at this particular CFRP-hoop location during maximum applied load just before the rupture of this CFRP-hoop and the final development of the shear failure for specimen BEAM 2R-1. The variation of the applied shear force with the measured CFRP hoop strain is depicted in figure 20; it is almost linear with different slope in two distinct ranges; the first for a shear force value from zero to $Q=205\text{kN}$ and the second for a shear force value larger than $Q=205\text{kN}$ up to $Q_{av} = 215.8\text{kN}$, when the rupture of the CFRP occurred.

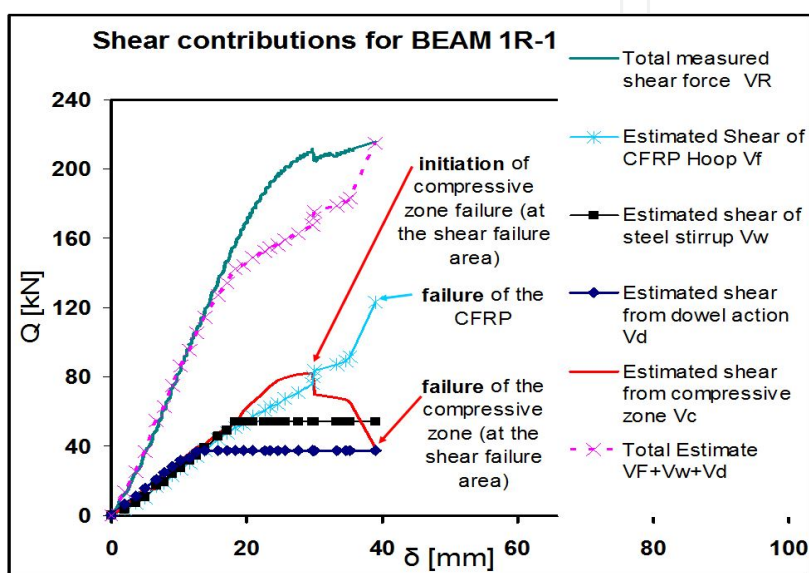
Figure 22. Shear resistance contributions, extracted from the mechanism of shear failure for specimen BEAM 2R-1.

The variation of the estimated shear contributions of the CFRP-hoops (V_f), the steel stirrup (V_w), the dowel action of the longitudinal reinforcement (V_d) as well as the sum of all these ($V_f+V_w+V_d$) are plotted in figure 22 together with the measured total shear force (V_R) for specimen BEAM 2R-1. The common basis for the plotted displacements between the estimated contributions and the measured values is found from the correspondence of the load and strain measurements during testing. In addition, in the same figure, the variation of the

contribution of the compressive concrete zone is plotted by subtracting from the total measured shear force (V_R) the contributions of the steel stirrups and the CFRP hoops ($V_c = V_R - V_w - V_f$). After the formation of the shear cracks this contribution includes the dowel action of the longitudinal reinforcement. This results in a maximum value $V_c = 84.14$ kN, which is in agreement with predictions based on formulas suggested by various researchers. Moreover, it can be seen that the summation of the various contributions is in good agreement with the total measured shear force if the contribution of the compressive zone is added, after the formation of the shear cracks and up to the initiation of the crushing of the compressive zone concrete.

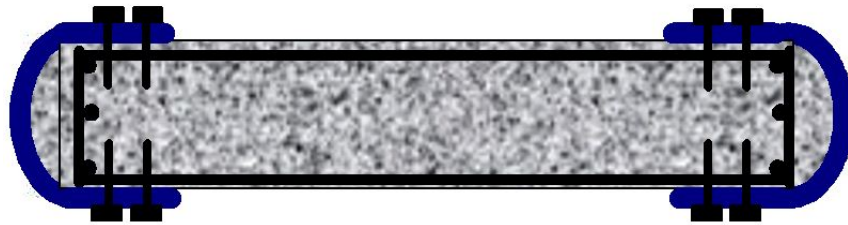
Figure 23. R/C cross-sections with one side longer than the other ($h/b > 1.5$) and CFRP partial confinement.

The upgrading of reinforced concrete (R/C) cross-sections, with one side rather longer than the other ($h/b > 1.5$), by partial application of CFRP (Carbon Fiber Reinforcing Plastic) confinement is investigated here (figure 23). This partial application of CFRP confinement is aimed at the retrofitting of bridge-pier type R/C cross-sections in order to prohibit, up to a point, the development of premature compressive failure at the base of the pier due to combined compression and flexure from seismic loads (see figure 24 and [36], [37]). The performance of such structural elements was studied extensively in the past ([38], [39]). This type of partial confinement may also be applied to upgrading vertical structural members with non-accessible sides. Design guidelines for rectangular FRP jackets applied on rectangular columns have been proposed with the limitation that the cross-sections have aspect ratio $h/b < 1.5$ [37]. For higher aspect ratios it is recommended to design a circular or oval jacket. However, it is expected that for rectangular cross sections with aspect ratios larger than 1.5 the radius of a circular or rectangular jacket will be too large and will result in ineffectual confinement and will prove costly and impractical. For this reason it is desirable to investigate alternative schemes for increasing the confinement of rectangular cross-sections with relatively large aspect ratio without resorting to complete circular or oval jackets. Such a scheme is studied here using CFRP layers that do not extend all around the cross-section (figure 23 "partial confinement").

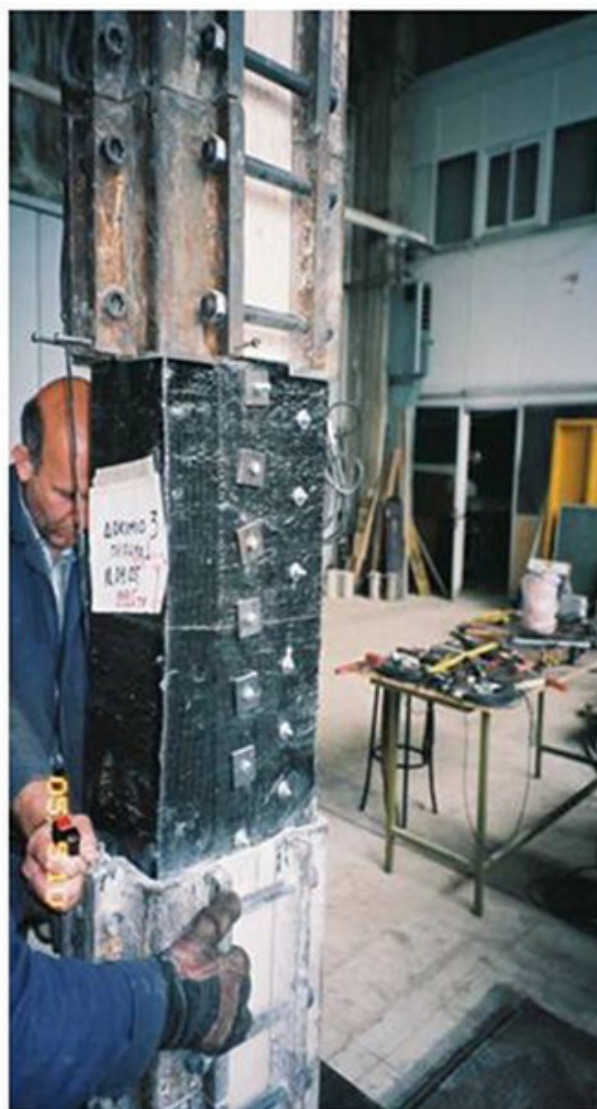
Figure 27. Specimen with confining steel brackets at the edges and partial CFRP confinement at the mid-part

The reinforcing details are depicted in figure 26. As can be seen, the total height of the specimens was 1600mm. They had a mid-part height of 580mm that was left to develop the compression failure (figure 26, part denoted as CROSS SECTION A). The cross section of this mid-part was the one shown in figure 25b, including the two distinct parts (the weak and the strong). The two edges of the specimens, with a height of 510mm each, were confined during the experiment with strong steel brackets covering these parts from all sides thus prohibiting any compressive failure developing at those two edges (see figure 27).

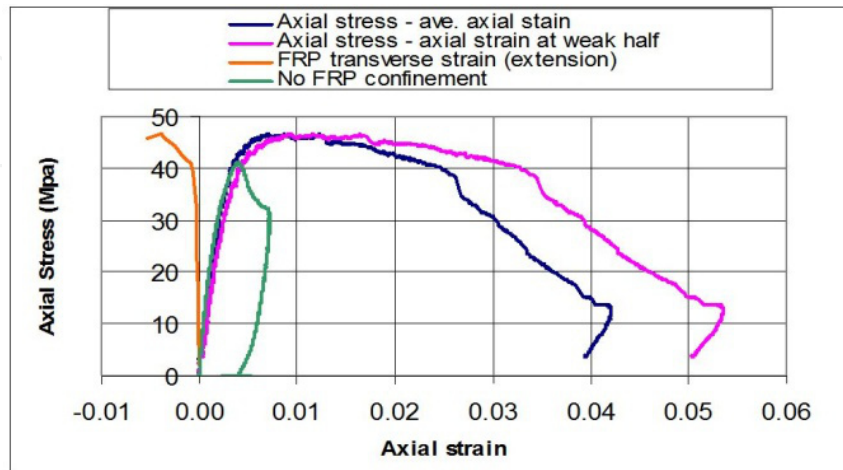
Figure 29. Specimen 4, Test 1 (5 layers CFRP) Comparison with Specimen 1 Test 1 (no confinement).

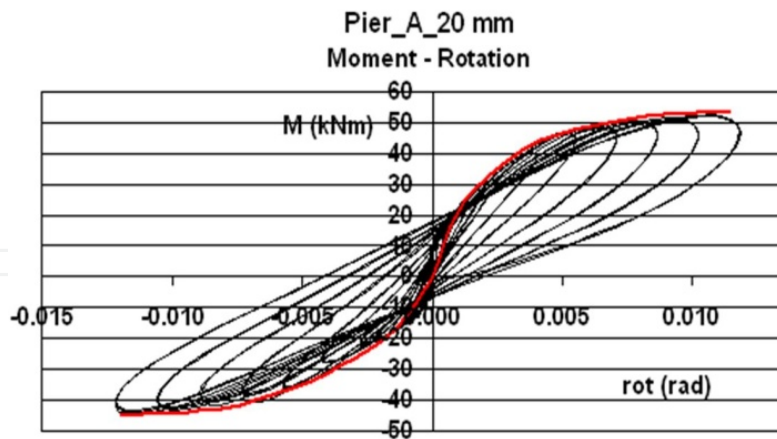
Figure 38. The measured flexural response of Pier A in terms of bending moment - plastic rotation.

The yield stress of the longitudinal reinforcements was equal to 344.8MPa whereas the concrete strength was equal to 21.2MPa. Based on these mechanical characteristics and the cross-section reinforcing detailing, predictions of the limit-state flexural behavior for this virgin specimen (without CFRP) were obtained in terms of the M-N interaction. The limit-state flexural behavior of a specimen with 2 layers of CFRP attached to both vertical sides of a repaired specimen is also obtained, based on the assumption that the cross-sections under flexure remain plane even with the attachment of the CFRP layers. The development of flexural cracks took place as shown in figure 37. At this horizontal cross-section the measured flexural behavior of Pier A is depicted in figure 38, which presents the variation of the resulting bending moment at this cross-section of the specimen against the rotation of the same cross section,. The rotation was obtained from measurements made by displacement transducers that were placed at the two sides of the pier monitoring the relative vertical displacement between the upper part of the specimen and its foundation block. Additional instrumentation was provided to monitor the rocking or the sliding of the foundation block itself, which proved to be non-significant. The observed maximum bending moment value compares quite well with the corresponding predictions of the limit-state flexure for this cross-section. The red line in these plots represents the corresponding envelope curve.

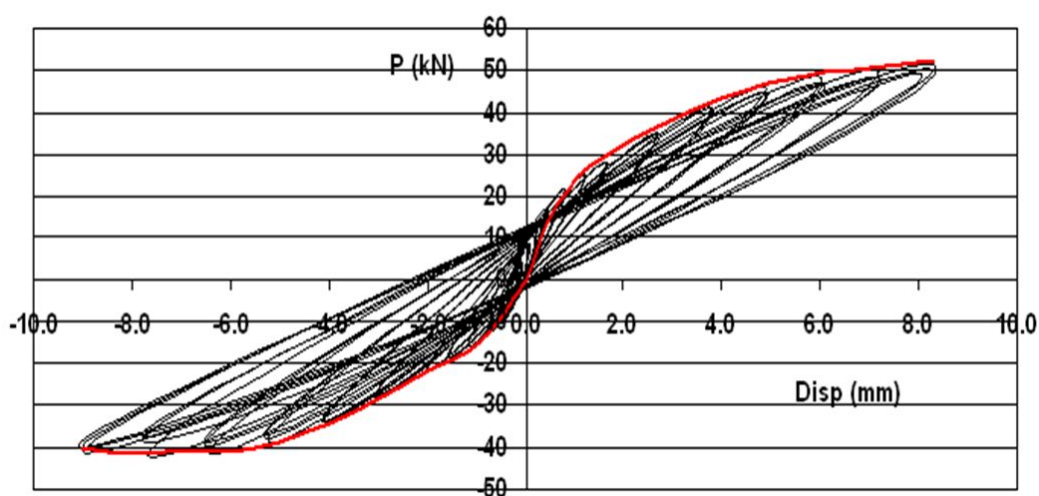
Figure 40. The measured flexural response of Rep-1 Pier A in terms of Horizontal load - Horizontal Displacement.

The loading sequence, described before, was applied to this repaired specimen. During increasing of the imposed horizontal displacement the debonding of the CFRP layer at the right side of the pier occurred as depicted in figure 39c. The obtained flexural behavior is depicted in figure 40 in terms of applied horizontal load against the imposed horizontal displacement at the top of the pier. If this behavior is compared with the corresponding behavior of the virgin specimen Pier A, a modest increase in its bearing capacity of approximately 20% can be observed as a result of the applied CFRP repair scheme, despite the debonding of the CFRP layers. The red line in this figure represents the corresponding envelope curve.

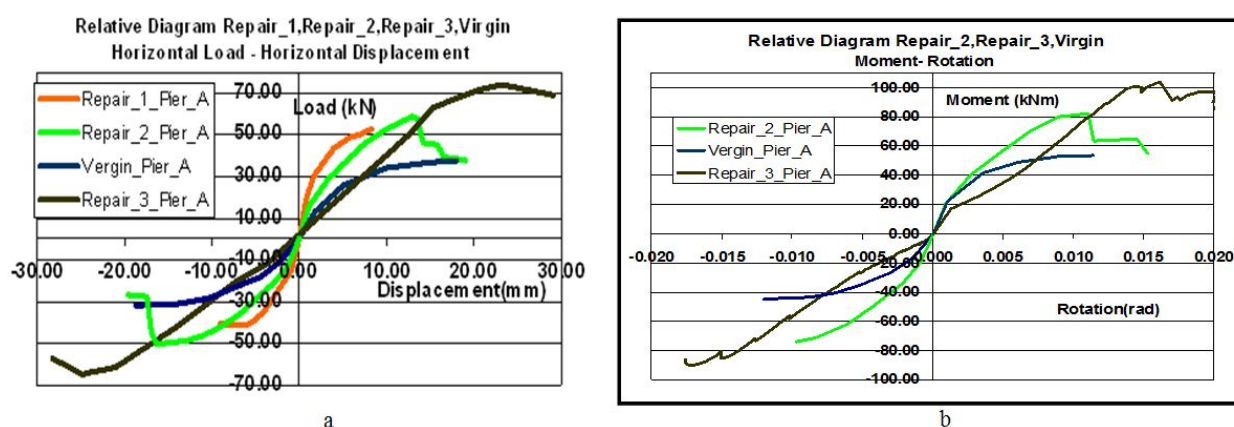
Figure 45. Comparison of flexural response of repaired specimens Rep-3, Rep-2, Rep-1 and virgin specimen. 45b. Comparison of flexural response of repaired Rep-3, Rep-2 and virgin specimens.

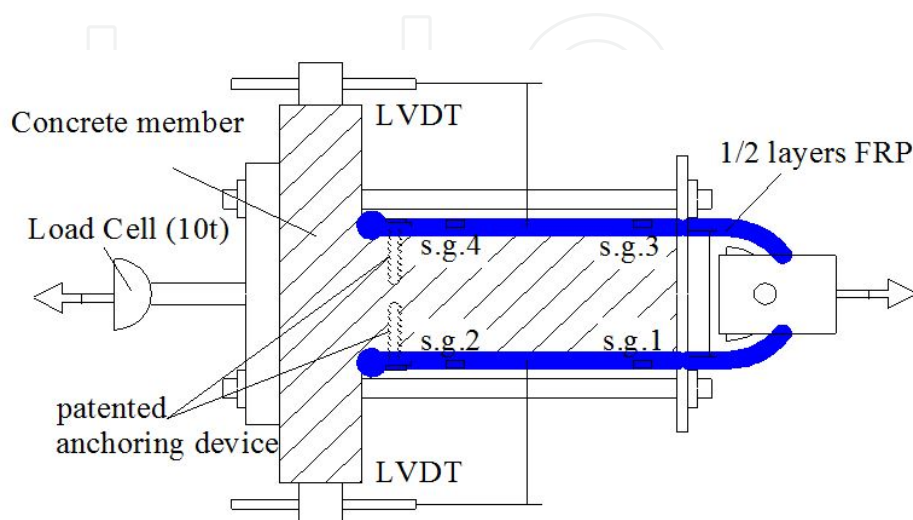
Figure 46. Experimental Set-up.

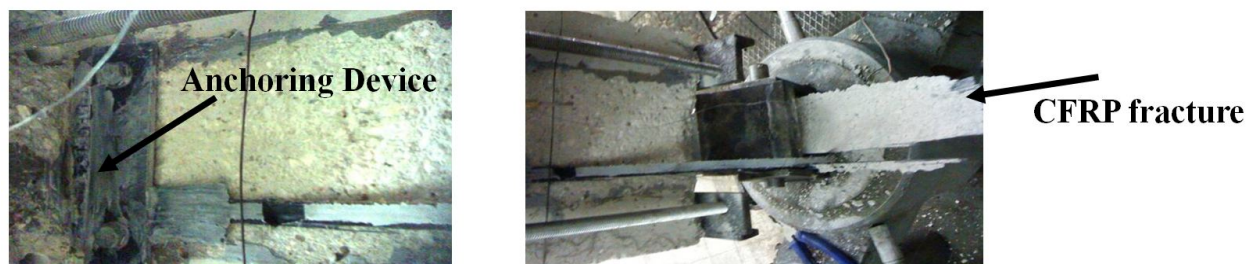
Figure 48. Detail of the anchoring device and the fracture of the CFRP strip when such an anchoring device is employed.

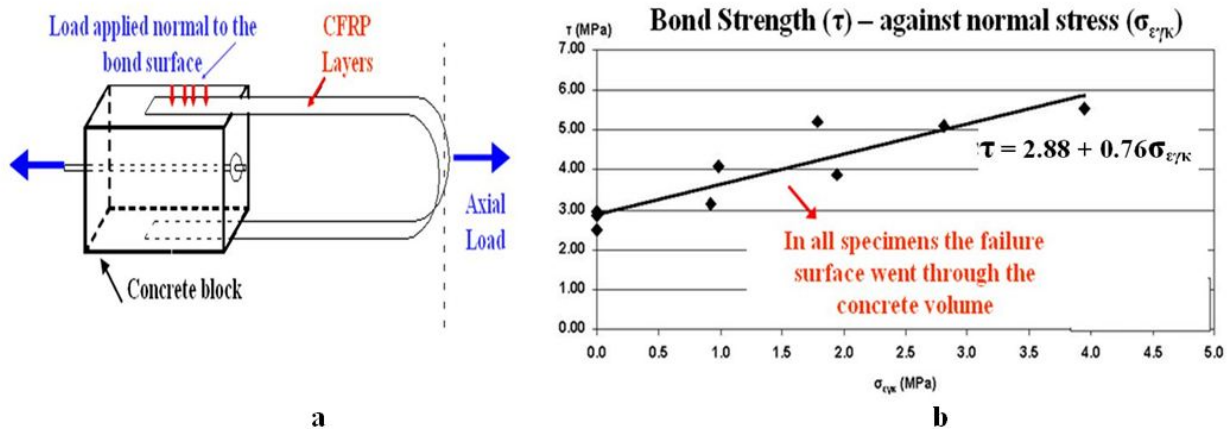
Figure 49. a Test for estimating the bond between CFRP layers and concrete surface and b obtained results.
