Acoustic Emission of Composite Vessel

Hyun-Sup Jee and Jong-O Lee

1. Introduction

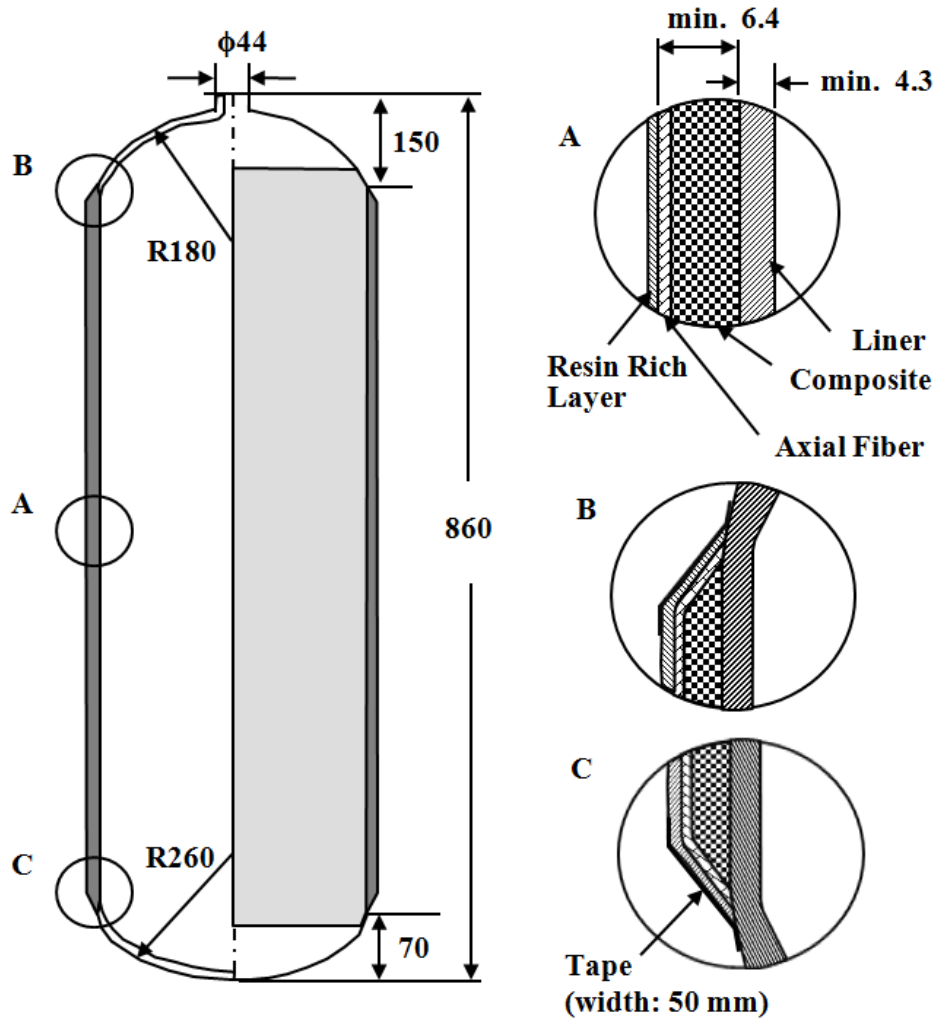
Experiment vessel used in this research is a 64 Liter CNG fuel tank used in vehicles. The thickness of the liner in the shell is about 6 mm and was made using the DDI (Deep Drawing Ironing) method[12,13] using 34CrMo4 steel plate, and is a type-II vessel in which glass fiber is hoop-wrapped on the shell of the liner.

Figure 1. Schematic diagram of experimental vessel

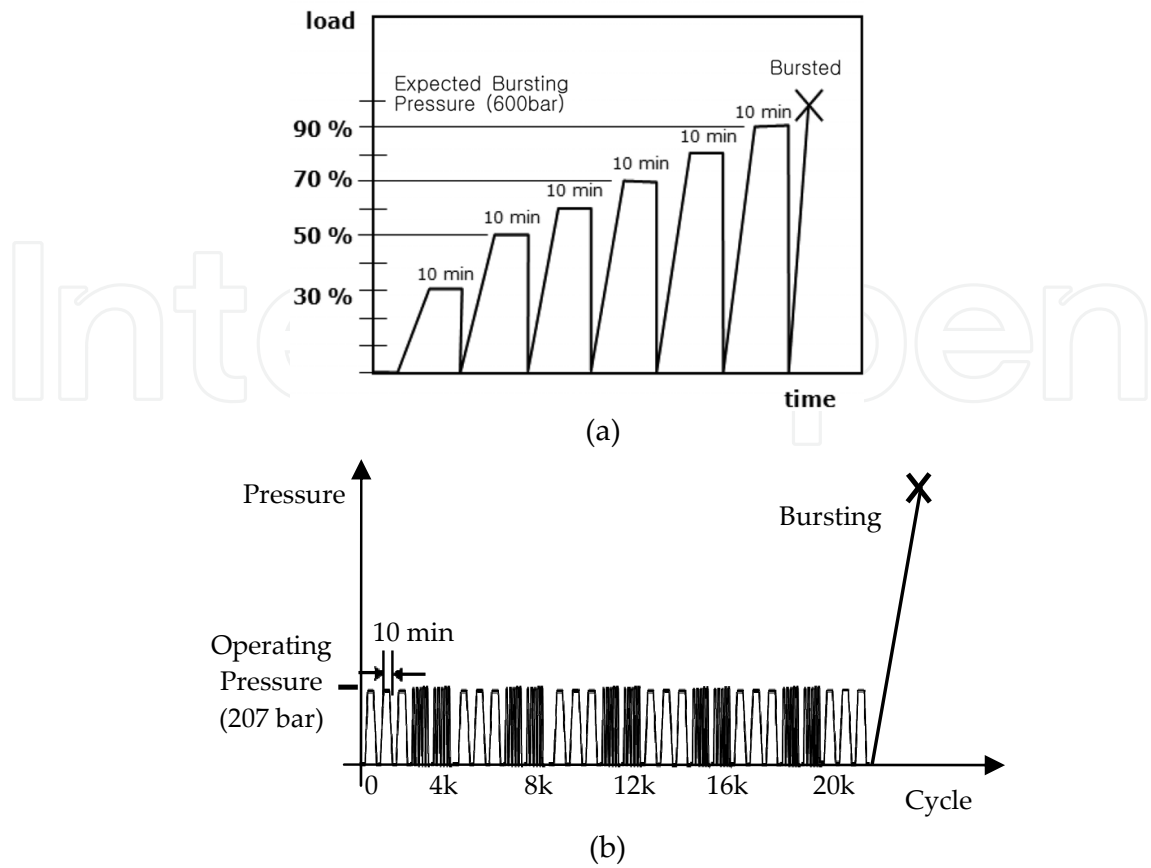
The burst pressure was estimated to be 600 bar under the pressured conditions. By raising the pressure to 30%, 50%, 60%, 70%, 80% and 90% of estimated burst pressure and keeping each pressure stage for 10 minutes as in Figure 3(a), we acquired the AE signal from each stage. As can be seen in the figure, pressure was put on the vessel with a pump to control the pressure and acoustic emission signals were detected using acoustic emission sensors attached to the vessel. And the signal were processed and analyzed after fed into AE equipment. The fatigue test repeated 20000 cycles between 0 and 207 bar, afterwards which has a used pressure of 0 and afterwards, the pressure was continuously increased and the burst test was carried out. Figure 3(b) shows the conditions for pressurization.

Figure 3. Loading sequence : (a) Burst and (b) fatigue test

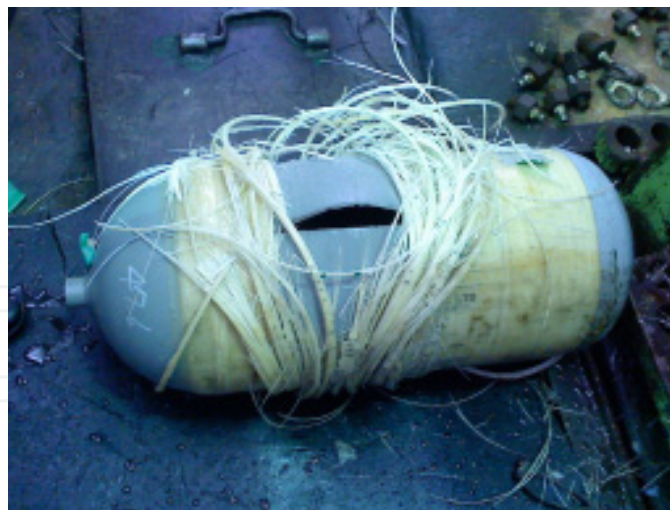
First, the composite materials wrapped in the metal liner were separated due to the matrix crack and then each layer was separated from each other. Then, some section of the fuel tank was weakened due to the cutting of some reinforced fiber, causing the destruction of metal liner of that part and finally destroying the vessel.

Figure 4. Composite vessel after burst test

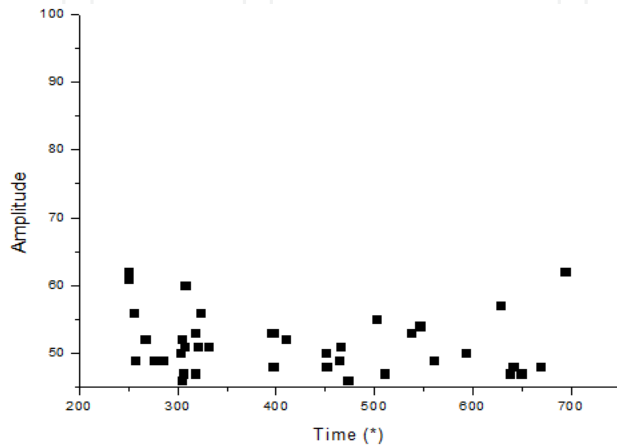
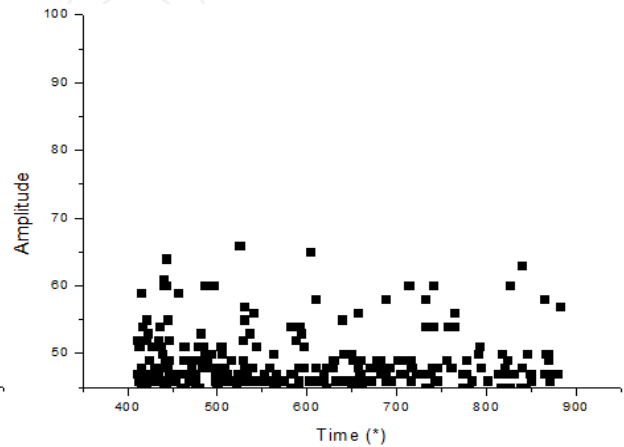
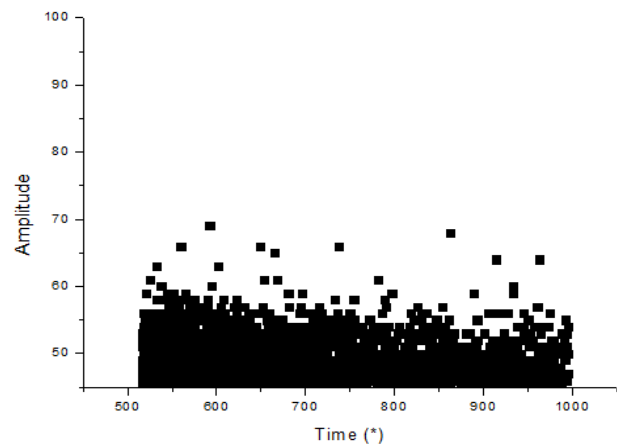
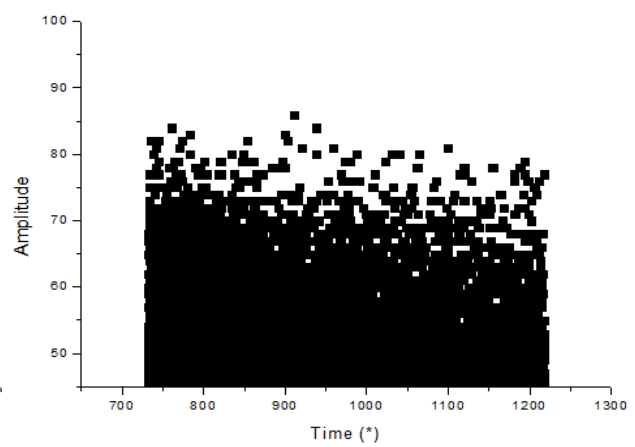
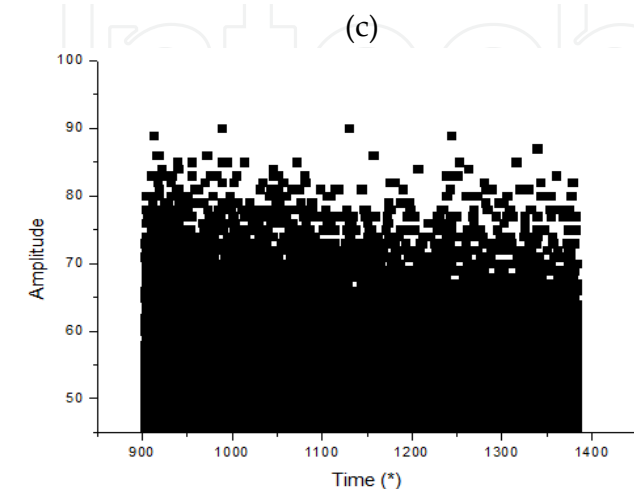
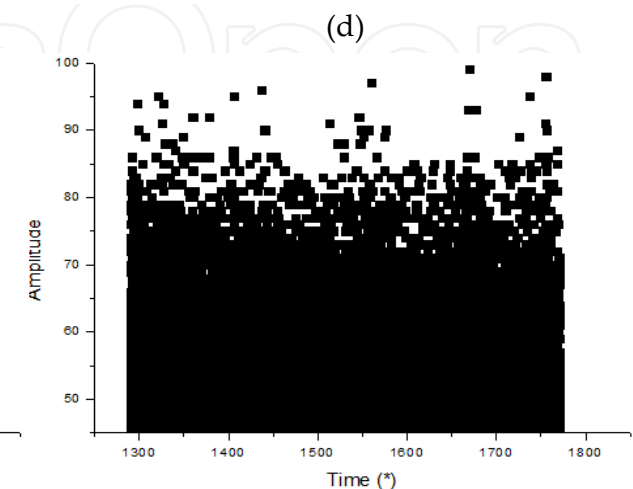
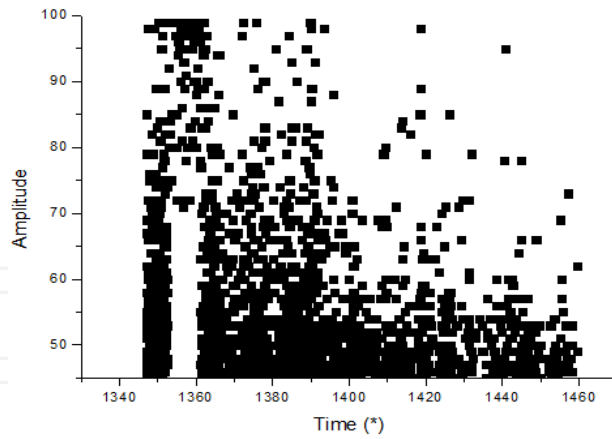
pressure on the vessel and keeps the pressure for some time until some sound emits from it. This is called the analysis of creep effect. The values in Figure 5 show that the pressure up to 360 bar, or 60% of the expected burst press is weak, showing that the vessel is not likely to receive significant damages. But after 70% of the expected pressure, the signals of 60dB or more are often shown, which may mean that there is a lot of creep effect and that the significant damages have been done to the vessel.

Figure 5. Amplitude vs Time plot during load holding : (a)30% (b)50% (c)60% (d)70% (e)80% (f)90% and (g)fractured

The pressure rise to the 80 % and 90 % of the expected burst pressure shows a lot of signals with high amplitudes. At the pressure stage of 540 bar or higher, where the burst is likely to occur, the signals with the amplitude of 80-100 dB continue to occur while giving the continuous leak signal from 1352 seconds to 1361 seconds. The burst occurred when the pressure rapidly went down to 400 bar. Figure 6 shows the total hits from 2 minutes after the start of each load. There is a rapid increase in the number of hits when the load pressure goes over 70 % of the expected burst pressure where the significant damage is likely to happen. In the final destruction, the number of total hits is low because the time to destruction was short, considering the felicity ratio and the pressure rising up to the fracture.

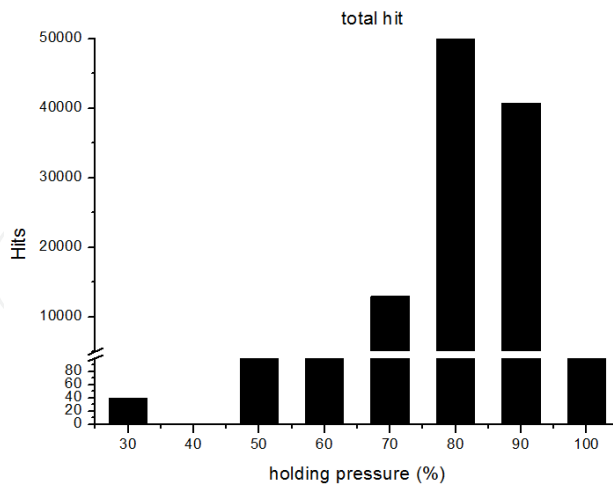
Figure 6. Total hits during load holding

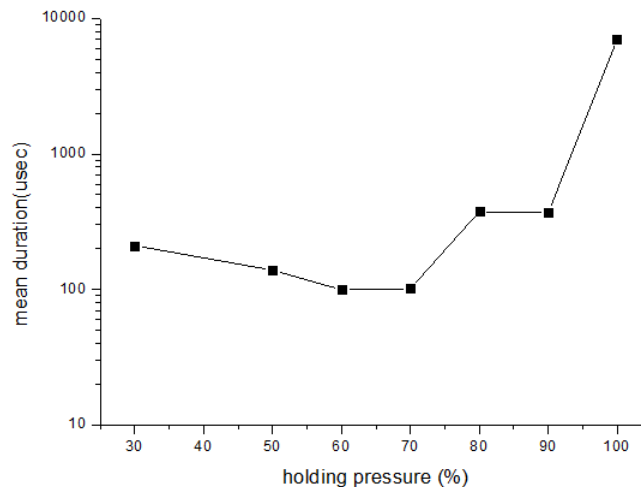
Figure 7 and 8 show that the average rise time and duration for the signals occurred during the holding time of each load. The rise time and duration become shorter up to loads up to 70 % while those from time of 80 % to the time of burst get longer, during which the damage is likely to be greater.

Figure 8. Mean duration during load holding

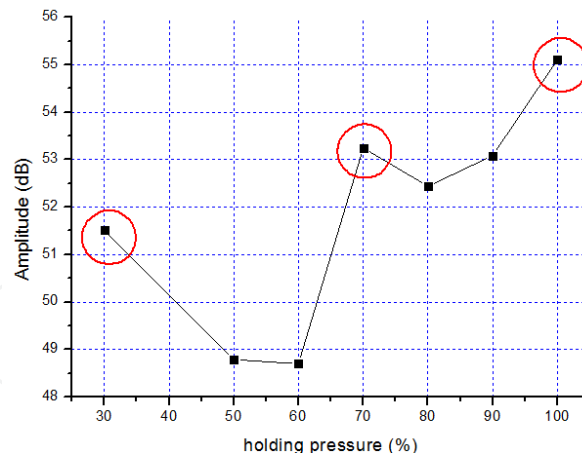
As shown below, the composite material pressure vessel has many damage mechanisms in it. The initial damage mechanism contains the matrix crack due to the stress as well as the crack grown. As shown in Figure 10 (a), the rise time appears at the range of 10 μ s and 100 μ s. This shows the creation of matrix crack and the growth of this crack. The signal from around 10 μ s is related to the creation of cracks while the signals from 100 μ s look to be related to the growth of the cracks.

Figure 9. Mean amplitude during load holding

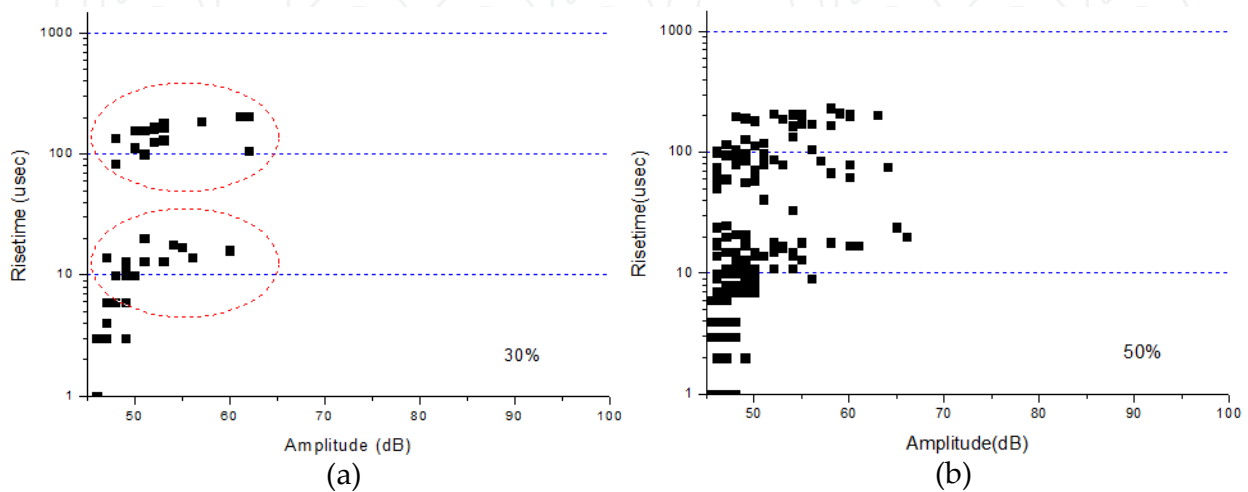
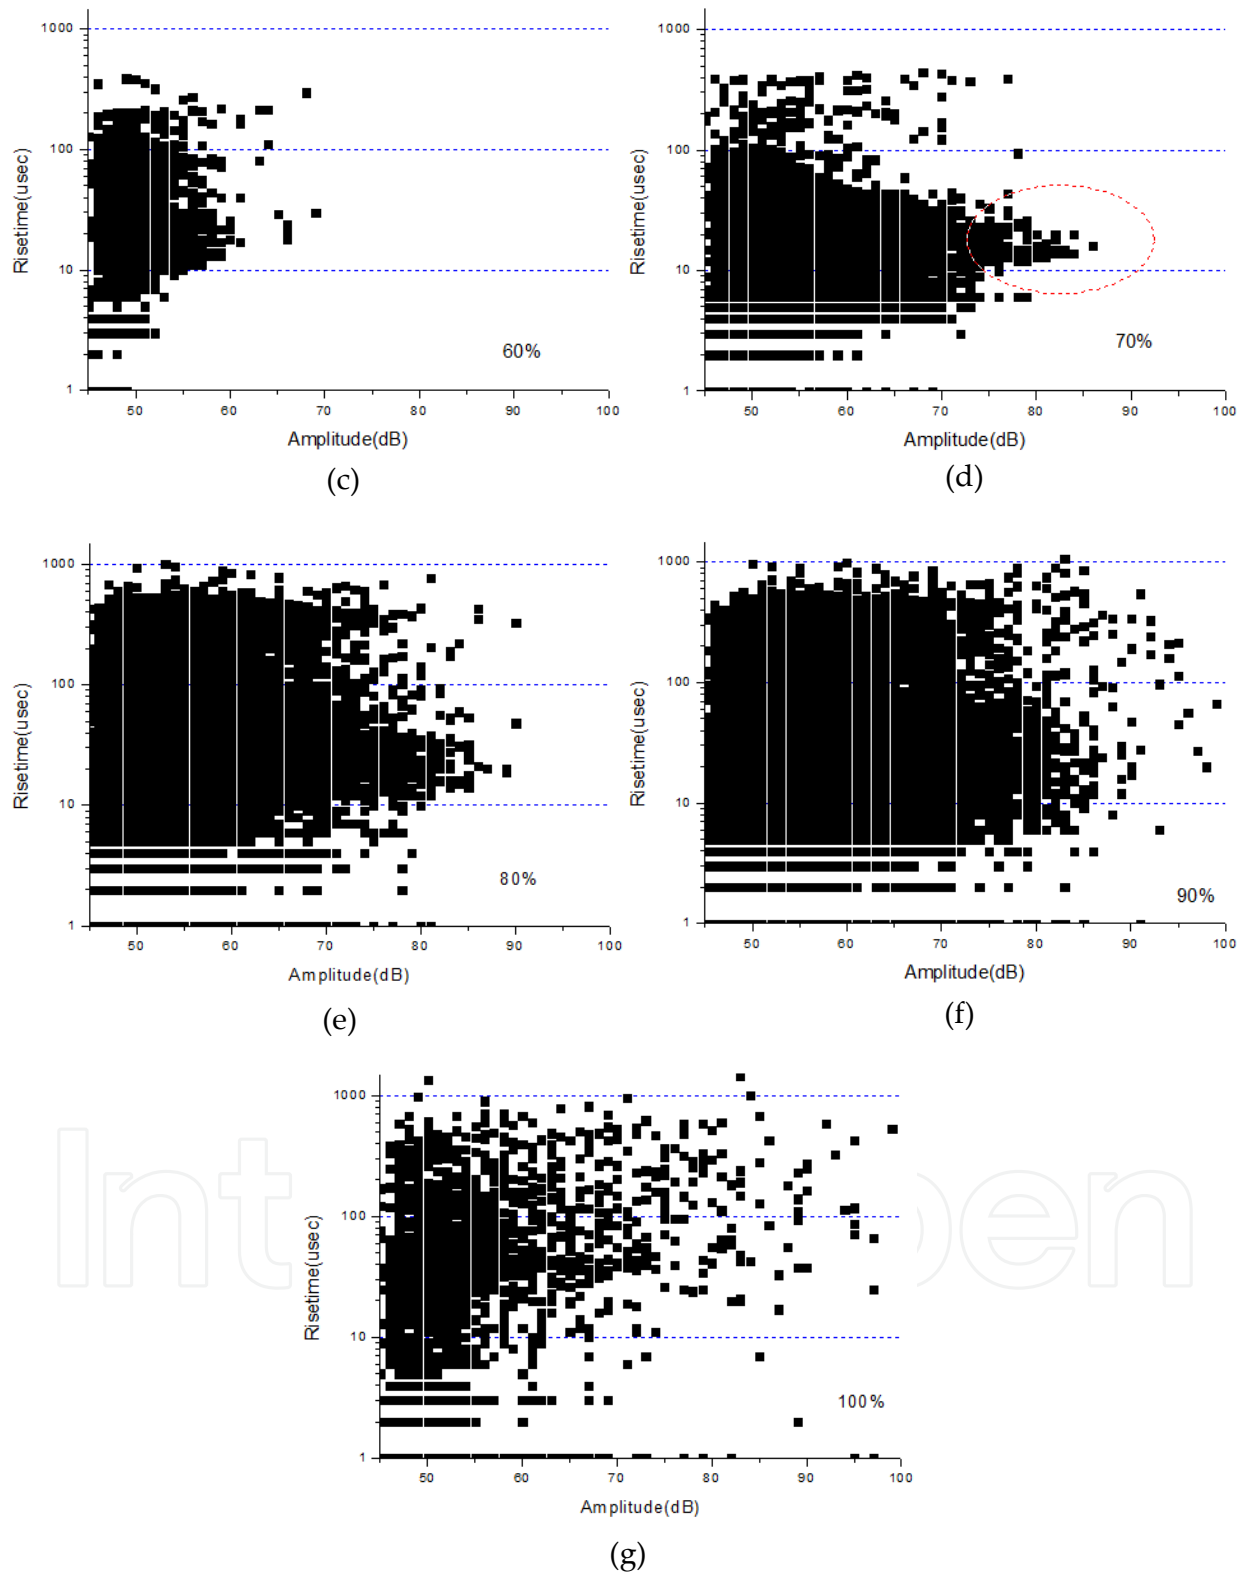
AE signals at the load of 50% and 60% show that the matrix crack and growth occur in this range instead of the additional causes for damages. At the load of 70%, a lot of the rise time of AE signals come from 500 μ s appear. It is likely to indicate that the new damage elements such as cut of reinforcement fiber appear. The rapid increase in AE signals around 10 μ s shows that the growth of matrix cracks such as growth of existing cracks and interlayer separation occur at a fast pace. Then, at the load of 80~90%, it is estimated that rapid damages such as growth of the previous matrix cracks and the cutting of reinforcement fiber occur, making much sound from cutting of reinforcement fiber. The 800 μ s of rise time at this stage is likely to be caused by the cutting of several lines of reinforcement fibers. Then, at 100% load, a composite of damage mechanisms occur, increasing the damage of vessel and then destroying the last metal liner.

Figure 10. Rise time vs amplitude plot during load holding : (a)30% (b)50% (c)60% (d)70% (e)80% (f)90% and (g)fractured

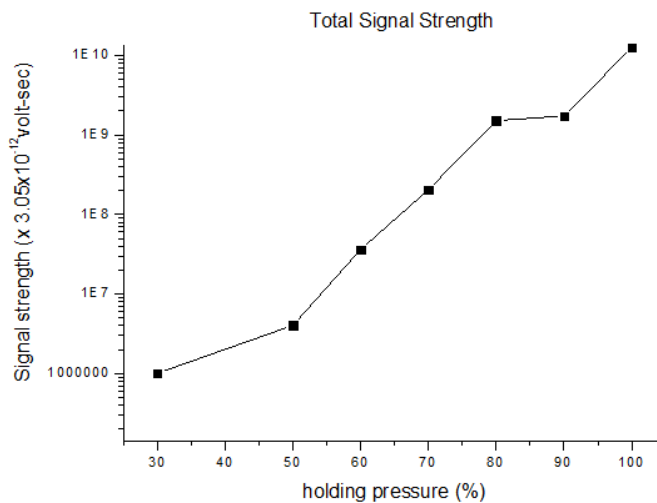
Figure 12. Total signal strength during load holding

Figure 11 shows the total count of sound emission signals which occur during the 2 minutes of holding time. These variables are better indications than mean rise time in Figure 7, mean duration of Figure 8 or mean amplitude of Figure 9. It was discovered that it was difficult to assess the damage against the vessel with variables such as mean amplitude, total hit, mean rise time, or mean duration but the total count and the total signal strength of the sound emitted when the load is pressed on, activation and vessel's damage were better indications for damages on the vessel.

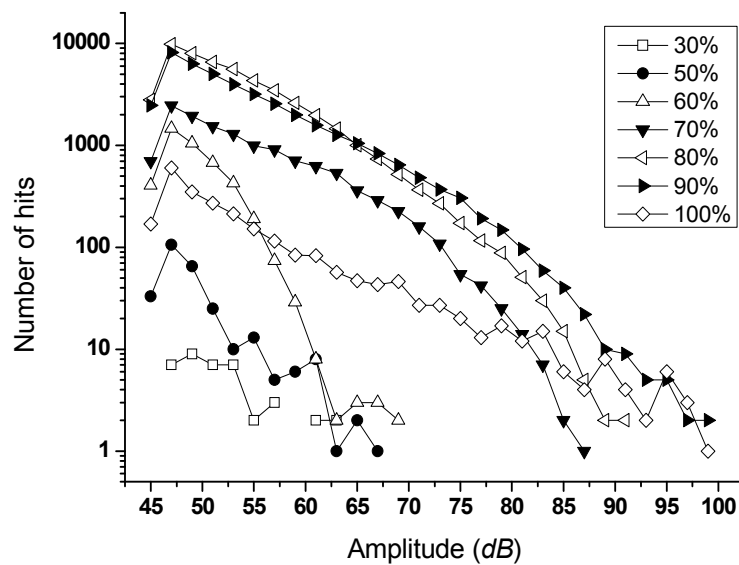
I did not use the signals during the initial 2 minutes among the 10 minutes to minimize the flow noise which often includes the initial stages of pressing in the pressure test. After that, I observed the number of hits and creep effect of the sound emission signals which occur during the holding time. Even though there were creation and growth of cracks on substrate under the load of 60 % of the estimated burst pressure, they did not cause much damage to the vessel. But it was found that at the load of 70 % pressure, the vessel was quickly destroyed.[4] Figure 13 shows the distribution of amplitude of signals occurring after 2 minutes of the pressure holding at each load. At the load of 60 % or less, there were not a lot of signals of 60 dB or higher but less than 70 dB. At this time, I could estimate that at the initial stage of the vessel damage, the composite material substrate wrapping around the vessel were showing some cracks and their growth. I could observe the cracks with my own eyes at the 2000th cycle of fatigue test when the pressure was at 207 bar. The used pressure was more than 30 % of the estimated burst pressure (180 bar). During the burst test, at the

load of 30 % to 60 %, even though there was increase in the number of signals, there was not a big increase in amplitude. Accordingly, we now that up to 60 %, there is not much of a creep affect but just the low amplitude of signals. I think that this is mainly caused by the creation and growth of cracks of substrate. After pressing, there were the creep effects, which show the significant increase in AE signal and the signals with the amplitude of 85 dB. In addition, as the distribution of amplitude appears different from the previous one, I think that the damages on the vessel are significant. It seems that there are more creations and growths of cracks in the composite materials and the cutting of reinforcement fiber and peeling of substrate cause the damage mechanism. In addition, the slope of the distribution of amplitude is known to be related to the mechanism of the signals[8], In the load of 70 % or higher, the slop looks similar, meaning that the damage is caused by the similar damage mechanism.

Figure 13. Amplitude distribution during load holding

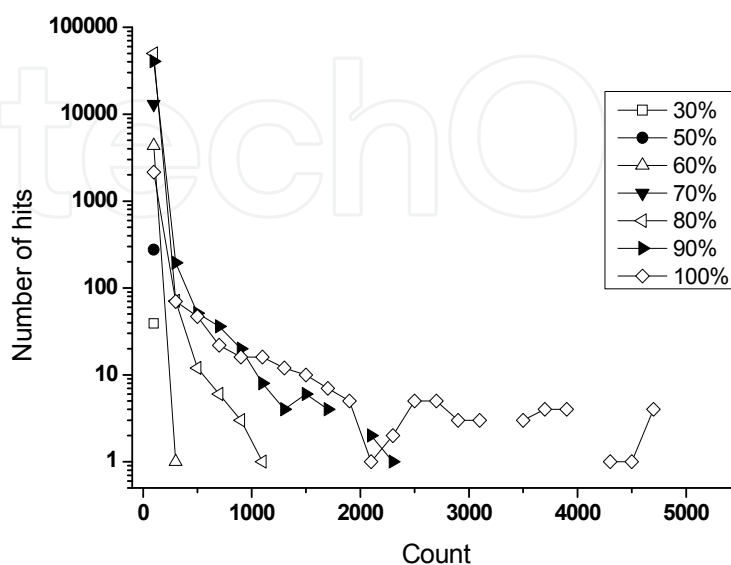
Figure 14. Count distribution during load holding

Figure 14 shows the distribution of counts of AE signals coming from each load of pressure. When the signal with counts of 500 or less occurred under the load of 60 %, the damage was caused by the creation of growth of substrate crack under the load of 60 % pressure. At the pressure of 80-90 % where the significant damage is done to vessel, the number of counts was 1000 or more. At the burst stage the number of counts was 2,500 or more.

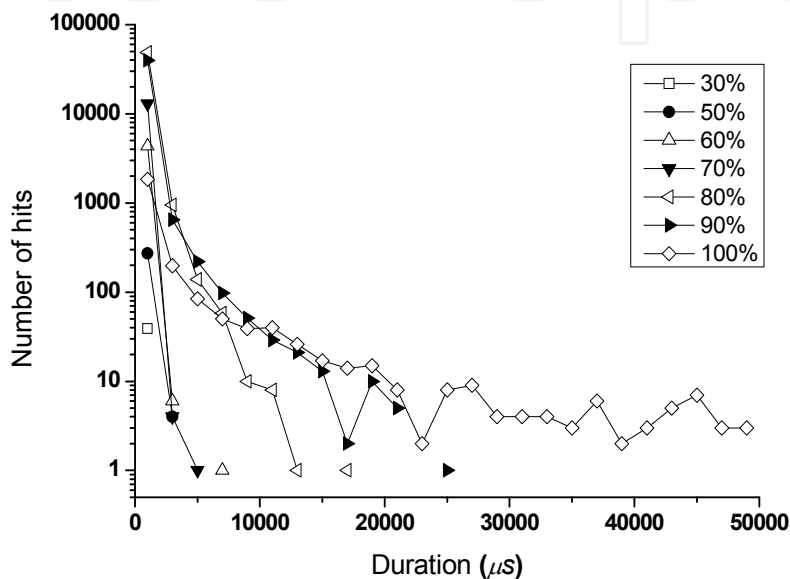
Figure 15 shows that the duration of signal occurs with the range of 500 μs at the load of up to 70 % and that the signal of over 10000 μs started to appear at the load of 80 % or higher. At the load of 90 %, the 20000 μs appears during the final burst stage where the signals of 25000 ~ 50000 μs appeared.

Figure 15. Duration distribution during load holding

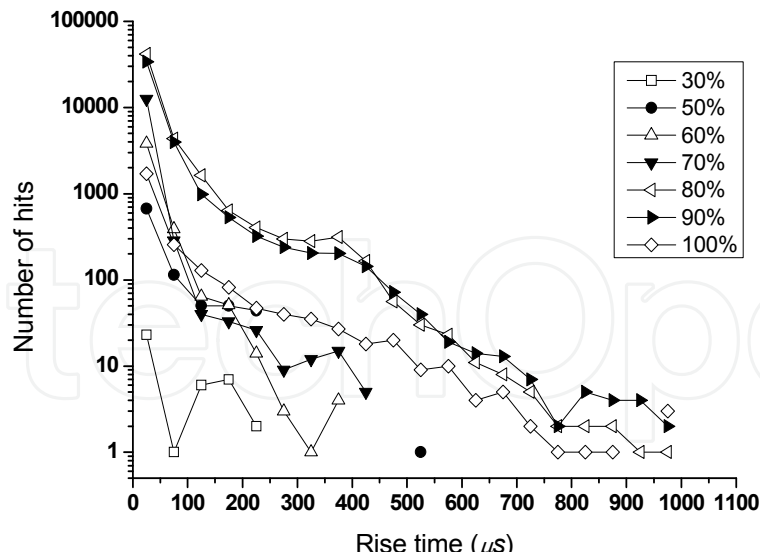
Figure 16 shows the rise time of 100 μs or less and the signal of 100-200 μs at the load of up to the initial 30 %. As we understand the distribution of the amplitude from the fatigue test of 20,000 cycles, there may be no mechanism other than the creation and growth of cracks at the load of 30 % pressure. It means that the signal of 200 μs or less is caused by the creation and growth of cracks of the vessel materials. Even though there were 1 and 4 signals of 300 μs or higher at the load of 50-60 %, they are negligible considering the total number of signals. It seems that the damage was mainly caused by creation and growth of cracks on composite materials rather than by new damage mechanisms. At the load of 70 % pressure, the signal of 250-450 μs , which is longer than at previous load stage appeared, meaning that there may be new damage mechanism. It seems that it was caused by the additional damage mechanism such as the cutting of reinforcement fibers and interlayer peeling due to the increase in internal pressures. At the load of 80-90 %, the rise time of 500 μs or more is observed. It may be affected by the composite damage mechanism such as the growth of existing cracks, cutting of reinforcement fiber and inter-layer separation happening at the neighboring location. This trend is true of the distribution of counts and durations as specified above. The observation of the sound emission signals coming out of the neighboring location through the composite damage mechanism would be a good tool to assess the vessel.

Figure 16. Rise time distribution during load holding

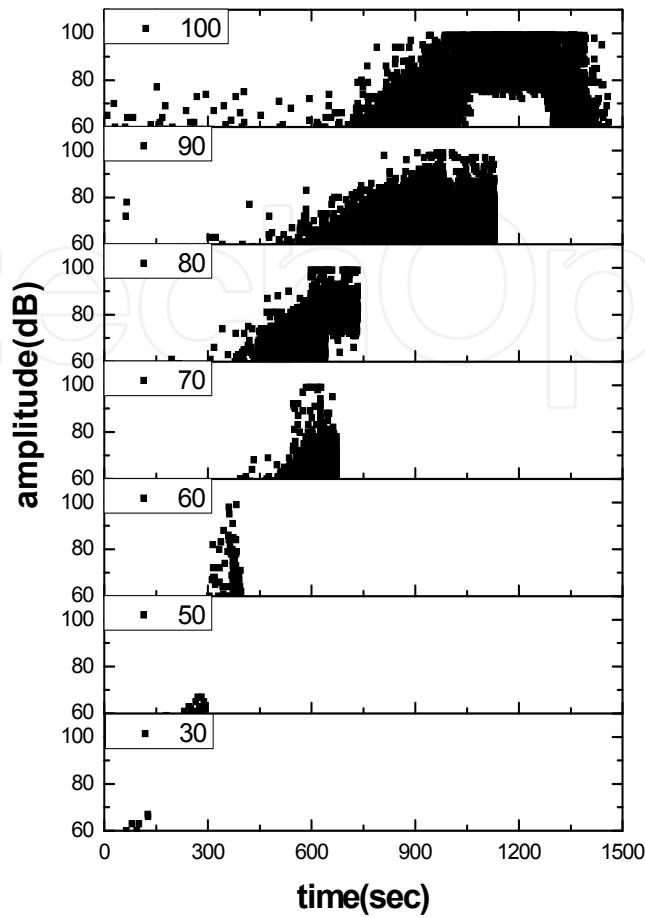
To estimate the damage with the sound emission signal, the signal of 60 dB or higher is used. Figure 17 shows the distribution of amplitude for hits of 60 dB or higher for each load of pressure. AE time becomes lower until the pressure of 70 % but at 80 %, it becomes faster. As the pressure rises at constant pace during the test, at 70 % pressure, there is no AE signal until 60 % pressures, showing the Kaiser effect. Accordingly, up to 60 % pressure, it looks like that there was no significant damage to the vessel. As the pressure rises up to 70 % that may have damaged the vessel, it looks like that AE happened due to the Felicity effect when the pressure goes up to 80 % as the vessel was damaged during the rise up to 80 %. At the 90 and 100 % pressure, there is the Felicity effect. Particularly, in the pressure range of up to 100 %, which experienced the load of 90 % or higher, there is AE signals of 60 dB or more from the beginning, showing that the damage is significant. In the actual burst test, the damage mechanism of Type II vessel, or the matrix crack in the direction of initial hoop occurs and then the creation of cracks and its growth and the interlayer separation (which belongs to matrix crack but has different damage mode) occur [4]. At the load of 60 %, the matrix crack in the direction of hoop was shown. But, the matrix crack in the direction of hoop did not affect the burst pressure of the vessel [8].

Figure 17. Amplitude distribution during loading at each loading stage (over 60 dB)

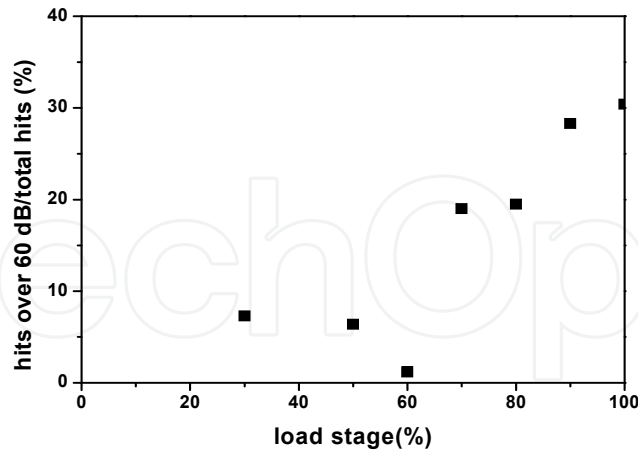
Figure 18 shows the count of hits where sound exceeds 60 dB at each stage of burst test. The rate decreases from 7 % to 1 % during the pressure of 30 % to 60 %. Then, the signals of 60 dB or higher rapidly go up to 20% at the load of 70 %. The rate goes up to 30 % at the load of 100 %. The signals of 60 dB or higher at an early stage may be caused by the creation of matrix crack on the composite materials. The reduction thereafter may be caused by the low amplitude (60 dB or less) rather than the creation of crack. At the load of 70 % or higher, there are not only the matrix cracks but also the damages by the new damage mechanism such as the cut of fibers, increasing the signals of 60 dB or higher. The measurement of the count of hits which are 60 dB or higher is a good tool to assess the damage.

Figure 18. Ratio of hits over 60 dB / total hits during each loading stage

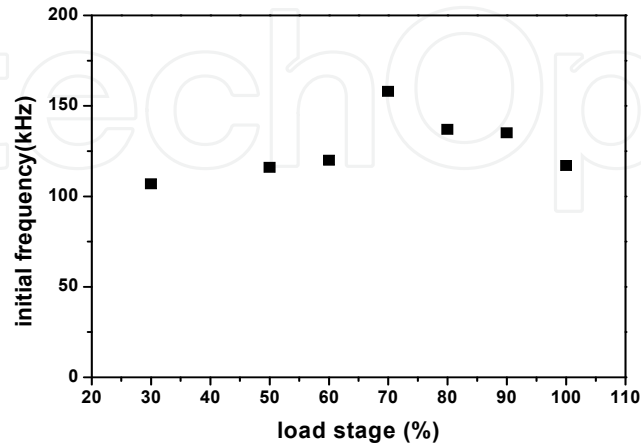
Figure 19-21 show the mean initial, reverberation and average frequency of AE signal at each load stage. The frequency is obtained not from the analysis of wave form but from the duration and counts. The frequency shows the difference between above and below 70 % load. As for the initial frequency, it did not show a big change at the load of up to 60 % or 100 kHz but it goes up at the load of 70 % until going down a little. This is likely to be

Figure 19. Mean initial frequency during each loading stage

related to the source mechanism. It shows the creation and growth of matrix crack at the load of up to 60 % and the additional damage mechanism such as the cut of fiber at the load of 70 % or higher. The reverberation frequency shows a little difference between below and above 70% but is constant in most stages while the average frequency was also constant with a little rise at the load of initial 30 % pressure.

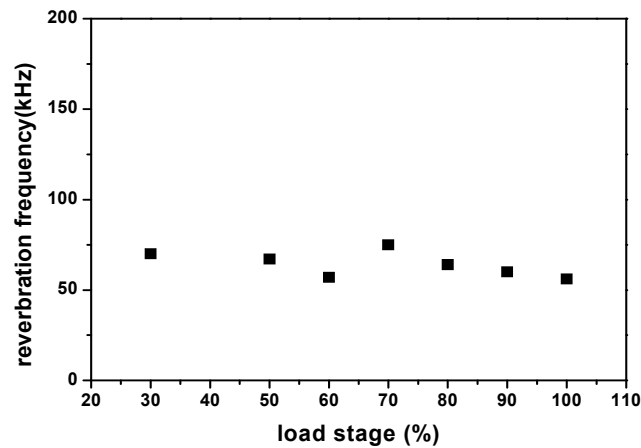
Figure 20. Mean reverberation frequency during each loading stage

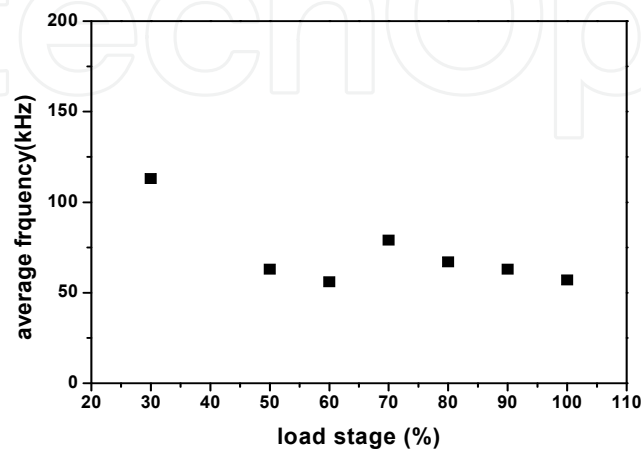
Figure 21. Mean average frequency during each loading stage

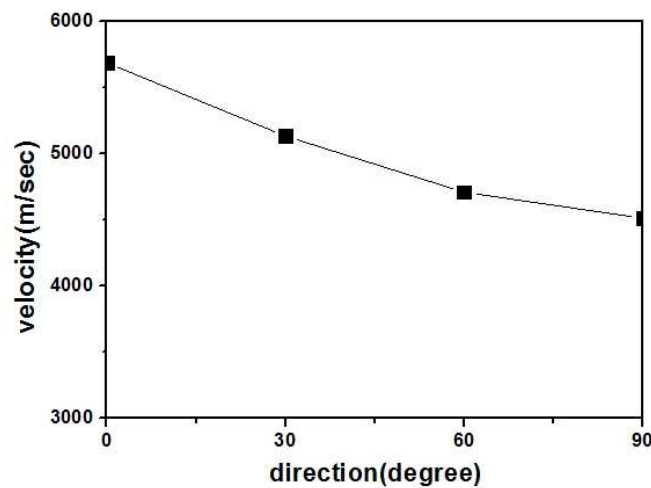
Figure 22 shows the results of measuring the elastic wave speed of the artificial acoustic emission source for the acoustic emission location on the fiber-wrapped composite material. As shown on the picture, the speed of longitudinal elastic wave was 4512 m/sec and the elastic wave speed of the wrapped direction was 5689 m/sec showing the characteristic of anisotropy. Thus, the location was identified using anisotropic vessel source location that uses the difference of time for the acoustic emission signal is to be reached.

Figure 22. The elastic wave velocity with degree between propagation and wrapping direction

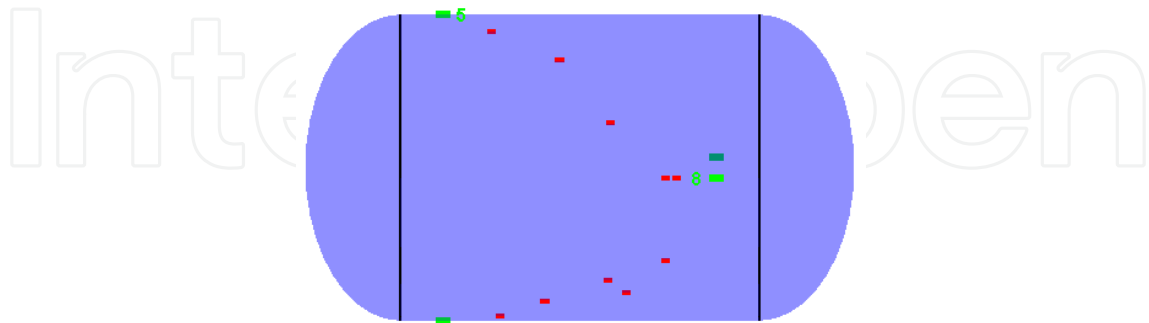
Figure 23 is the location of the sensor and the result of the identification test of the location using the artificial acoustic emission source. The four sensors were attached in staggered locations in channel 5, 6, 7, 8 and channel 7 refers to the backside of 8. The acoustic emission source is located diagonally in equal intervals between channel 5 and 8 and between channel 6 and 8.

Figure 23. Confirm of Source location

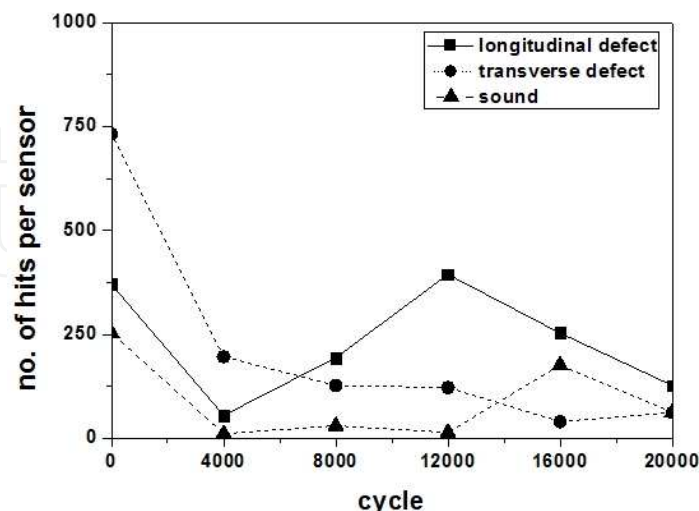
Figure 25 shows the average number of hit per sensor during the fatigue test of vessel. The vessel with the artificial defect has more number of hits compared to the sound vessel and when you see the tendency in increase and decrease, the number of hits for transverse defect vessel and sound vessel decreases as the number of cycle increases; however, the number of hits for longitudinal defect vessel decreases in 4000 cycle and then increases and then decreases in 8000 and 12000 cycles.

The reason the number of hit in the early stages is big is related to the initiation and growth of the matrix rupture in the comparatively weak areas within the vessel. The number of hits decrease and the initiation and growth of ruptures are comparatively slowed until sufficient amount of resilience is stored to bring about new initiation and growth.

Figure 25. The number of hits per channel during fatigue test for artificial defect and sound vessel

Figure 27 compares the number of hit per sensor and the number of events using Figure 25 and 26 and shows the event/hit ratio according to the increase in the number of cycle. This is a figure that shows the % of the number of hits that can precisely show the source among the total number of hits. In the case of longitudinal defect vessel, it was 41.8 % in the 4000th cycle, 55.7 % in the 8000th cycle. An event can be calculated using the difference in time that the resilience from the source (acoustic emission signal) sent through the walls of the vessel reaches the sensor and has to be extracted from at least 3 sensors. Hits that do not go by such standards cannot be used to calculate events and if the location was identified by simulation or if the signal is weak or is static, it cannot be recorded as an event. In the case of longitudinal defect vessel, the number of hits is small in the 4000th and 8000th cycle but the growth of the rupture is relatively easy and it sends hits to at least 3 sensors with signals with sufficient amplitude so the number of event/hit rate increases.

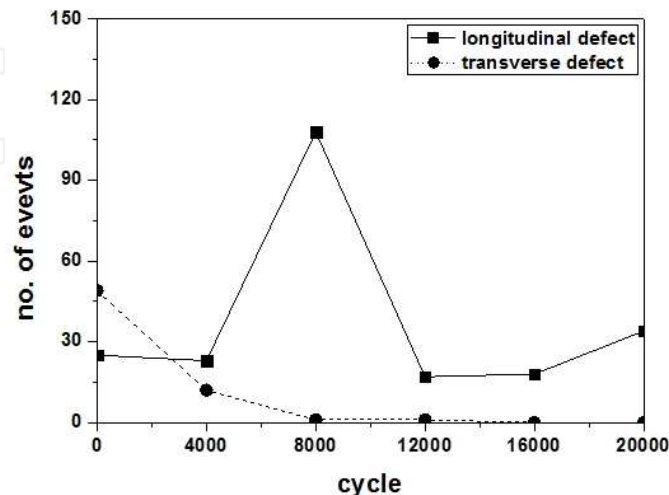
Figure 26 shows the number of events extracted during the fatigue test on longitudinal defect and transverse defect vessel. An event shows the number of sources calculating the

location of the acoustic emission source within vessel using the acoustic emission signal that hit the sensor and in the case transverse defect vessel which includes a transverse defect, the number of events is noticeably decreased as the number of cycle increases, but in the case of longitudinal defect vessel which has longitudinal defect, the number of events increases a lot in 8000th cycle and does not change much as the number of cycle increases.

Figure 26. The number of events during fatigue test for artificial defect vessel

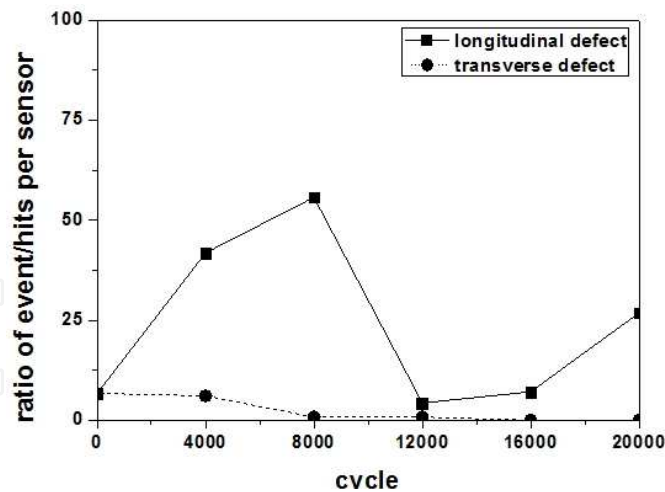
Figure 27. The ratio of events/ hits per sensor during fatigue test for artificial defect vessel

In the case of c), in the 8000th fatigue cycle, 108 events were clustered around the artificial defect and as mentioned in the explanation in Figure 27 more than 50% of the occurred hits were signals related to the artificial defect. Afterwards, events that occurred in d) ~f) were those that mostly occurred near the artificial defect so we can acknowledge that the damage on the composite material is progressed around the artificial defect. Figure 29 shows the surroundings of the longitudinal artificial defect after the 20000th cycle and shows that at the end of the defect, there is a matrix rupture progressing in a hoop-direction and although not clear in the picture, at the end of the depth in the artificial defect, delaminating was observed on the overall defect. In the case of vessel with transverse defects, after the 8,000th fatigue test, less than 1 event was created and the location of the artificial defect could not be shown clearly.

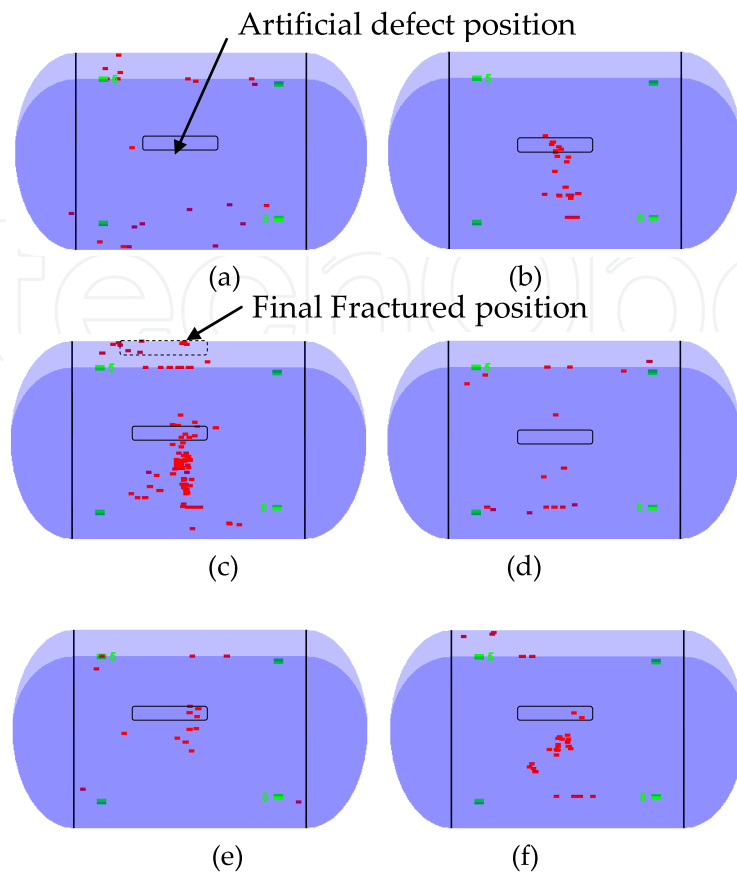
Figure 28 is the result of the location due to the acoustic emission test performed during the fatigue test on longitudinal defect vessel. Figure 28 (a) shows the location of 25 events during the first 3 fatigue test cycles. It does not show the location of artificial defects but shows the overall looks on the whole vessel. Such results are not shown in pictures but also in transverse defects vessel, 49 events in Figure 26 shows looks like a) on the whole vessel and it seems that signals were created on the weakest areas of the whole vessel when the first pressure was put. In the case of b), after the 4,000th cycle, in the 3rd fatigue test, 23 events were shown to be clustered around the artificial defect. As for the vessel with transverse defects, after the 4,000th fatigue test cycle, in the 3rd fatigue test, 12 events were created but they were all over the whole vessel so we could not show the location of the artificial defect.

Figure 28. The result of source location with cycle for longitudinal defect : a)0, b)4000, c)8000, d)12000, e)16000, f)20000

On the other hand, after the 20000th fatigue test, in the burst test, the location of the burst is marked in c) of Figure 28 and events are also observed in a), d), e), and f). The source of the acoustic emission signal is assumed to be the fatigue rupture in the weak areas of the steel liner rather than in the composite material. The final burst in the case of the longitudinal defect accompanies matrix rupture and delaminating as mentioned above during the fatigue test and burst test so the whole vessel area, which is the length of the defect, is thinner in terms of thickness like the depth of the defect and thus is weaker than other areas and it is thought that it burst at the final burst location in which the fatigue rupture occurred in the steel liner.

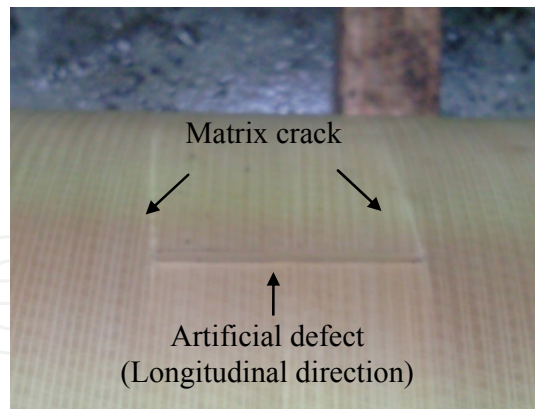
Figure 29. Longitudinal defect and matrix crack after 20000 cycle fatigue test

In order to analyze the characteristics of acoustic emission signals that occurred in the final burst position, event signals observed around the final burst location within 200 mm hoop direction in terms of length as marked in Figure 29 were analyzed. 18 events were occurred during the 20000th fatigue cycle and the number of related hits was 59. Figure 35 shows accumulated amplitude distribution and there are only 3 that are over 60 dB and 49 of them are below 50 dB. You can see the slope as ③ but if you observe closely, it is possible to observe that the same slope exists as ① in Figure 34 and also that it include the initiation of matrix crack. Seeing it as showing the slope of ③, as a signal according to a sole damage mechanism, it is estimated to be related to liner damage and the size is 0.06

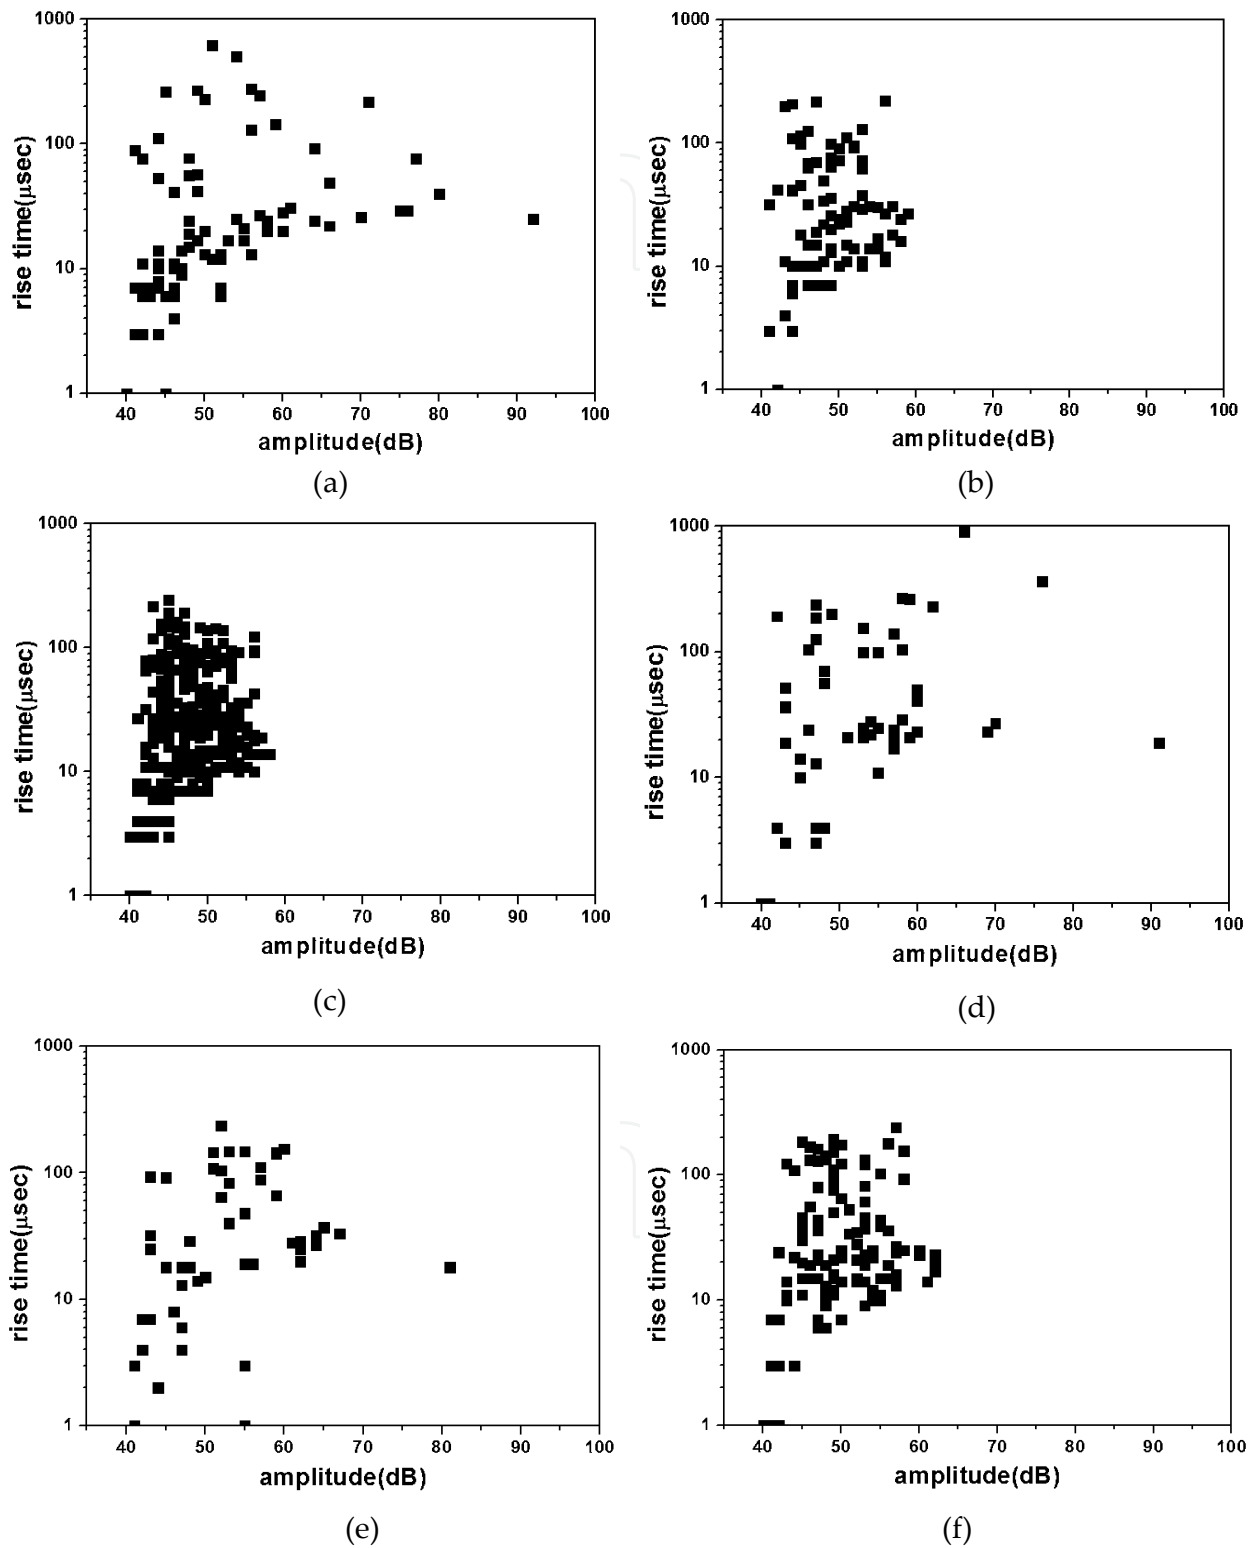
Figure 31 a) shows the relationship between the amplitude of the signals of events occurring during the first three cycles of the vessel and related hits and rise time and is clustered around 10 μs in the figure and is also scattered around 100-800 μs . It is judged that the initiation and growth of matrix crack will happen in weak areas of the overall vessel. Especially, a higher rise time can be observed when the source forms a cluster around the defect as shown in b), c), e), f) of Figure 31 than when the source is scattered overall on the vessel like a) or d) so the growth of cracks around the defect has a lower rise time than the initiation of cracks.

On the other hand, after the 4000th fatigue cycle, the average rise time of the signal occurring in defect vessel are shown to be higher than the average rise time of signals occurring in sound vessel.

In the case of a sound vessel, the growth of individual cracks occurs far away in other cracks. But, in the case of vessel with defects, the growth of multiple cracks occurs around the defects because the elastic energy needed for the growth of matrix crack in the vessel with defect is smaller than that of sound vessel. And generated signals overlap with other signals. Therefore, the rise time of signal is extended.

Figure 31. The rise time distribution of hits connected with event during fatigue cycle for longitudinal defect vessel: a) 0, b) 4000, c) 8000, d) 12000, e) 16000, f) 20000 cycles
