Acoustic Emission of Composite Vessel

Hyun-Sup Jee and Jong-O Lee

1. Introduction

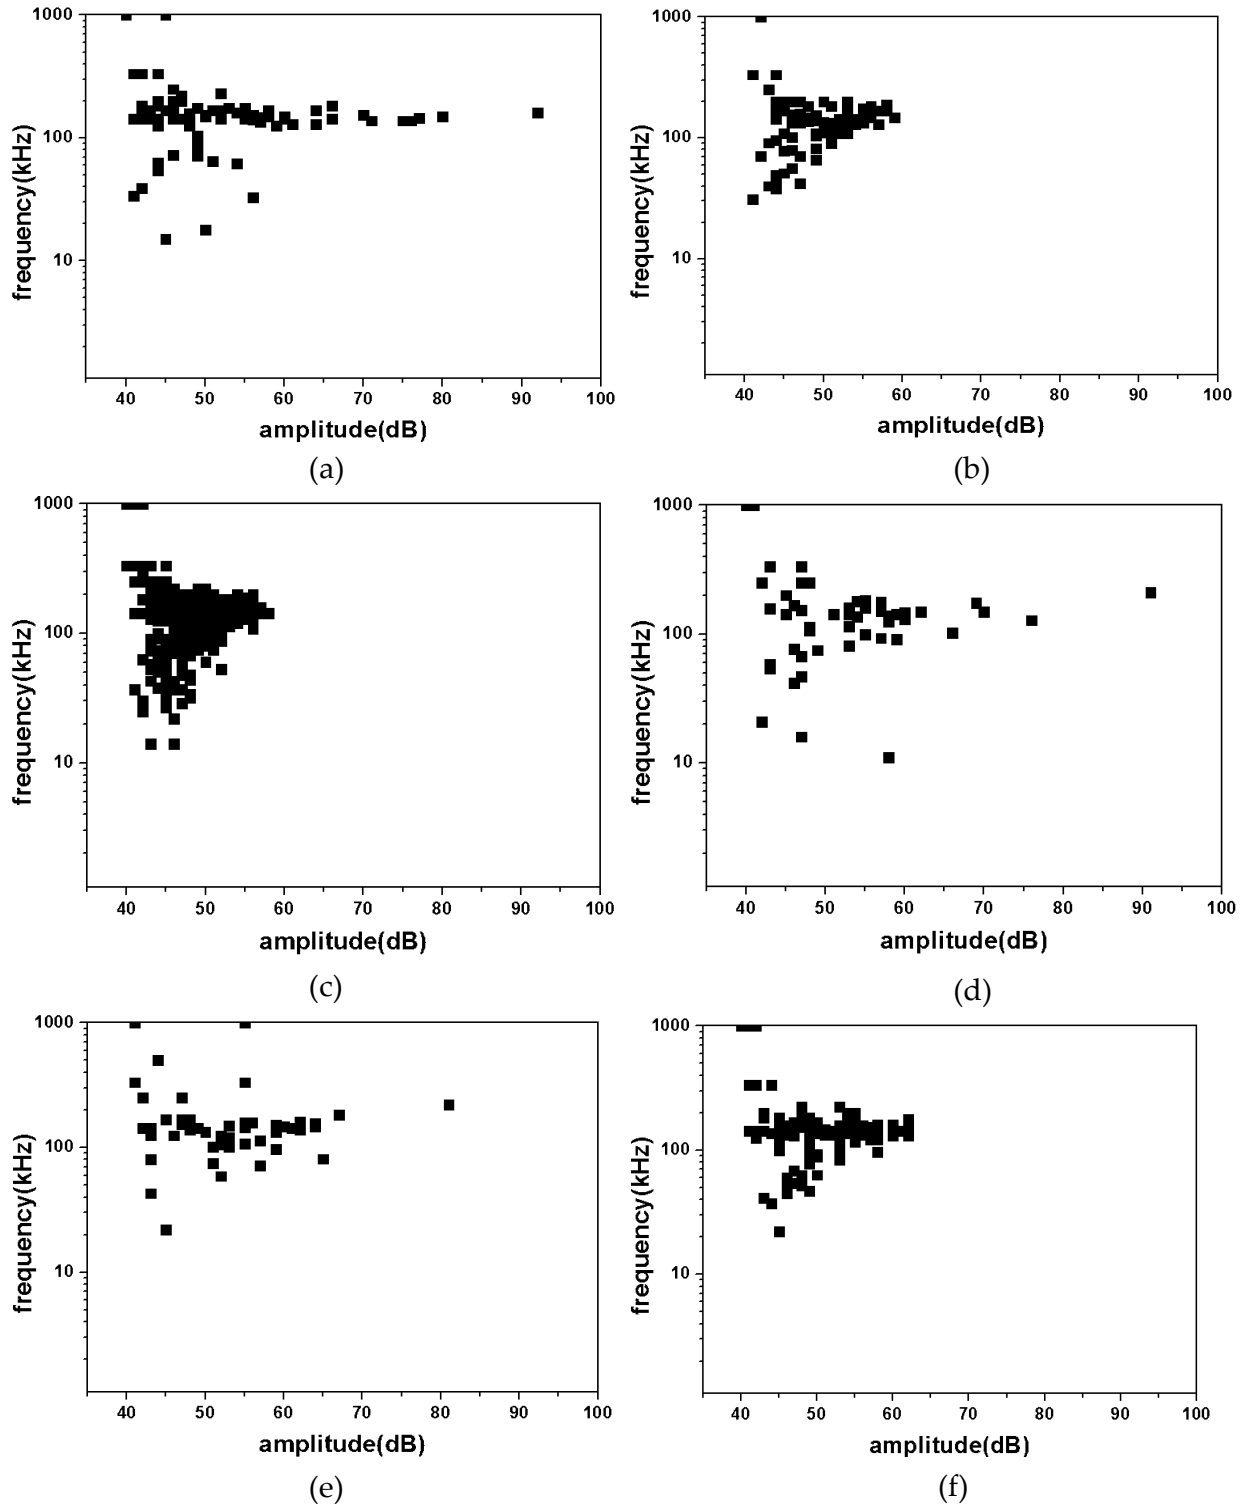
Figure 32 shows the distribution of initial frequency versus the amplitude with fatigue cycle but it is dispersed around 100-200 kHz, which is unrelated to the fatigue cycle. It is in accord with the result that the average frequency of signal which is generated due to initiation and growth of matrix crack is around 100 kHz in the burst test using resonant type sensors [7].

Figure 32. The initial frequency distribution of hits connected with event during fatigue cycle for longitudinal defect vessel: a) 0, b) 4000, c) 8000, d) 12000, e) 16000, f) 20000 cycles

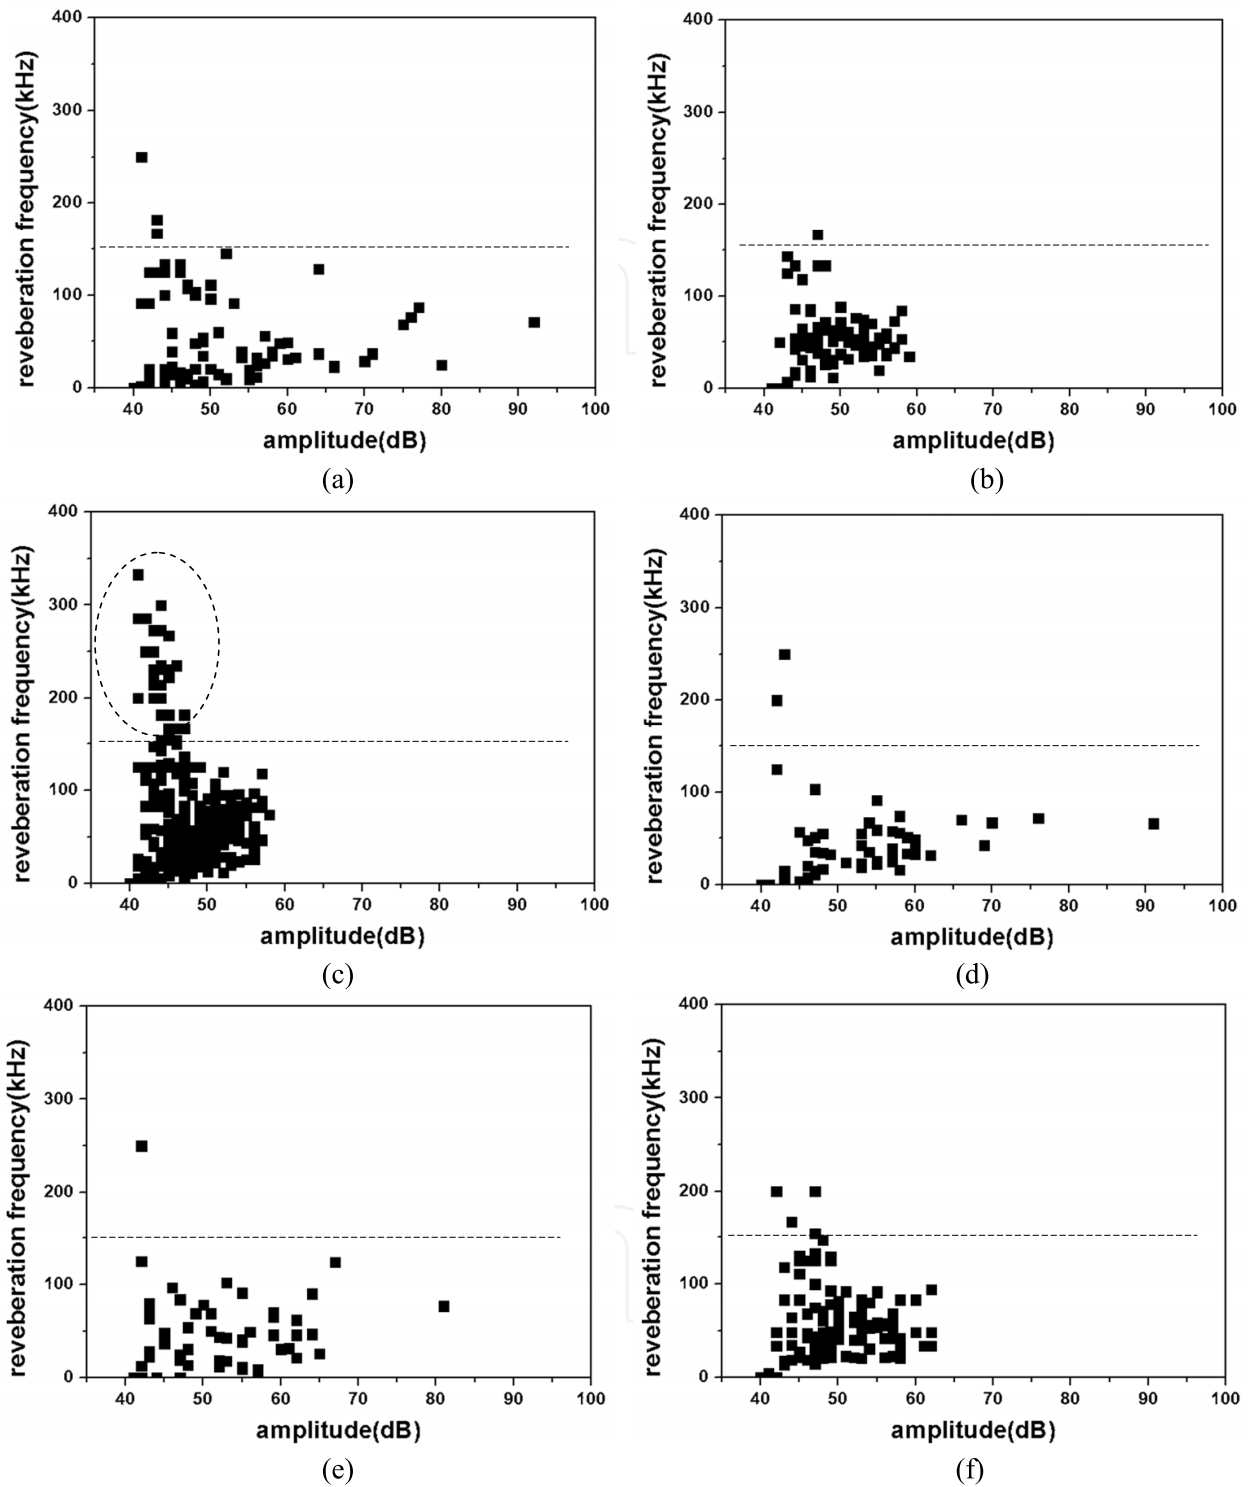
Figure 33. The reverberation frequency distribution of hits connected with event during fatigue cycle for longitudinal defect vessel: a) 0, b) 4000, c) 8000, d) 12000, e) 16000, f) 20000 cycles

Figure 33 shows the distribution of reverberation frequency on amplitude according to the number of fatigue tests but besides the oval area in Figure 33 c) which is the result of the 8000th fatigue test, most are dispersed below 150 kHz. The average reverberation frequency

on signals relating to all events of Figure 33 c) was 73 kHz and these accords to the fact that the average reverberation frequency is between 50 - 75 kHz in all stage of burst which includes the damage mechanism of composite materials in the cast of burst test.[7] On the other hand, the reverberation frequency during the burst test of the same vessel was known to occur in all stage of the burst test in the range of 150 - 350 kHz[8], and in such case, because it includes the mechanism of all damage, it is hard to differentiate damage mechanism as a frequency. There were 23 event signals that had a reverberation frequency in the 150 - 350 kHz area in Figure 33 c) and 16 of them, which are 70 %, occurred in the matrix crack area of Figure 29, which is an observation of artificial defects after the 20000th fatigue test. More than 90 % of the related 44 hits(150 - 350 kHz) were signals with rise time lower than 100 μ s and average rise time of 31 μ s. As mentioned in 3.2.1, it is assumed that it is due to the growth of matrix crack.

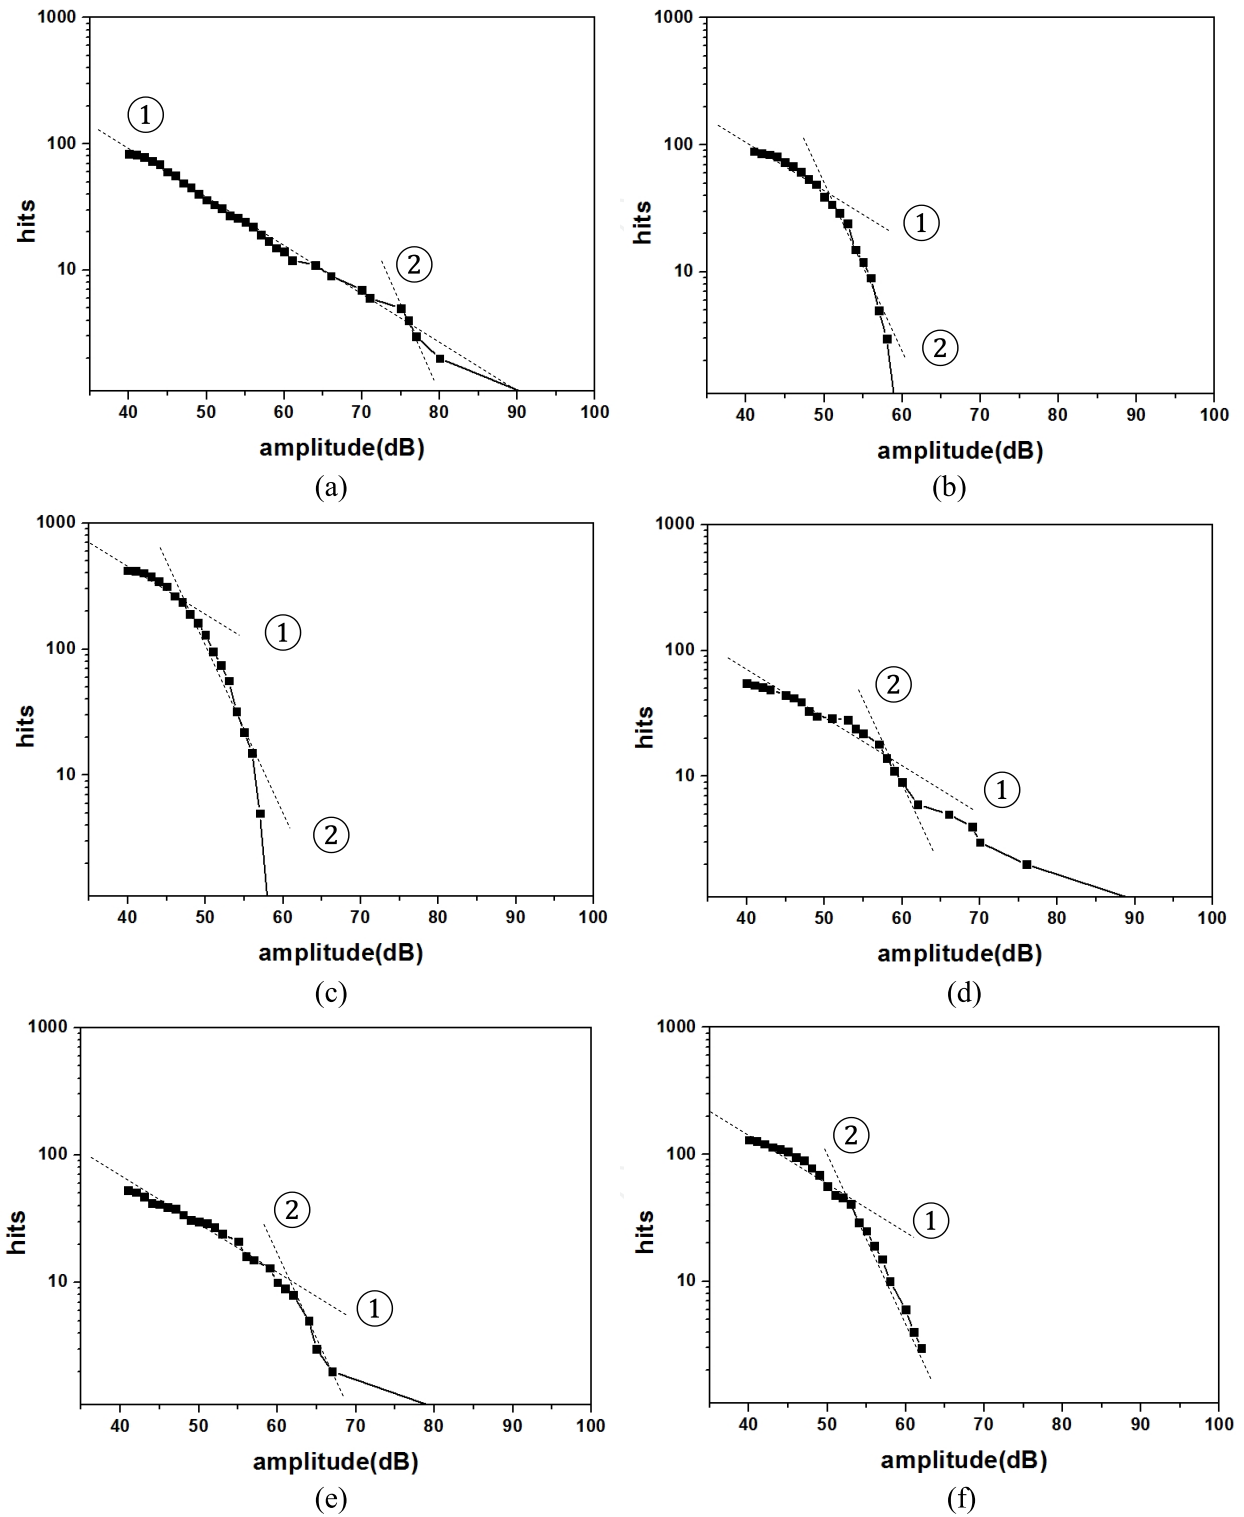
Figure 34 shows the amplitude distribution of accumulated hits according to the number of fatigue test and its slope has two types of shapes. Generally, the slope in the amplitude distribution of accumulated hit is known to be related to the mechanism of the source [8] and in vessel with defects as used in the experiment, as mentioned in the previous chapter, it includes mechanisms such as the initiation of matrix crack, growth of the created cracks (including delaminating), and the initiation and growth of liner fatigue cracks.

Initiation and growth of liner fatigue crack will be mentioned in the following chapter and in the view of the estimated result of the damage mechanism according to the number of fatigue explained in the previous chapter, the case of the initiation of matrix cracks is estimated to have a slope of ①(0.04) and the growth of cracks, a slope of ②(0.12).

Figure 34. The amplitude distribution of accumulated hits connected with event during fatigue cycle for longitudinal defect vessel: a) 0, b) 4000, c) 8000, d) 12000, e) 16000, f) 20000 cycles

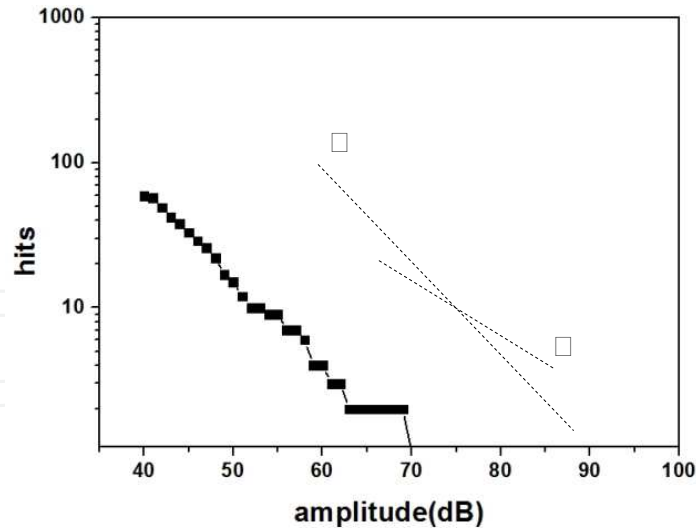
In order to analyze the characteristics of acoustic emission signals that occurred in the final burst position, event signals observed around the final burst location within 200 mm hoop direction in terms of length as marked in Figure 29 were analyzed. 18 events were occurred during the 20000th fatigue cycle and the number of related hits was 59. Figure 35 shows accumulated amplitude distribution and there are only 3 that are over 60 dB and 49 of them are below 50 dB. You can see the slope as ③ but if you observe closely, it is possible to observe that the same slope exists as ① in Figure 34 and also that it include the initiation of matrix crack. Seeing it as showing the slope of ③, as a signal according to a sole damage mechanism, it is estimated to be related to liner damage and the size is 0.06

Figure 35. The amplitude distribution of accumulated hits connected with event during fatigue cycle for longitudinal defect vessel

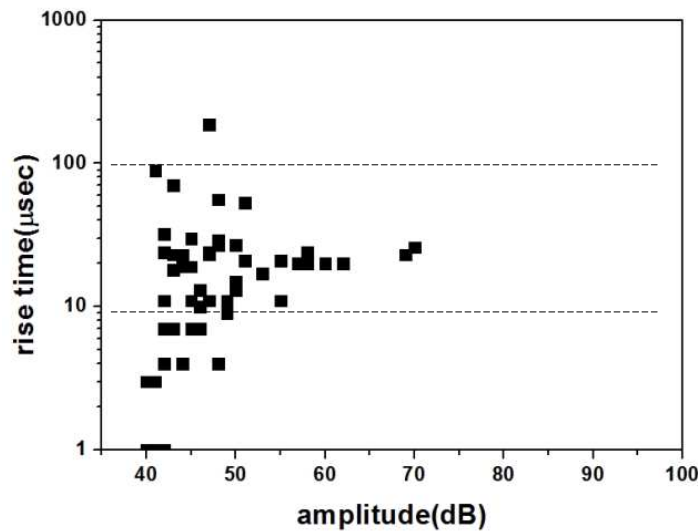
Figure 36 shows the distribution of rise time on the amplitude of the signals occurred in the final burst location. There is almost no rise time above 100 μ s and is dispersed around 10 μ s. It can be thought that the rise time which occurs during the growth of steel liner fatigue crack is similar to that during the growth of matrix crack.

Figure 36. Distribution of rise time on the amplitude of the signals

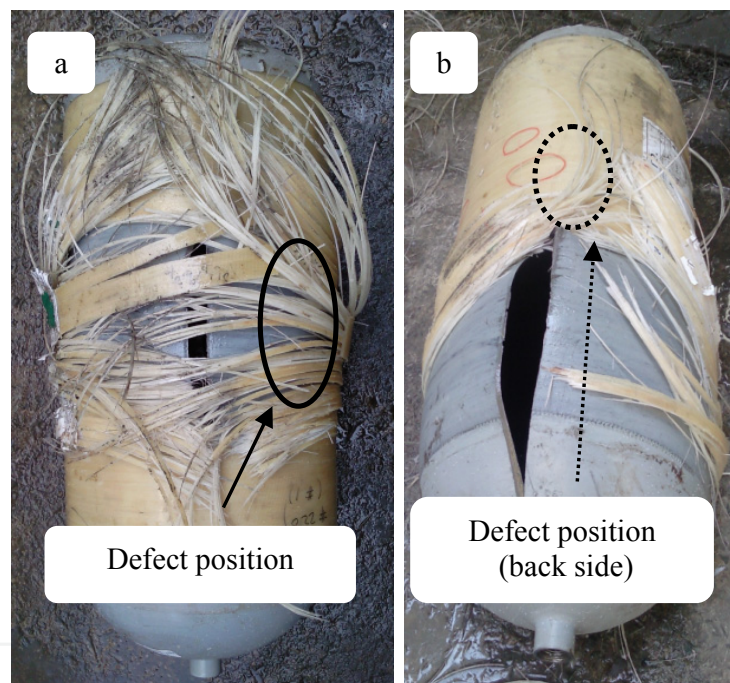
Figure 37 is a picture that shows the burst location in the vessel with the artificial defect. As shown in the picture, we can see that in the case of a vessel with a transverse defect, the final burst location is in the general burst location (cylinder and head area) for a well-constructed type II vessel. However, in the case of a vessel with a longitudinal defect, in both vessels, the final burst location was within the transverse vessel in which the defect was located. We think that this is because in the case of the longitudinal defect, the wrapped fiber is cut in 3 mm depth and in 50 mm length so the effect in which the thickness of the composite material is big, but in the case of the transverse defect, the fiber is cut only in 3 mm depth and in 3 mm length so the effect is small.

In this research, we cannot precisely know how much the depth of the defect has to be in order for the final burst pressure to change; however, the direction of the defect and the final burst location do have a correlation and we can infer that the longitudinal defect has a bigger effect on the final burst location.

Figure 37. Position of artificial defect and burst location : a) longitudinal, b) transverse
