Applying Post-Tensioning Technique to Improve the Performance of FRP Post-Strengthening

Mônica Regina Garcez,
Leila Cristina Meneghetti and
Luiz Carlos Pinto da Silva Filho

<http://dx.doi.org/10.5772/51523>

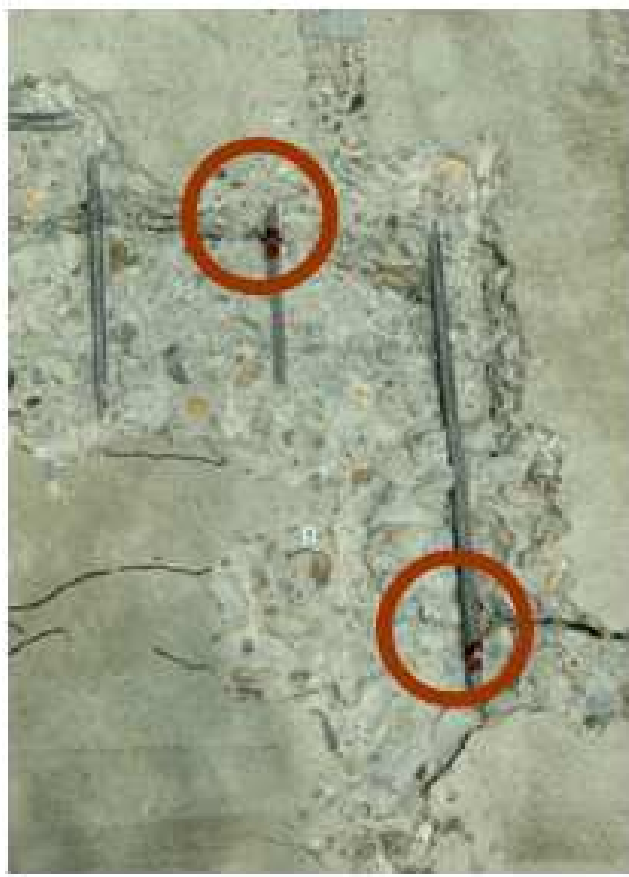
Figure 9. Failure of concrete beam after fatigue loading test.

Meier U. [22] highlights that the steel rebars fail before the FRP post-strengthening, as can be seen in Figure 9 that shows the steel rebars of a post-strengthened concrete beam after a fatigue failure. However, cyclic loads can also damage the adhesive and affect the interface concrete-adhesive and adhesive-FRP, leading to premature failures.

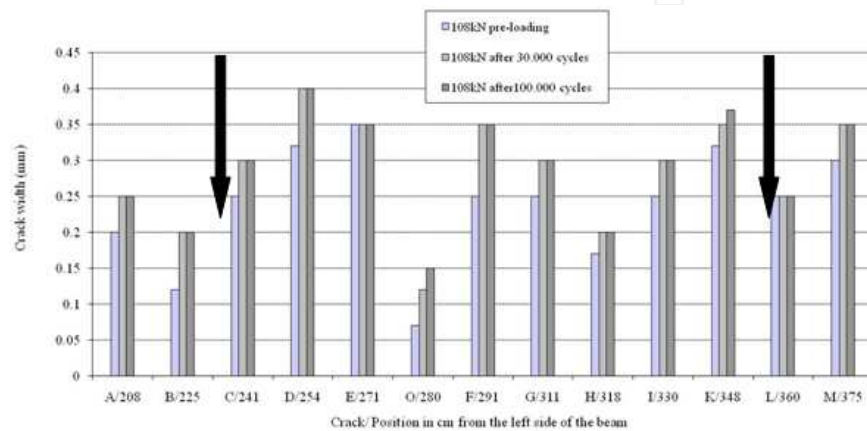
Figure 21. Cracks at mid-span of beam VFC_PC_01 after 100,000 cycles.

A high concentration of cracks can be observed at the mid-span of beam VFC_PC_01, between the four loading points. Figure 21 shows the crack openings at mid-span between the two central loading points (signaled on the figure by two vertical arrows). It is noteworthy that, before 100,000 cycles, crack openings did not reached 0.05mm.

The highest crack opening after 100,000 cycles, named D, was 0.4mm, located 254cm from the left side of the beam. However, apparently the post-strengthening failed due to a 2.2mm crack opening, named I, after 331,300 cycles. It is important to notice that, after 100,000 cycles, this crack opening was about 0.3mm (Figure 22).

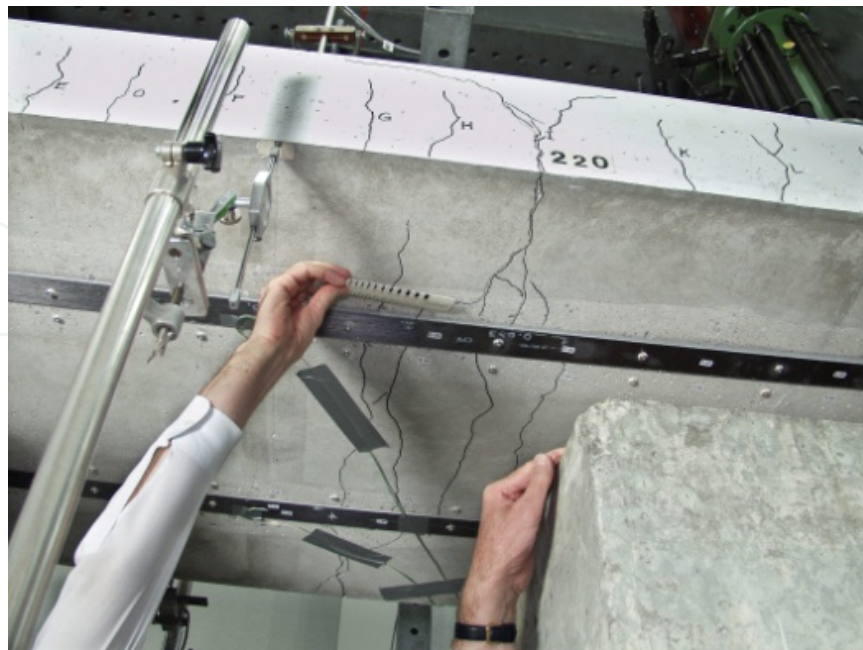
Figure 22. 2,2mm width crack at mid-span of beam VFC_PC_01 after post-strengthening failure.
