# Finite Element Analysis Applications in Failure Analysis: Case Studies

Ahmad Ivan Karayan, Deni Ferdian, Sri Harjanto,  
Dwi Marta Nurjaya, Ahmad Ashari and Homero Castaneda

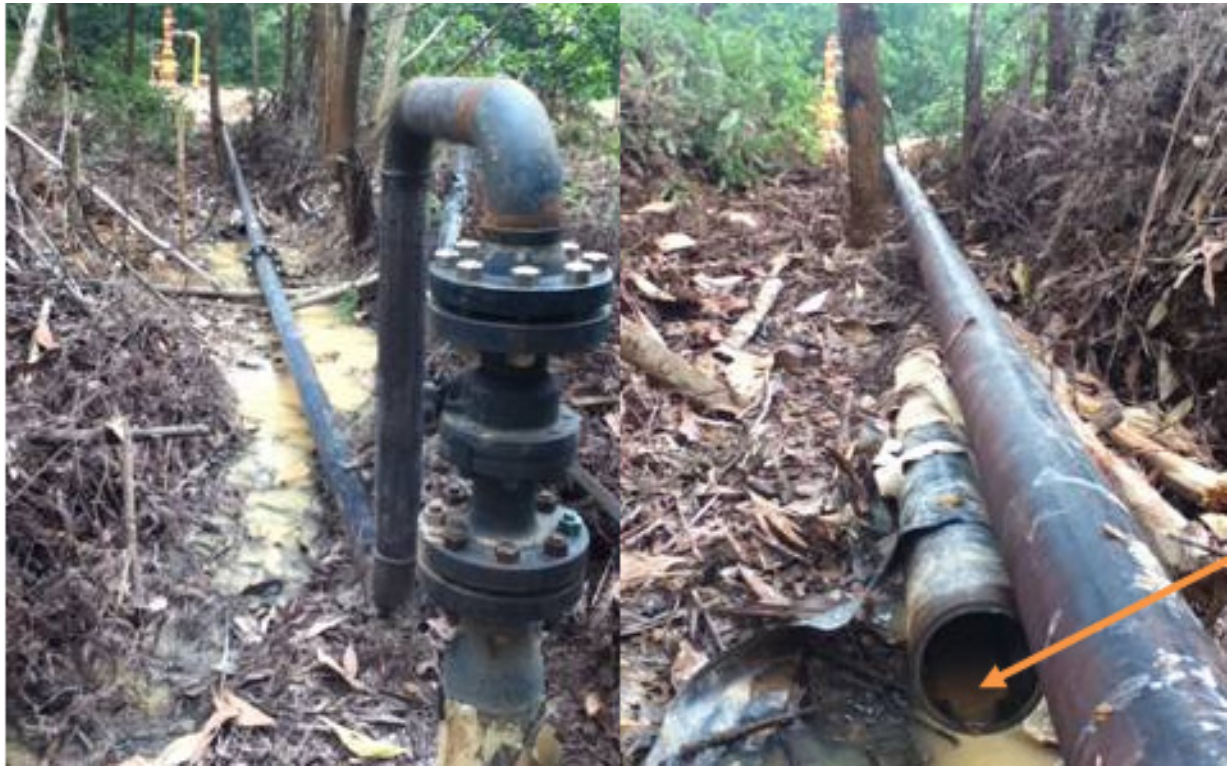
The last case is a trunkline that burst during service [19]. This incident produced a significant impact on the gas production of the company and also on the environment. The failure was characterized by a mesa-like attack and wall thinning at the 5-7 o'clock position on the inner surface. The location of failure is shown in Figure 5. A reddish brown corrosion product was noticed on the surface, but there with no indication of the occurrence of an H<sub>2</sub>S attack found in the material. This trunkline, carrying the gas with a total pressure of 905 psi, spanned across the jungle in the descending position. The analysis of the gas composition is listed in Table 1. The topography and characteristics of the soil in which the trunkline was located and also the material specification data is listed in Table 2.

**Figure 5.** The specimen sent to the laboratory for analysis is indicated by arrow

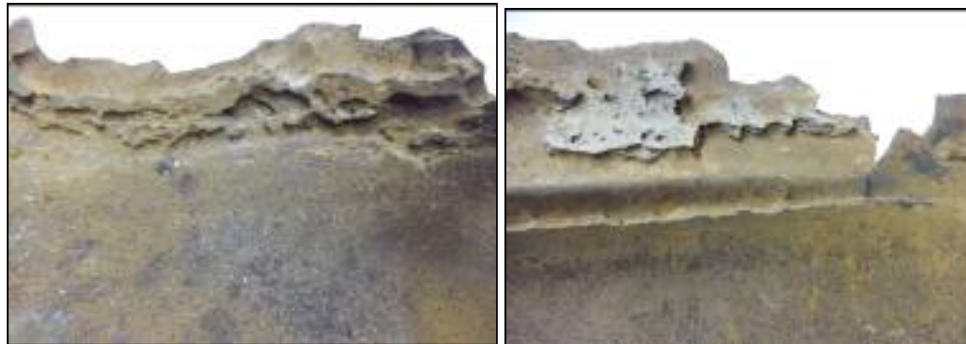
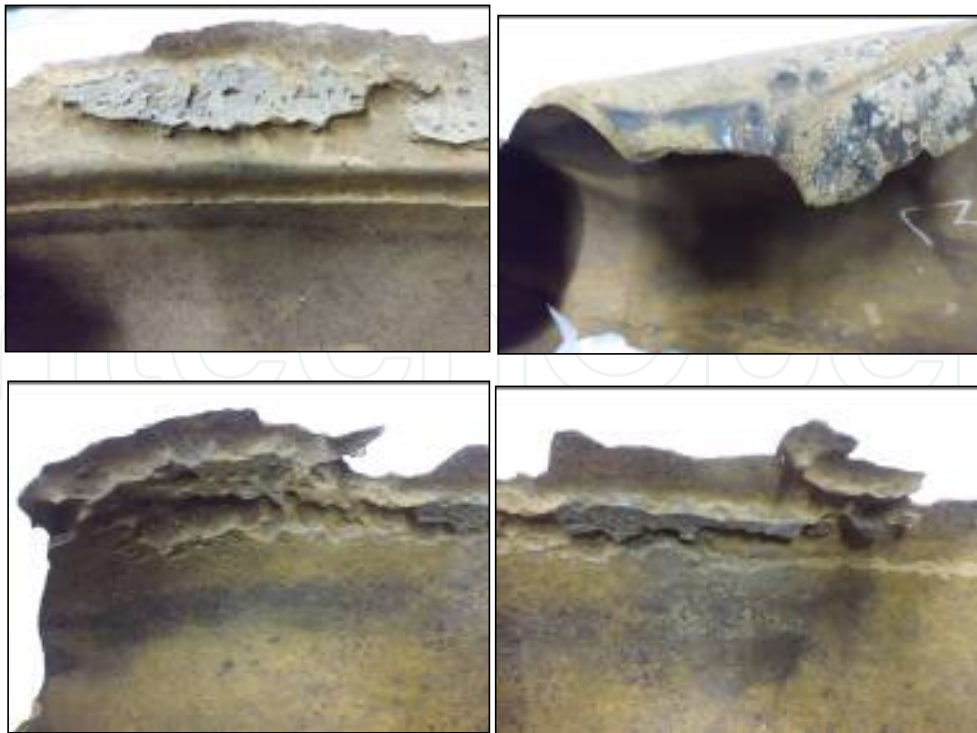
A visual examination showed that the burst area was located at the 6 o'clock position of the (a) downstream part and the (b) upstream part (Fig. 6). Some points on the inner surface of the downstream part at the 5-7 o'clock position showed surface degradation with wall thinning and pits (Fig. 7). Some points on the inner surface of the upstream part at the 5-7 o'clock position also showed surface degradation with wall thinning and pits (Fig. 8). A uniform attack at the burst area from the 5-7 o'clock position is shown in Figure 9.

**Figure 7.** Wall thinning and pits at 5 – 7 o'clock position of downstream part.

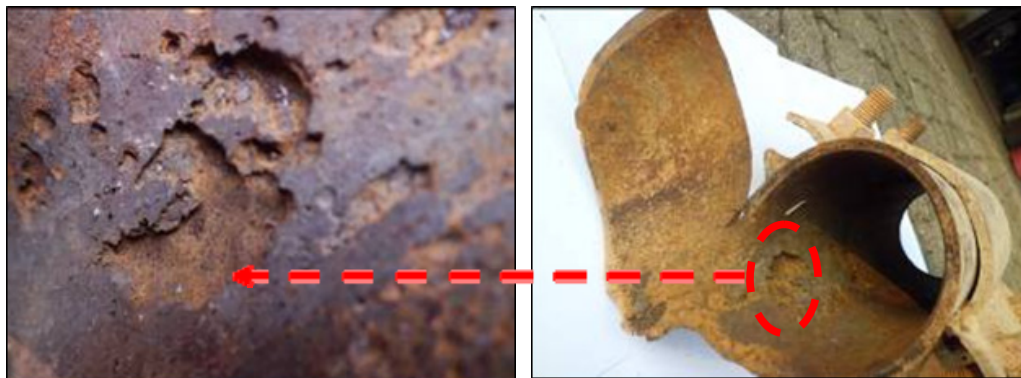
**Figure 8.** Wall thinning and pits at 5 – 7 o'clock position of upstream part.

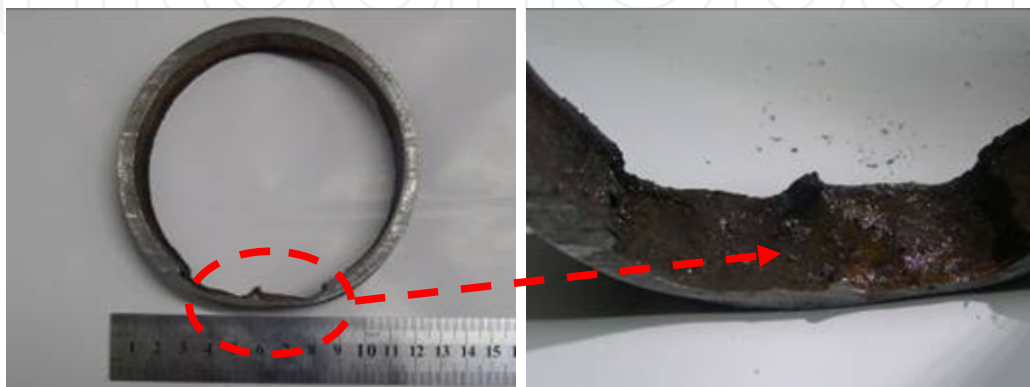
**Figure 9.** Uniform attack at the burst area from 5-7 o'clock position.

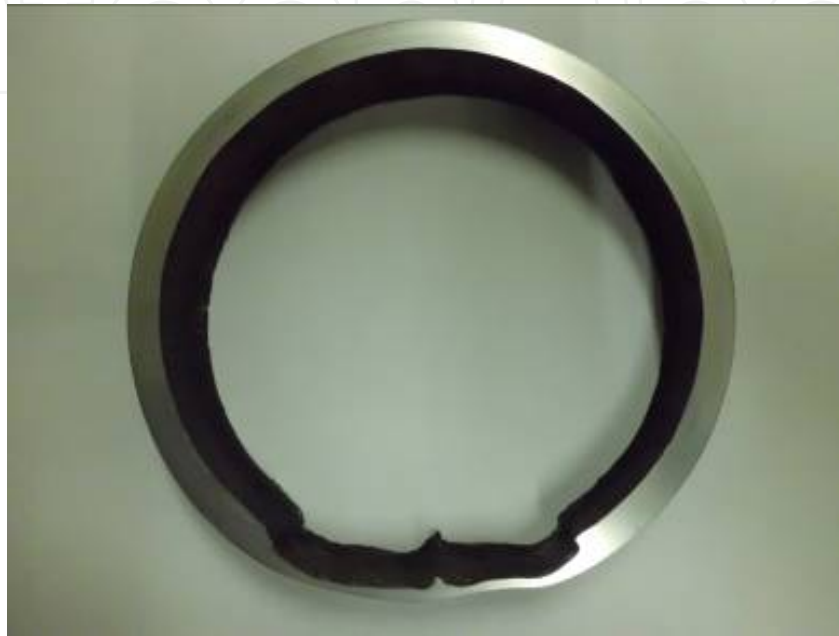
The metallographic preparation and macroetching were performed on the perimeter of the trunkline, and the results showed that the trunkline was made of seamless pipe (Figs. 10 and 11). The thinning area shown in Figure 9 was an ERW (electric resistance welding)-free area (Fig. 10). This information indicates that the failure could not be attributed to the ERW pipe issue.

**Figure 10.** Results of macroetching showing the absence of ERW.

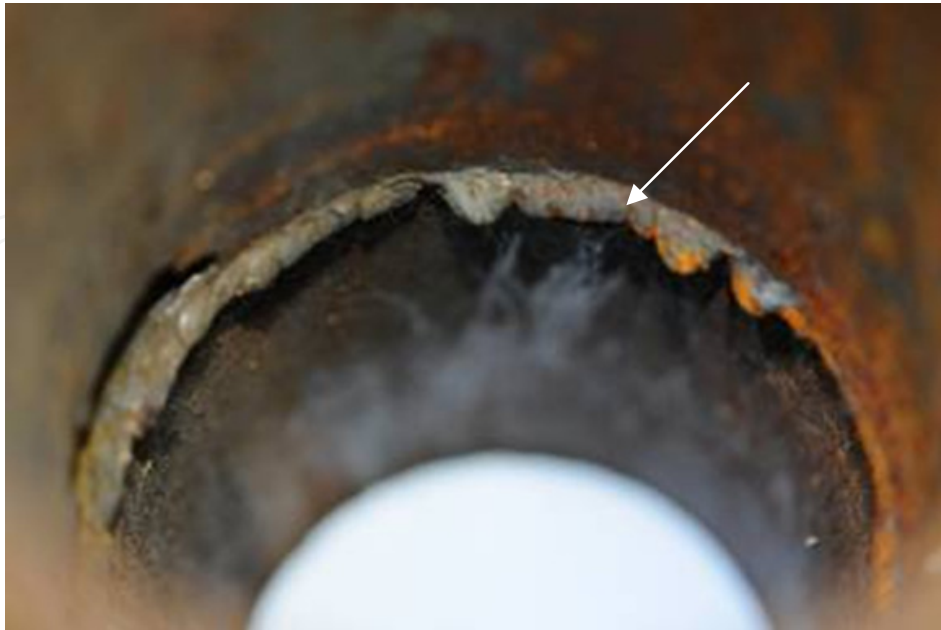
The finite element analysis was executed around the overfill, and the results (Fig. 13) showed that the area at which the pipe burst had a dead or eddy zone due to the excessive overfill (Figs. 14 and 15). Because there was no information about the initial overfill height, we assumed an overfill height of 1 cm for the finite element simulation. This selection was based on the fact that there was one point at the remaining overfill that had a height of 1 cm. The other areas were mostly degraded, with heights of less than 0.5 cm. Severe corrosion was noticed on every peak of overfill.

**Figure 14.** The inner side of circle area in Fig. 11 showing an excessive overfill (arrow) in the failed pipe at 12 o'clock position.

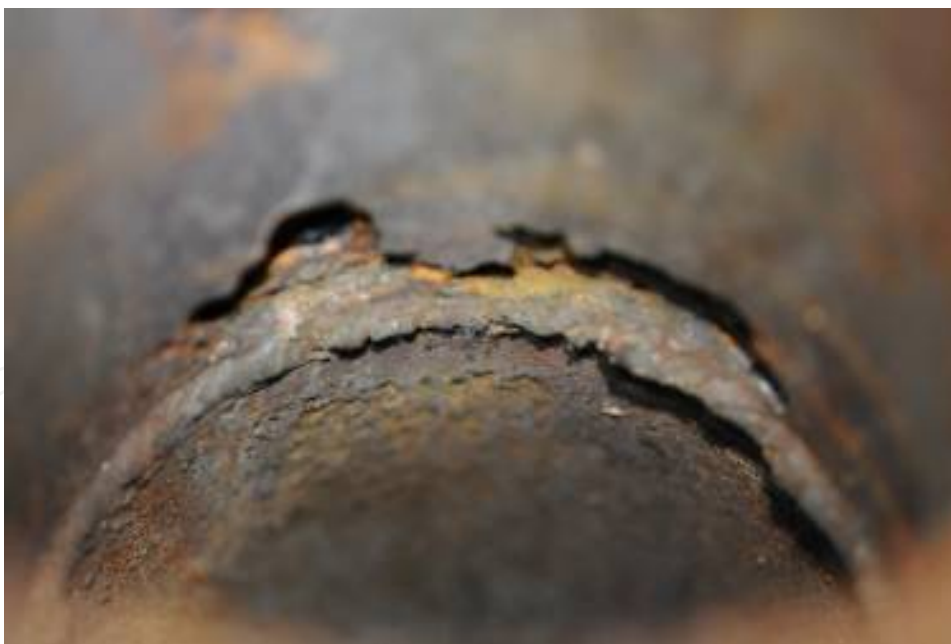
**Figure 15.** An excessive overfill and severe surface degradation beside overfill at 6 o'clock position.
