Land Use Changes and Environmental Problems Caused by Bank Erosion: A Case Study of the Kolubara River Basin in Serbia

Slavoljub Dragicevic, Nenad Zivkovic, Mirjana Roksandic, Stanimir Kostadinov, Ivan Novkovic, Radislav Tomic, Milomir Stepic, Marija Dragicevic and Borislava Blagojevic

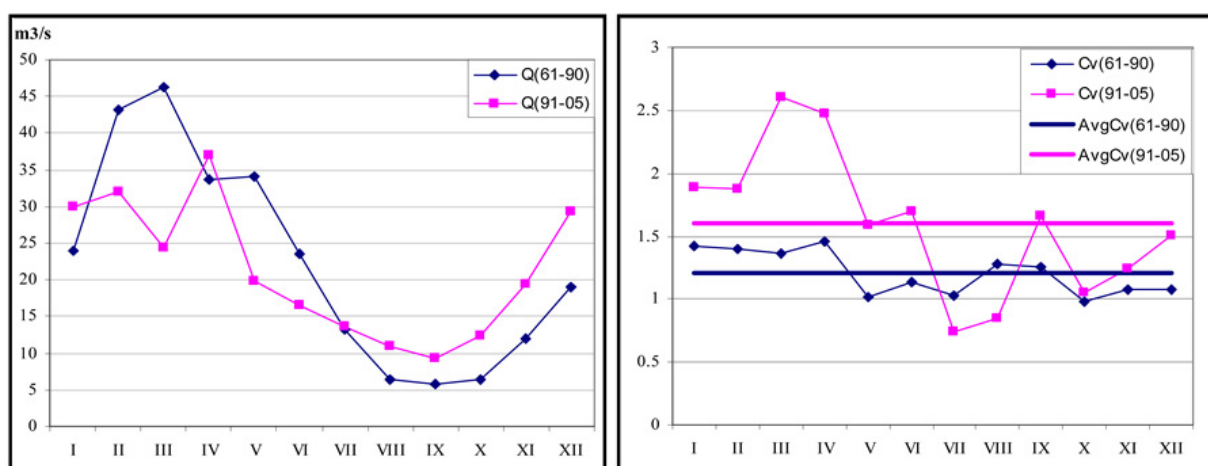
Figure 2. Mean monthly discharges (Q) and coefficients of variation (Cv) of the Kolubara River measured in Drazevac gauging station for the both periods of observation

To study water balance of the Donjokolubarski basin we used the following periods: 1925-1960, 1961-1990 and 1991-2005. With this approach it was possible to determine the changes that may be occurred after diverting the Kolubara River into the Pestan's riverbed in 1959. Briefly, precipitation analysis showed that the second period was a bit wetter than the first, actually about 60 mm in the Pestan River basin and 80 mm in the Turija River basin and the Tamnava River basin. Meanwhile, higher air temperatures and higher evaporation caused almost the same specific discharges of these rivers. The last period was in mean values similar to the second, apart from intensified variation of extreme values of all climatic elements. The discharges were influenced by more frequent alternation of wet and dry periods, which could be seen on figure 2.

Preliminary results of the Donjokolubarski basin annual flow variation show discrepancy in spring and summer monthly flow among two studied periods (Figure 2 - right). Further research should examine correlation of monthly flow and bank erosion intensity.

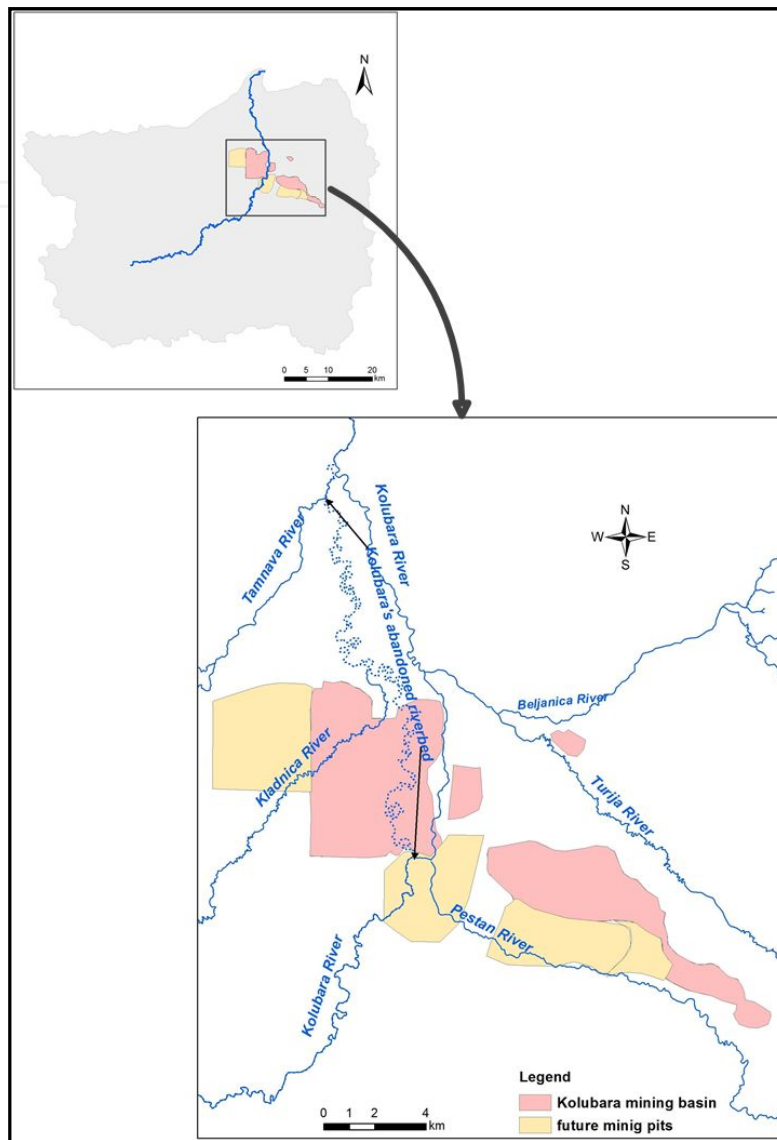
Figure 3. Plan of the mining fields in Kolubara mining basin [28]

Opencast lignite exploitation in Kolubara mining basin started in 1952 when the mining field "A" was open (it was exploited till 1966). Mining field "B" was opened in 1952, mining

field "D" in 1961, "Tamnava-East Mining Field" in 1979, "Tamnava-West Mining Field" in 1994 and mining field "Veliki Crljeni" in 2008 [28].

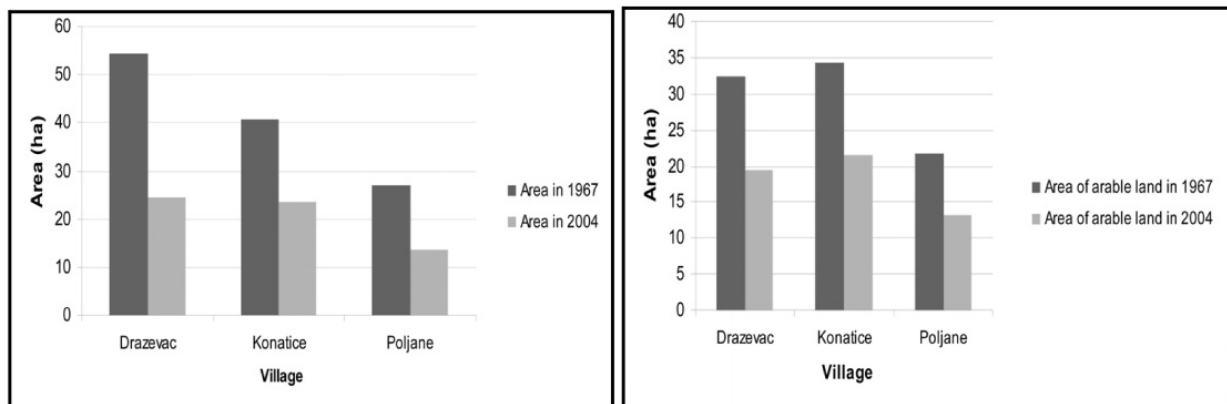
Figure 4. Land use changes in total area (left) and area of arable land (right) in Drazevac, Konatice and Poljane between 1967 and 2004

From 247 endangered land parcels, 136 are arable land with the area of 111.6 ha in 1967, and 76.48 ha in 2004, which means that within 37 years 35.12 ha of arable land was lost for farming, and it is 31.5 % of the initial area (in 1967). The woods comprise 21 of all endangered land parcels with area of 6.87 ha in 1967, and 3.01 ha in 2004, which means that it has been lost 3.86 ha of woods. There are only the three endangered land parcels with pastures, and their area was 1.27 ha in 1967, and 0.57 ha in 2004. All five endangered land parcels with meadows are in the area of Drazevac village.

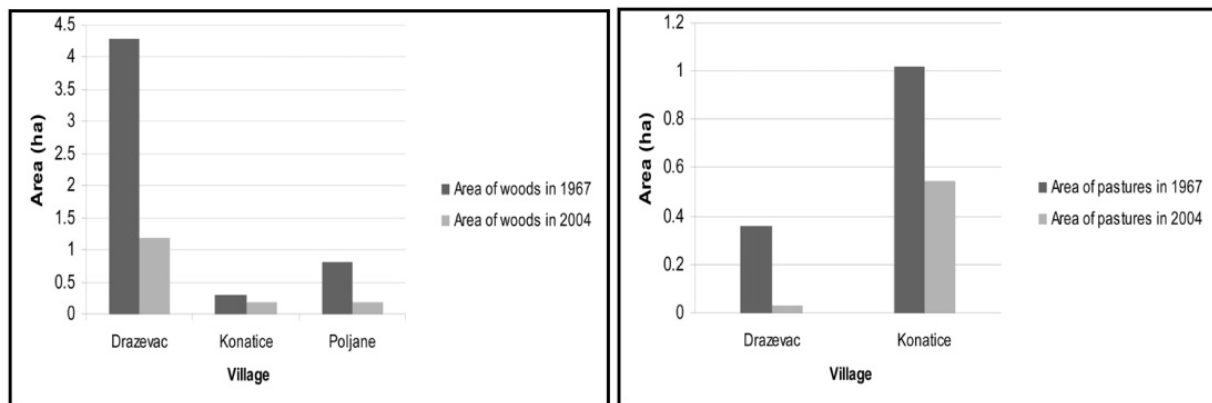
Figure 5. Land use changes in area of woods (left) and area of pastures (right) in Drazevac, Konatice and Poljane between 1967 and 2004

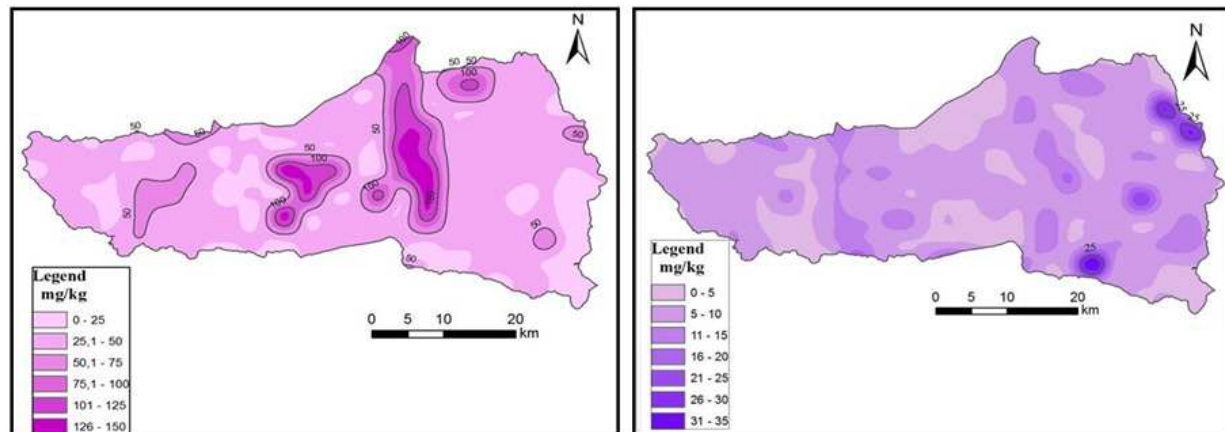
Figure 6. Distribution of Ni (left) and As (right) in the soil of the Donjokolubarski basin [18].

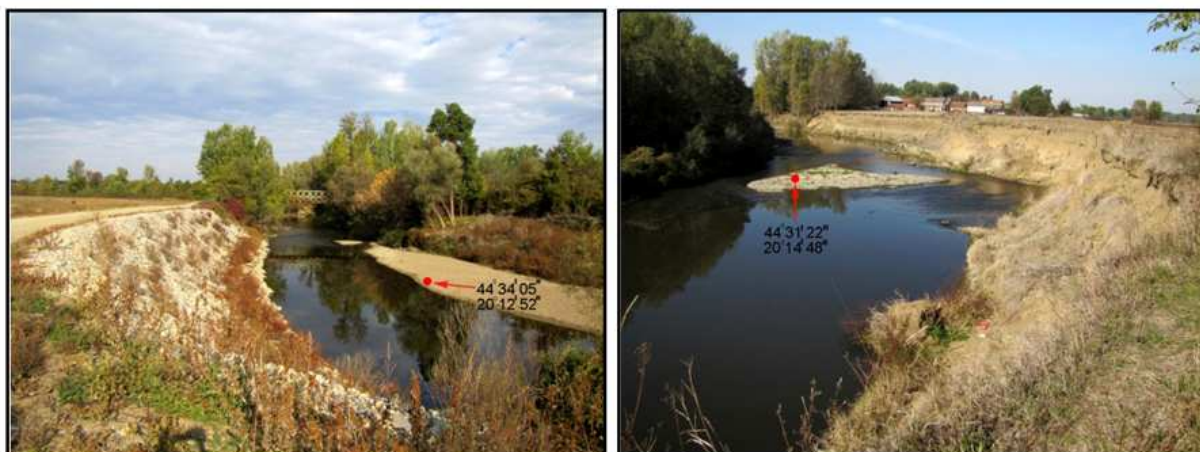
Figure 7. Sampling of deposited sediments on location 1 (left) and 2 (right)

The deposited sediments have sandy-clay texture. Chemical characteristics of deposited sediments from Kolubara's riverbed are: mildly alkaline reaction, high bases saturation degree and low humus content. The average heavy metal concentration in sediments decreased in the order: Ni > Cr > Zn > Pb > Cu > Cd.
